2006 Annual Inspection Report

CertainTeed Site (Site # C915185) Buffalo, New York

ENVIRONMENTAL INSPECTION FORM

CertainTeed Site (Portions of Parcels 1 and 2 of Hanna Furnace)

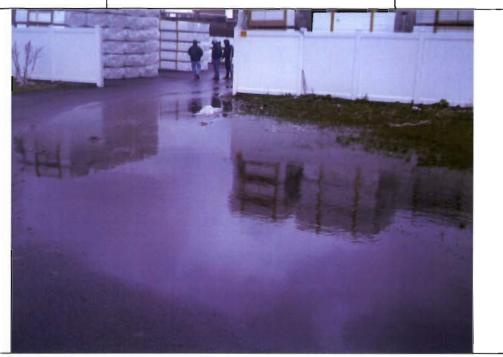
3) Grass cover impacted by truck traffic at turns in pavement - see photos #1, #	‡3 and #5.	
Mitigation of these items is anticipated in late spring of 2007.

East entrance to storage yard.

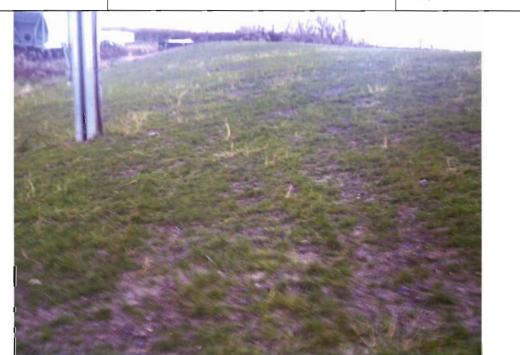
2 11/17/06 Direction Photo Taken:

1) Sparse grass cover on eastern site berm - See photo #2.		
2) Sparse grass cover and related soil erosion on south side of west entrance to see photos #4 and #6.	rear materials	storage yard -

East berm.

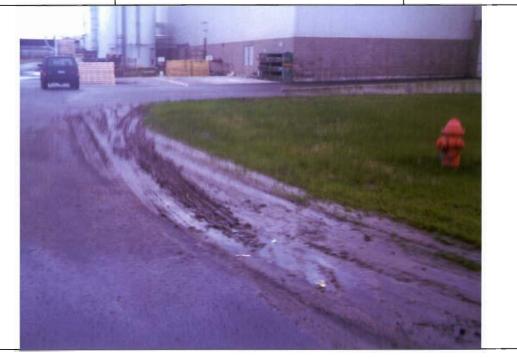
East side of plant.

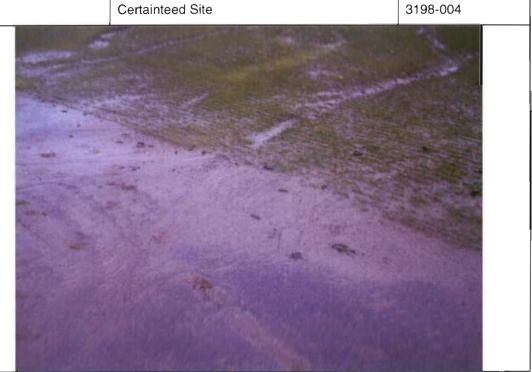
South side of West entrance to storage yard.

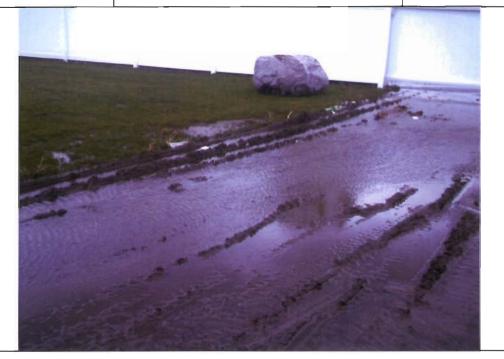
Photo No. 11/17/06 5

West entrance to Storage yard.

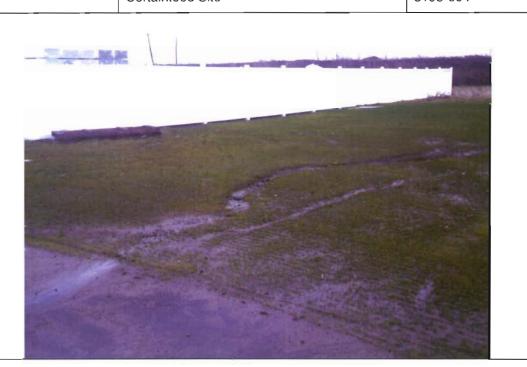
West Side of storage yard.

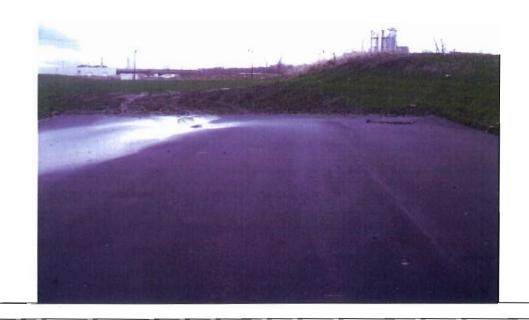
0009 11/17/06 Direction Photo Taken:

- At the western end of the site near were the field trailer was located
- North of and adjacent to the manufacturing building where planting of ornamental trees was completed.
- To the east of the eastern paved lot.

East end of Eastern paved lot.

Completion of the grass cover will occur as soon as growing conditions allow next spring.

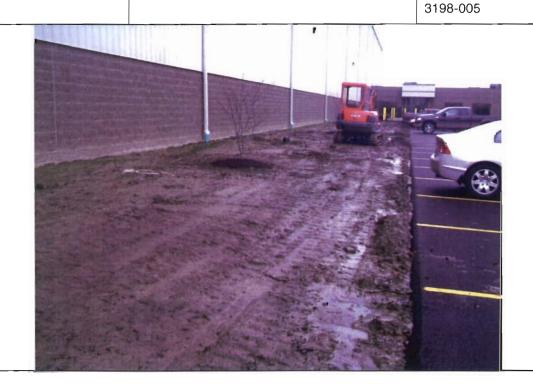
0010 11/17/06 Direction Photo Taken:

Area between Northern wall of building and main parking lot.
