Subject:
Annual Periodic Review Report
Buffalo Lakeside Commerce Park (Certain Teed Site), BCP Site #C915185 Buffalo,
New York

ENVIRONMENTAL INSPECTION FORM

Site Name: Buffalo Lakeside Commerce Park (CertainTeed Site)

Inspection Date: August 19, 2011

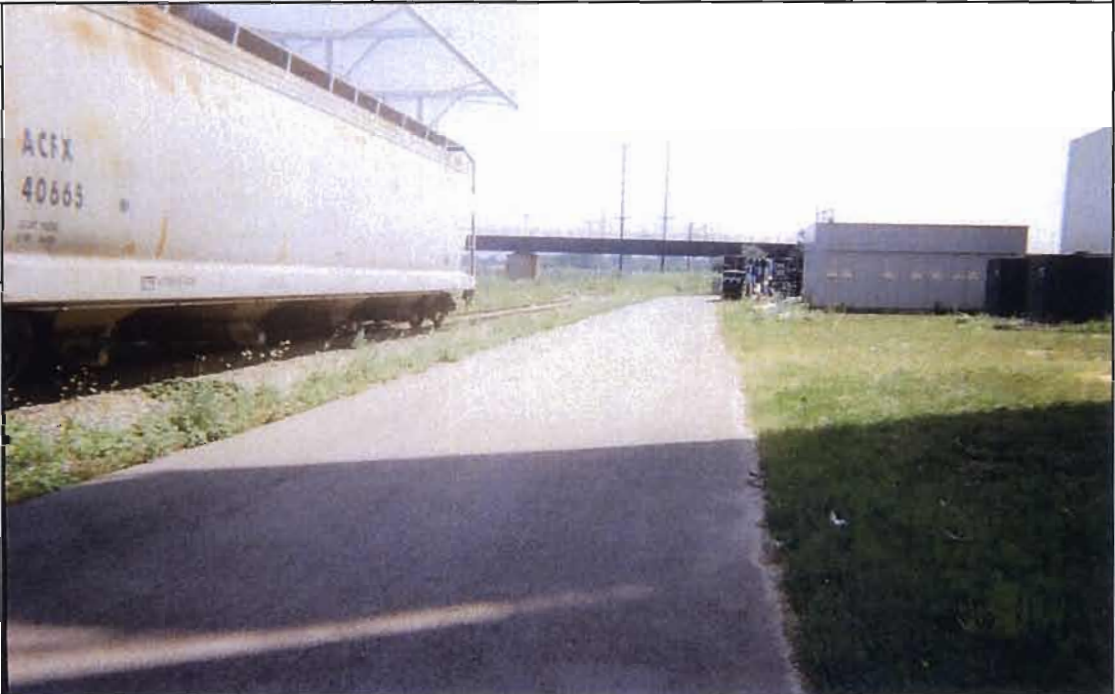
Project: Certain Teed Site – Annual Site Cover System Inspection		Location: Buffalo, New York	Project No. 06223001.0000
Photo No. 2	Date: 08-19-11

Direction Photo Taken: South			
Description: East side access road to south storage yard.

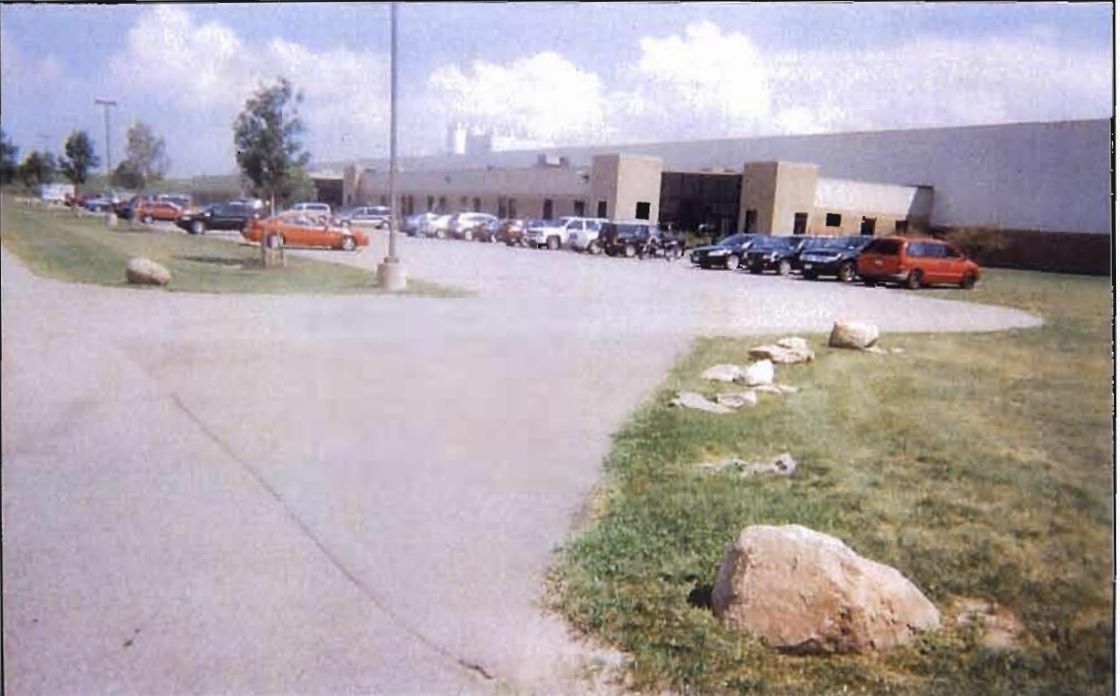
Project: Certain Teed Site – Annual Site Cover System Inspection		Location: Buffalo, New York	Project No. 06223001.0000
Photo No. 7	Date: 08-19-11

Direction Photo Taken: Southeast			
Description: Main parking lot with added pavement and traffic control rocks at entrance.

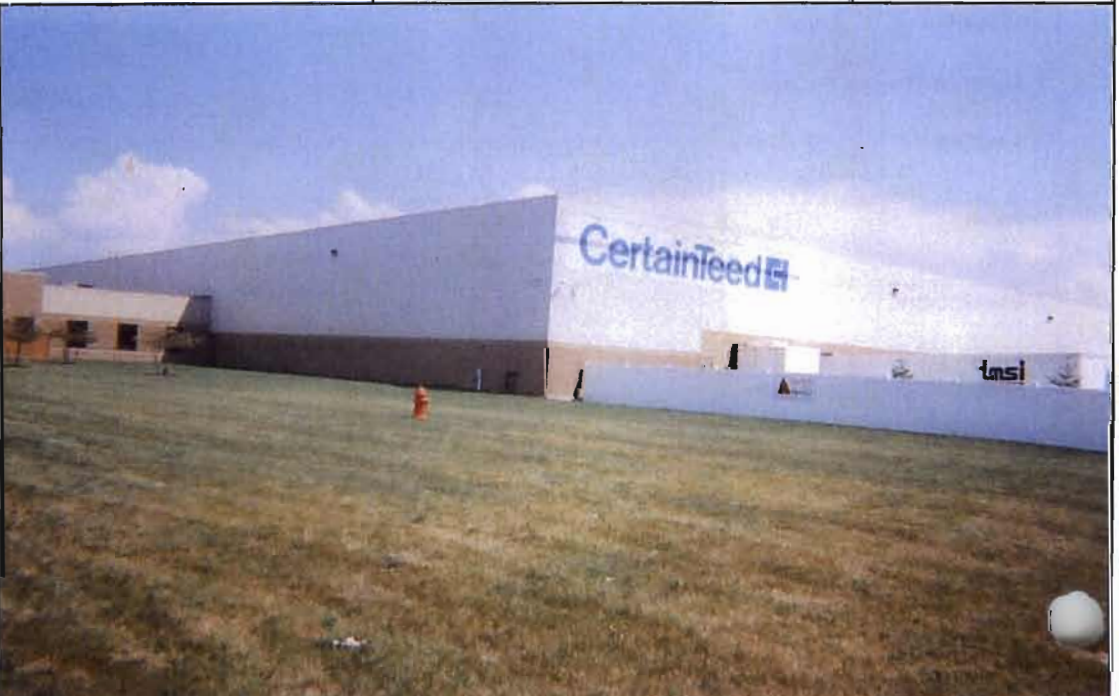
Project: Certain Teed Site – Annual Site Cover System Inspection		Location: Buffalo, New York	Project No. 06223001.0000
Photo No. 8	Date: 08-19-11

Direction Photo Taken: Southeast			
Description: Front lawn with improved grass coverage.

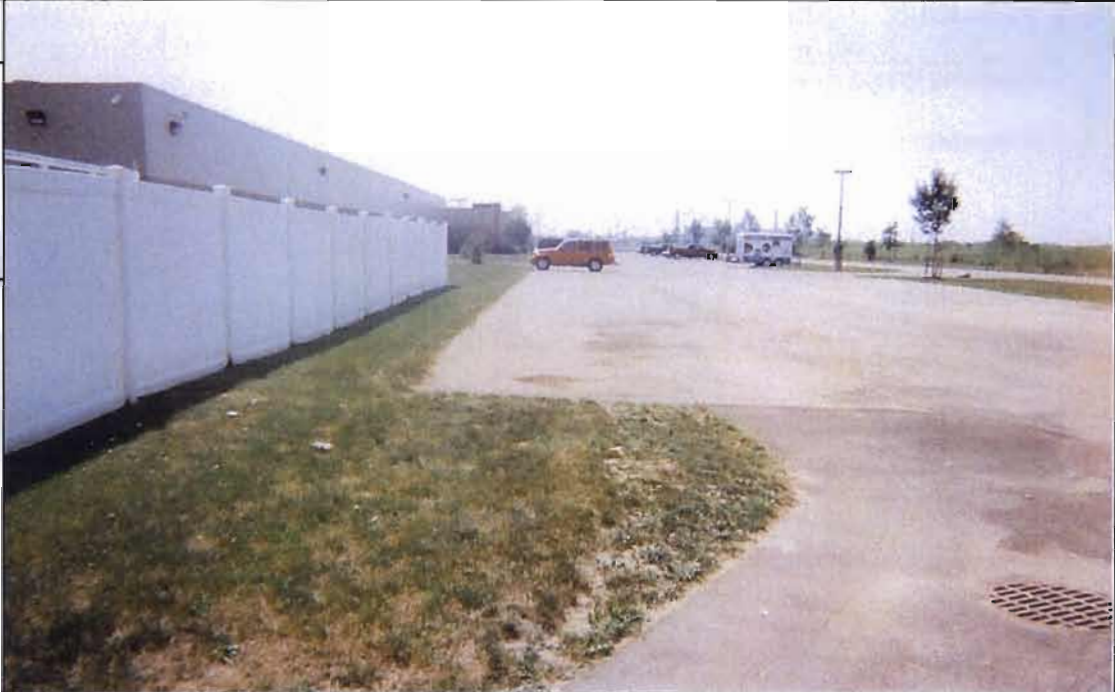
Project: Certain Teed Site – Annual Site Cover System Inspection		Location: Buffalo, New York	Project No. 06223001.0000
Photo No. 11	Date: 08-19-11

Direction Photo Taken: West			
Description: East end of main parking lot with adjoining lawns.

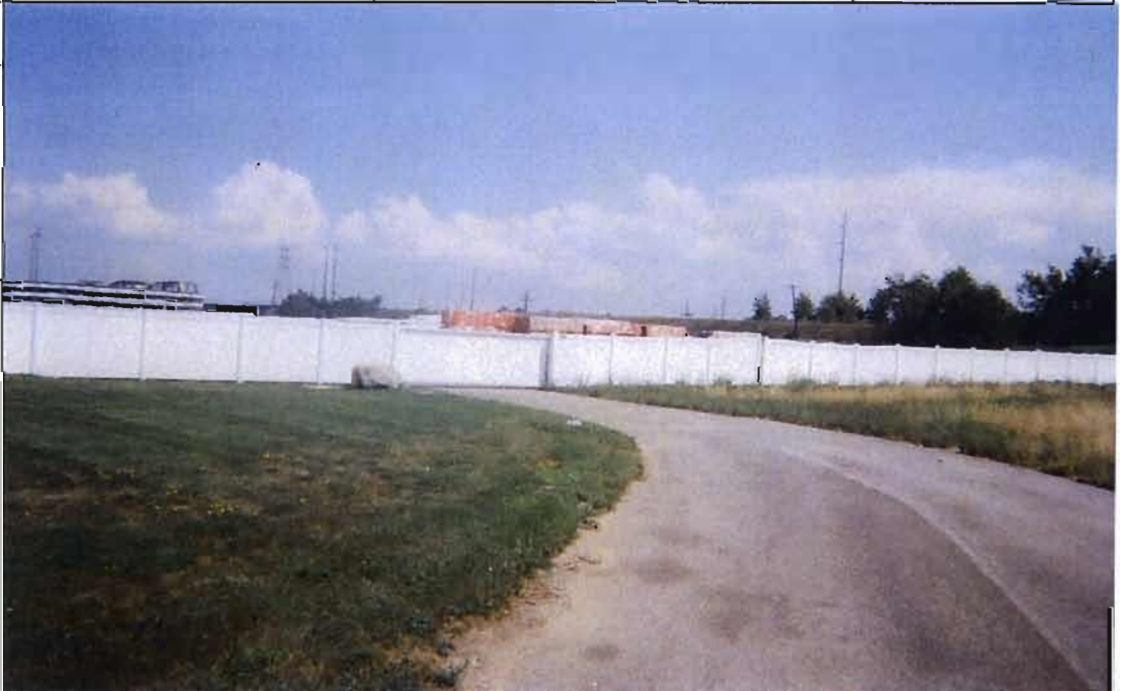
Project: Certain Teed Site – Annual Site Cover System Inspection		Location: Buffalo, New York	Project No. 06223001.0000
Photo No. 19	Date: 08-19-11

Direction Photo Taken: Southeast			
Description: Full vegetative cover at pavement edges along west entrance road to the south storage yard. (improved from last year)
