# 2021 PERIODIC REVIEW REPORT BUFFALO LAKESIDE COMMERCE PARK (CertainTeed Site) BUFFALO, NEW YORK BROWNFIELD CLEANUP PROGRAM Site Number C915185

April 30, 2021 File No. 21.0056854.00

Re: 2021 Periodic Review Report
Buffalo Lakeside Commerce Park (CertainTeed Site)
231 Ship Canal Parkway, Buffalo, New York
Brownfield Cleanup Program Site (Number C915185)

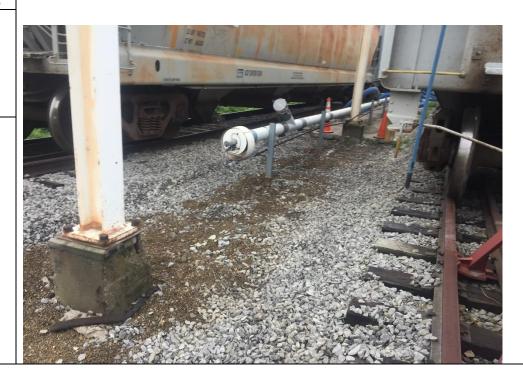
Area of removed and planned replacement of concrete pavement (between two rail lines).

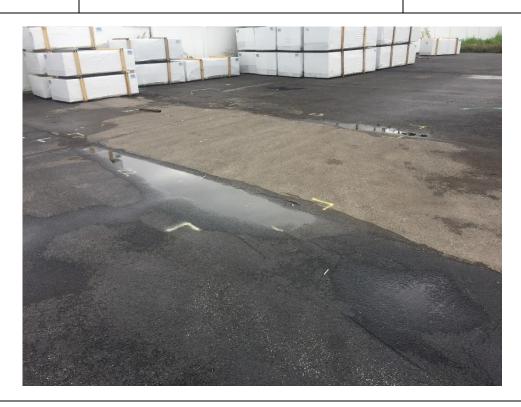
Photo No. 7

Marked (in yellow) areas of planned pavement repairs.

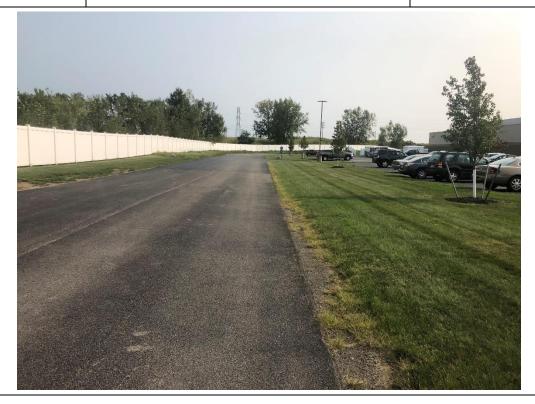
- The vegetative cover of the soil cover system has a few areas of bare spots due mostly to trucks driving slightly off pavement, cutting corners, and material storage extending off paved surfaces; (see Photos # 1, 2, 3, and 19).
- One area of the paved Site road showed signs of cracking, and weathering; (See Photo # 4).

- The vegetative cover of the soil cover system has a few areas of bare spots due mostly to trucks driving slightly off pavement, cutting corners, and material storage extending off paved surfaces; (see Photos # 1, 2, 3, and 19).
- One area of the paved Site road showed signs of cracking, and weathering; (See Photo # 4).
- Grass cover is missing in areas where product storage extends off of pavement; (See Photo #16).

View along Site Entrance Road. Limited areas of missing grass cover along road edges from vehicle tires.

During the spring and summer of 2021, CertainTeed will repair vegetative cover and pavement in the areas mentioned above. The next site inspection is planned for early fall (September/October) of 2021 to demonstrate the above improvements.

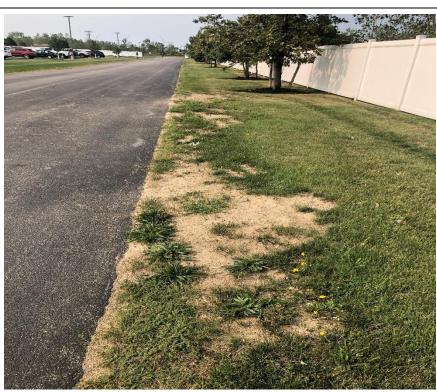
2 ...

Bare patches in grass cover along entrance road.

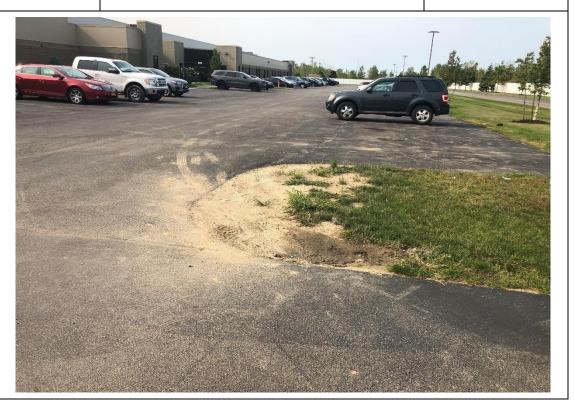
Missing grass by employee parking lot due to vehicle traffic.

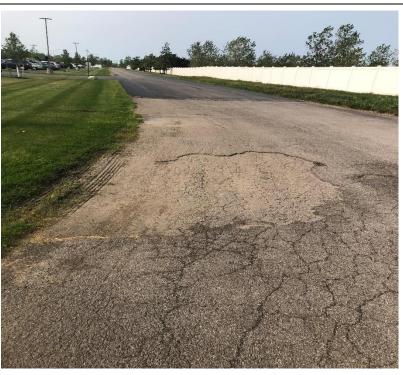
4

Cracked and weathered asphalt pavement of entrance road. Pavement cover still complete.

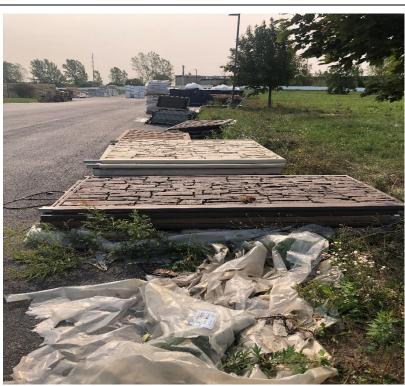
Photo No. Date: 16 9-16-20

Grass cover is missing in areas where product storage extends off of pavement; (See Photo #16).

Product storage extending off pavement. Missing grass cover observed as a result.

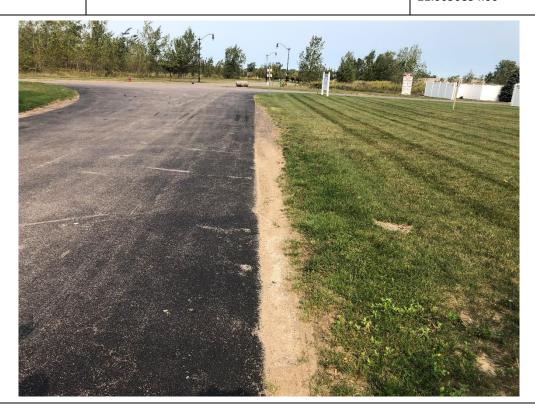
Missing grass cover along Site road to loading docks – caused by truck tires.
