Periodic Review Report

*Tecumseh Phase III Business Park
Sites III-7 and III-8
NYSDEC Site Nos. C915199G & C915199H*

*2537 Hamburg Turnpike
Lackawanna, New York*

April 2020

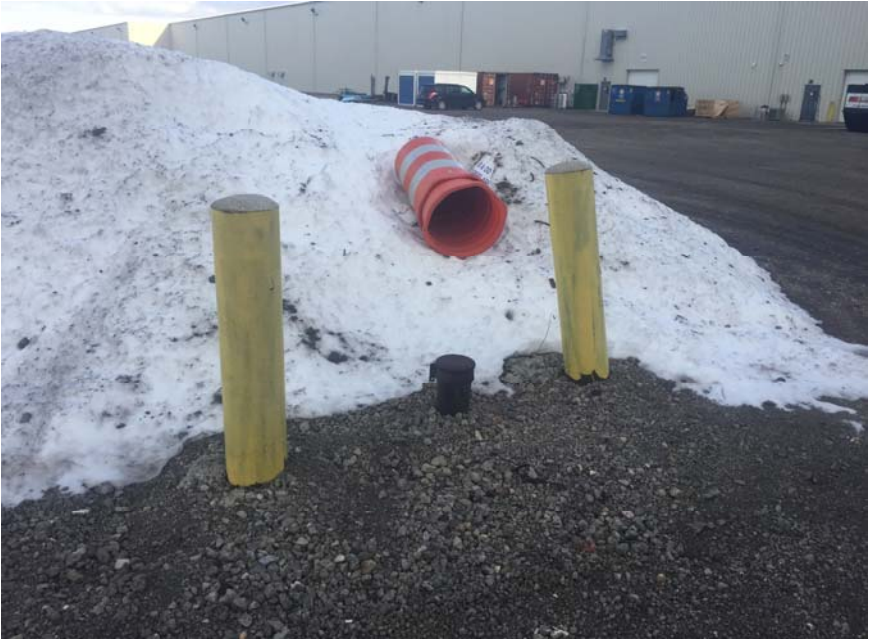
Client Name: Welded Tube USA, Inc.		Site Location: Welded Tube - Lackawanna NY Phase III-BP-7 & 8	Project No.: 0262-020-001
Photo No. 1	Date 02/02/17

Direction Photo Taken: North			
Description: Monitoring Well Maintenance - Conversion of stickup monitoring well to flush mount.

On March 13, 2017, Earth Dimensions, Inc. (EDI) converted five stickup monitoring wells to less intrusive flush mount monitoring wells to avoid potential damage from heavy yard equipment and vehicles. EDI cut the existing monitoring well protective casing below ground surface (but within the cover system layer) and installed at grade road-boxes set into a 1-foot by 1-foot concrete pad. Benchmark personnel oversaw the monitoring well

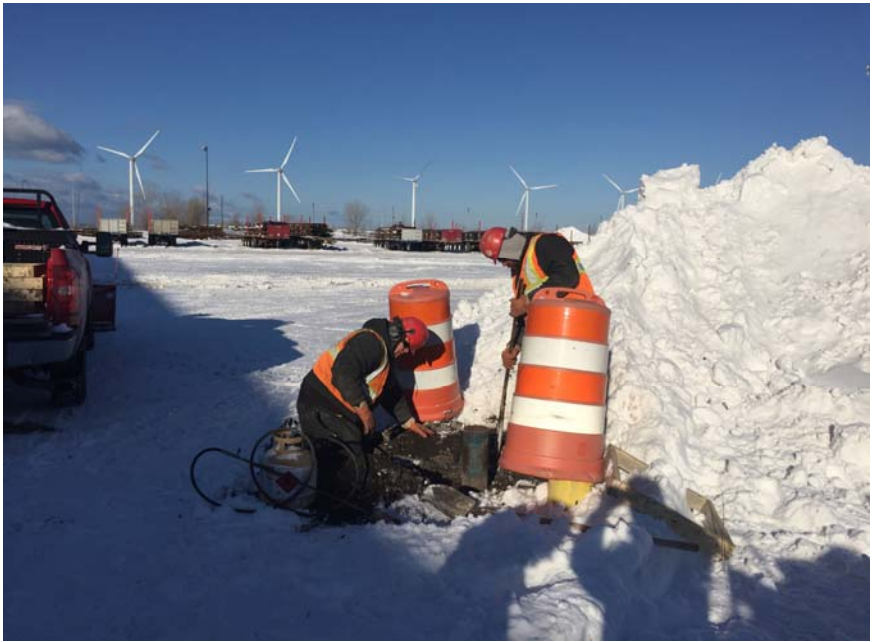
Photo No. 2	Date 03/13/17

Direction Photo Taken: West		
Description: Monitoring Well Maintenance - Conversion of stickup monitoring well to flush mount.

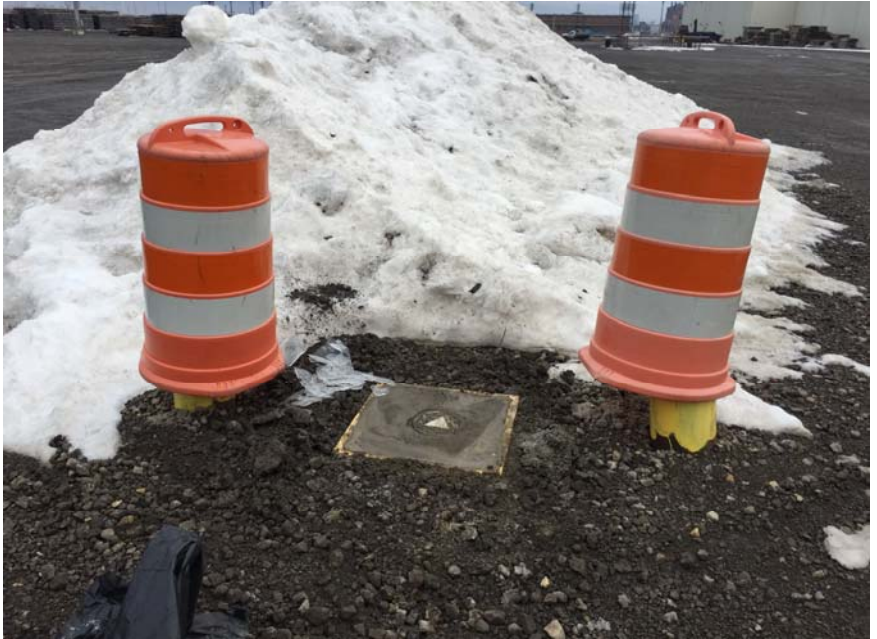
Client Name: Welded Tube USA, Inc.		Site Location: Welded Tube - Lackawanna NY Phase III-BP-7 & 8	Project No.: 0262-020-001
Photo No. 3	Date 03/24/17

Direction Photo Taken: North			
Description: Monitoring Well Maintenance - Conversion of stickup monitoring well to flush mount.

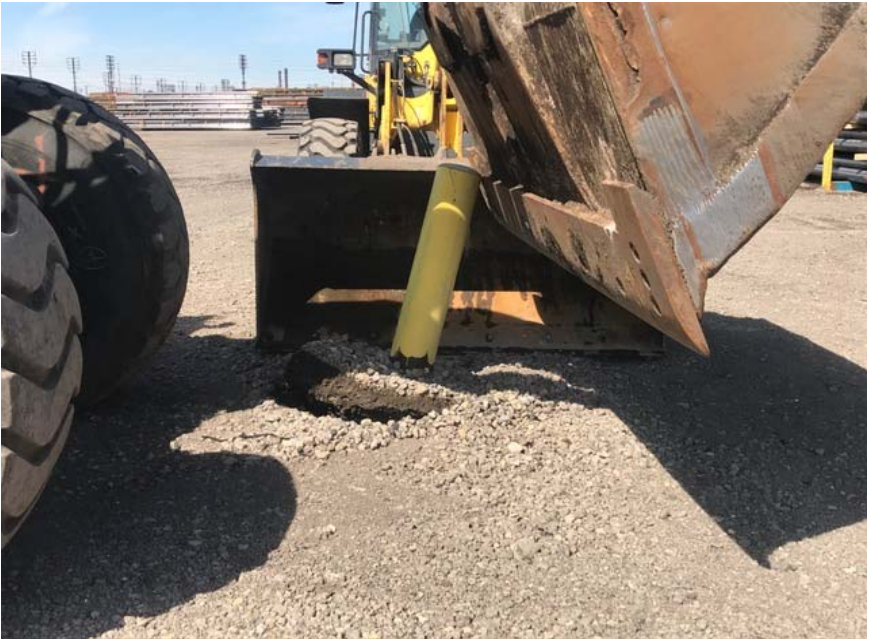
Photo No. 4	Date 03/24/17

Direction Photo Taken: North		
Description: Bollard Removal

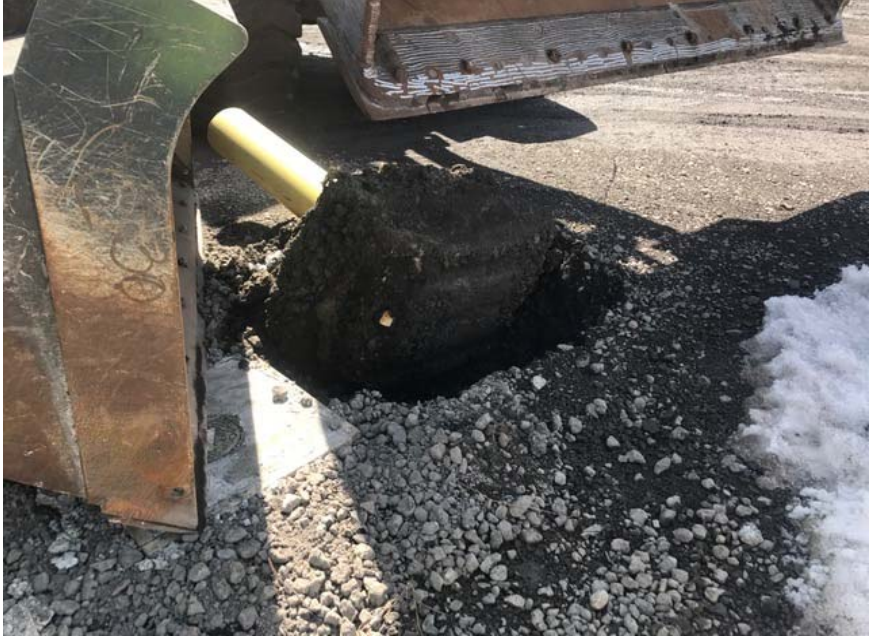
Client Name: Welded Tube USA, Inc.		Site Location: Welded Tube - Lackawanna NY Phase III-BP-7 & 8	Project No.: 0262-020-001
Photo No. 5	Date 03/24/17

Direction Photo Taken: NA			
Description: Bollard Removal

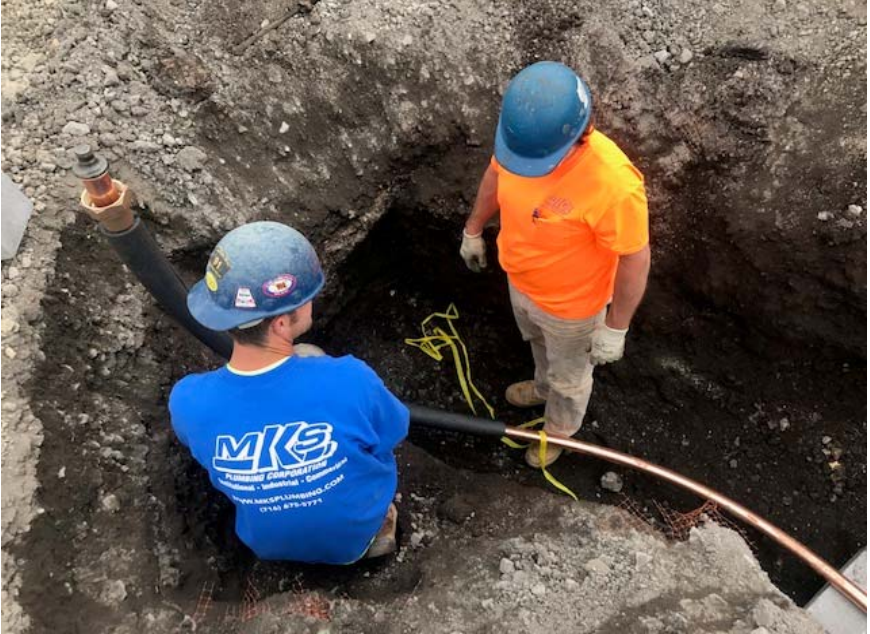
Client Name: Welded Tube USA, Inc.		Site Location: Welded Tube - Lackawanna NY Phase III-BP-7 & 8	Project No.: 0262-020-001
Photo No. 7	Date 06/29/17

Direction Photo Taken: North			
Description: Water Line Connection/Hydrostatic Testing

On June 29, 2017, MKS Plumbing (site contractor) completed an approximate 50' trench to approximately 4.5 feet below grade to allow installation of a water line to service a new hydrostatic pressure testing unit. Initially the upper 12-inch slag cover material was removed and set aside away from work. Subgrade materials were excavated, field screened by Benchmark personnel, and temporarily stockpiled adjacent to work area. Benchmark personnel oversaw ground intrusive activities as required by the SMP. After the new waterline was connected and successfully pressure tested, MKS Plumbing used the screened stockpiled material as subgrade backfill, placed demarcation fabric 12-inches below grade, and repaired the cover with 12-inches of washed no. 1A virgin stone from Gernatt Asphalt Products, Inc. Air monitoring was not performed due to precipitation. Copies of daily field logs are included in Appendix C and a photolog of ground intrusive activities is provided in Appendix B. No materials were exported from the Site.

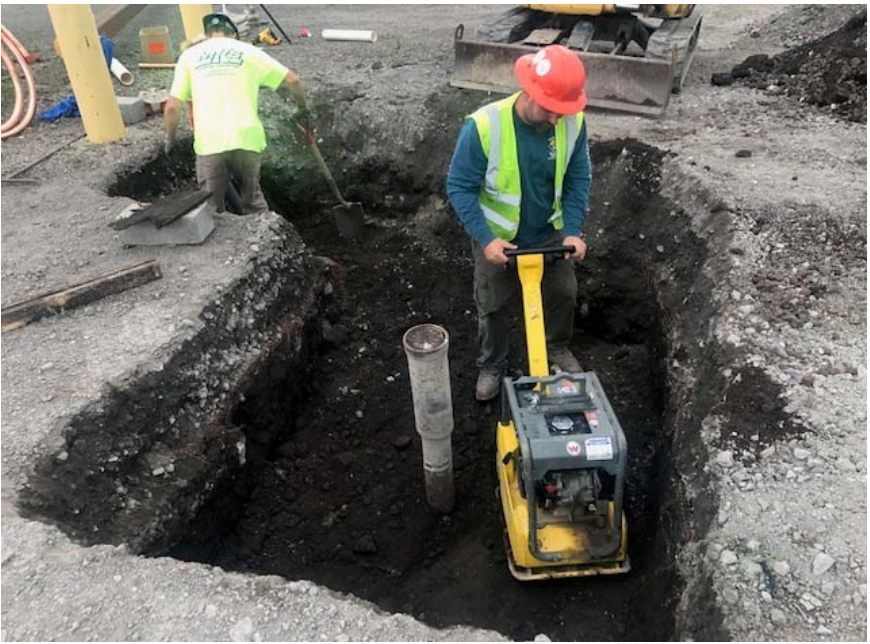
Photo No. 8	Date 06/29/17

Direction Photo Taken: North		
Description: Water Line Connection/Hydrostatic Testing

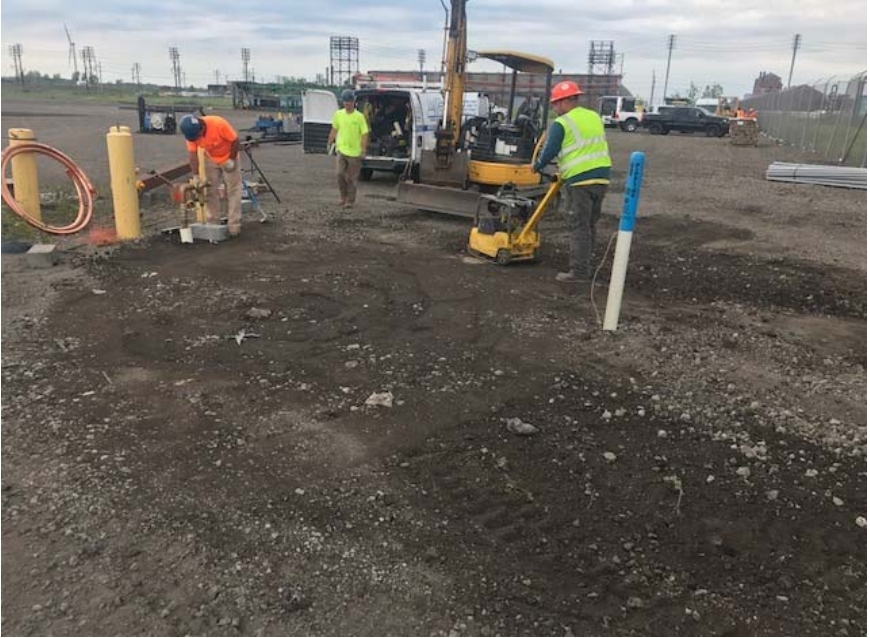
Client Name: Welded Tube USA, Inc.		Site Location: Welded Tube - Lackawanna NY Phase III-BP-7 & 8	Project No.: 0262-020-001
Photo No. 9	Date 06/29/17

Direction Photo Taken: North			
Description: Water Line Connection/Hydrostatic Testing

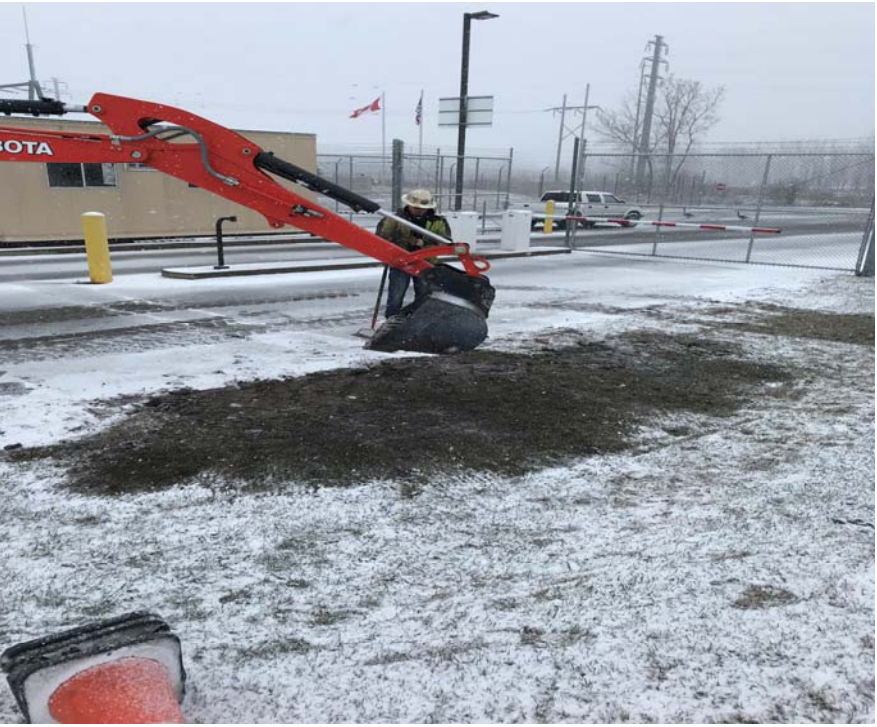
Client Name: Welded Tube USA, Inc.		Site Location: Welded Tube - Lackawanna NY Phase III-BP-7 & 8	Project No.: 0262-020-001
Photo No. 11	Date 04/06/18

Direction Photo Taken: South			
Description: Electric Line Repair Activities - Backfill and compaction.

On April 6, 2018, Ferguson Electric (site contractor) completed an excavation to a depth of two feet below grade to replace damaged electrical cable that powers four light poles on the south side of the property near the front guard shack. Benchmark personnel oversaw ground intrusive excavation activities as required by the SMP to ensure segregation of the upper one-foot of slag cover material above the existing demarcation layer and assure no visual or olfactory evidence of impact was encountered. Upon completion of the repair existing clean bedding stone was reused as backfill; the demarcation layer above the clean stone was replaced; and the cover system was restored using existing slag cover material. Air monitoring was not performed due to snow. No materials were imported or exported from the Site. Copies of daily field logs are included in Appendix C and electric line repair activities are photo documented in Appendix B.

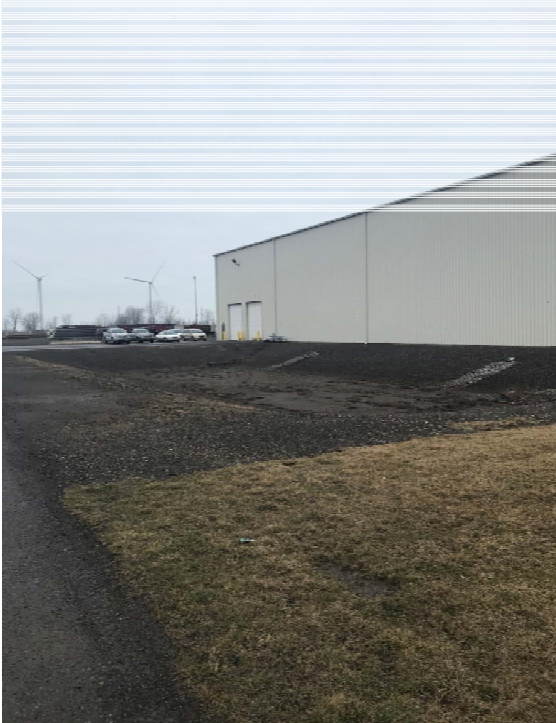
Photo No. 12	Date 03/19/20

Direction Photo Taken: Northwest		
Description: Infiltration basin on south side of building.

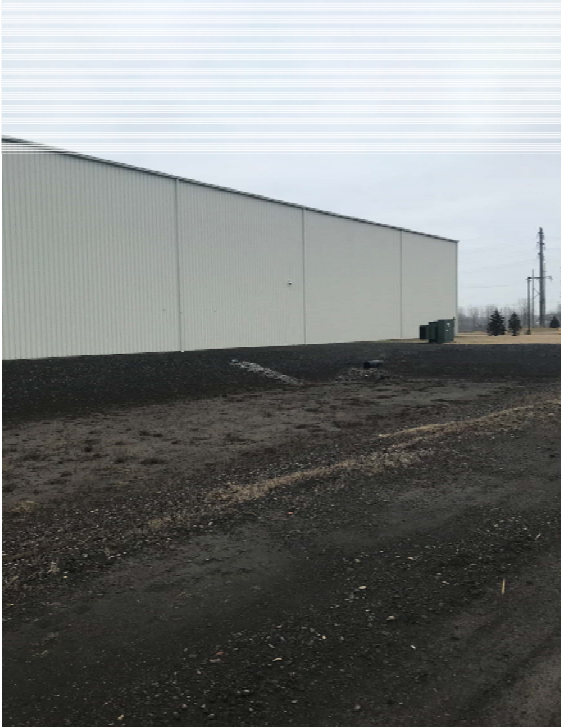
Client Name: Welded Tube USA, Inc.		Site Location: Welded Tube - Lackawanna NY Phase III-BP-7 & 8	Project No.: 0262-020-001
Photo No. 13	Date 03/19/20

Direction Photo Taken: Northeast			
Description: Infiltration basin on south side of building.

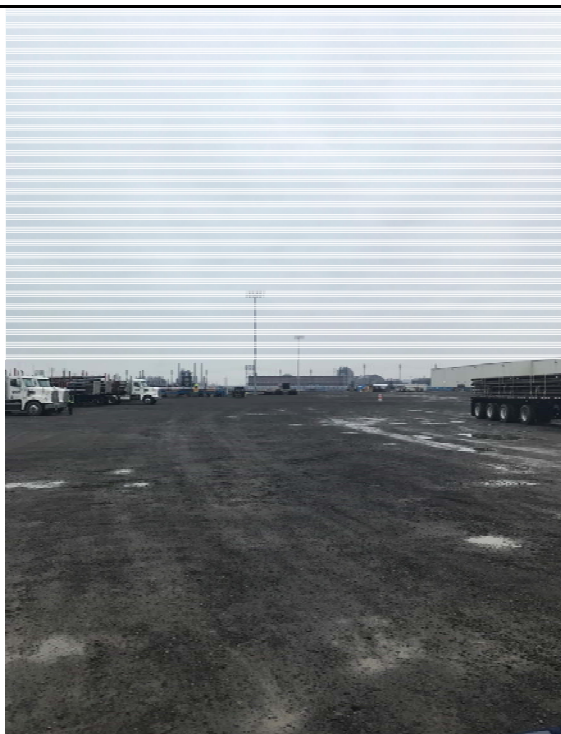
Photo No. 14	Date 03/19/20

Direction Photo Taken: North		
Description: Laydown yard behind building

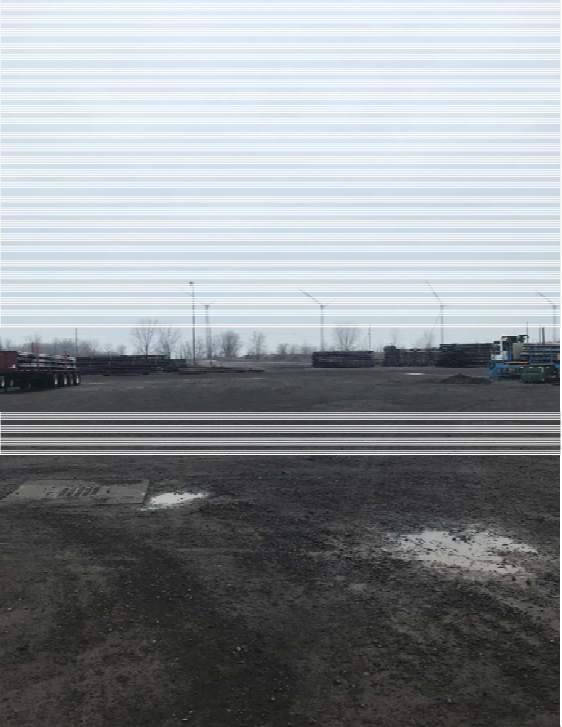
Client Name: Welded Tube USA, Inc.		Site Location: Welded Tube - Lackawanna NY Phase III-BP-7 & 8	Project No.: 0262-020-001
Photo No. 15	Date 03/19/20

Direction Photo Taken: West			
Description: Laydown yard behind building.

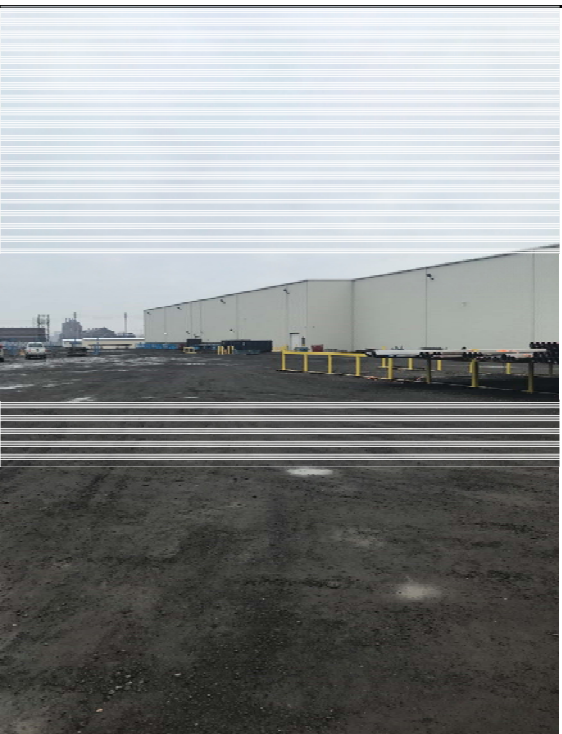
Photo No. 16	Date 03/19/20

Direction Photo Taken: Northeast		
Description: Back west side of building.

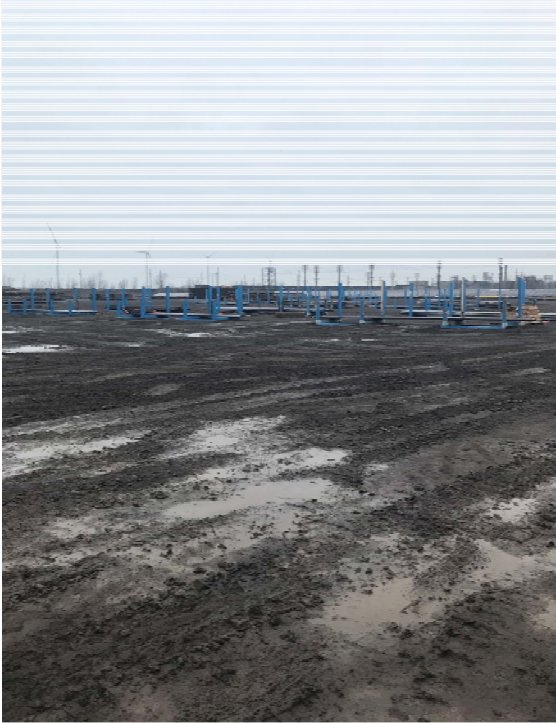
Client Name: Welded Tube USA, Inc.		Site Location: Welded Tube - Lackawanna NY Phase III-BP-7 & 8	Project No.: 0262-020-001
Photo No. 17	Date 03/19/20

Direction Photo Taken: Northwest			
Description: Pipe laydown area near northern limit of property.

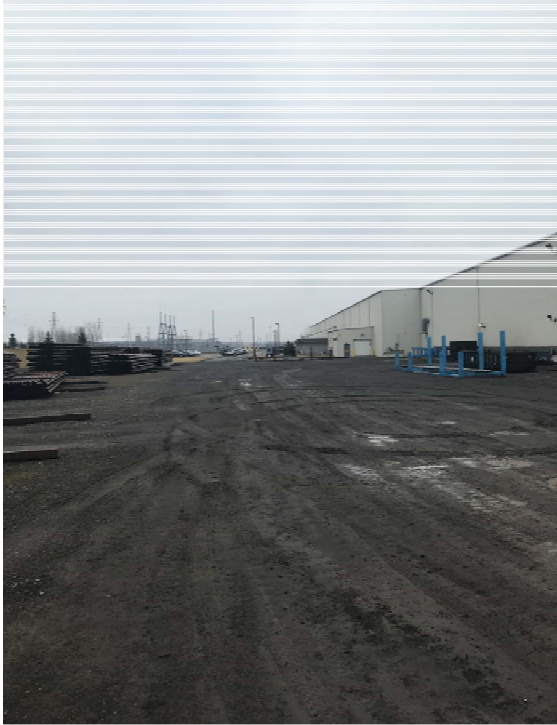
Client Name: Welded Tube USA, Inc.		Site Location: Welded Tube - Lackawanna NY Phase III-BP-7 & 8	Project No.: 0262-020-001
Photo No. 19	Date 03/19/20

Direction Photo Taken: South			
Description: East side of building looking south.

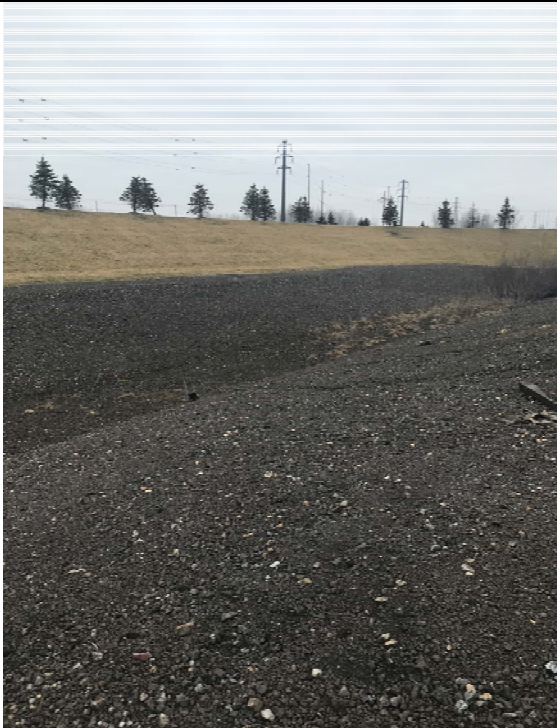
Photo No. 20	Date 03/19/20

Direction Photo Taken: Southeast		
Description: Infiltration basin east of building.

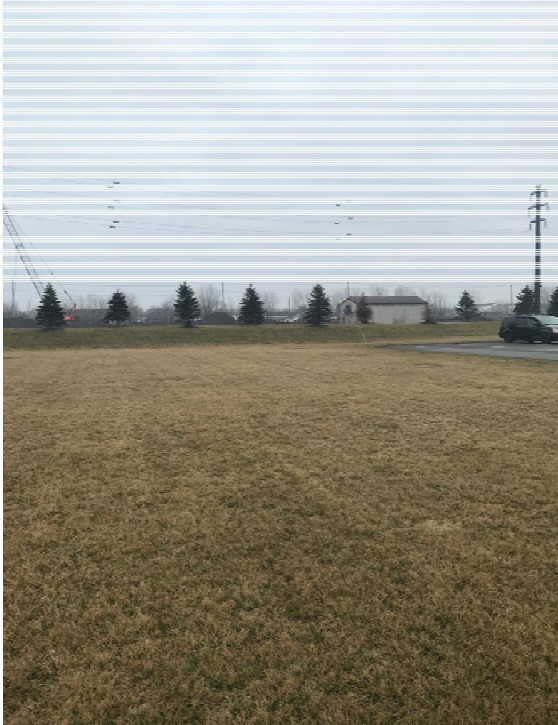
Client Name: Welded Tube USA, Inc.		Site Location: Welded Tube - Lackawanna NY Phase III-BP-7 & 8	Project No.: 0262-020-001
Photo No. 21	Date 03/19/20

Direction Photo Taken: East			
Description: Berm east of building.

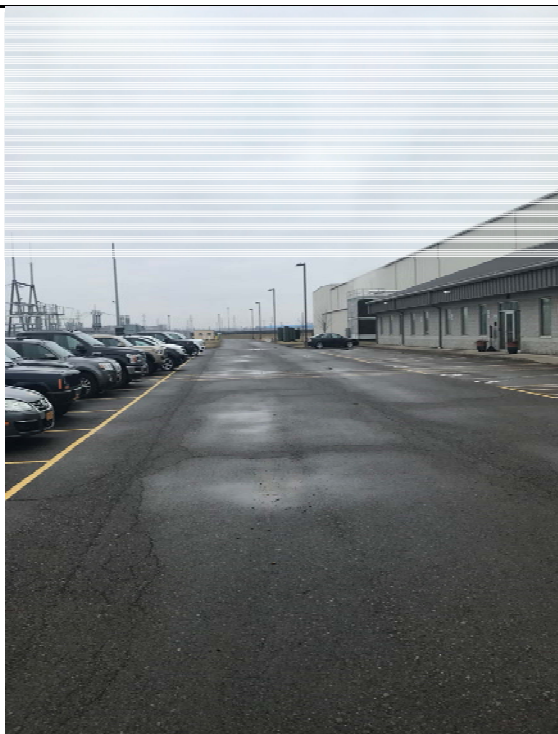
Photo No. 22	Date 03/19/20

Direction Photo Taken: South		
Description: Parking lot & driveway along east side of building.

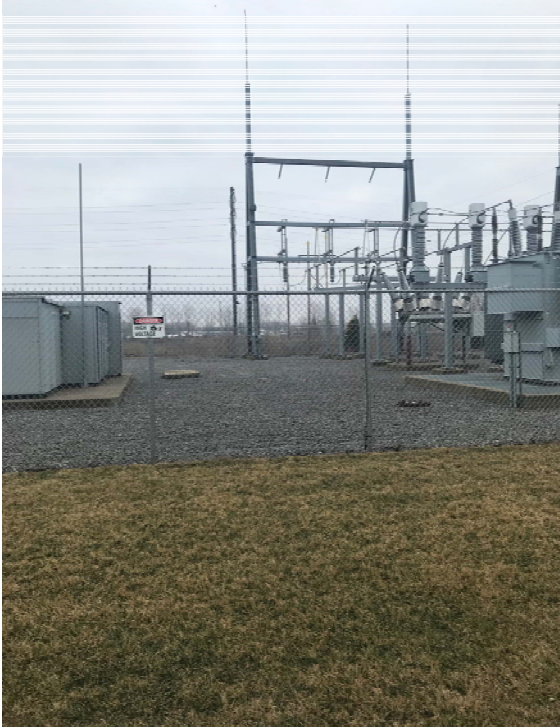
Client Name: Welded Tube USA, Inc.		Site Location: Welded Tube - Lackawanna NY Phase III-BP-7 & 8	Project No.: 0262-020-001
Photo No. 23	Date 03/19/20

Direction Photo Taken: East			
Description: Transformer Pad.

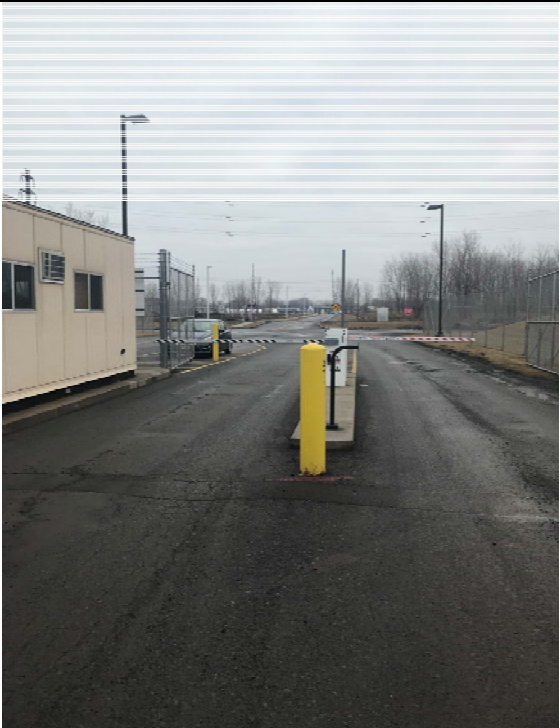
Photo No. 24	Date 03/19/20

Direction Photo Taken: East		
Description: Entrance drive looking east toward Dona Street Extension.
