**Re: Annual Periodic Review
Former NL Industries Site No. C915200**

2017 Periodic Review Report

Former NL Industries Site
NYSDEC Site No. C915200
3241 Walden Avenue
Depew, New York

The annual comprehensive Site inspection was conducted on June 7, 2017. The following sections discuss the findings of the 2017 inspection. The completed Site Inspection Form is provided as Appendix A to this report.

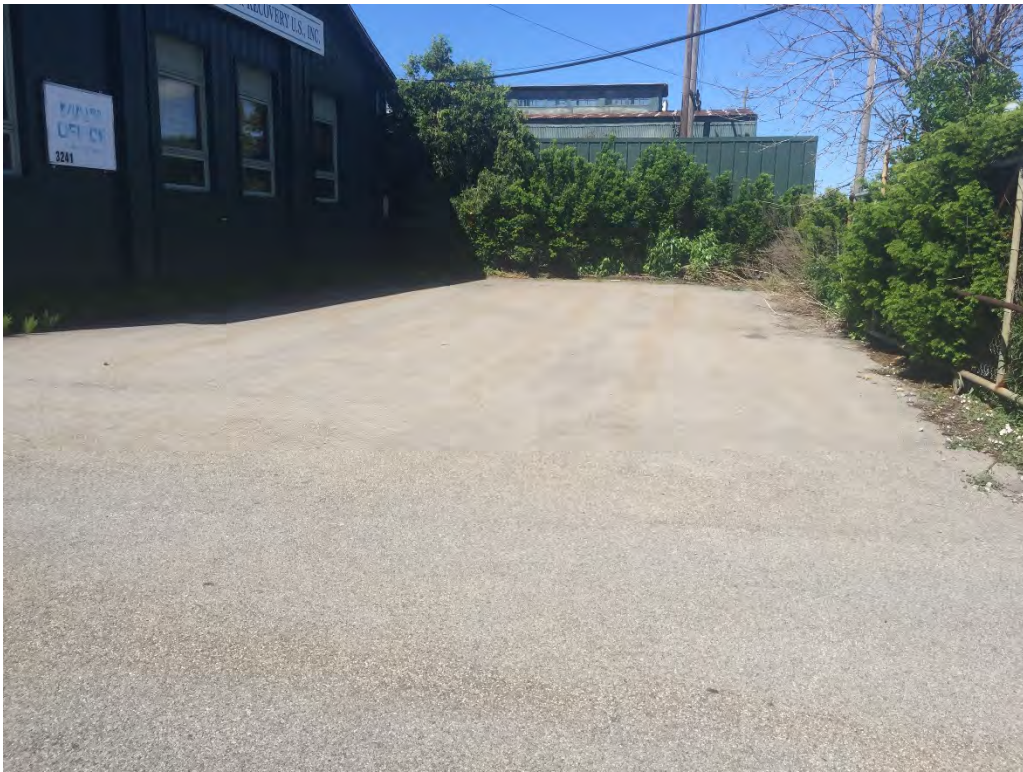
The Parking Lot was repaved in 2011 and is generally free of cracks and deterioration. Photos of the pavement are provided in Appendix B.

Photo 1 – Parking lot looking west along north side of office.

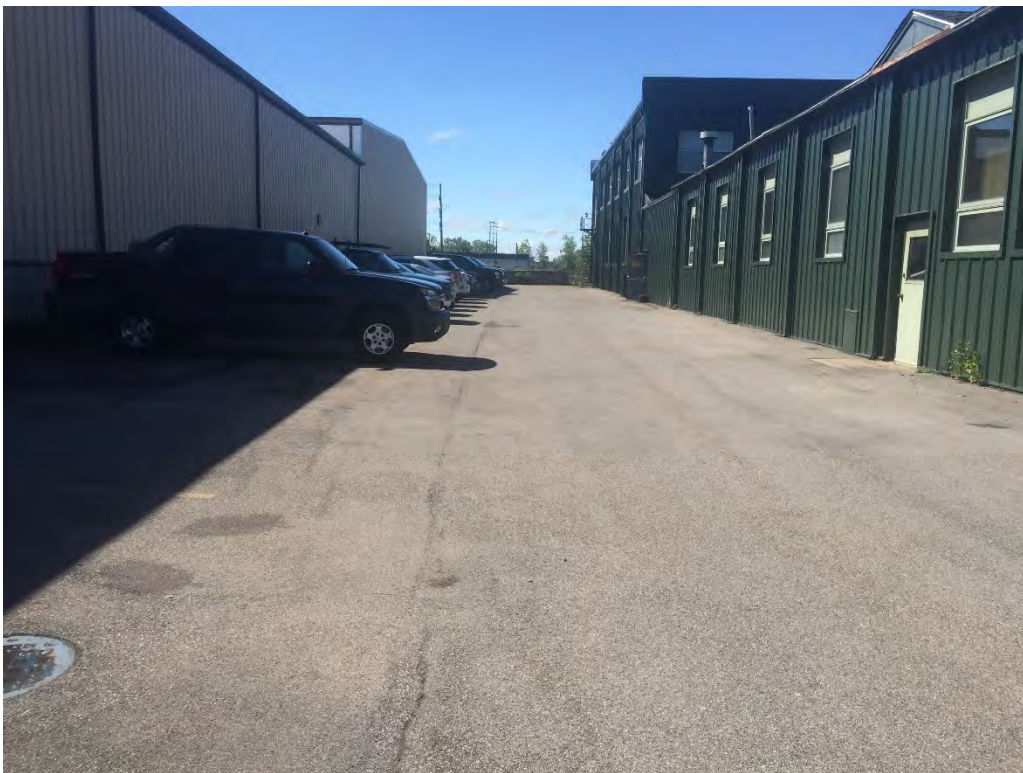
Photo 2 – Parking lot looking south.

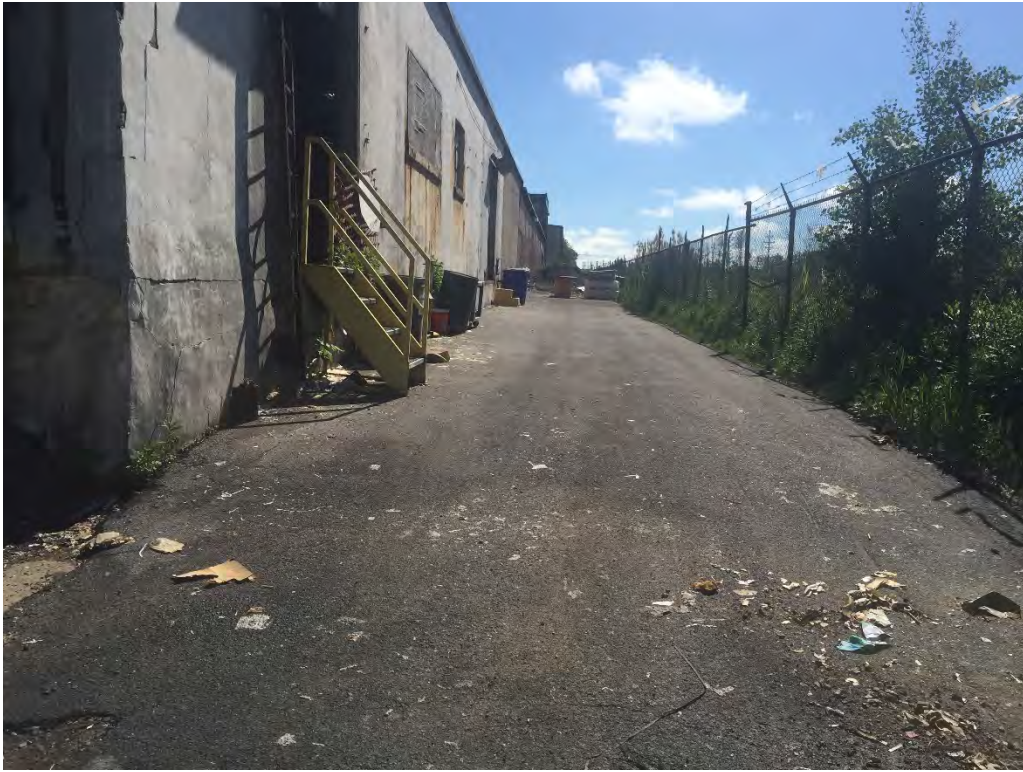
The asphalt cover on the Former Rail Siding was generally free of cracks and deterioration and appeared in good condition, although the presence of staged inventory within the area inhibited full inspection. Photos of the pavement are provided in Appendix B.

Photo 3 – Former rail siding looking east.

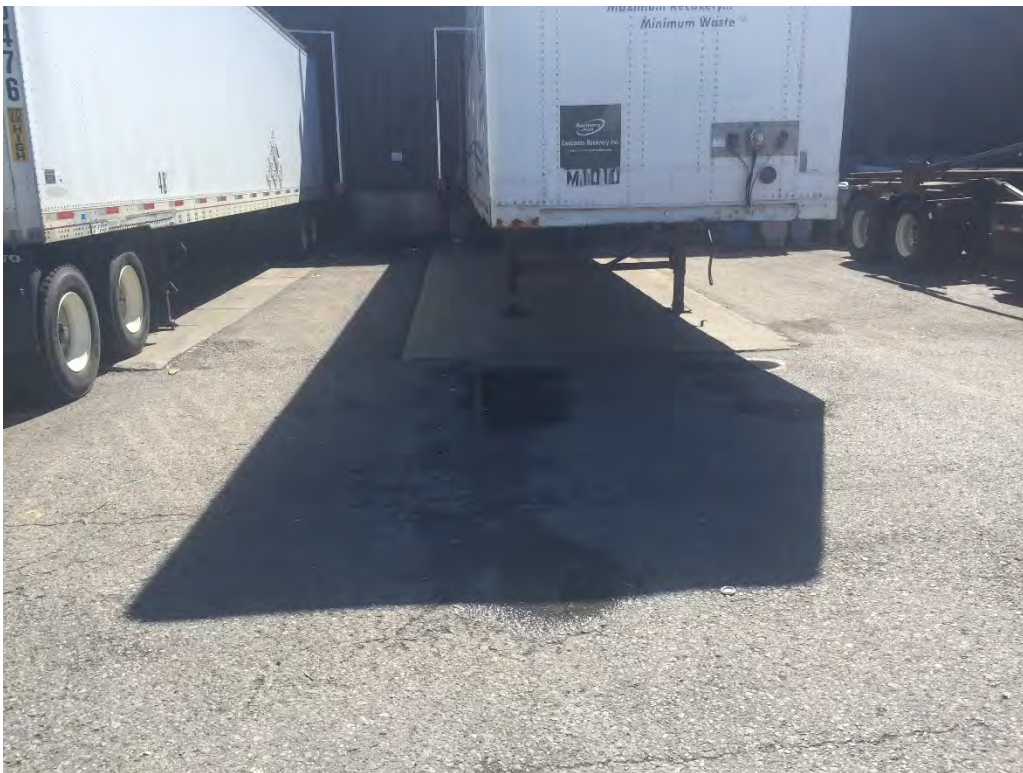
The building floor slab and apron concrete were visually inspected for cracks and deterioration. Shallow cracks are present on some areas of the apron; however, these cracks do not penetrate the full thickness of the apron slab and do not impact the effectiveness of the cover. These areas will be addressed as part of routine maintenance. Damaged areas identified in 2015 were patched with asphalt and tar sealant and remain in generally good condition. The need for more permanent repair/replacement will be evaluated again in 2018. Photos of the concrete are provided in Appendix B.

YES NO If yes, please describe Several areas of shallow
cracked concrete on aprons. Maintenance and sealing
should be conducted. Notable areas are between doors
Y2 + 3/4 and the pad at 3/4

Photo 4 – Building Apron Concrete System (north end of building) looking east.

No corrective action is necessary for the building and apron concrete cover system at this time.

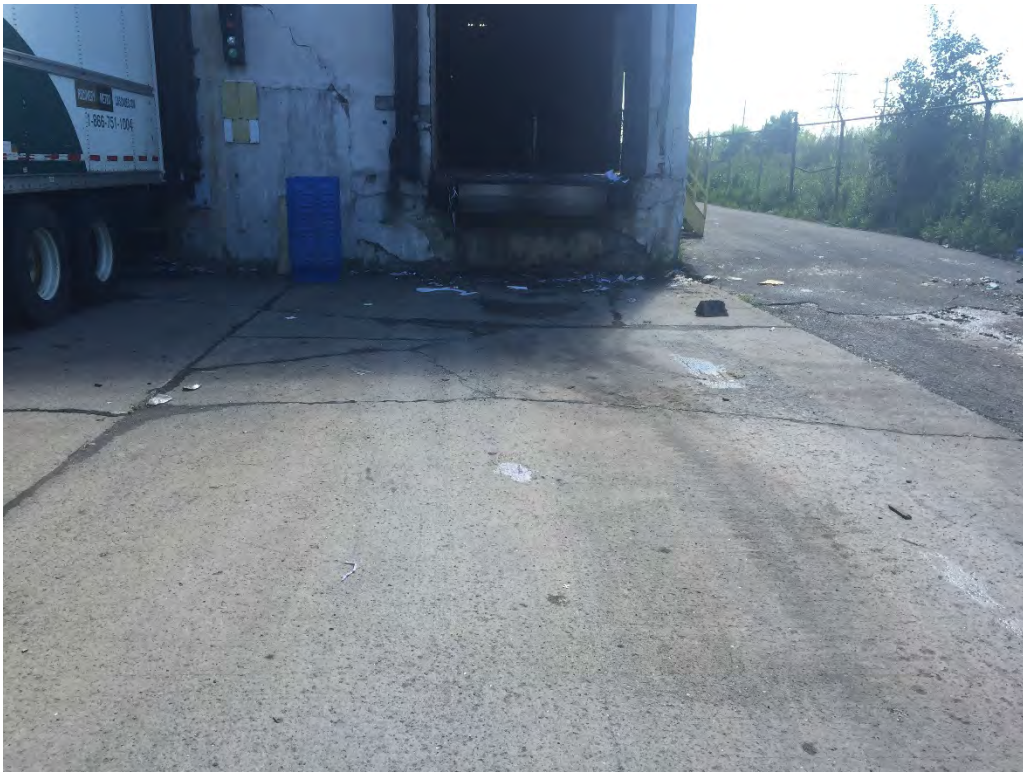
Photo 5 – Building Apron Concrete System (south end of building) looking east.

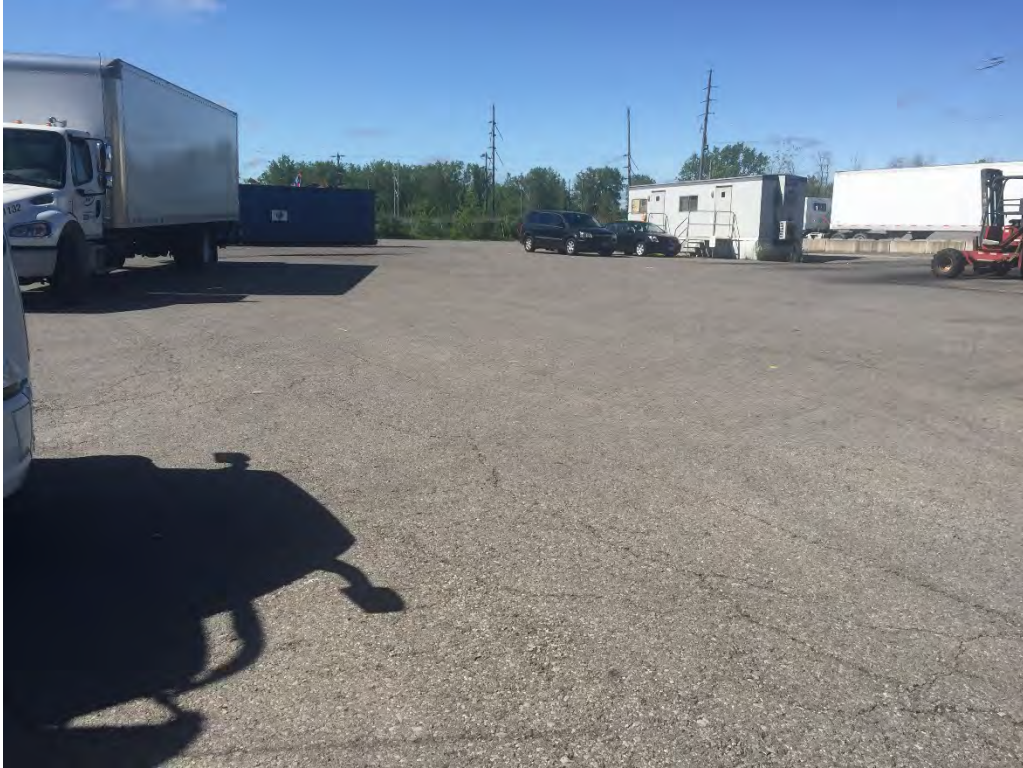
The asphalt surface in the trucking yard generally appeared in satisfactory condition. Some minor surficial cracking is present; however, these cracks do not impact the integrity or effectiveness of the cover. Larger cracks (greater than 0.25 inch in width) that were sealed in 2015 remain in good condition. Sealing of minor cracks will be addressed as part of routine maintenance to prevent further deterioration. The test pit locations excavated in 2009 were repaved in 2011 and remain in good condition. Photos of the trucking yard are provided in Appendix B.

YES NO If yes, please describe No damage, but
sealing and maintenance should be conducted.

Photo 6 – Trucking Yard looking south-southwest.

No corrective action is necessary for the asphalt-only cover system at this time.

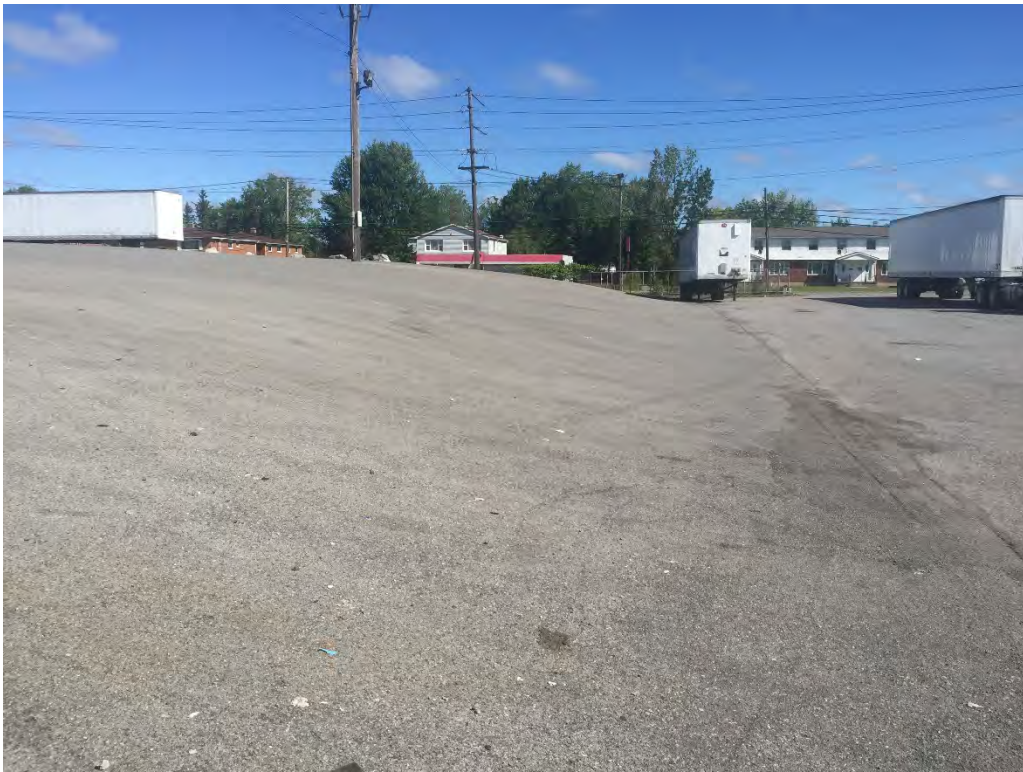
Photo 7 – Trucking Yard looking north.

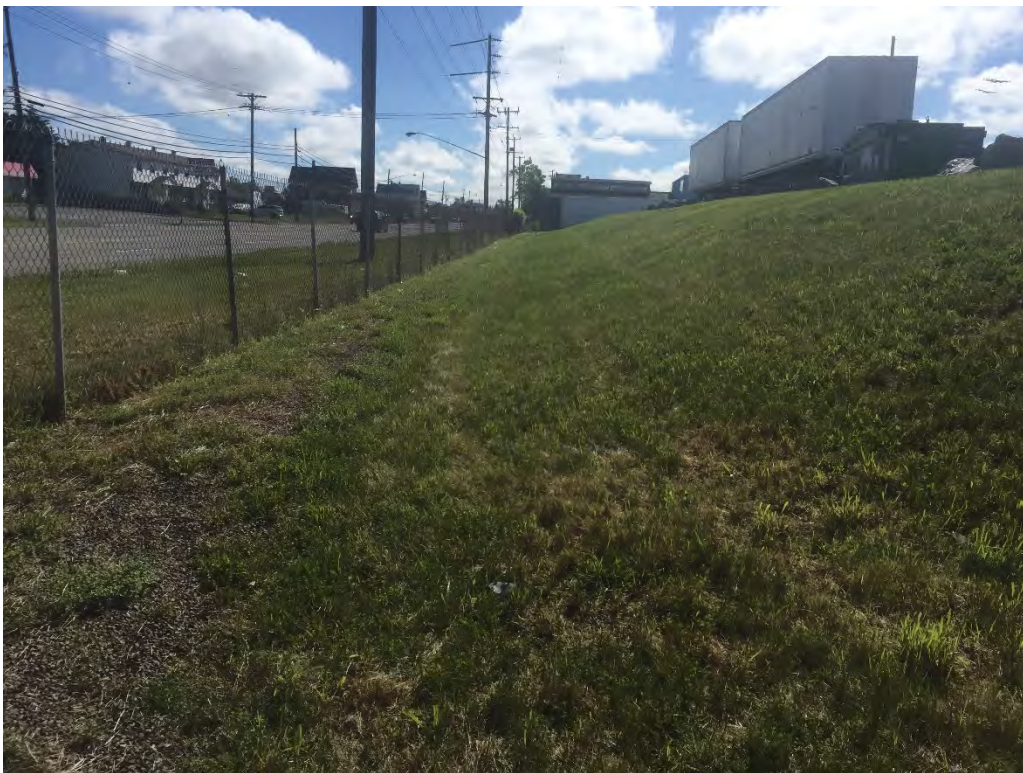
The GCL and soil cover system was visually inspected as part of the annual comprehensive Site inspection. No areas of subsidence, erosion, or exposed GCL were observed. At the time of the inspection, the grass was approximately 2 to 4 inches in length and was regularly maintained throughout the year. Photos of the GCL and soil cover are provided in Appendix B.

Photo 8 – GCL and Soil Cover System looking east along north slope.

Corrective action is not necessary for the GCL and soil cover system at this time.

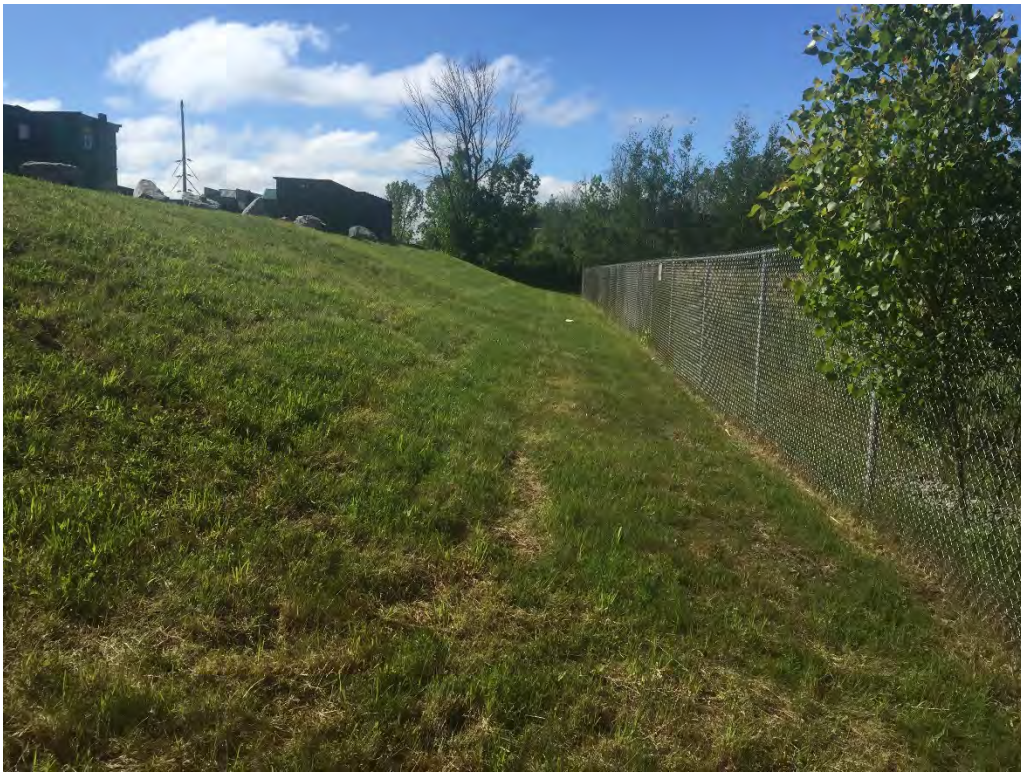
Photo 9 – GCL and Soil Cover System looking south along west slope.

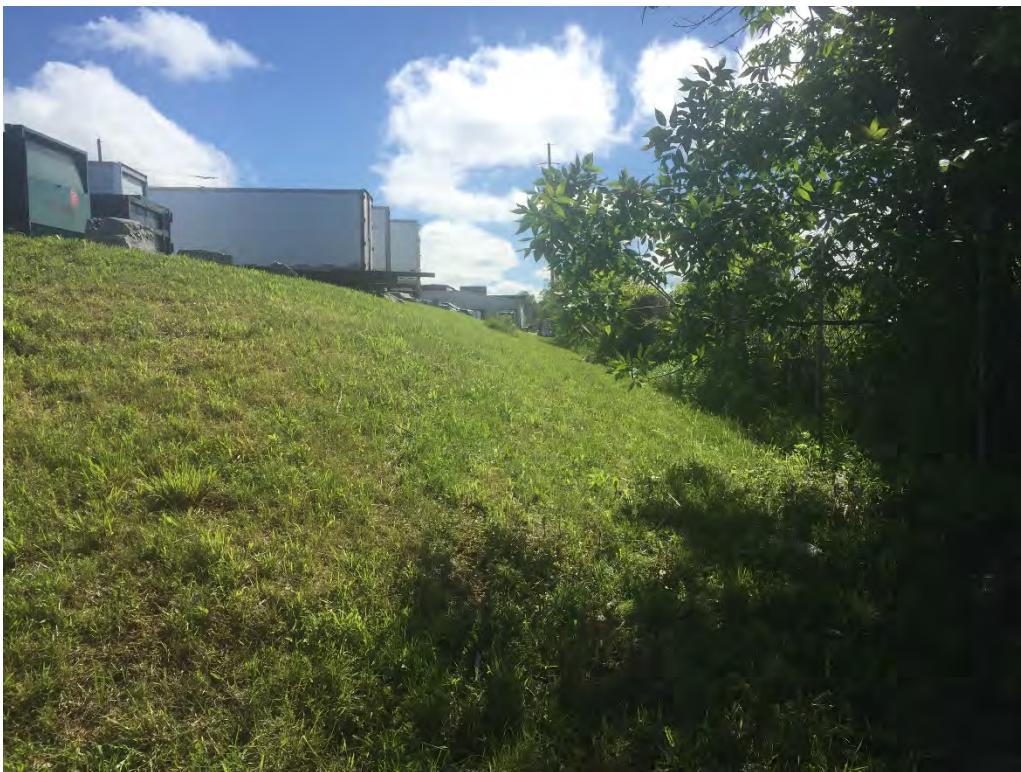
Photo 10 – GCL and Soil Cover System looking east along south slope.

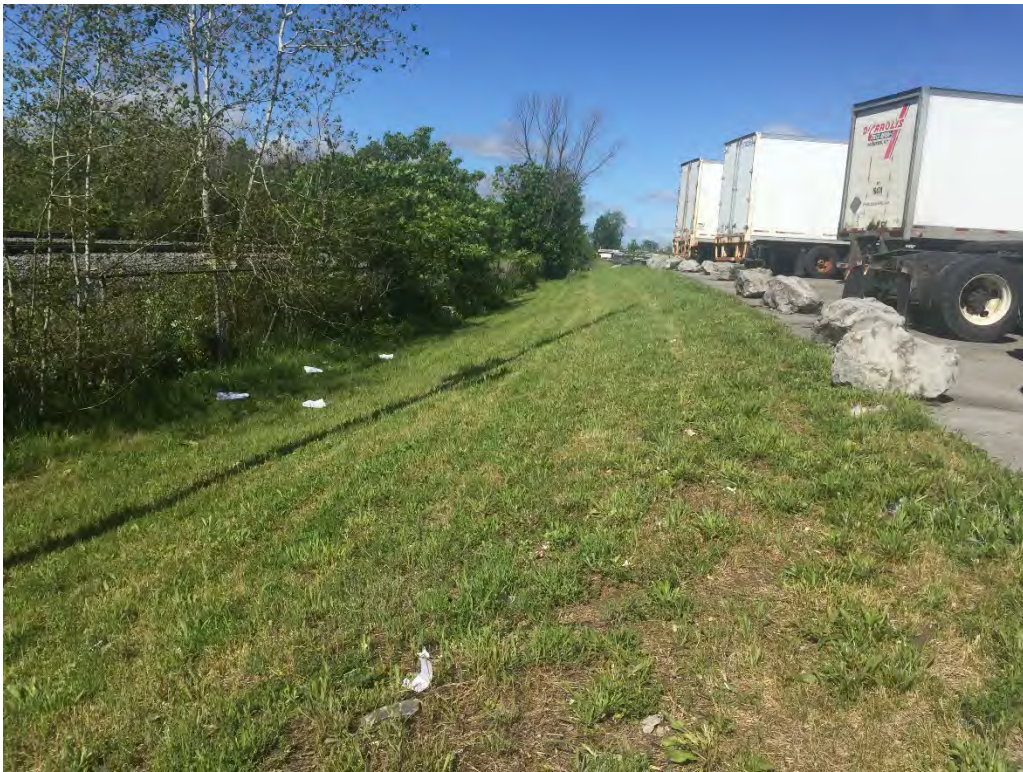
Photo 11 – GCL and Soil Cover System looking west along south slope.

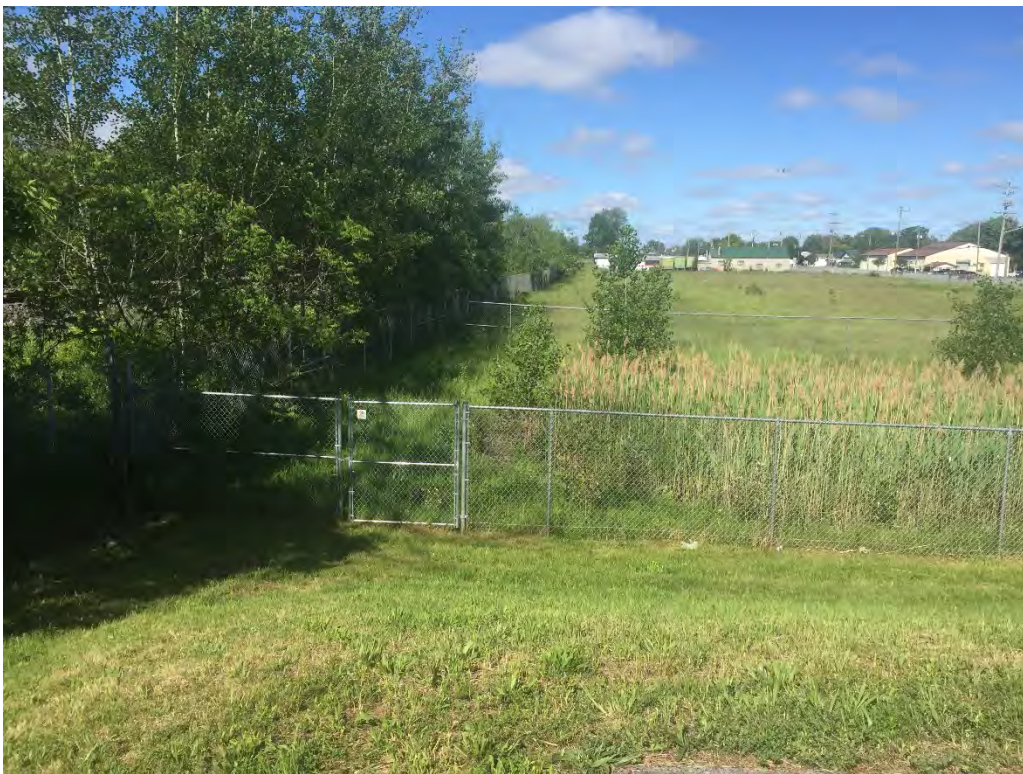
A gate was installed at the southeast corner of the pond fence enclosure in June 2011 to allow access for mowing and maintenance. The gate is locked to prevent unauthorized access. Photos of the retention pond are provided in Appendix B.

Photo 12 – South end of retention pond enclosure.

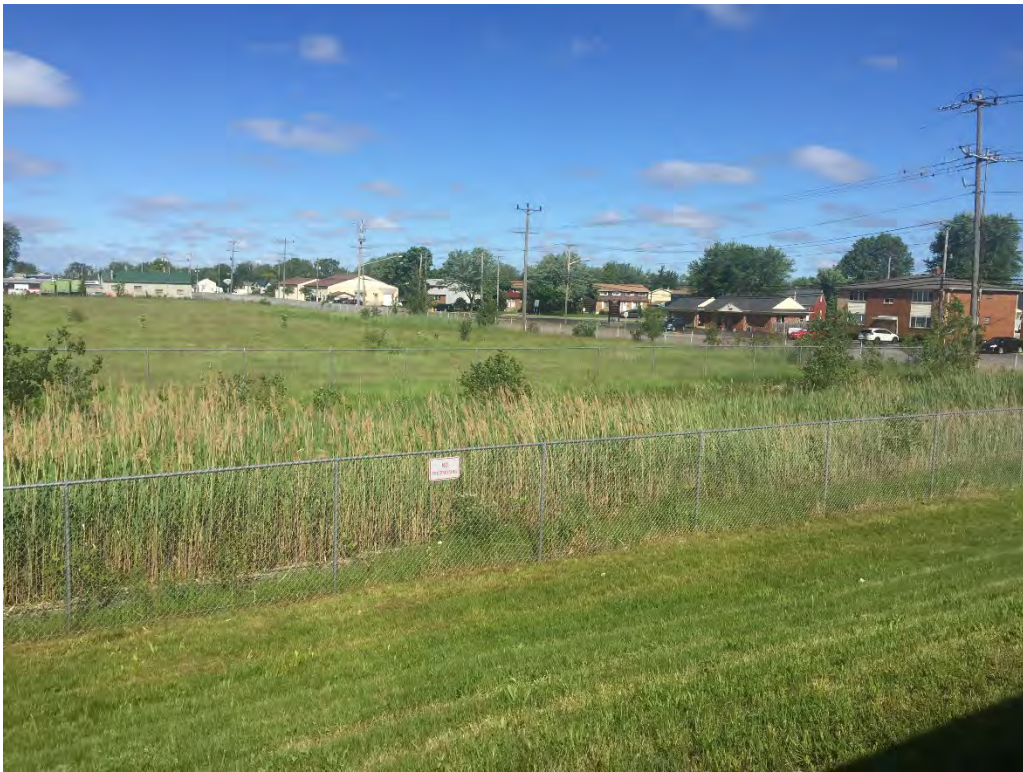
The retention pond was inspected as part of the annual comprehensive Site inspection. Approximately 6 inches of standing water was present in the center of the pond, as the water level was below the invert of the outflow pipe. Although vegetation was cut in 2015, significant plant growth is present within the pond, primarily invasive phragmites. No other debris was observed and the outlet pipes are open. No evidence of erosion was observed along the banks of the pond.

Photo 13 – Looking northwest across retention pond.

No corrective action is necessary with regard to vegetation growth within the pond.

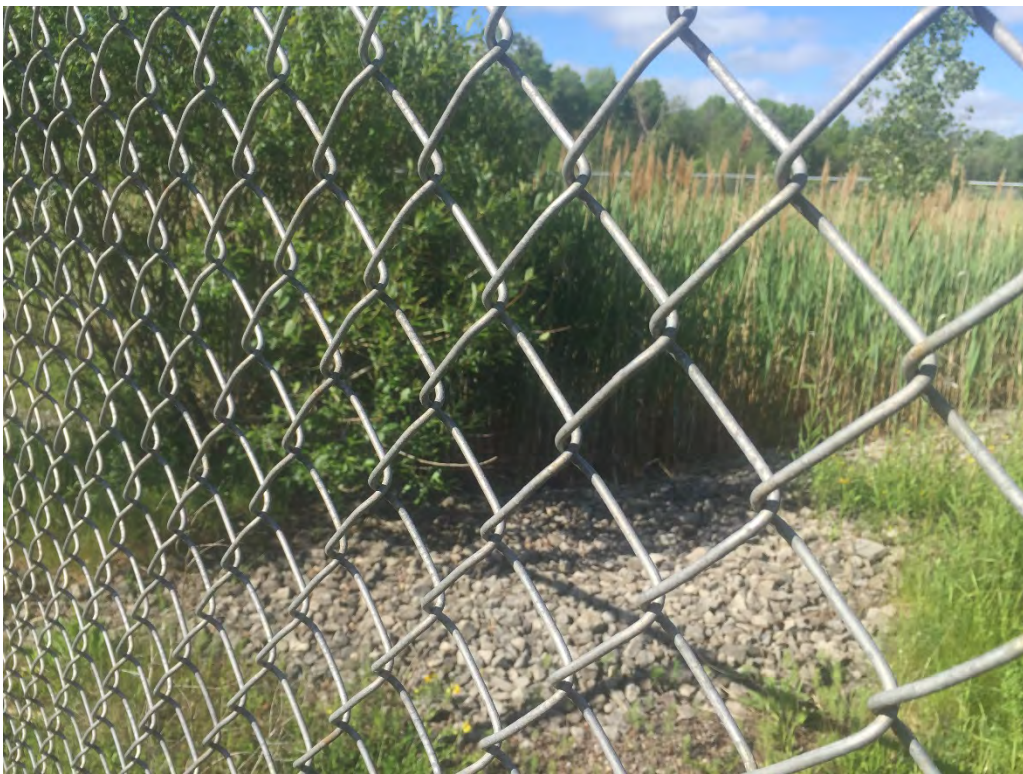
Photo 14 – Retention pond outlet pipes in northeast corner.

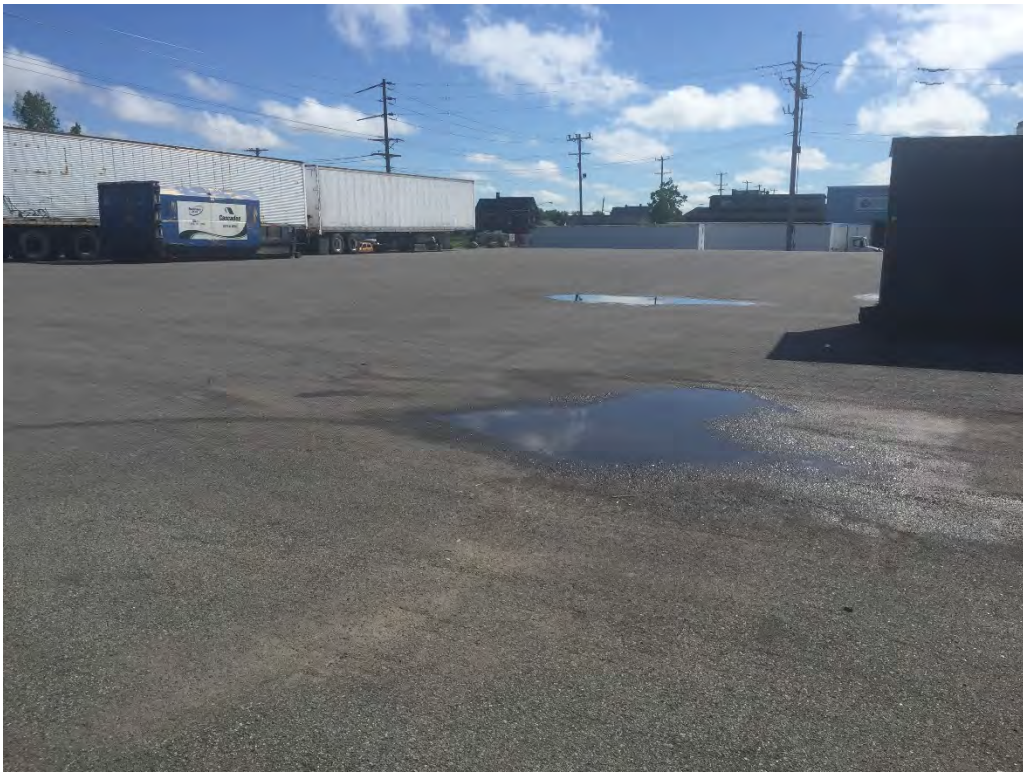
The GCL and asphalt cover system was visually inspected as part of the annual comprehensive Site inspection. No areas of subsidence or exposed GCL were observed. Minor surface indentations caused by tractor-trailer supports were noted in the asphalt, consistent with past years. The indentations were approximately 0.25 to 0.5 inch in depth, but do not affect the integrity of the cap. Photos of the GCL and asphalt cover are provided in Appendix B.

YES NO If yes, please describe Some minor cracking at base of slope should be monitored.

Photo 15 – GCL and Asphalt Cover System looking northeast across cap.

No corrective action is necessary for the GCL and asphalt cover system at this time.

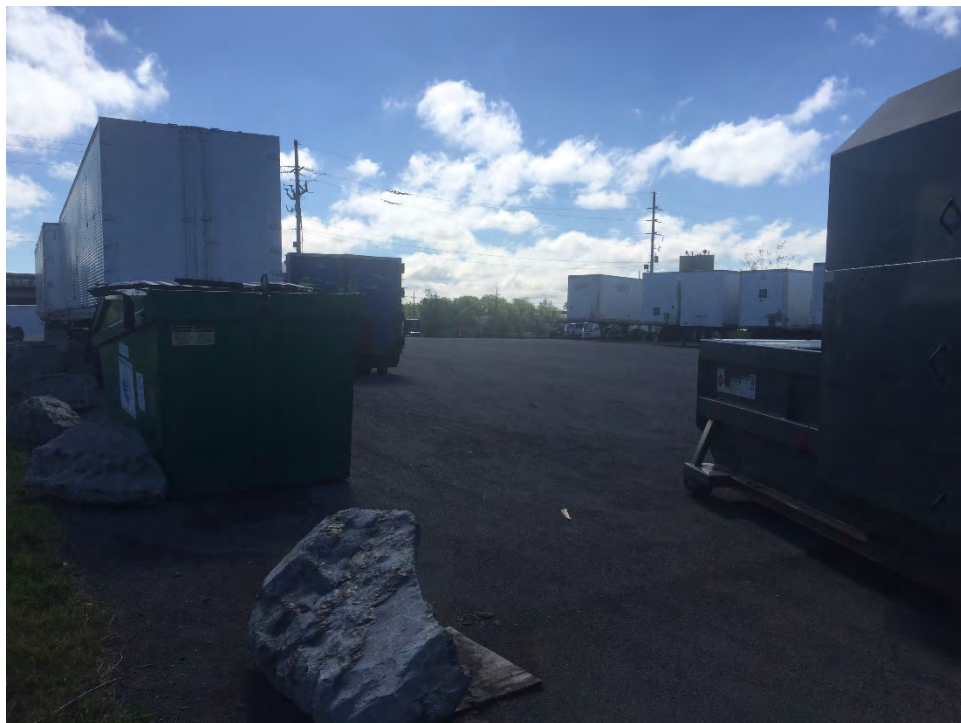
Photo 16 – GCL and Asphalt Cover System looking southeast across cap.

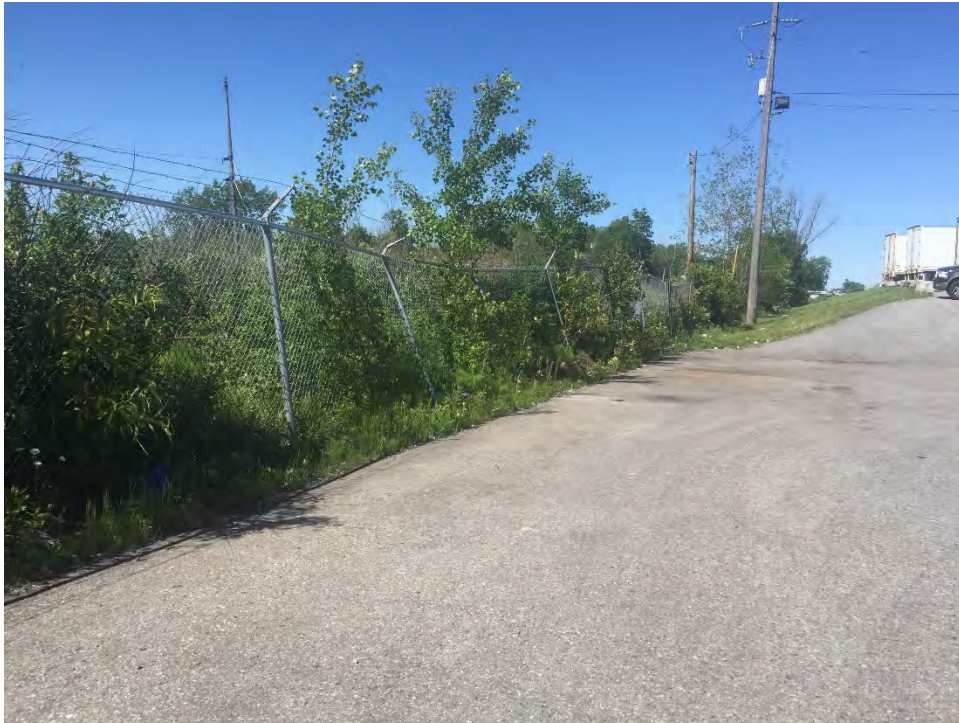
The fencing was inspected as part of the annual comprehensive site inspection. Damage to fence posts and rails was observed at two areas on the south fence. Although the chain link has not been breached, the posts and rail will be addressed as part of routine maintenance to prevent further deterioration or damage to the fence. The fence north of the Site along Walden Avenue was constructed with braided wire rather than a top support pole. At the time of the inspection, the wire provided sufficient support for the fence. Photos of the fencing are provided in Appendix B.

YES NO If yes, please describe South of truck yard and on south slope along tracks posts need to be repaired / reset

Photo 17 – Damaged fence along southern truck yard.

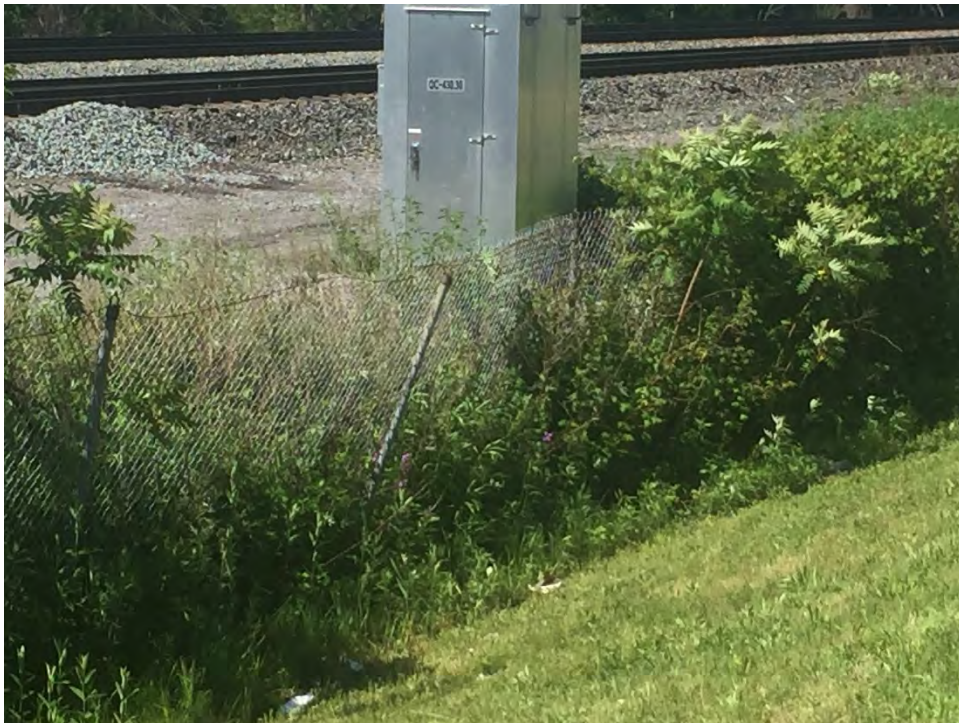
Photo 18 – Damaged fence along southern slope of GCL Area.
