**Re: Annual Periodic Review
Former NL Industries Site No. C915200**

2018 Periodic Review Report

Former NL Industries Site
NYSDEC Site No. C915200
3241 Walden Avenue
Depew, New York

Cascades Containerboard Packaging, A Division of Cascades Canada ULC

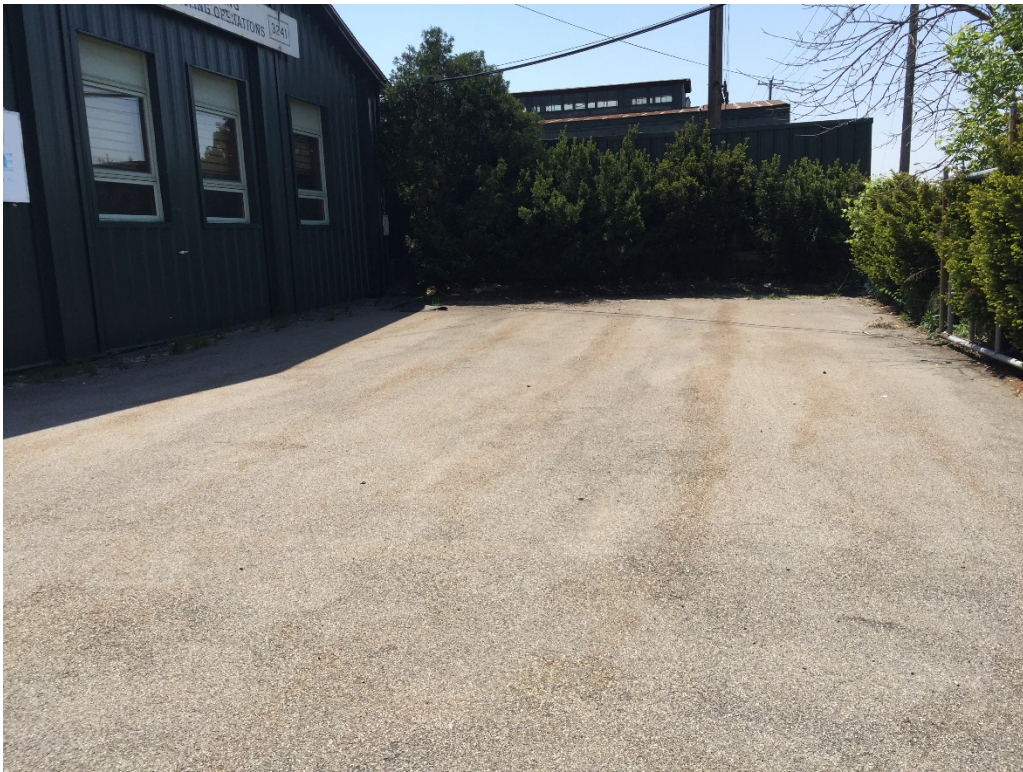
The Parking Lot was repaved in 2011 and is generally free of cracks and deterioration. Photos of the pavement are provided in Appendix B.

Photo 1 – Parking lot looking west along north side of office.

No corrective action is necessary for the asphalt-only cover system at this time.

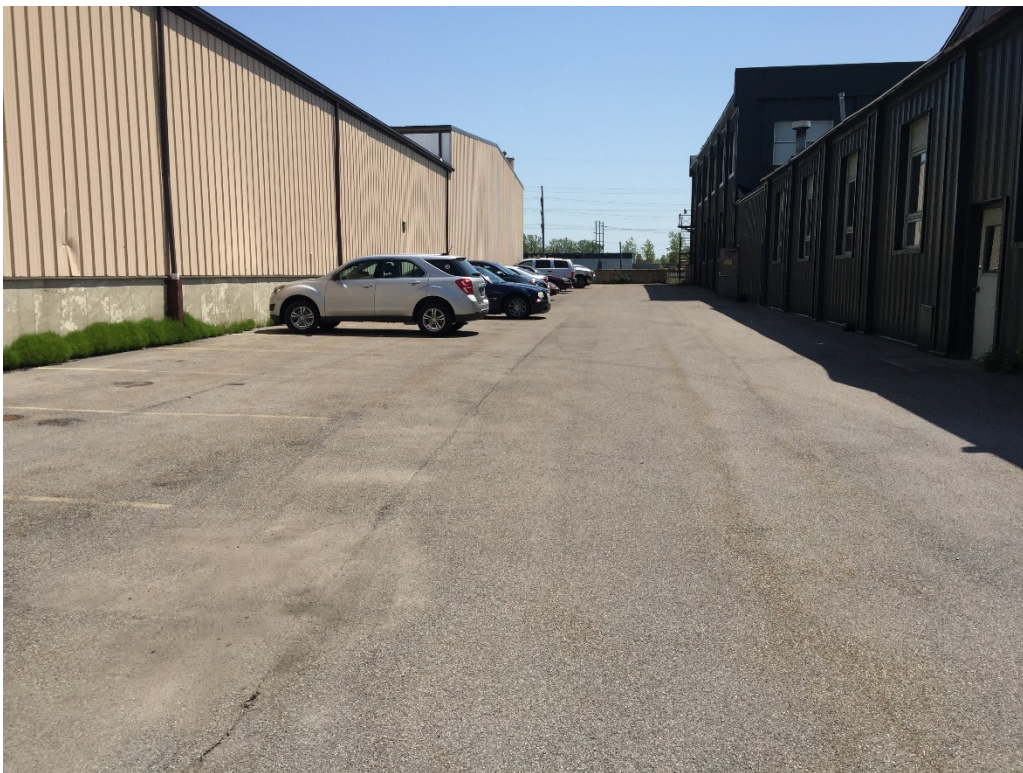
Photo 2 – Parking lot looking south.

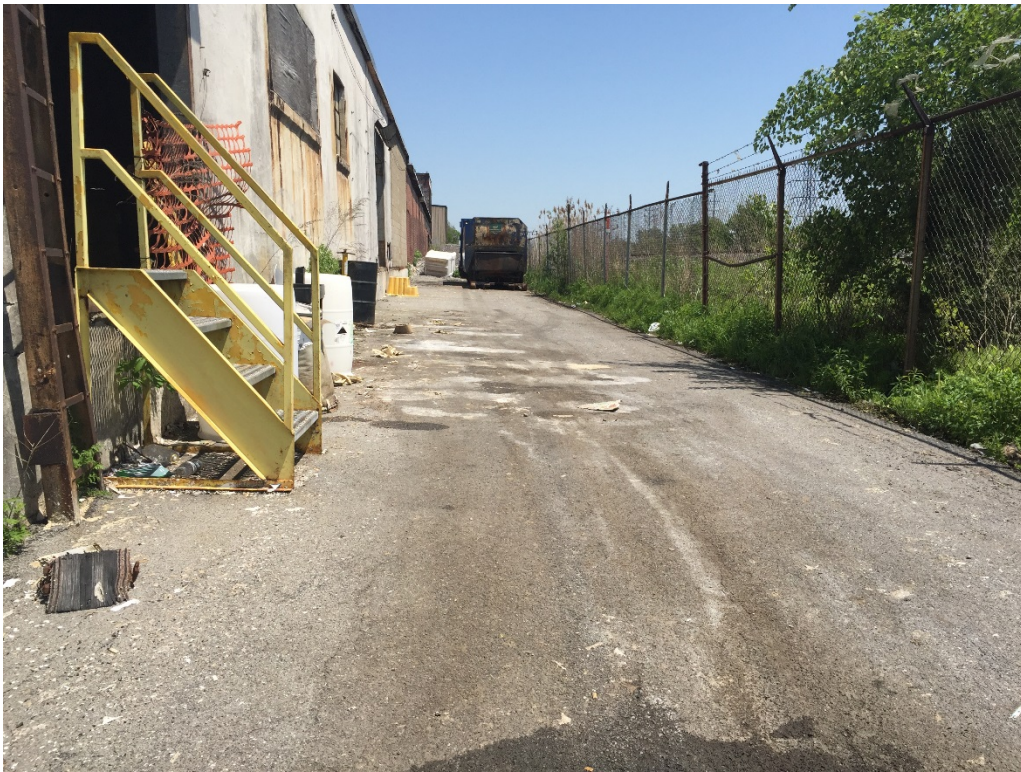
The asphalt cover on the Former Rail Siding was generally free of cracks and deterioration and appeared in good condition, although the presence of staged inventory within the area inhibited full inspection. Photos of the pavement are provided in Appendix B.

Photo 3 – Former rail siding looking east.

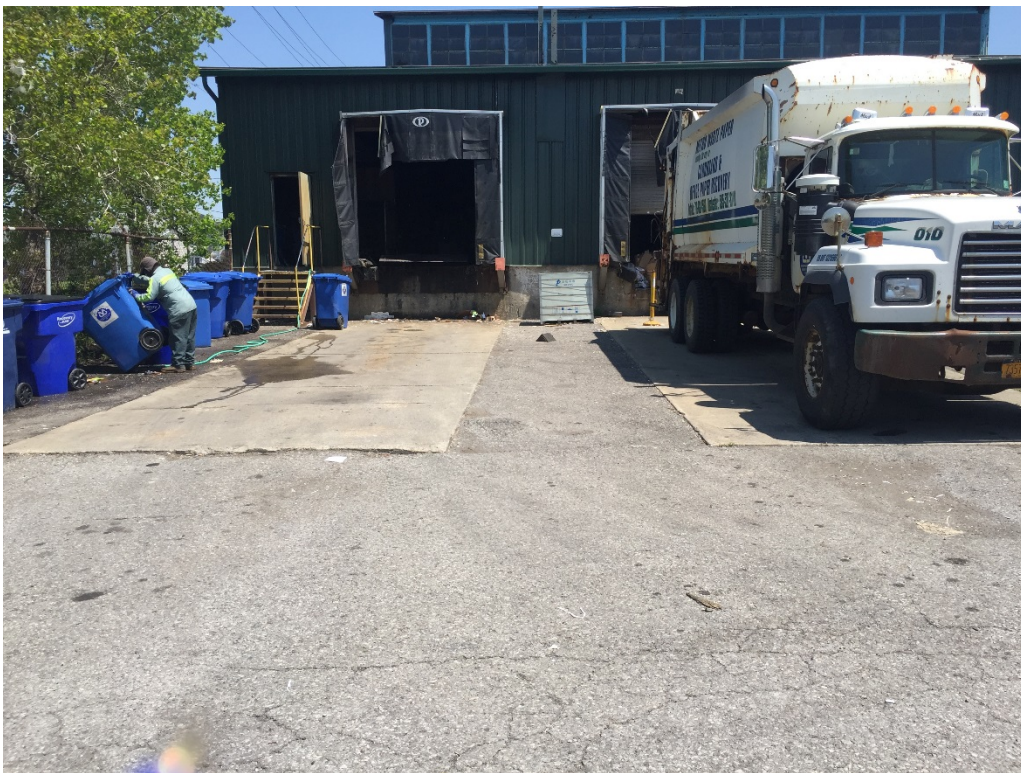
The building floor slab and apron concrete were visually inspected for cracks and deterioration. Shallow cracks are present on some areas of the apron; however, these cracks do not penetrate the full thickness of the apron slab and do not impact the effectiveness of the cover. These areas will be addressed as part of routine maintenance. Damaged areas identified in 2015 were patched with asphalt and tar sealant and remain in generally good condition. The building and apron cover system has not deteriorated significantly from 2017. Photos of the concrete are provided in Appendix B.

Photo 4 – Building Apron Concrete System (north end of building) looking east.

No corrective action is necessary for the building and apron concrete cover system at this time.

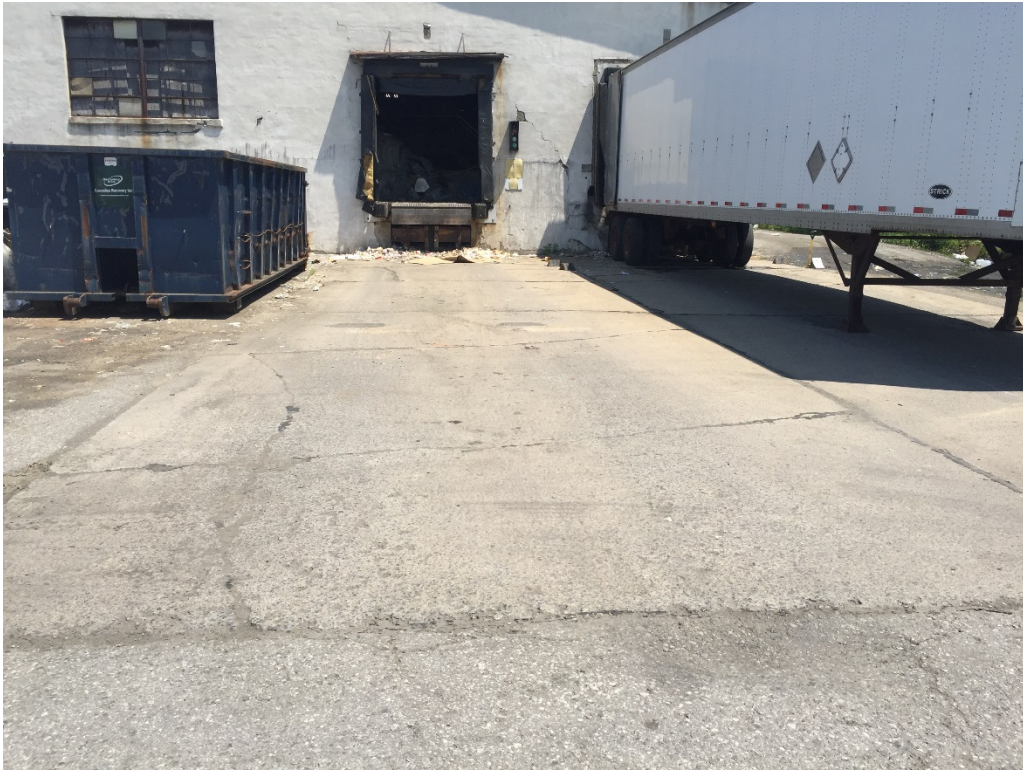
Photo 5 – Building Apron Concrete System (south end of building) looking east.

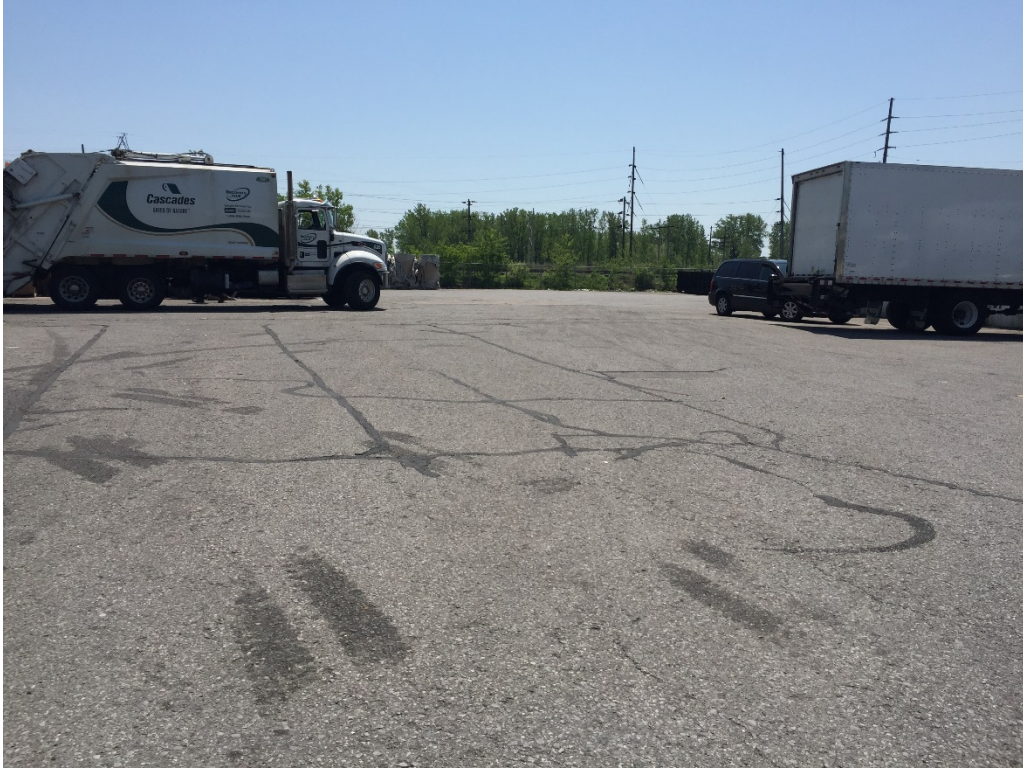
The asphalt surface in the trucking yard generally appeared in satisfactory condition. Some minor surficial cracking is present; however, these cracks do not impact the integrity or effectiveness of the cover. Larger cracks (greater than 0.25 inch in width) that were sealed in 2015 remain in good condition. Sealing of minor cracks identified in 2017 was completed as part of routine maintenance to prevent further deterioration. The test pit locations excavated in 2009 were repaved in 2011 and remain in good condition. Photos of the trucking yard are provided in Appendix B.

Photo 6 – Trucking Yard looking south-southwest.

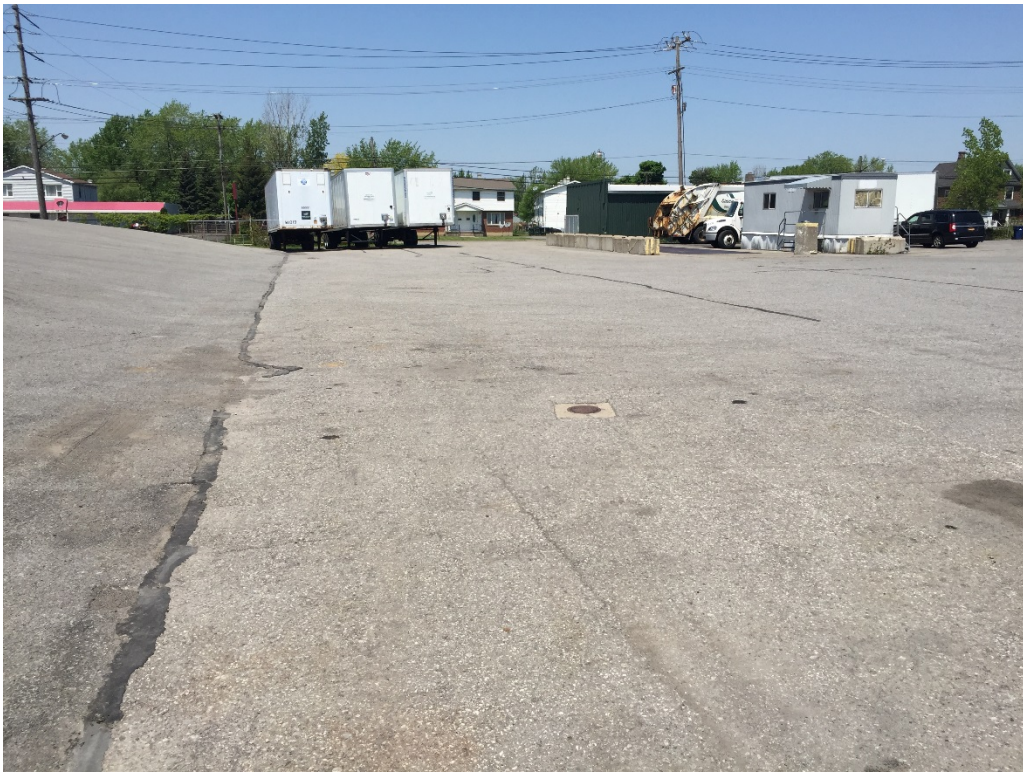
Photo 7 – Trucking Yard looking north.

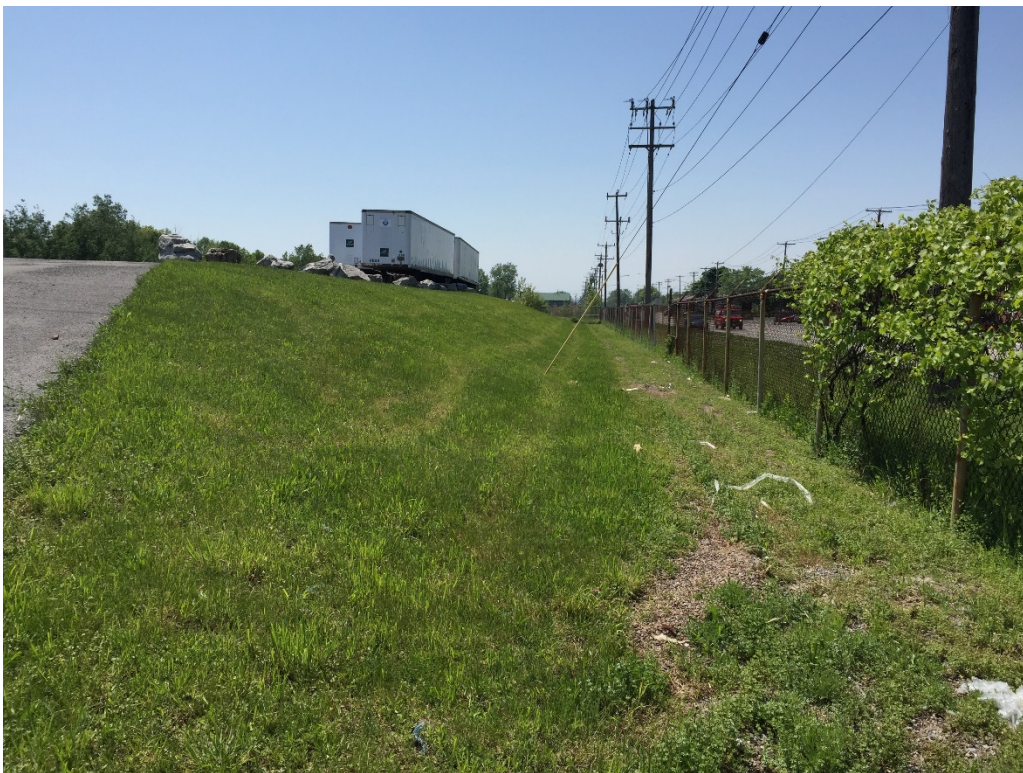
The GCL and soil cover system was visually inspected as part of the annual comprehensive Site inspection. No areas of subsidence, erosion, or exposed GCL were observed. At the time of the inspection, the grass was approximately 2 to 4 inches in length and was regularly maintained throughout the year. Photos of the GCL and soil cover are provided in Appendix B.

Photo 8 – GCL and Soil Cover System looking west along north slope.

Corrective action is not necessary for the GCL and soil cover system at this time.

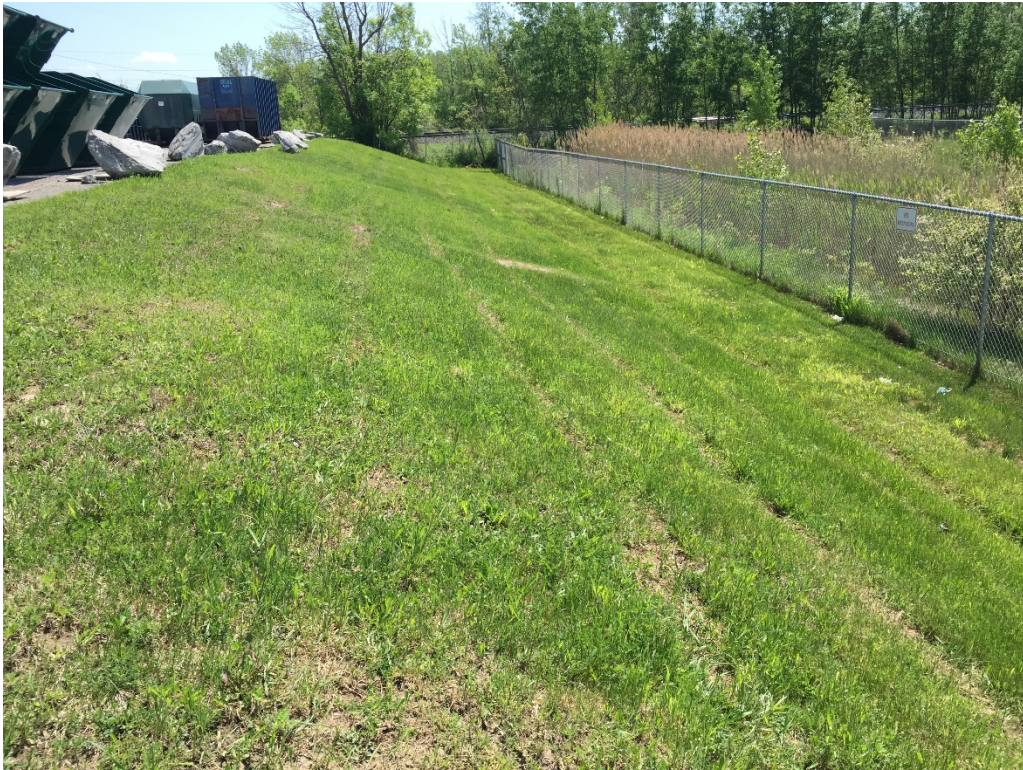
Photo 9 – GCL and Soil Cover System looking south along west slope.

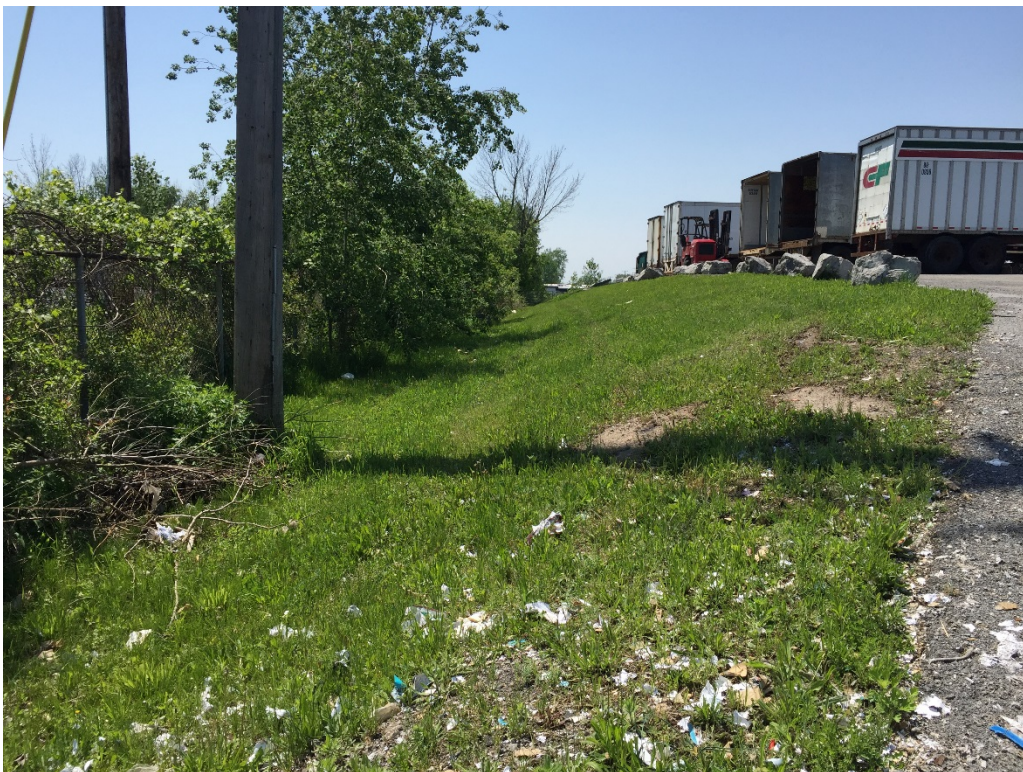
Photo 10 – GCL and Soil Cover System looking west along south slope.

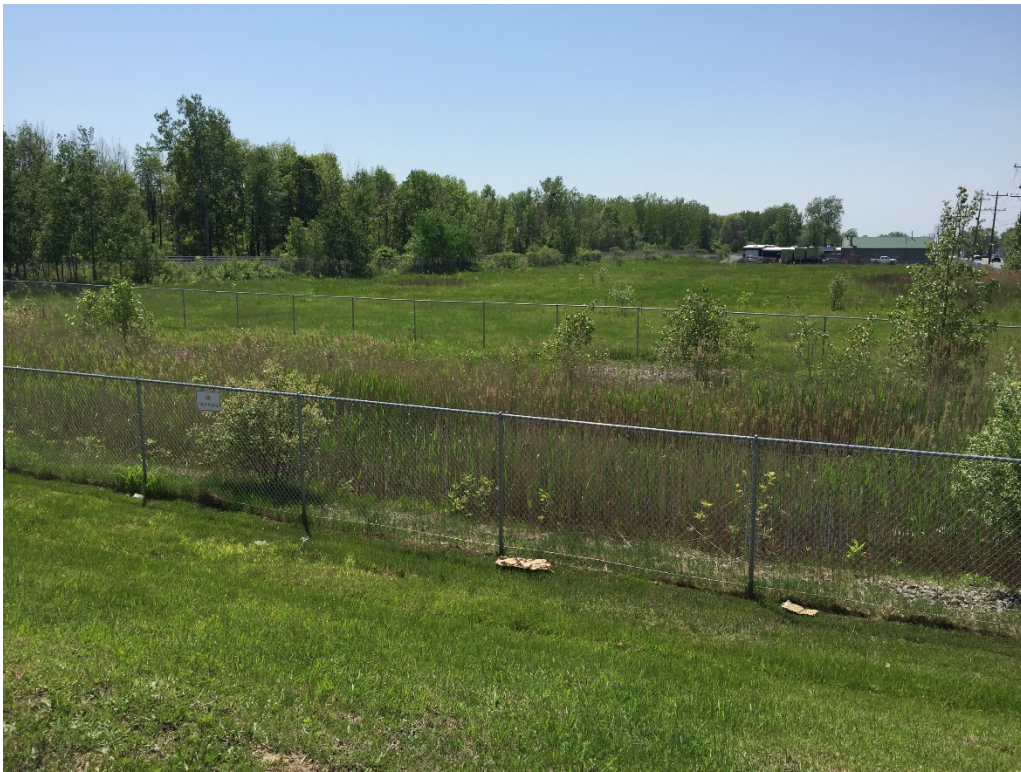
The retention pond was inspected as part of the annual comprehensive Site inspection. Approximately 12 inches of standing water was present in the center of the pond, as the water level was below the invert of the outflow pipe. Although vegetation was cut in 2015, significant plant growth is present within the pond, primarily invasive phragmites. No other debris was observed and the outlet pipes are open. No evidence of erosion was observed along the banks of the pond.

Photo 11 – Looking southwest across retention pond.

No corrective action is necessary with regard to vegetation growth within the pond.

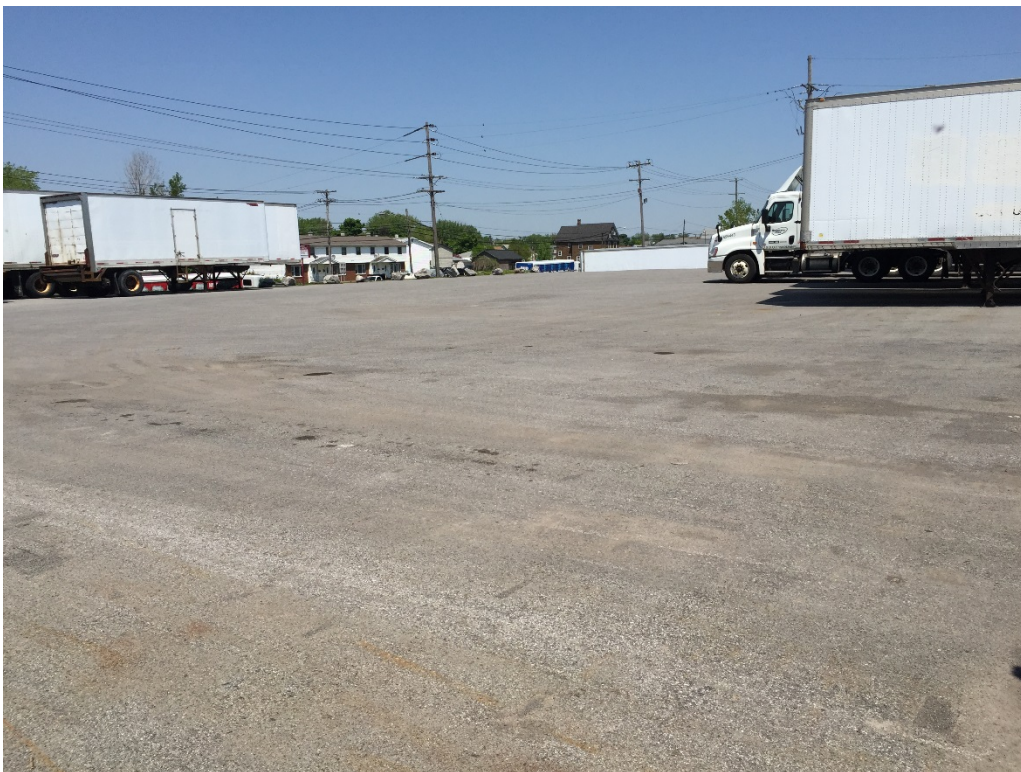
The GCL and asphalt cover system was visually inspected as part of the annual comprehensive Site inspection. No areas of subsidence or exposed GCL were observed. Minor surface indentations caused by tractor-trailer supports were noted in the asphalt, consistent with past years. The indentations were approximately 0.25 to 0.5 inch in depth, but do not affect the integrity of the cap. Photos of the GCL and asphalt cover are provided in Appendix B.

Photo 12 – GCL and Asphalt Cover System looking northeast across cap.

No corrective action is necessary for the GCL and asphalt cover system at this time.
