**Re: Revised Annual Periodic Review
Former NL Industries Site No. C915200**

2020 Periodic Review Report

Former NL Industries Site
NYSDEC Site No. C915200
3241 Walden Avenue
Depew, New York

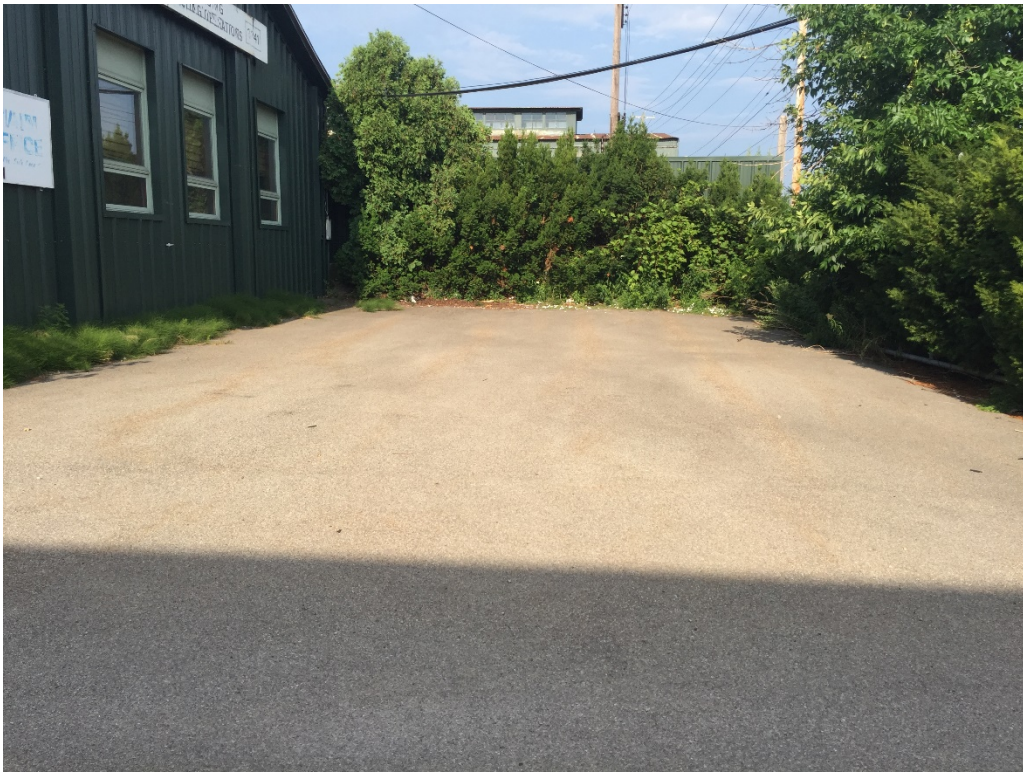
The Parking Lot was repaved in 2011 and is generally free of cracks and deterioration. Photos of the pavement are provided in Appendix B.

Photo 1 – Parking lot looking west along north side of office.

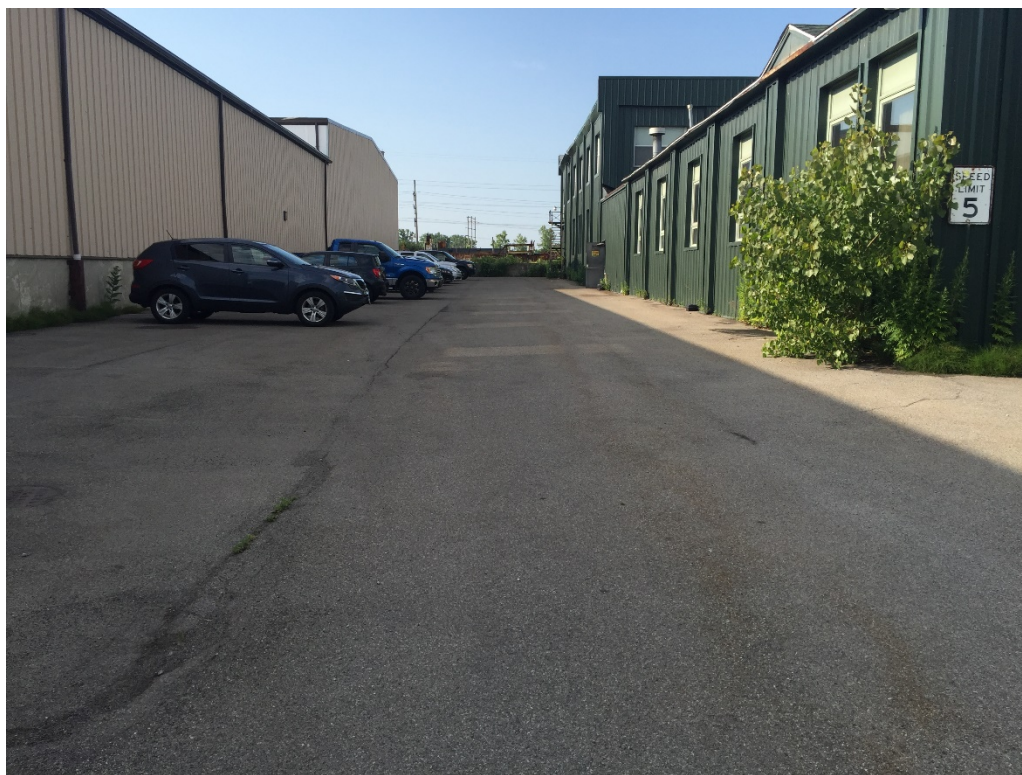
Photo 2 – Parking lot looking south.

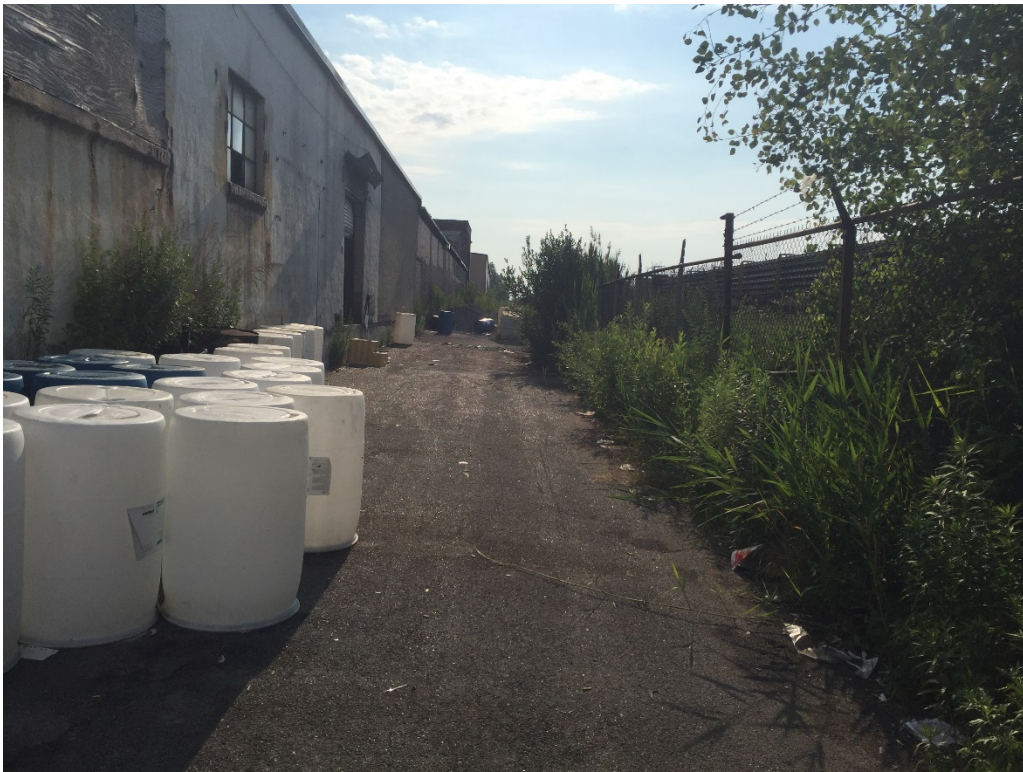
The asphalt cover on the Former Rail Siding was generally free of cracks and deterioration and appeared in good condition, although the presence of staged inventory within the area inhibited full inspection. Photos of the pavement are provided in Appendix B.

Photo 3 – Former rail siding looking east.

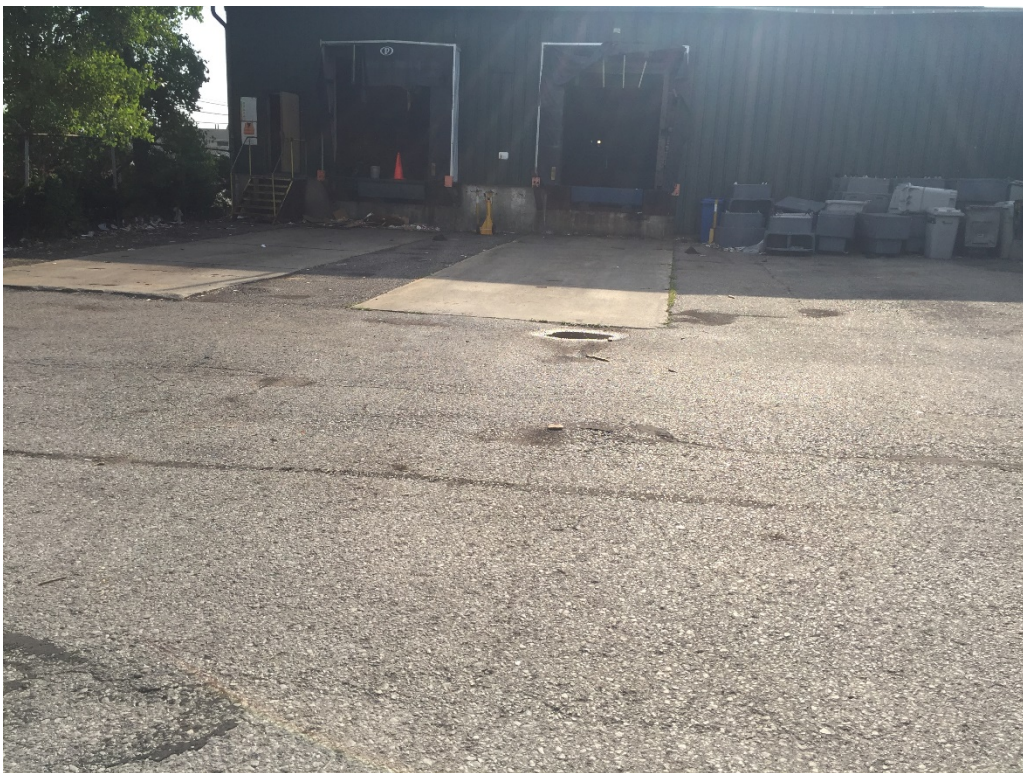
The building floor slab and apron concrete were visually inspected for cracks and deterioration. Shallow cracks are present on some areas of the apron; however, these cracks do not penetrate the full thickness of the apron slab and do not impact the effectiveness of the cover. Damaged areas identified in July 2020 were patched with asphalt and/or tar sealant as part of a routine maintenance program completed in September 2020. The building and apron cover system has not deteriorated significantly from 2019. Photos of the concrete are provided in Appendix B.

Photo 4 – Building Apron Concrete System (north end of building) looking east.

No corrective action is necessary for the building and apron concrete cover system at this time.

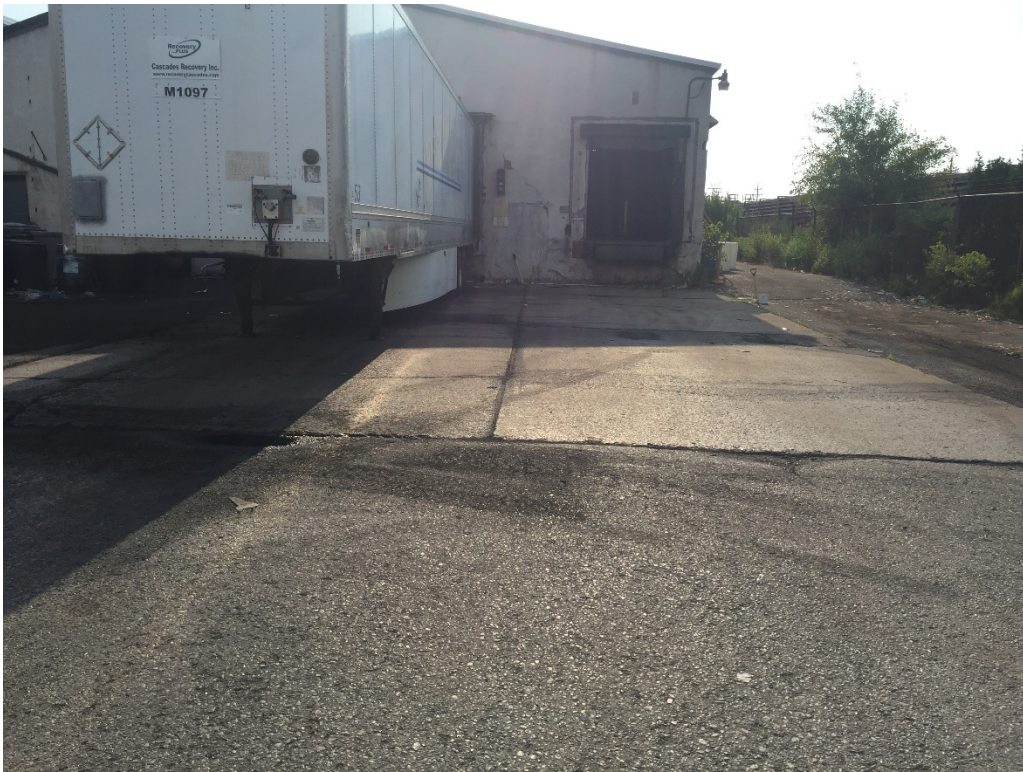
Photo 5 – Building Apron Concrete System (south end of building) looking east.

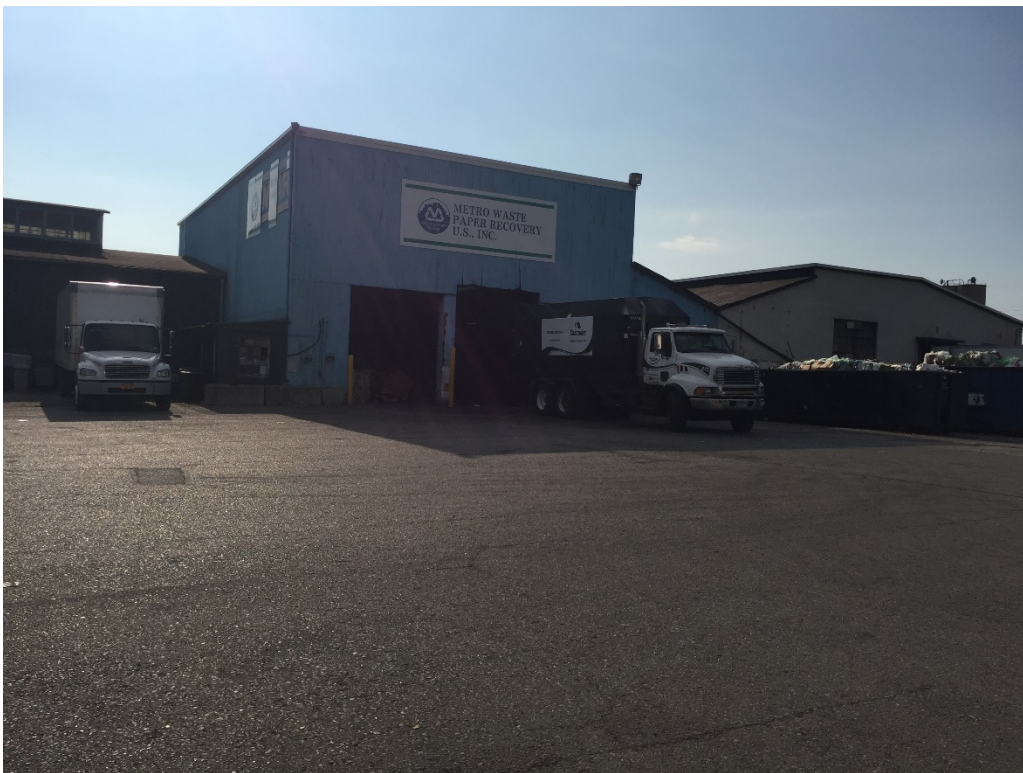
The asphalt surface in the trucking yard generally appeared in satisfactory condition. Some minor surficial cracking is present; however, these cracks do not impact the integrity or effectiveness of the cover. Larger cracks (greater than 0.25 inch in width) that were sealed in 2015 remain in good condition. Sealing of minor cracks identified in 2017 was completed as part of routine maintenance to prevent further deterioration and remain in good condition. The test pit locations excavated in 2009 were repaved in 2011 and remain in good condition. Photos of the trucking yard are provided in Appendix B.

Photo 6 – Trucking Yard looking east.

No corrective action is necessary for any portion of the asphalt-only cover system at this time.

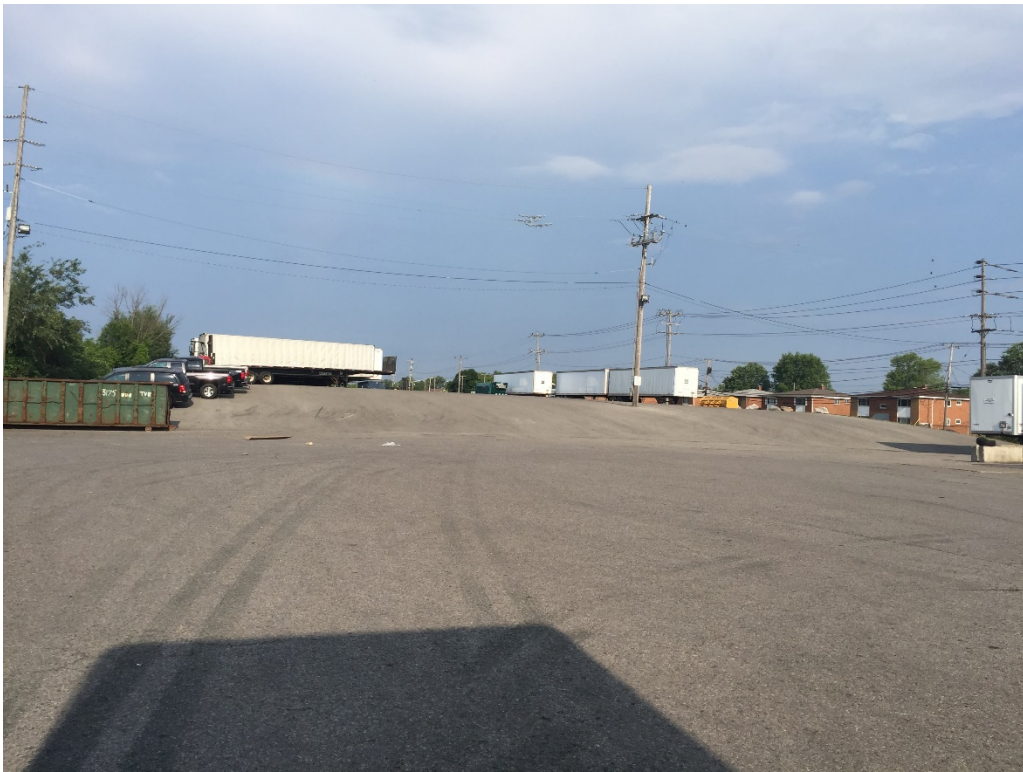
Photo 7 – Trucking Yard looking west.

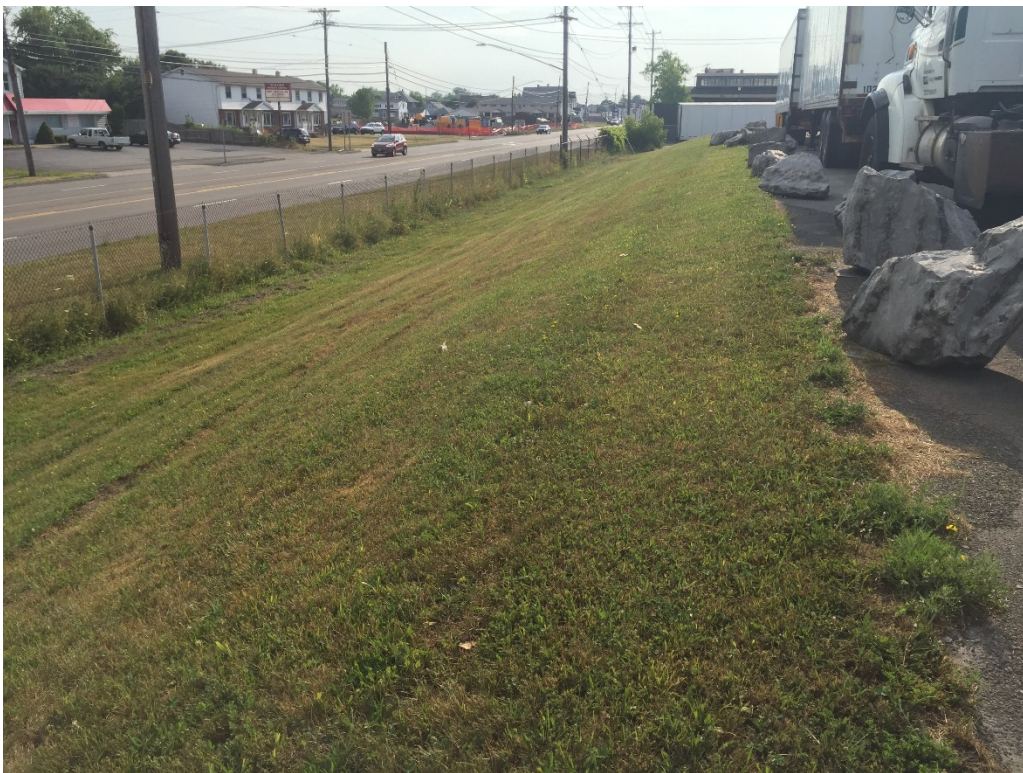
The GCL and soil cover system was visually inspected as part of the annual comprehensive Site inspection. No areas of subsidence, erosion, or exposed GCL were observed. At the time of the inspection, the grass was approximately 2 to 3 inches in length and was regularly maintained throughout the year. Photos of the GCL and soil cover are provided in Appendix B.

Photo 8 – GCL and Soil Cover System looking east along north slope.

Corrective action is not necessary for the GCL and soil cover system at this time.

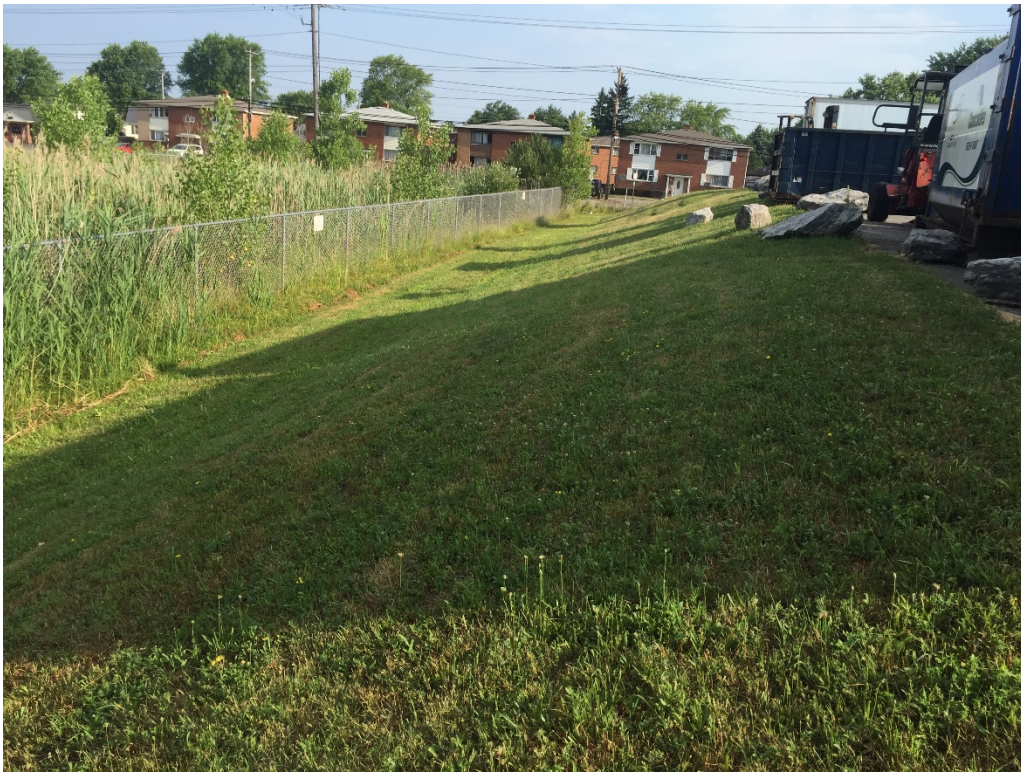
Photo 9 – GCL and Soil Cover System looking north along west slope.

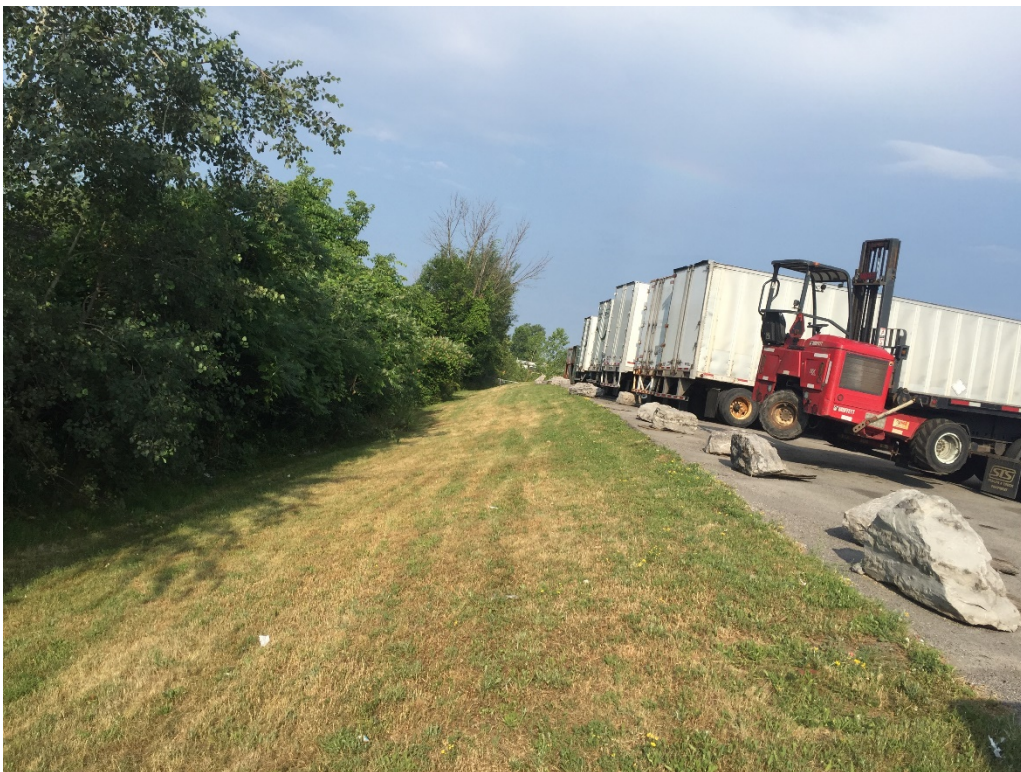
Photo 10 – GCL and Soil Cover System looking west along south slope.

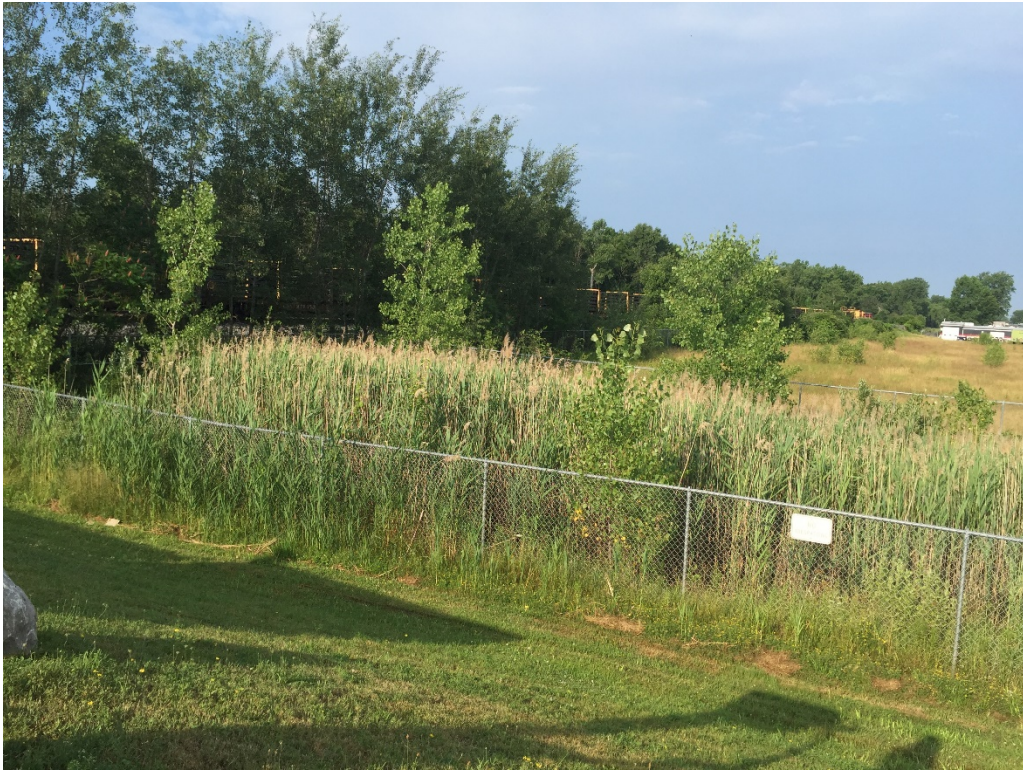
The retention pond was inspected as part of the annual comprehensive Site inspection. Approximately 12 inches of standing water was present in the center of the pond, as the water level was below the invert of the outflow pipe. Although vegetation was cut in 2015, significant plant growth is present within the pond, primarily invasive phragmites. No other debris was observed, and the outlet pipes are open. No evidence of erosion was observed along the banks of the pond.

Photo 11 – Looking southwest across retention pond.

No corrective action is necessary with regard to vegetation growth within the pond.

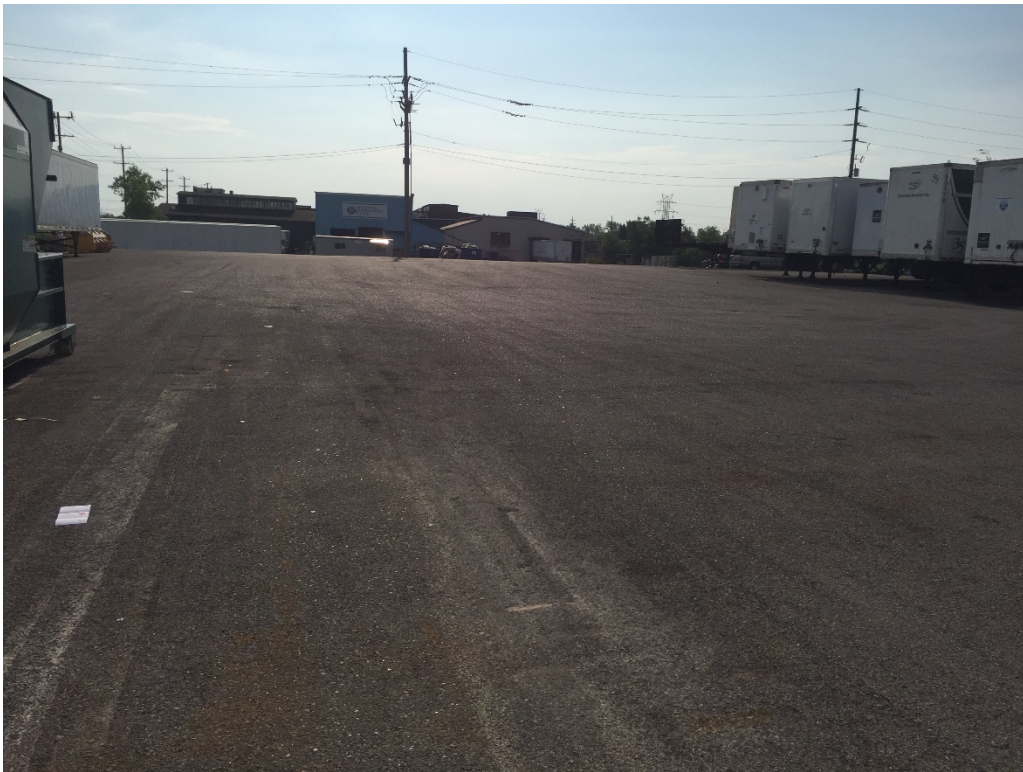
The GCL and asphalt cover system was visually inspected as part of the annual comprehensive Site inspection. No areas of subsidence or exposed GCL were observed. Minor surface indentations caused by tractor-trailer supports were noted in the asphalt, consistent with past years. The indentations were approximately 0.25 to 0.5 inch in depth, but do not affect the integrity of the cap. Photos of the GCL and asphalt cover are provided in Appendix B.

Photo 12 – GCL and Asphalt Cover System looking east across cap.

No corrective action is necessary for the GCL and asphalt cover system at this time.

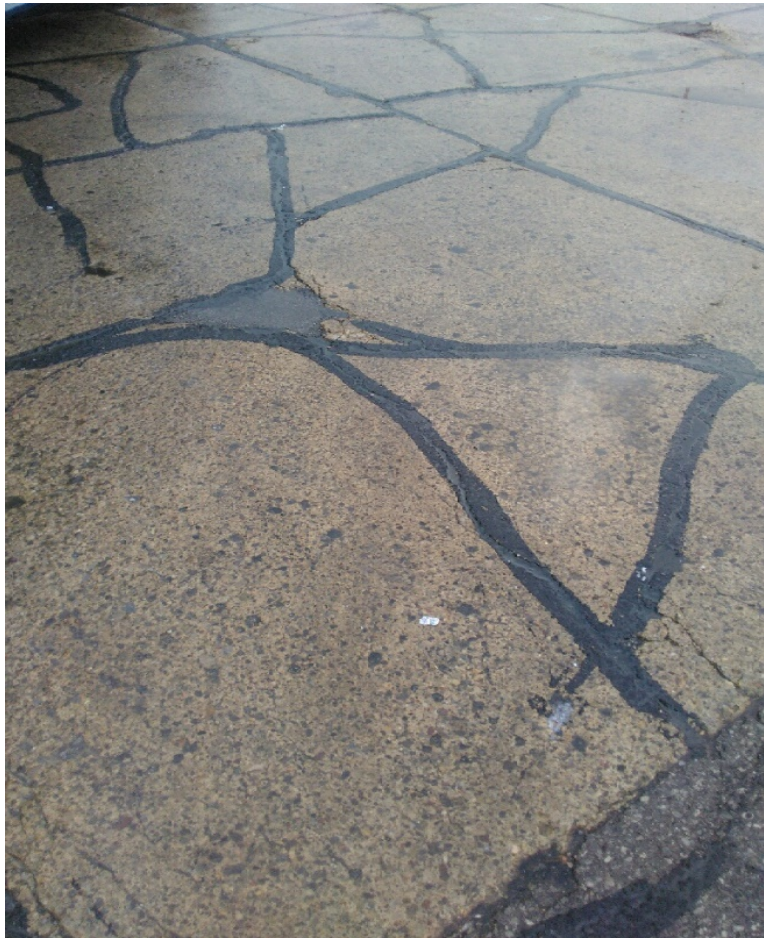
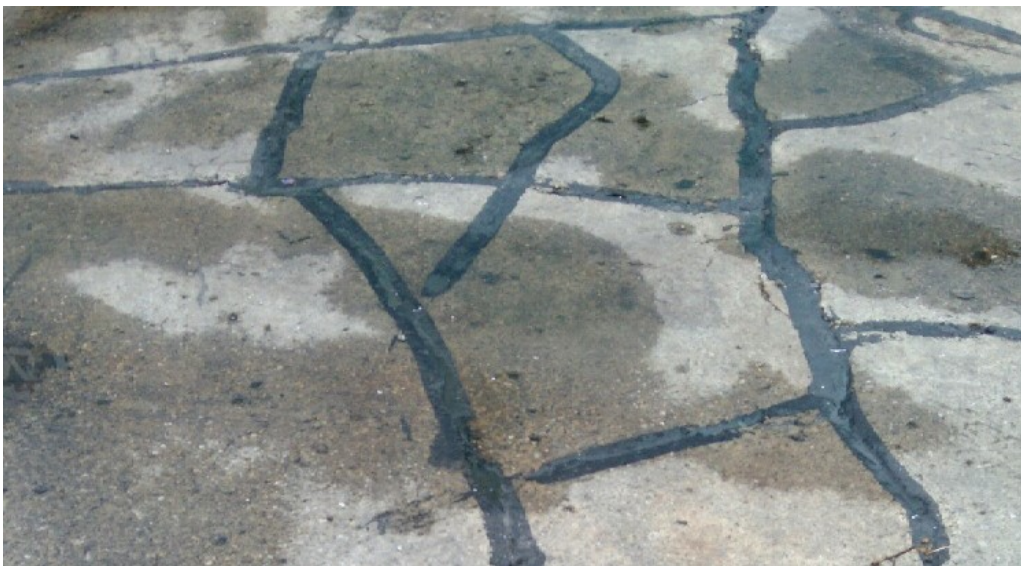
Photo 13 – Apron patching.

Photo 14 – Apron patching.

- The asphalt only cover system is generally in good condition.
- Areas of the building and apron concrete cover system where minor cracking and wear were observed were patched/sealed with asphalt and/or tar in September 2020 as part of routine maintenance.
- The GCL and soil and GCL and asphalt cover systems are generally in good condition with no deficiencies noted.
- Perimeter fencing is in good condition.
- While there is significant vegetation (phragmites) growth within the pond, the outlet pipes are not obstructed, so no action is required.
