2021 Periodic Review Report

**Former NL Industries Site
NYSDEC Site No. C915200**

Cascades Containerboard Packaging

September 29, 2021

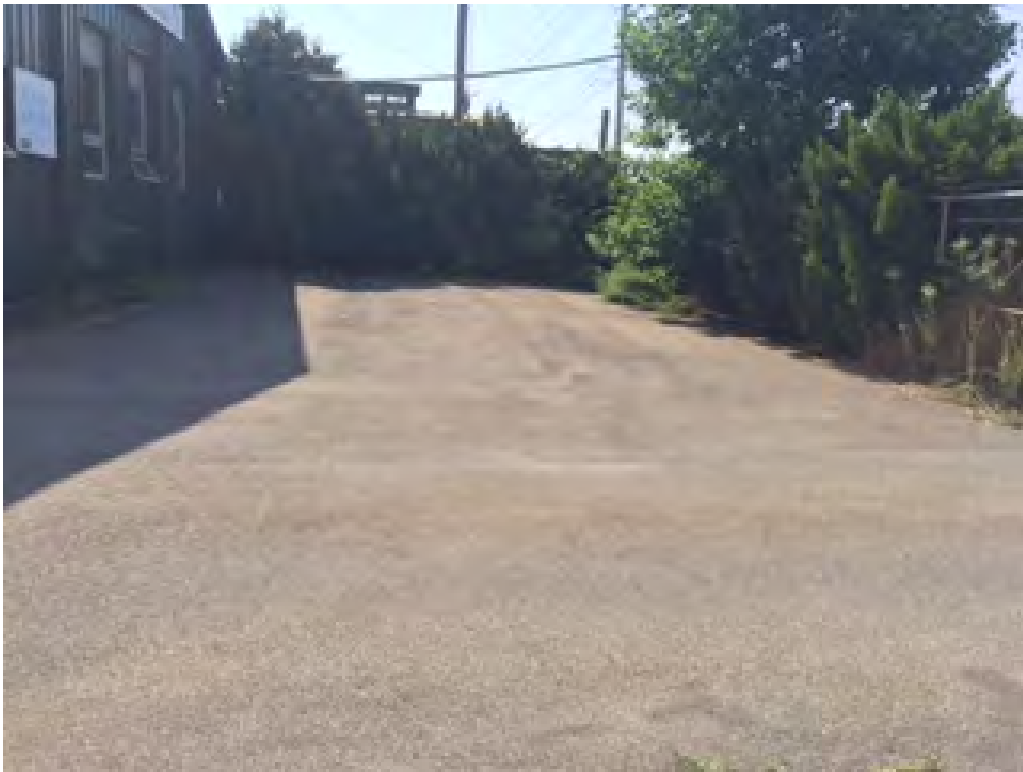
The Parking Lot was repaved in 2011 and is generally free of cracks and deterioration. Photos of the pavement are provided in Appendix B.

Photo 1 – Parking lot looking west along north side of office.

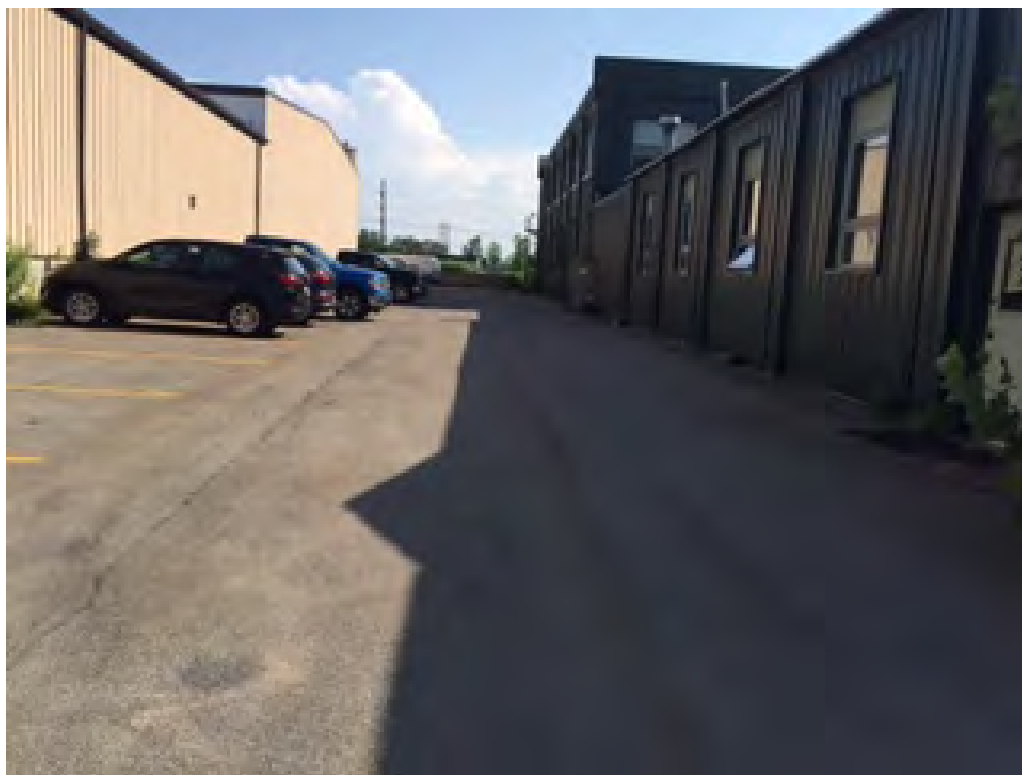
Photo 2 – Parking lot looking south.

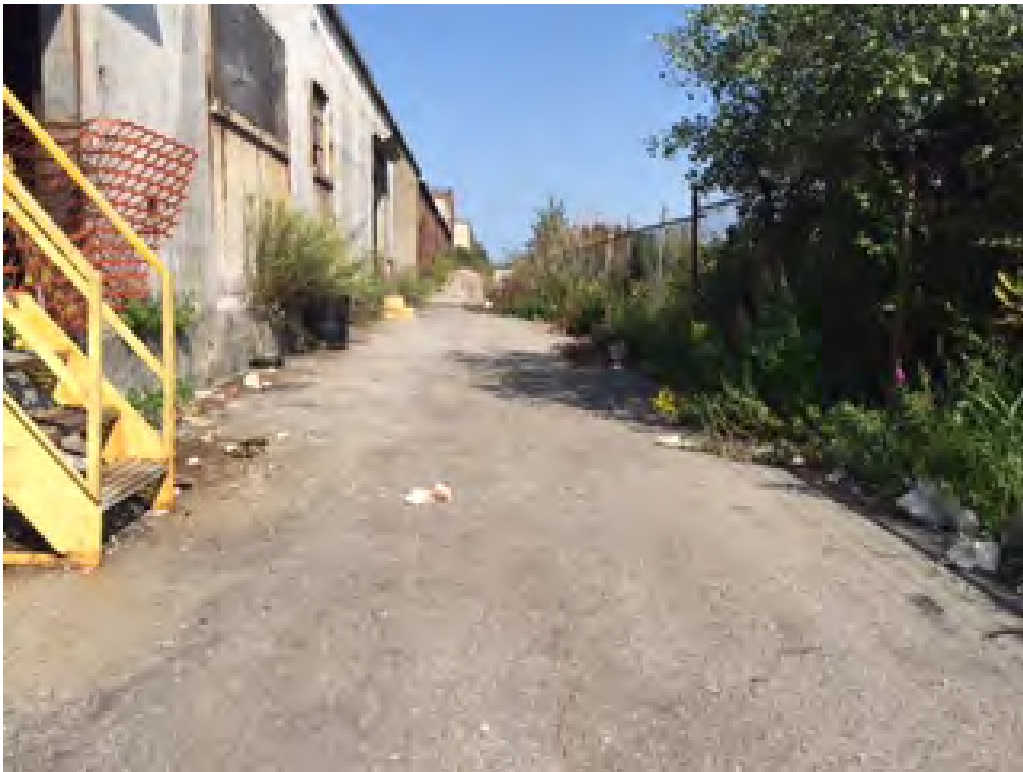
The asphalt cover on the Former Rail Siding was generally free of cracks and deterioration and appeared in good condition. Photos of the pavement are provided in Appendix B.

Photo 3 – Former rail siding looking east.

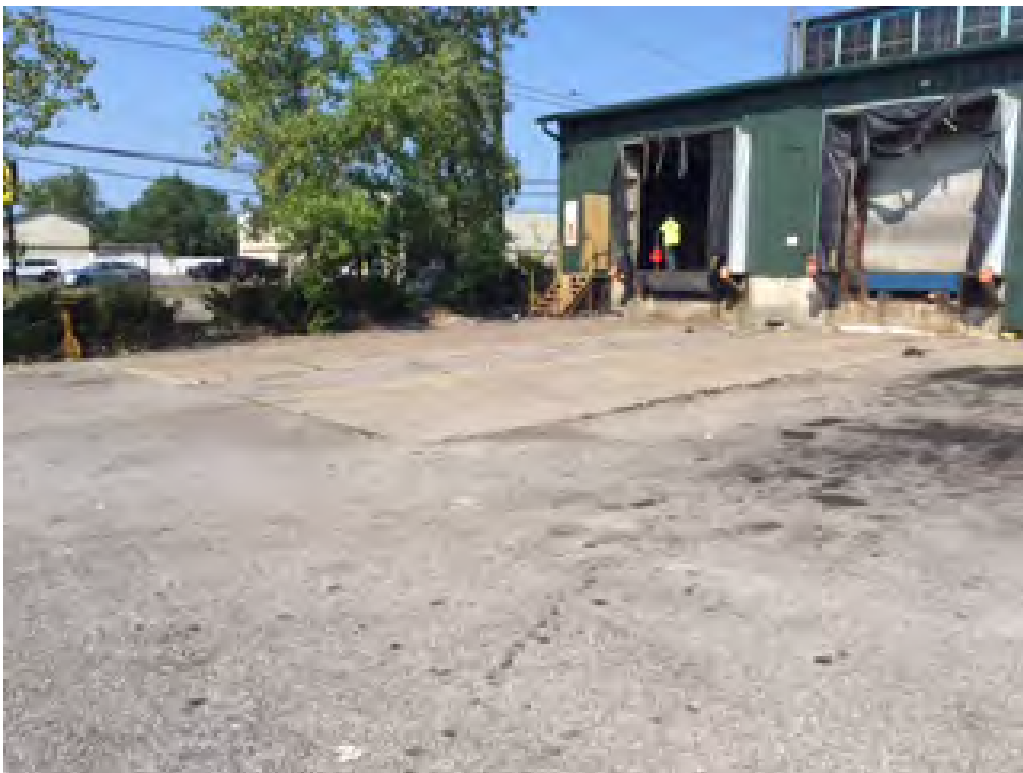
The building floor slab and apron concrete were visually inspected for cracks and deterioration. Significant cracks and areas of missing surface were observed on the concrete apron; however, these cracks do not penetrate the full thickness of the apron slab and do not currently impact the effectiveness of the cover. Photos of the concrete are provided in Appendix B.

Photo 4 – Front Dock building apron concrete system (north end of building) looking northeast.

The tipping floor dock (center) and back dock (south) aprons require significant repairs or replacement to prevent potential exposure to underlying contaminated soil. The work will be completed as part of the Site maintenance for the 2021/2022 reporting period.

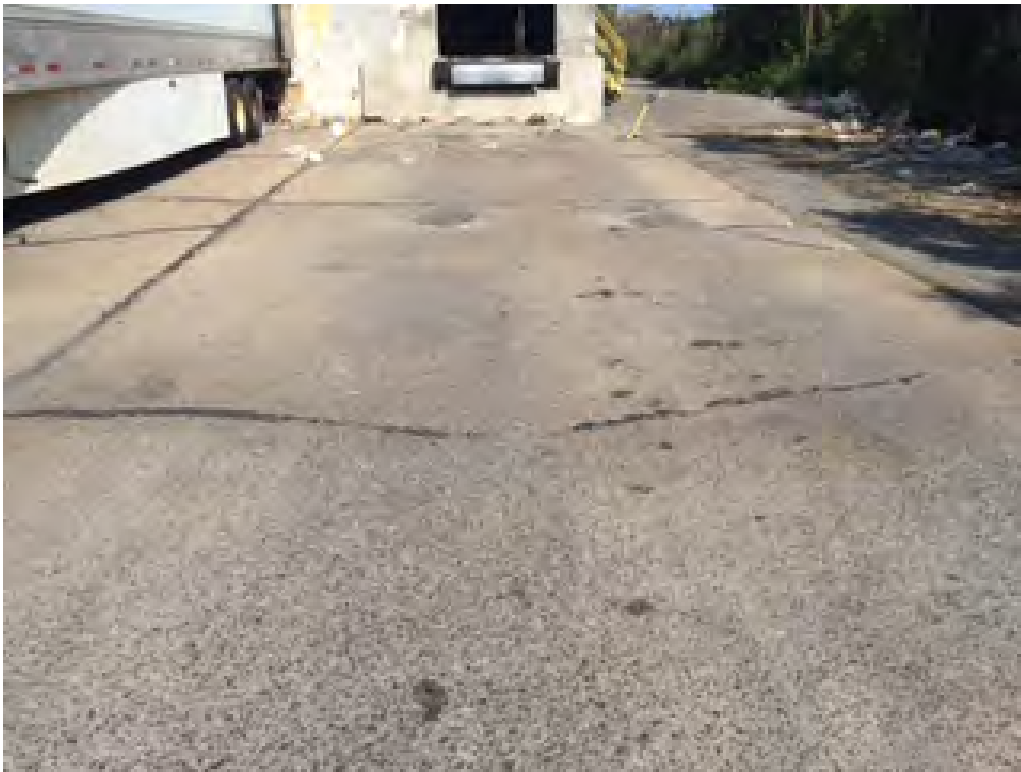
YES ☒ NO ☐ If yes, please describe ^{floor} The tipping dock and back dock aprons have significant cracks and wear with some spots missing surface concrete. Not full thickness. No waste or soil currently exposed.

Photo 5 – Building Apron Concrete System (south end of building) looking east.

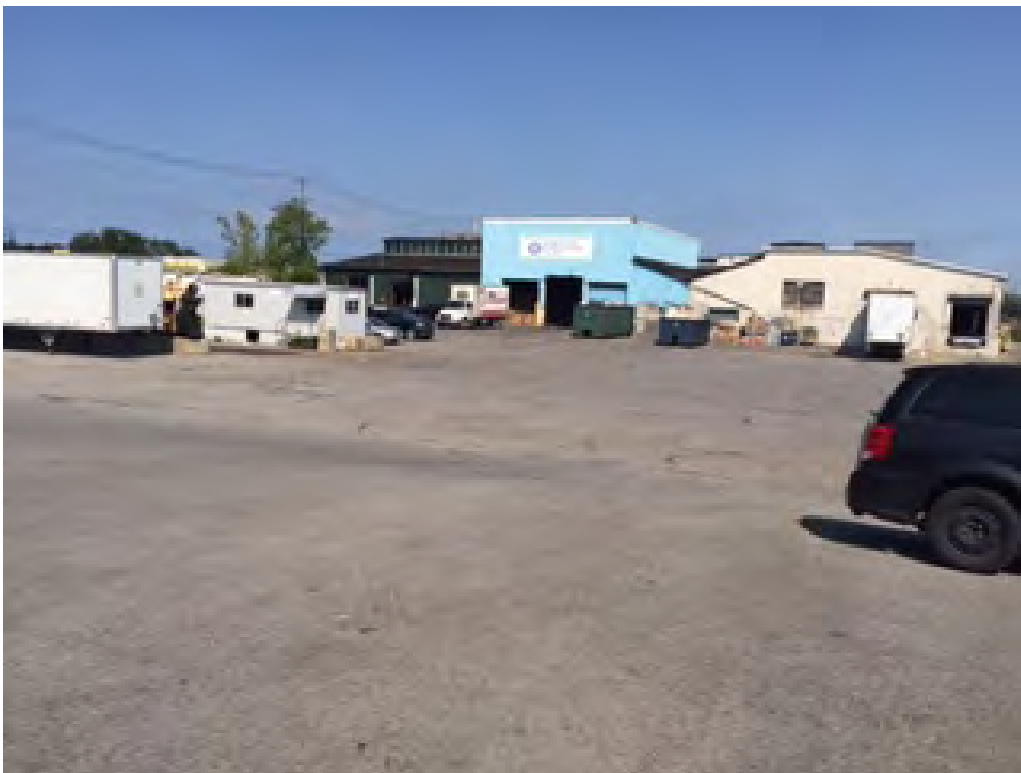
The asphalt surface in the trucking yard is exhibiting clusters of cracking. No asphalt is currently missing; however, the severity of cracking warrants more significant action than crack sealing. Maintenance or repair of the asphalt surface (i.e., resurfacing) is needed to prevent further deterioration. Work will be completed as part of the 2021/2022 maintenance. Photos of the trucking yard are provided in Appendix B.

Photo 6 – Trucking Yard looking east.

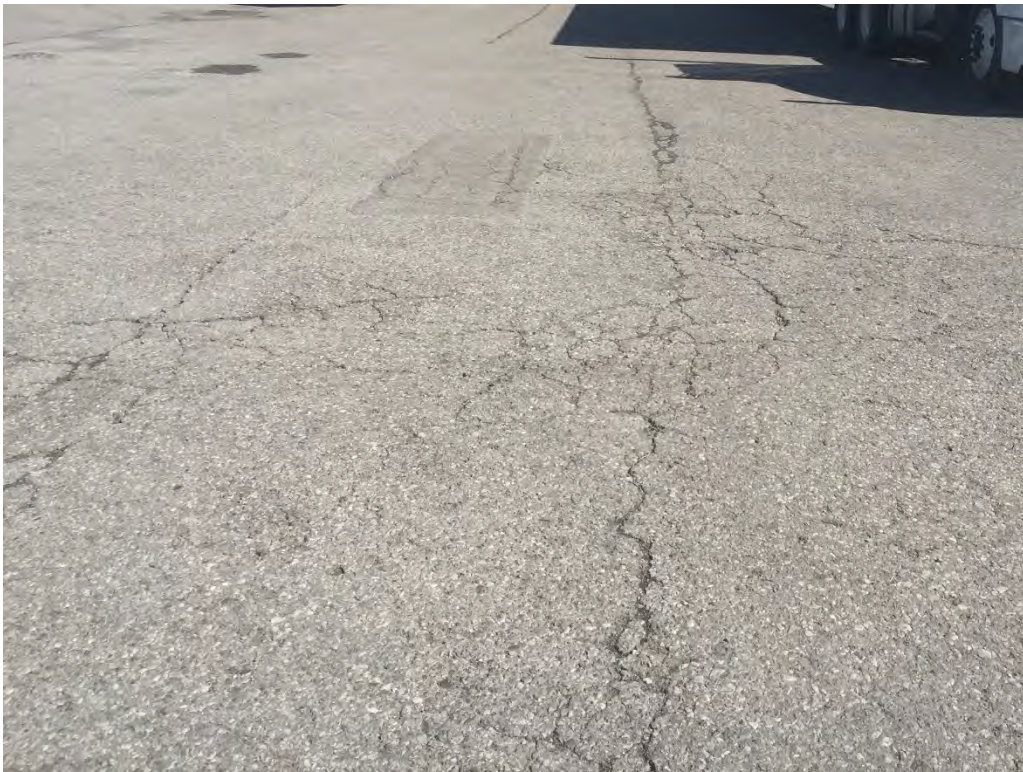
Photo 7 – Example of asphalt cracking in Trucking Yard.

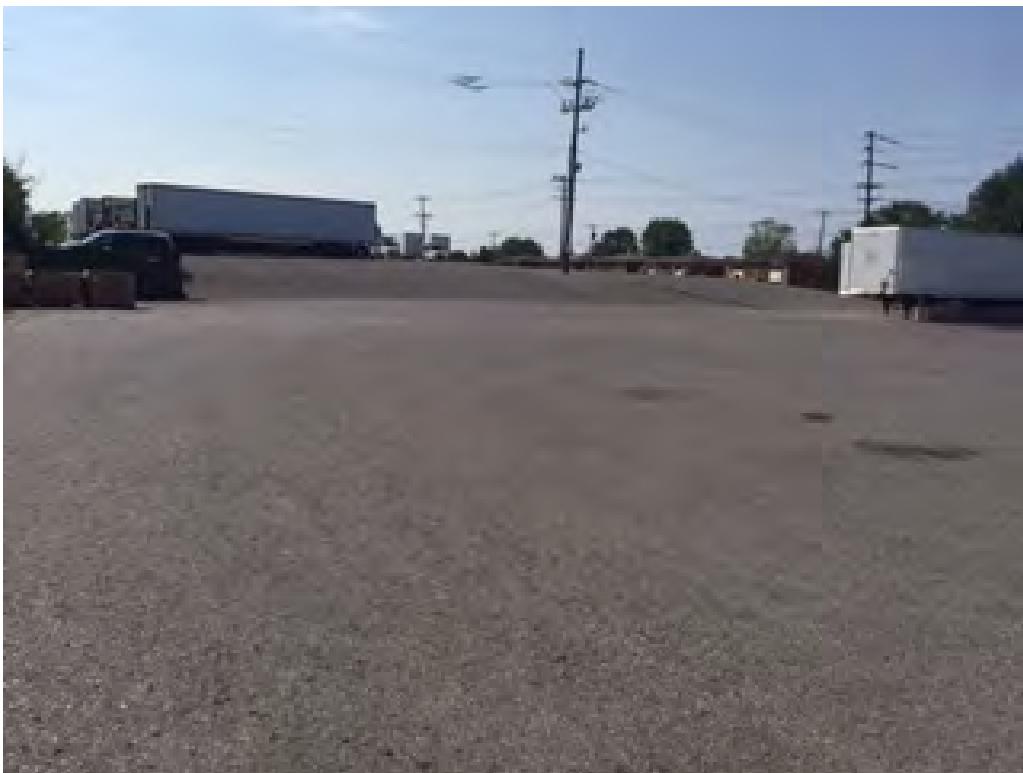
Photo 8 – Trucking Yard looking west.

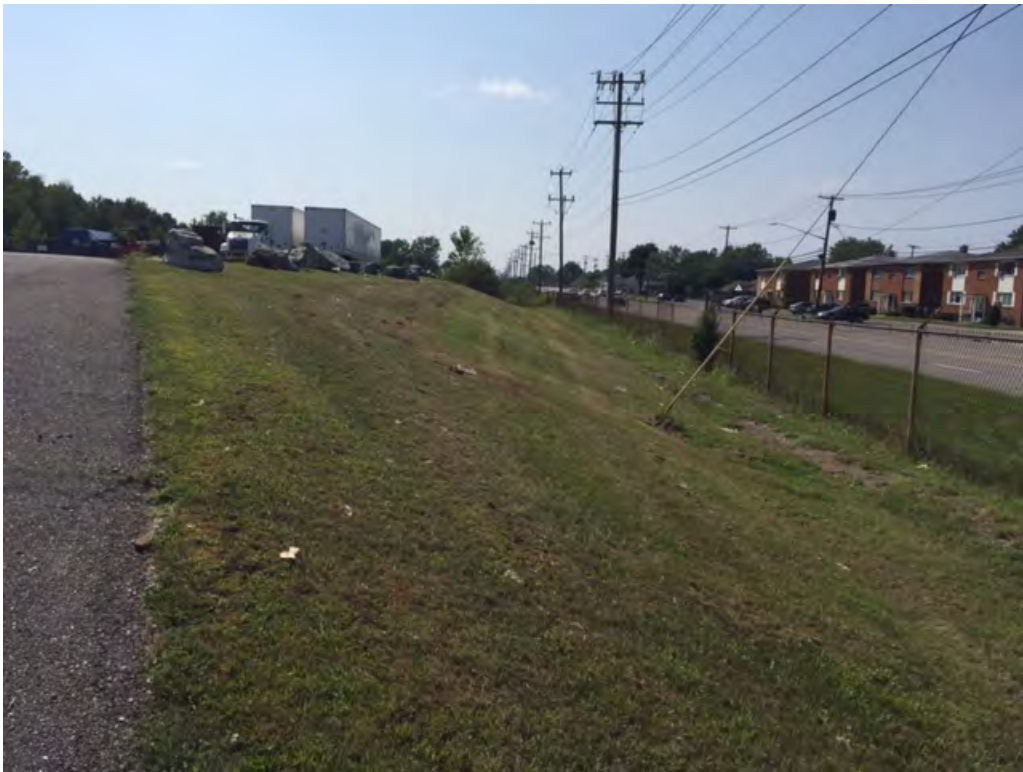
The GCL and soil cover system was visually inspected as part of the annual comprehensive Site inspection. No areas of subsidence, erosion, or exposed GCL were observed. At the time of the inspection, the grass was approximately 1 to 2 inches in length and was regularly maintained throughout the year. Some bare spots were observed on the western slope of the containment cell. They appeared to be the result of cutting the grass too short and the hot, dry weather in the weeks leading up to the inspection. Photos of the GCL and soil cover are provided in Appendix B.

Photo 9 – GCL and Soil Cover System looking west along north slope.

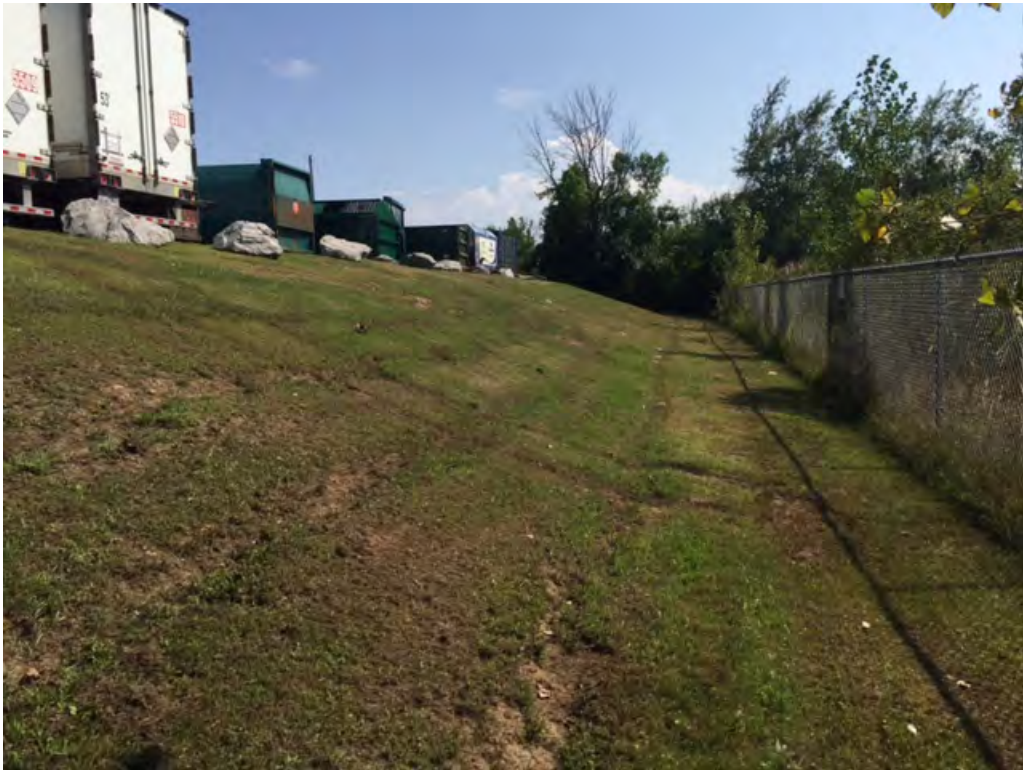
The vegetative cover was inspected as part of the annual comprehensive Site inspection. No areas of distressed vegetation, invasive species, or woody growth were observed. Some bare spots were observed on the western slope of the containment cell. They appeared to be the result of cutting the grass too short and the hot, dry weather in the weeks leading up to the inspection. Photos of the vegetative cover are provided in Appendix B.

Photo 10 – GCL and Soil Cover System looking south along west slope.

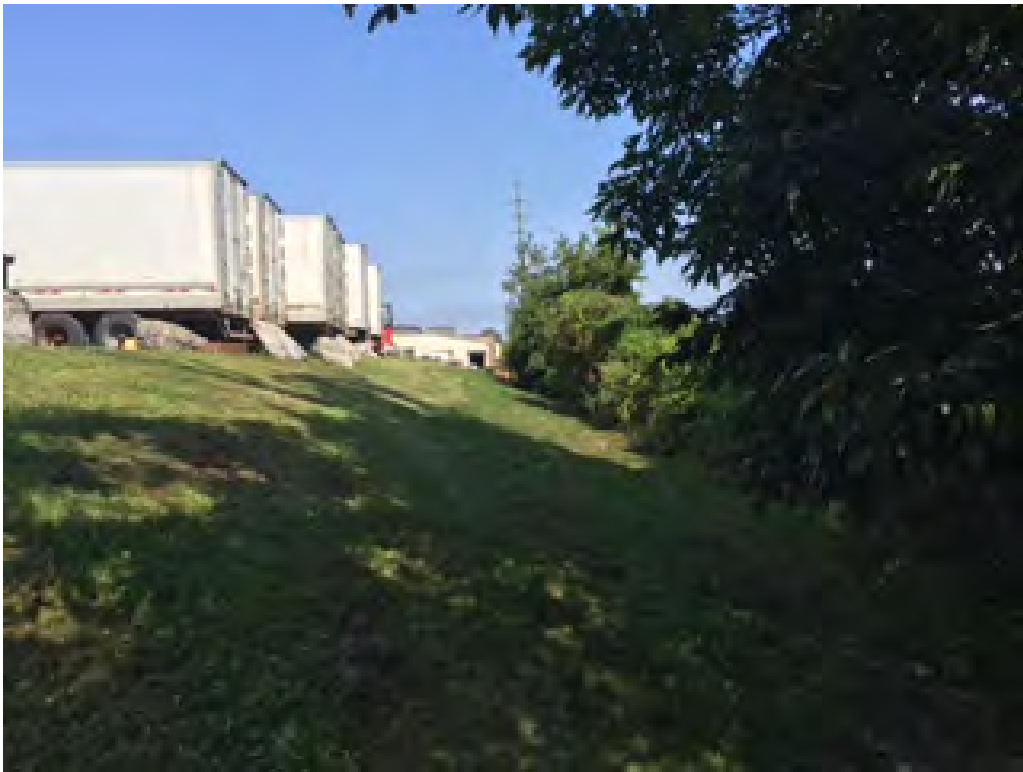
Photo 11 – GCL and Soil Cover System looking east along south slope.

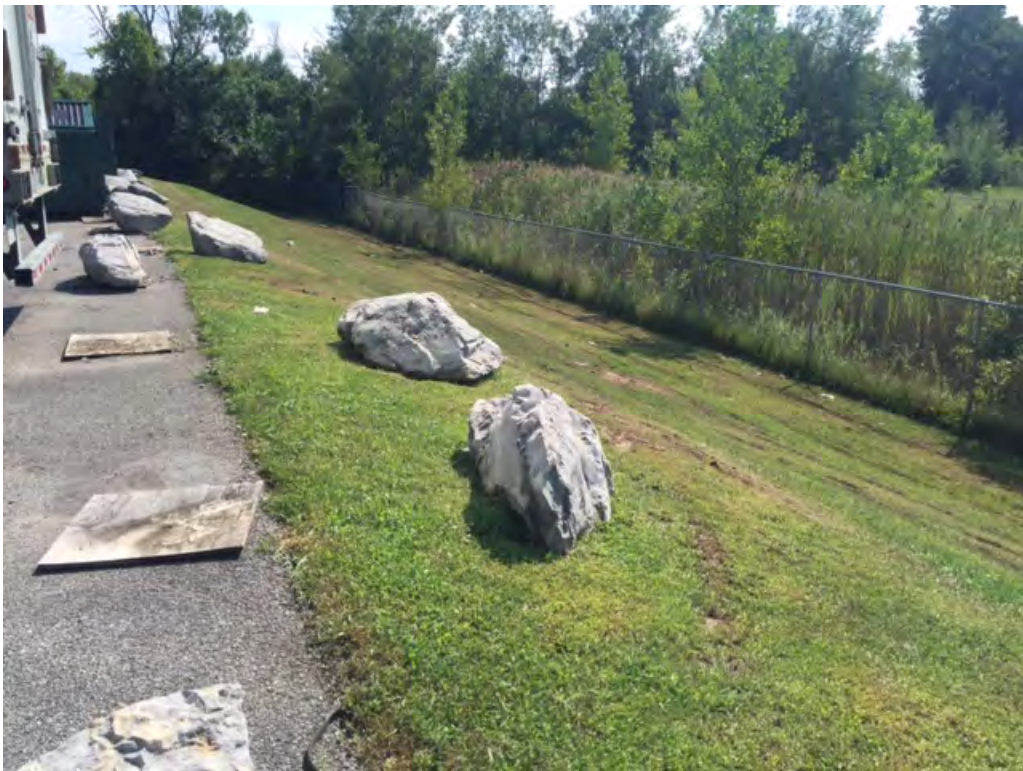
The retention pond was inspected as part of the annual comprehensive Site inspection. Approximately 12 inches of standing water was present in the pond. Significant plant growth is present within the pond, primarily invasive phragmites. Some individual and small clusters of phragmites were observed growing outside the stone perimeter of the pond. No other debris was observed, and the outlet pipes were open. No evidence of erosion was observed along the banks of the pond. Photos of the retention pond are provided in Appendix B.

Photo 12 – Looking southwest at south slope and retention pond.

- Some phragmites were observed growing outside of the stone banks of the retention pond. The annual mowing/cutting of the phragmites around the interior and exterior perimeter of the pond will be incorporated into the annual maintenance activities to prevent further migration.

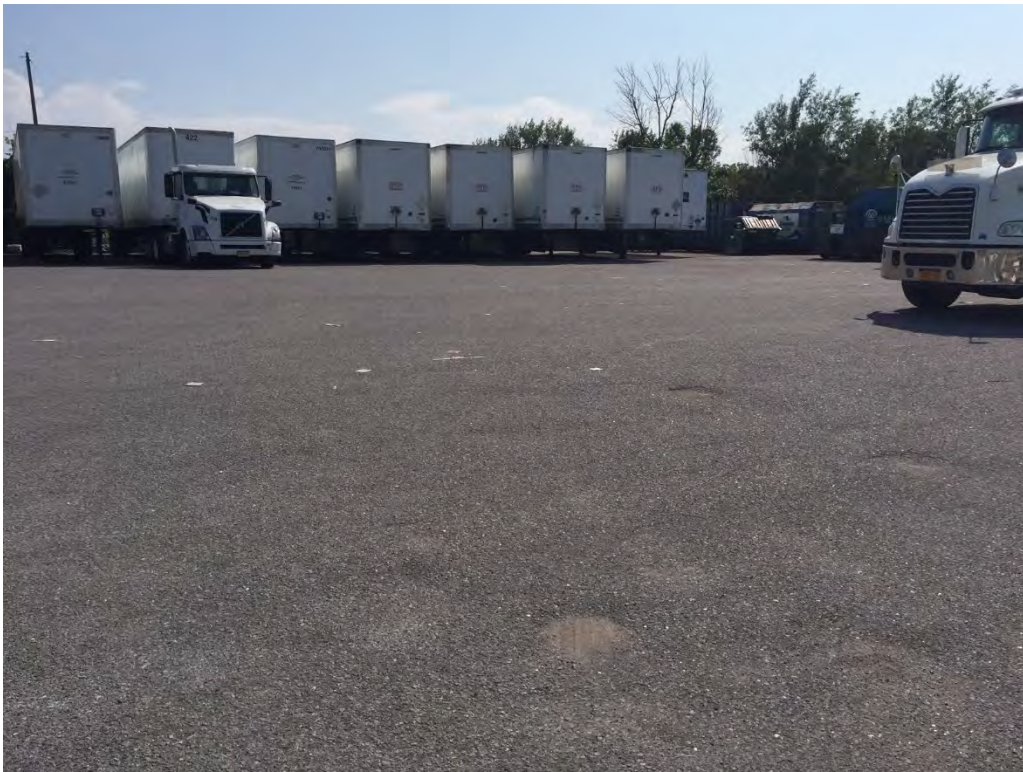
The GCL and asphalt cover system was visually inspected as part of the annual comprehensive Site inspection. No areas of subsidence or exposed GCL were observed. Minor surface indentations caused by tractor-trailer supports were noted in the asphalt, consistent with past years. The indentations were approximately 0.25 to 0.5 inch in depth, but do not affect the integrity of the cap. Photos of the GCL and asphalt cover are provided in Appendix B.

Photo 13 – GCL and Asphalt Cover System looking southwest across cap.
