Annual Periodic Review Report, Former NL Industries Site No. C915200

2023 Periodic Review Report

**Former NL Industries Foundry, NYSDEC
Site No. C915200**

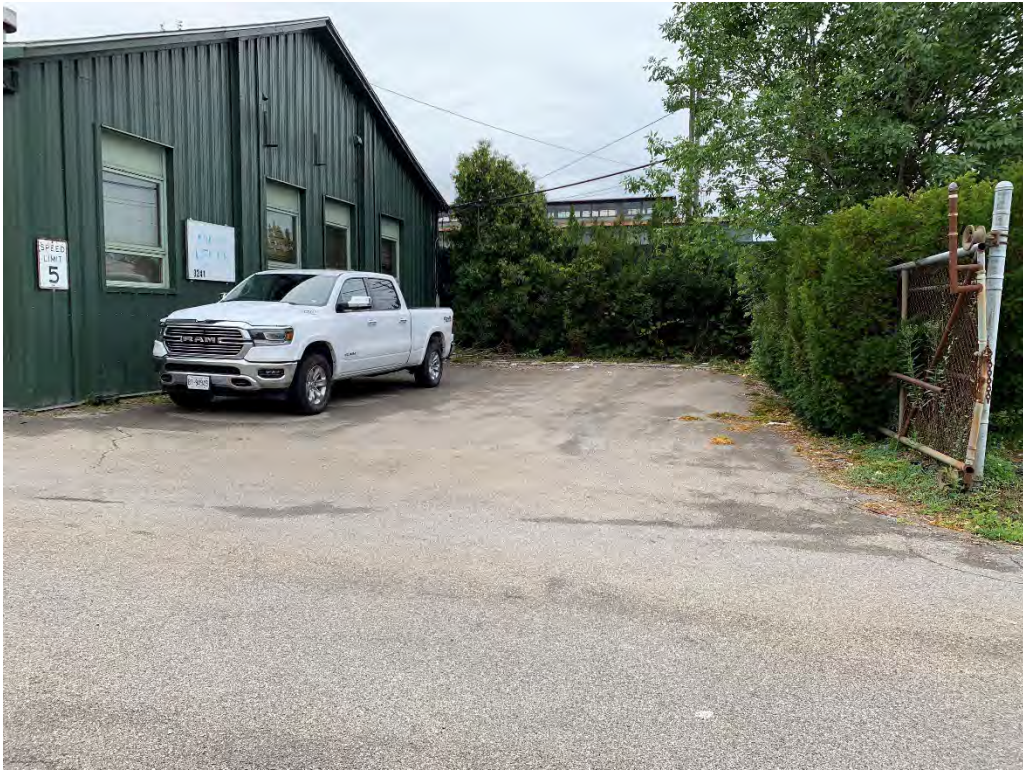
The Parking Lot was repaved in 2011 and is generally free of cracks and deterioration with no protruding vegetation. Photos of the pavement are provided in Appendix B.

Photo 1 – Parking lot looking west along north side of office.

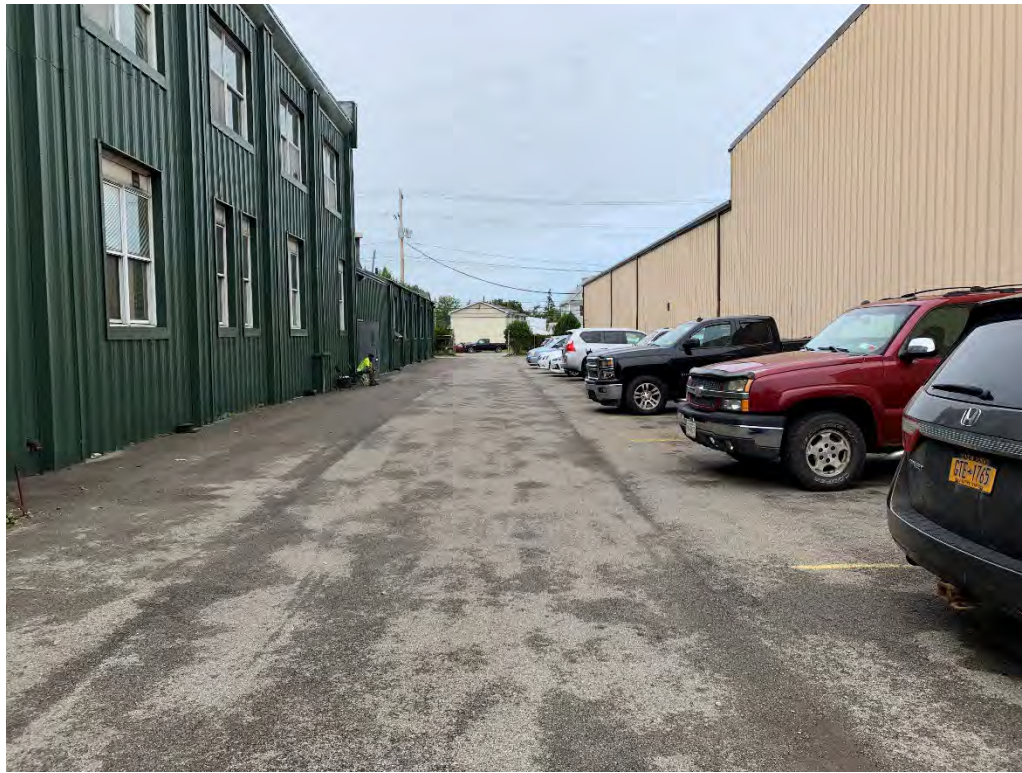
Photo 2 – Parking lot looking north.

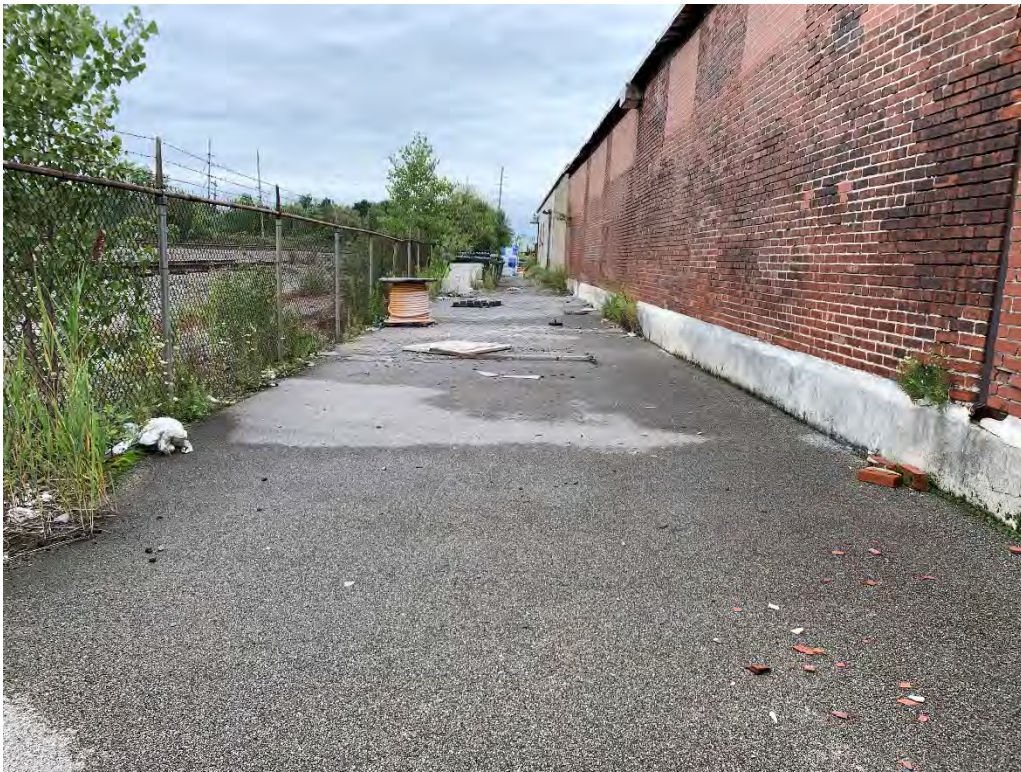
The asphalt cover on the Former Rail Siding was generally free of cracks and deterioration with no protruding vegetation and appeared in good condition. Photos of the pavement are provided in Appendix B.

Photo 3 – Former rail siding looking west.

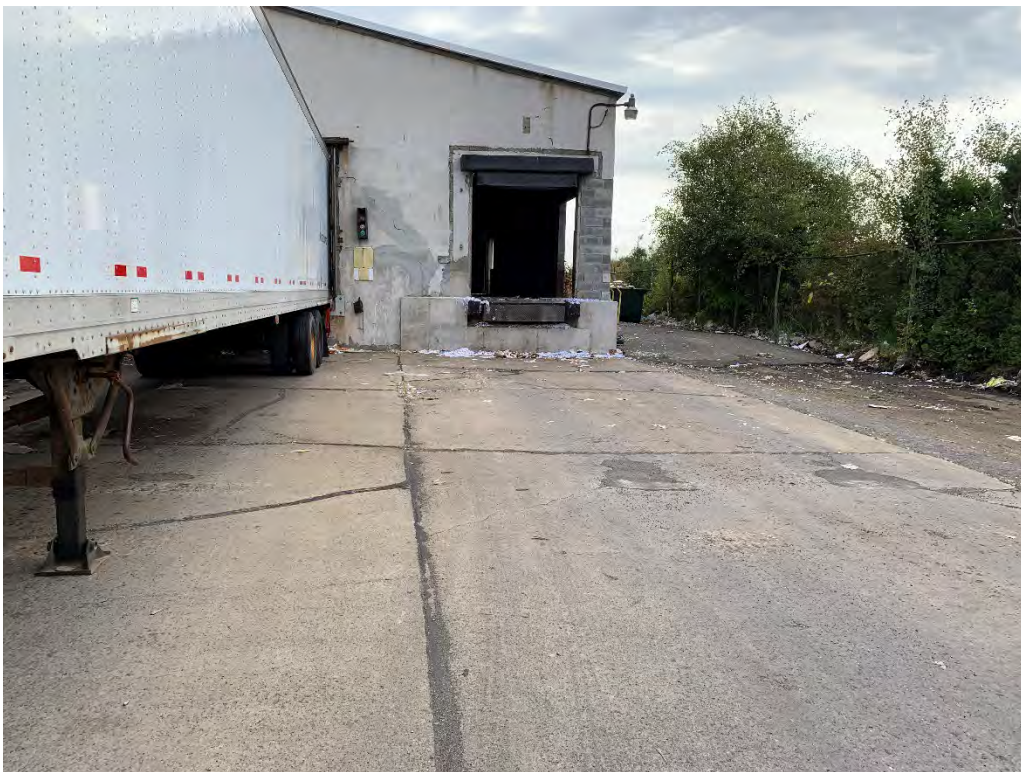
The building foundation and apron concrete were visually inspected for cracks and deterioration. The floor within the building is solid with no open penetrations. The building foundation is in good condition. Cracks and areas of missing concrete were observed on the concrete dock apron system; however, these were either filled with asphalt cold patch or tar sealant to prevent further water intrusion and damage from freeze/thaw cycles. While the tipping floor dock (center dock/apron area) and back dock (south dock/apron area) concrete aprons may eventually require replacement, the asphalt filling and tar sealing is sufficient to prevent potential exposure to underlying contaminated soil. Photos of the concrete aprons are provided in Appendix B.

Photo 4 – South concrete apron looking east.

While no corrective action is immediately necessary, routine monitoring and maintenance of the concrete aprons is required in lieu of replacement.

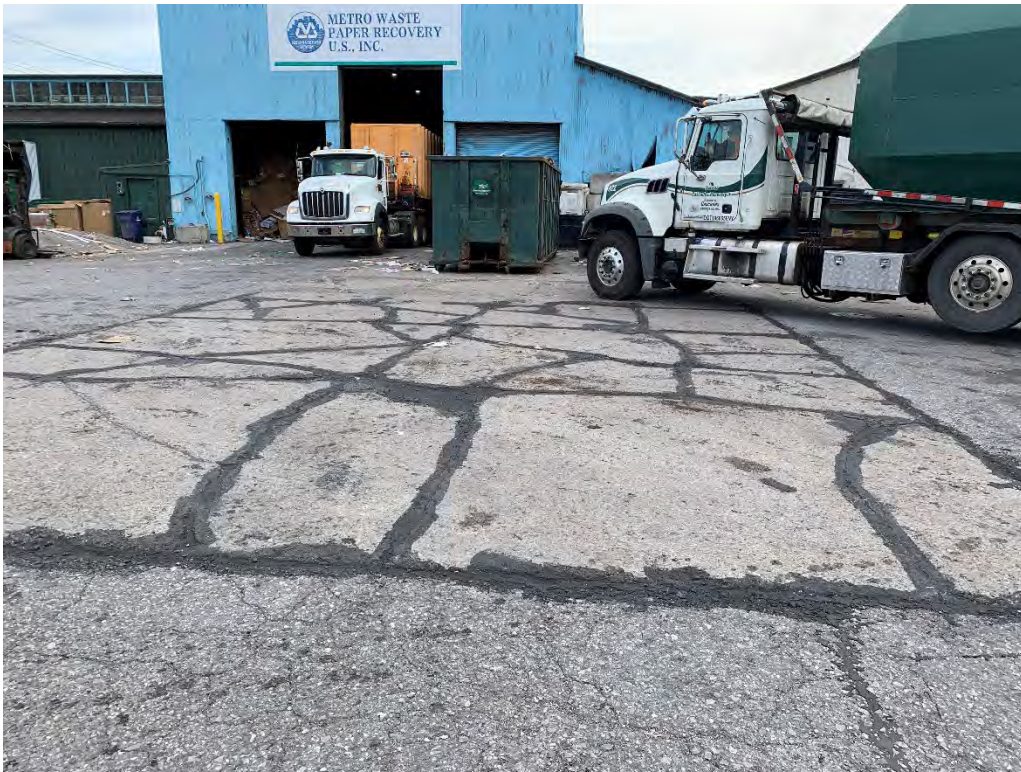
Photo 5 – Building Apron Concrete System (central portion) looking east. Surface cracks are sealed.

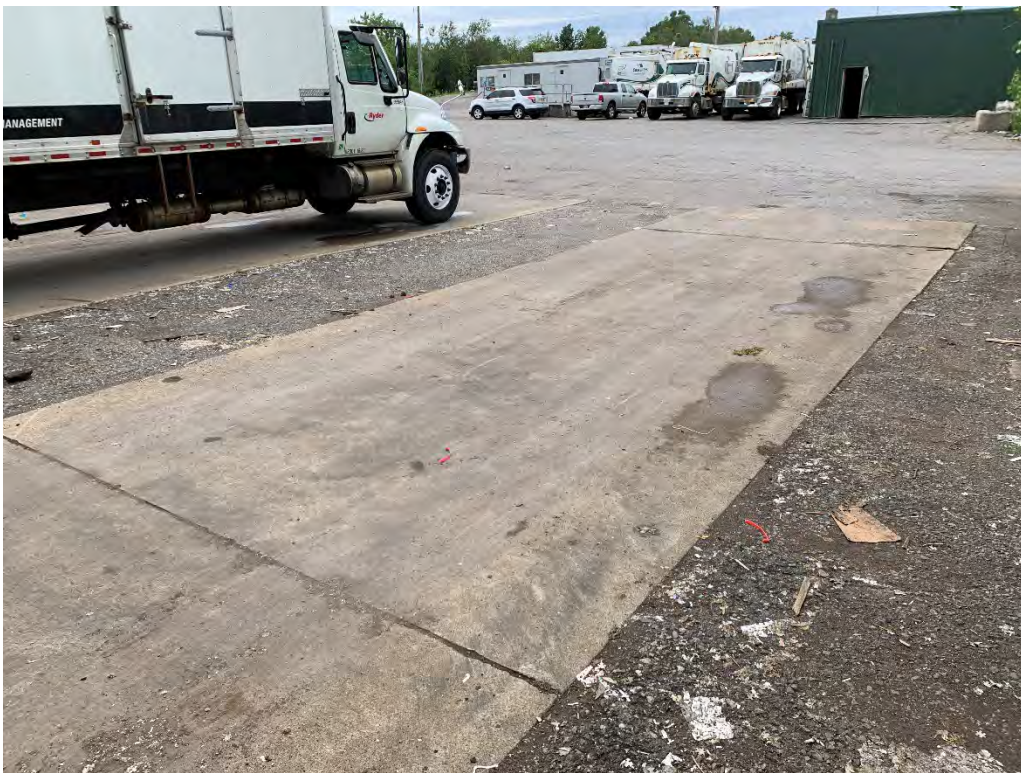
Photo 6 – North concrete aprons looking west-southwest.

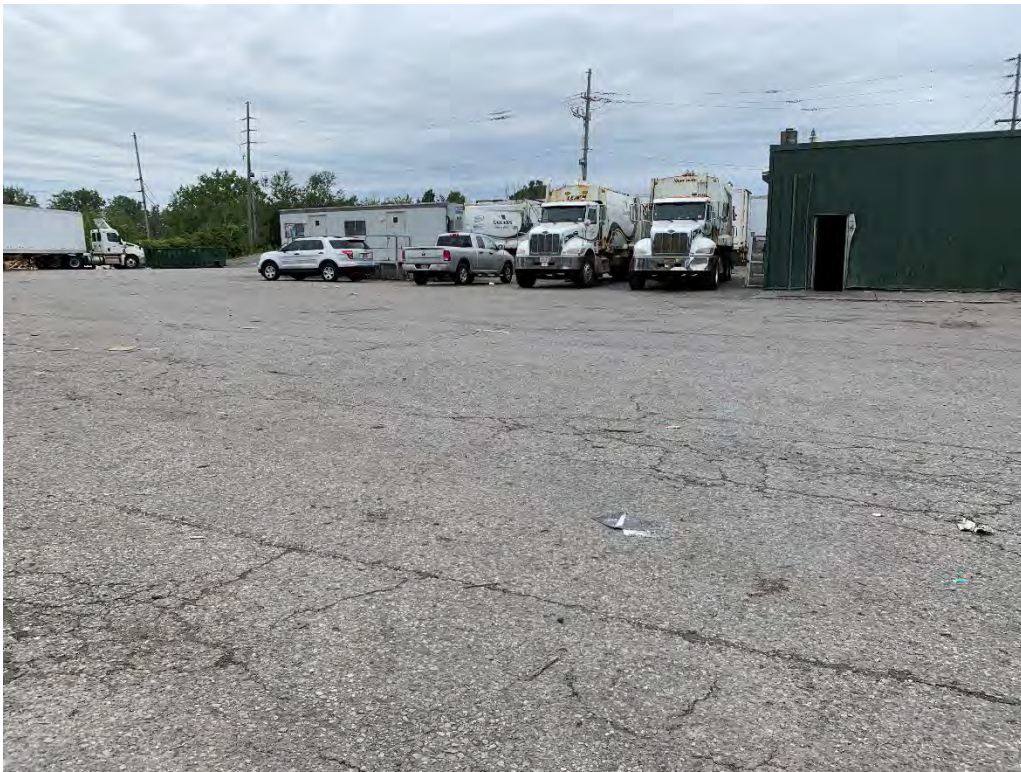
The asphalt surface in the trucking yard continues to exhibit clusters of cracking, although the condition appears consistent with the 2022 inspection. No asphalt is currently missing nor is vegetation protruding; however, the severity of cracking warrants more significant action than crack sealing. Resurfacing is needed to prevent more significant deterioration that would require replacement of the blacktop. Photos of the trucking yard are provided in Appendix B.

Photo 7 – Trucking yard looking southwest.

Resurfacing of the trucking yard is recommended before the next reporting period and is targeted to be completed by July 31, 2024, subject to weather and contractor availability. Cascades will notify NYSDEC of the actual schedule once a contractor has been selected.

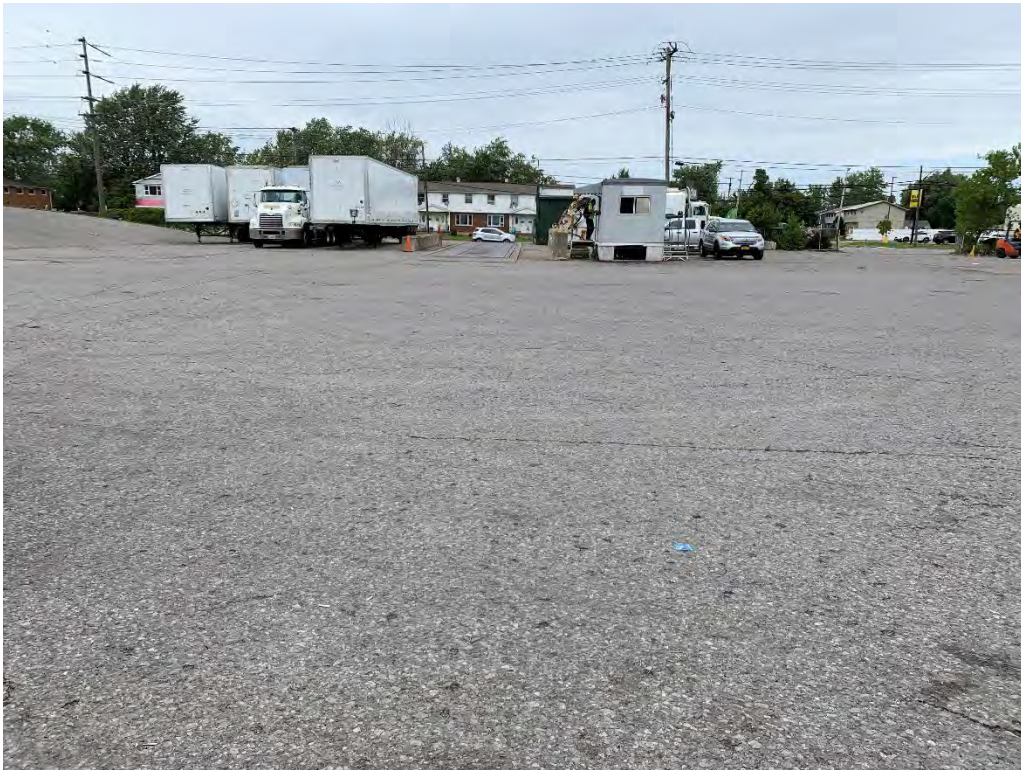
Photo 8 – Trucking yard looking north.

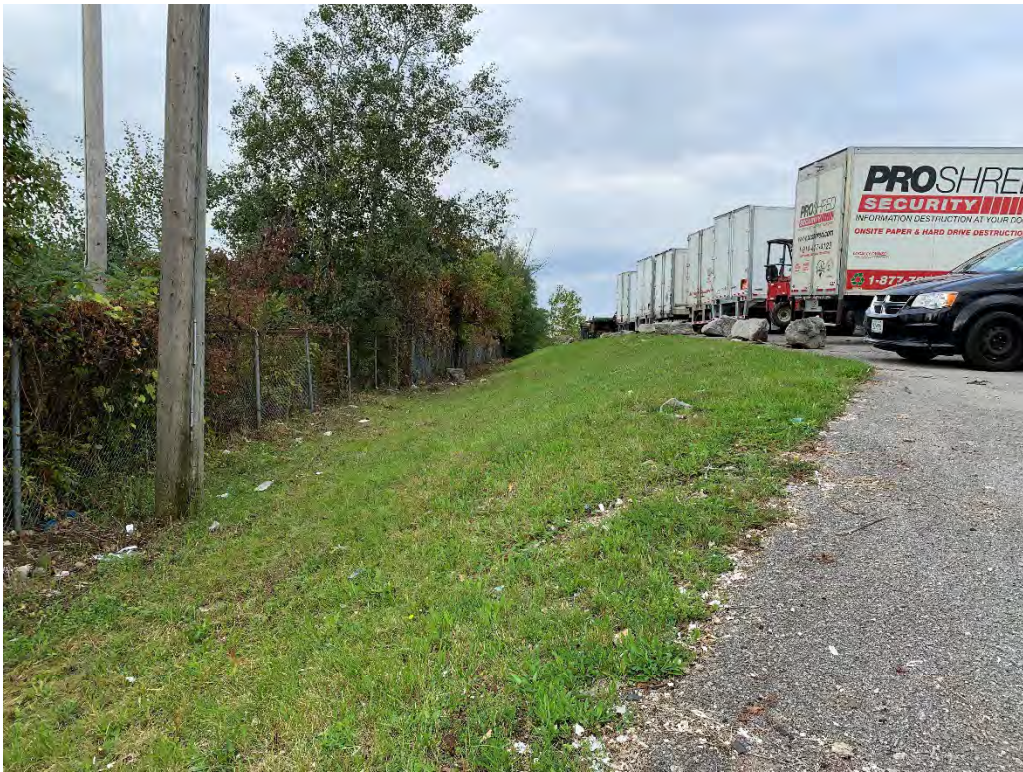
The GCL and soil cover system was visually inspected as part of the annual comprehensive Site inspection. No areas of subsidence, erosion, or exposed GCL were observed. At the time of the inspection, the grass was approximately 2 inches in length and was regularly maintained. A small area of grass/soil on the south slope observed during the 2022 inspection to have been gouged by a dislodged boulder was rolled after the 2022 inspection to level the area. Vegetation re-established during the current growing season. Photos of the GCL and soil cover are provided in Appendix B.

Photo 9 – GCL and Soil Cover System looking west along south slope.

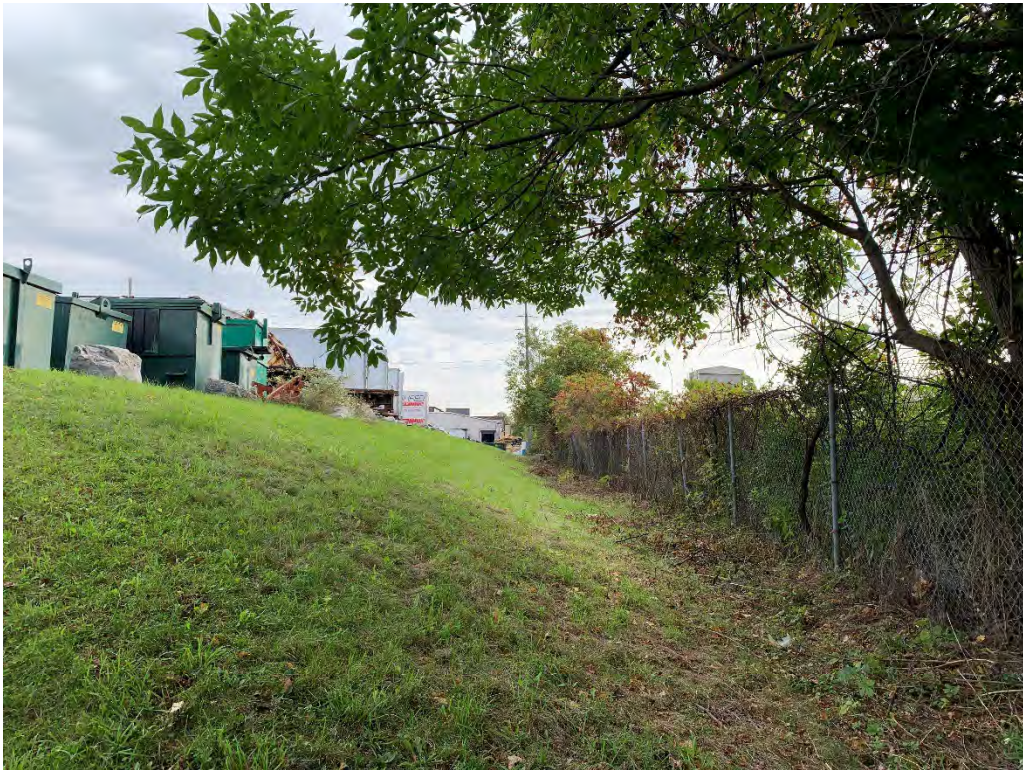
Photo 10 – GCL and Soil Cover System looking east along south slope.

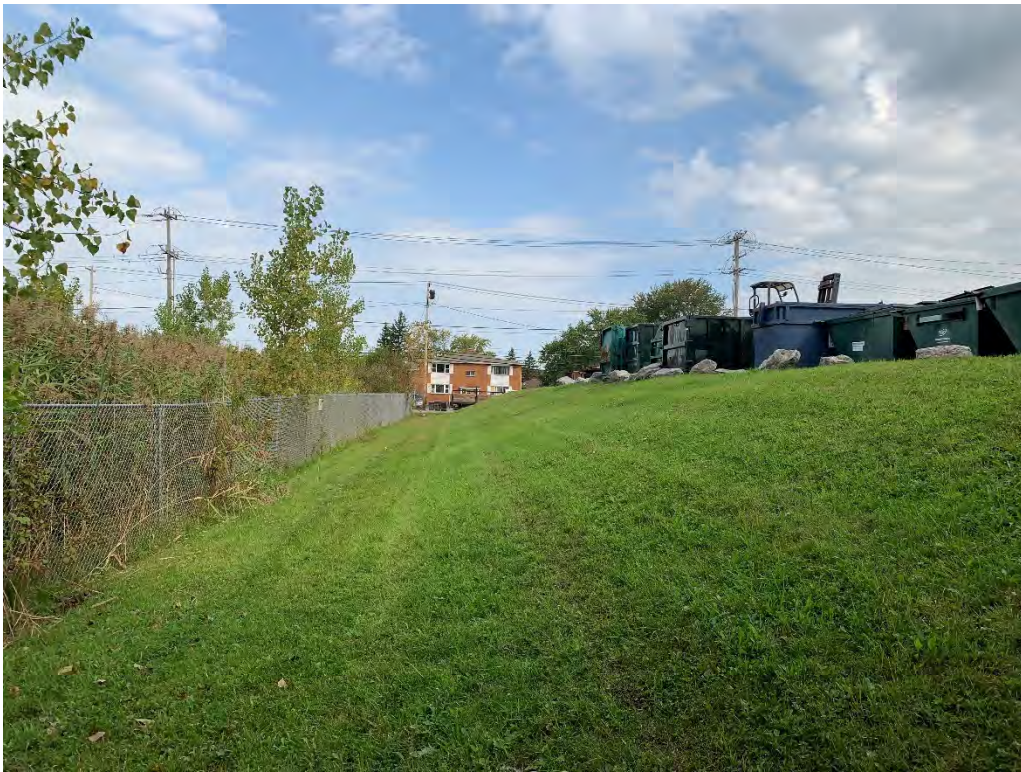
Photo 11 – GCL and Soil Cover System looking north along west slope.

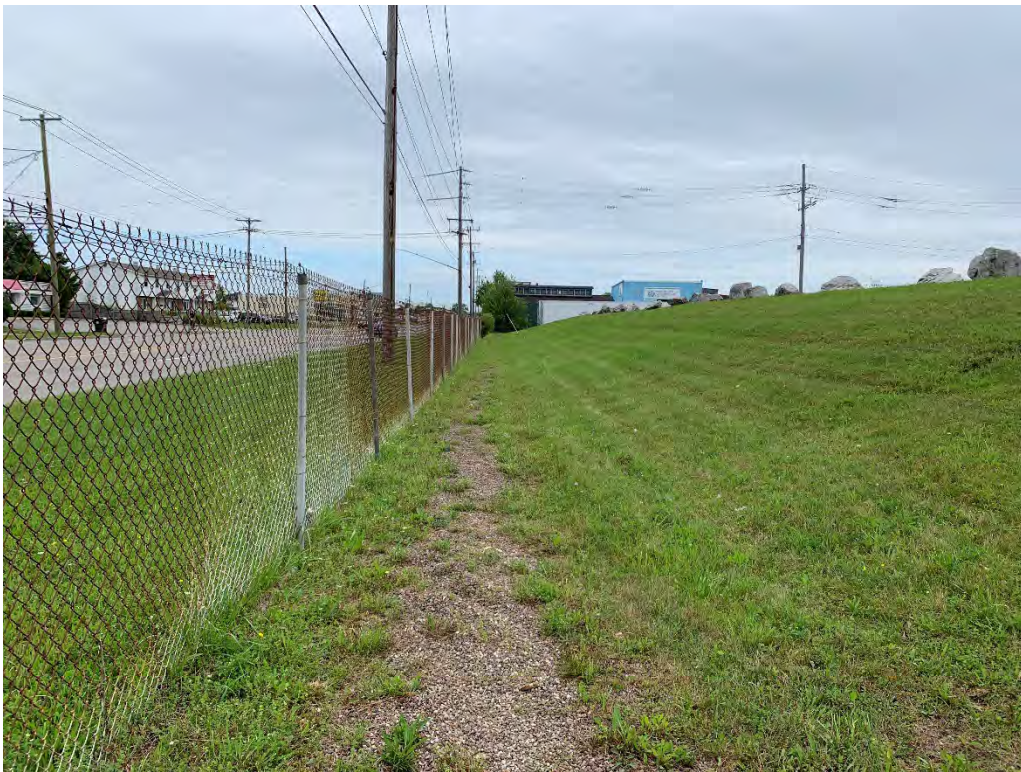
Photo 12 – GCL and Soil Cover System looking east along north slope.

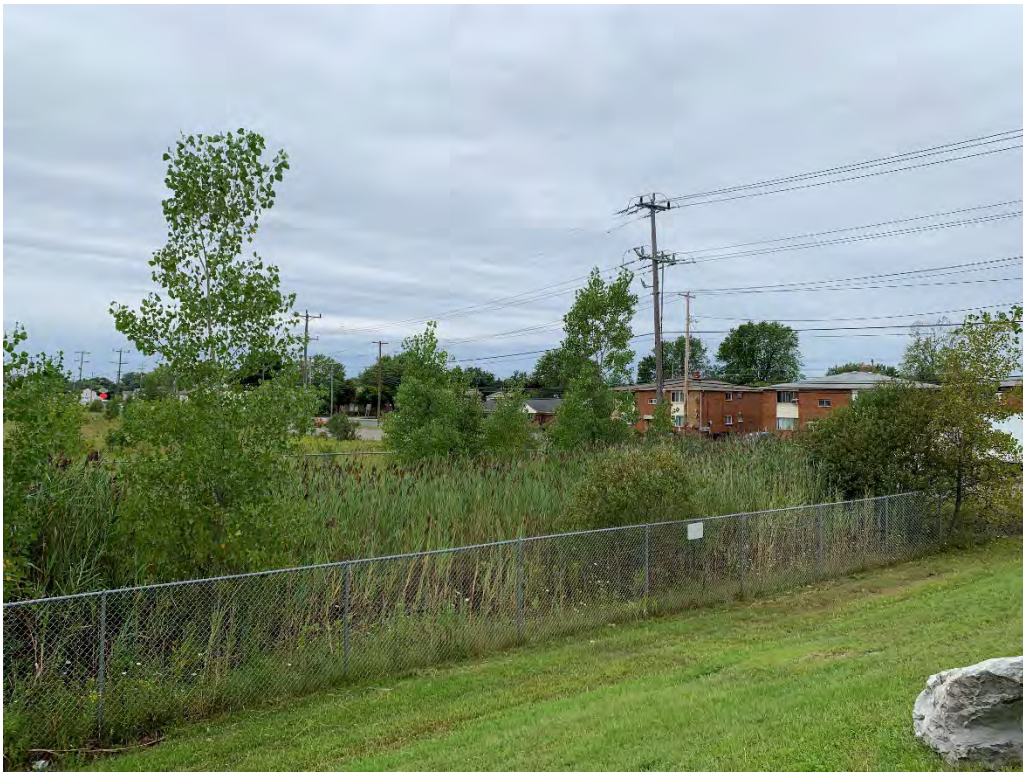
The retention pond was inspected semiannually by Cascades staff and as part of the annual comprehensive Site inspection by GHD. Little to no standing water was present in the pond at the time of the Site inspection. Significant plant growth is present within the pond, primarily invasive phragmites. Some individual and small clusters of phragmites were observed growing outside the stone perimeter of the pond. No other debris was observed, and the outlet pipes were open. No evidence of erosion was observed along the banks of the pond. The outlet pipes from the pond were clear of obstructions. Photos of the retention pond are provided in Appendix B.

Photo 13 – Looking northwest toward pond.

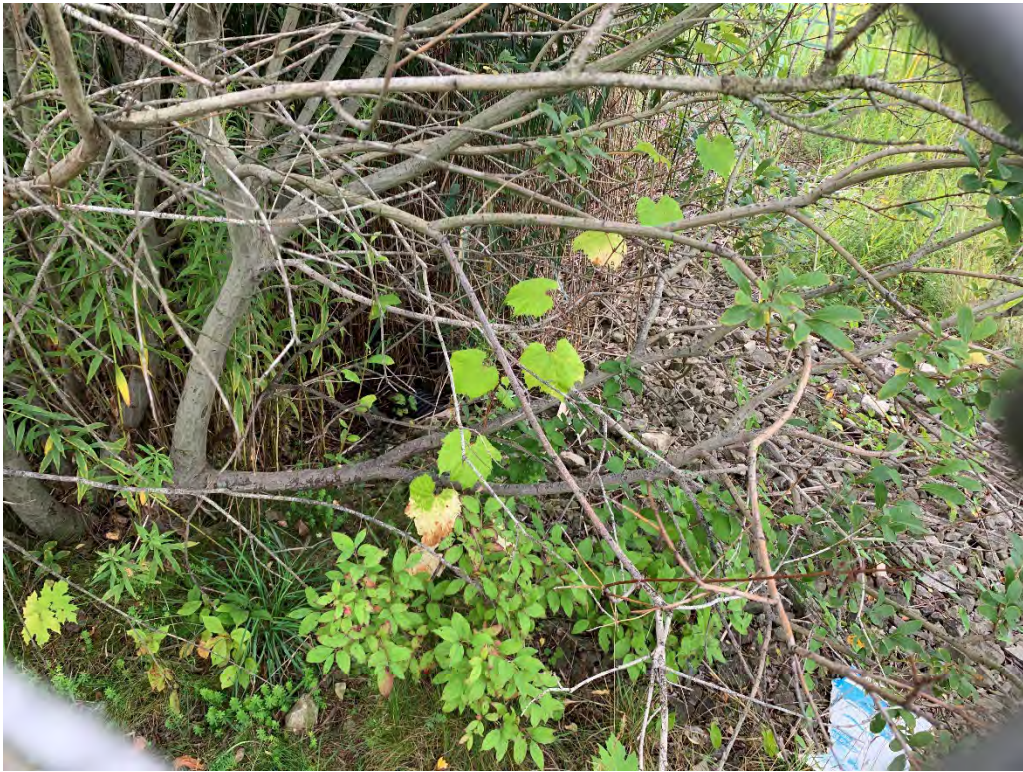
Photo 14 – Looking over outlet pipes of pond.

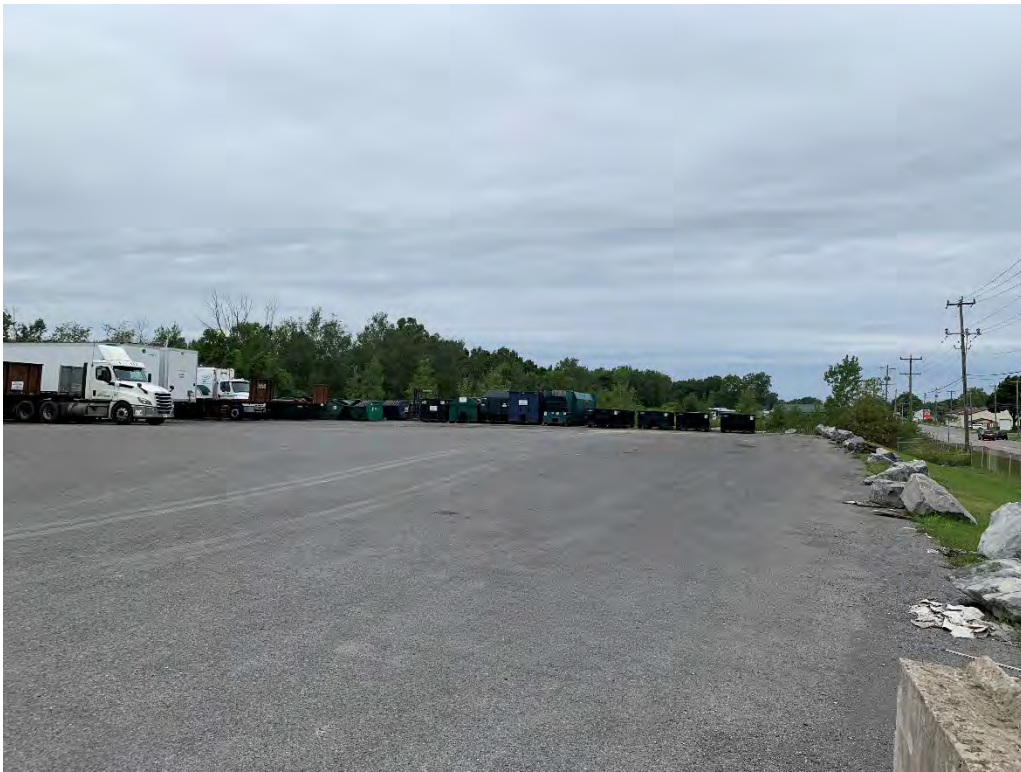
The GCL and asphalt cover system was visually inspected as part of the annual comprehensive Site inspection. No areas of subsidence or exposed GCL were observed. Minor surface indentations caused by tractor-trailer supports were noted in the asphalt, consistent with past years. The indentations were approximately 0.25 to 0.5 inch in depth, but do not affect the integrity of the cap. Photos of the GCL and asphalt cover are provided in Appendix B.

Photo 15 – Looking west across GCL/asphalt cover.

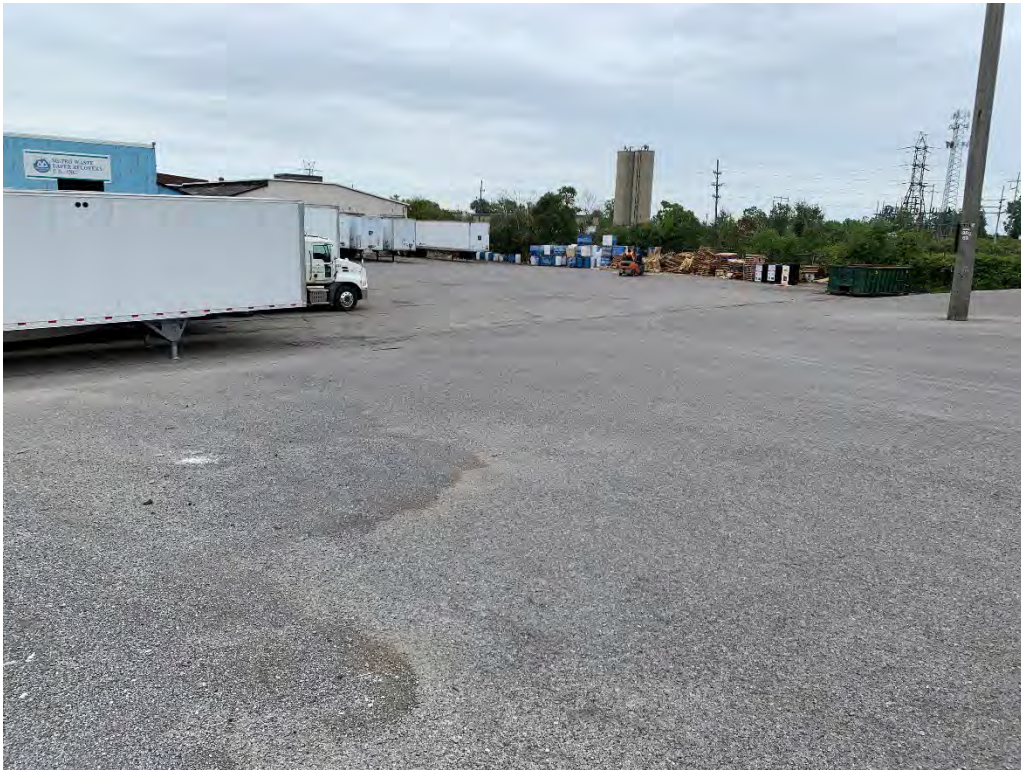
Photo 16 – Looking southeast across slope of GCL/asphalt cover toward trucking yard.

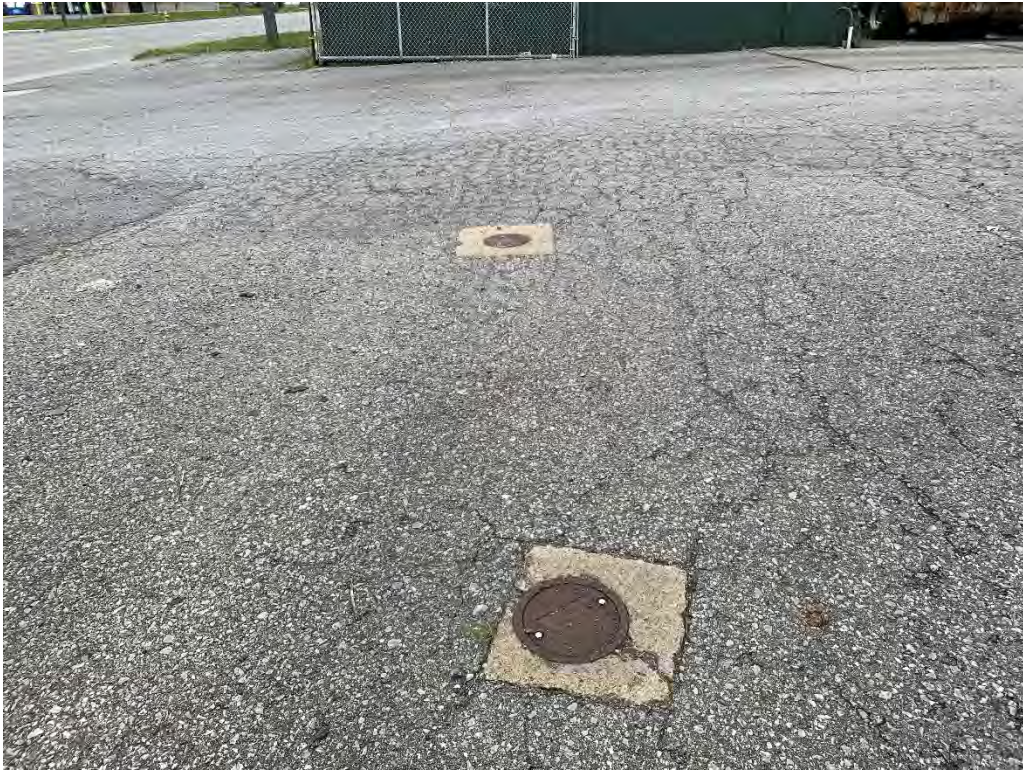
Photo 17 – Looking east across trucking yard entrance.
