**Annual Periodic Review Report, Former NL Industries Site No. C915200**

**Former NL Industries Foundry, NYSDEC  
Site No. C915200**

<b>Project name</b>		Cascades 2024 PRR					
<b>Document title</b>		2024 Periodic Review Report   Former NL Industries Foundry, NYSDEC Site No. C915200					
<b>Project number</b>		12615780					
<b>File name</b>		12615780-RPT2-2024 PRR.docx					
Status Code	Revision	Author	Reviewer		Approved for issue		
			Name	Signature	Name	Signature	Date
S4	0	Kathryn Ploss	K. Galanti

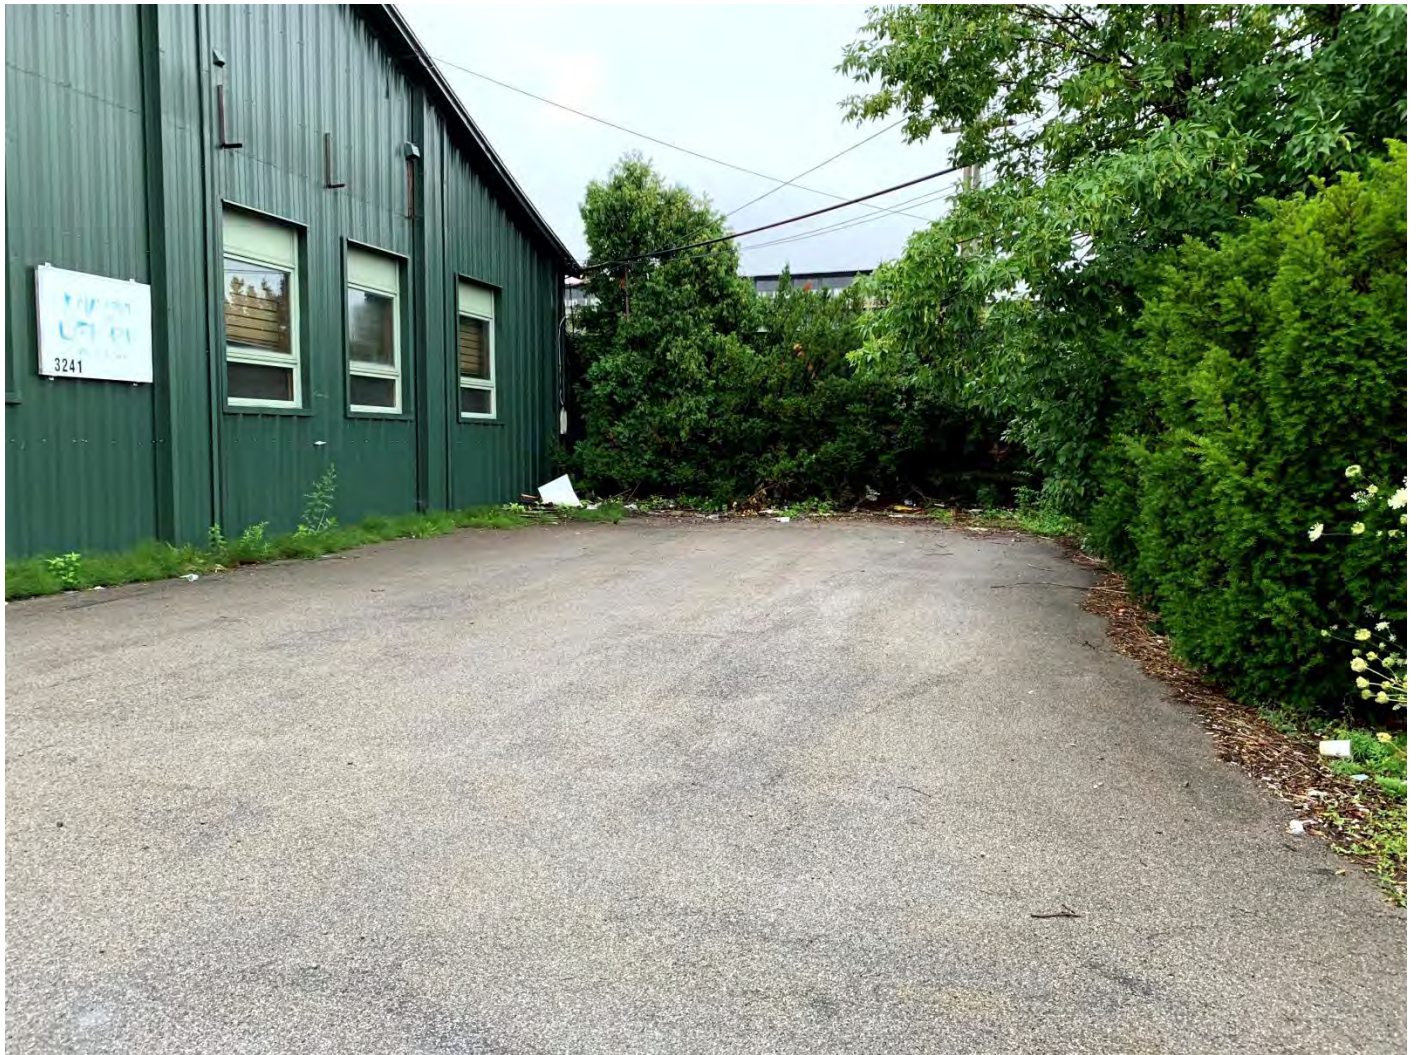
The Parking Lot was repaved in 2011 and is generally free of cracks and deterioration with no protruding vegetation through the asphalt surface. Some low weedy growth was observed emerging from the seam between the asphalt and building. This was pointed out to Cascade Recovery Plus personnel to remove as part of routine site maintenance. The growth is minor in nature and does not require formal corrective action or follow-up. Photos of the pavement are provided in Appendix B.

Photo 1 – Parking lot looking west along north side of office.

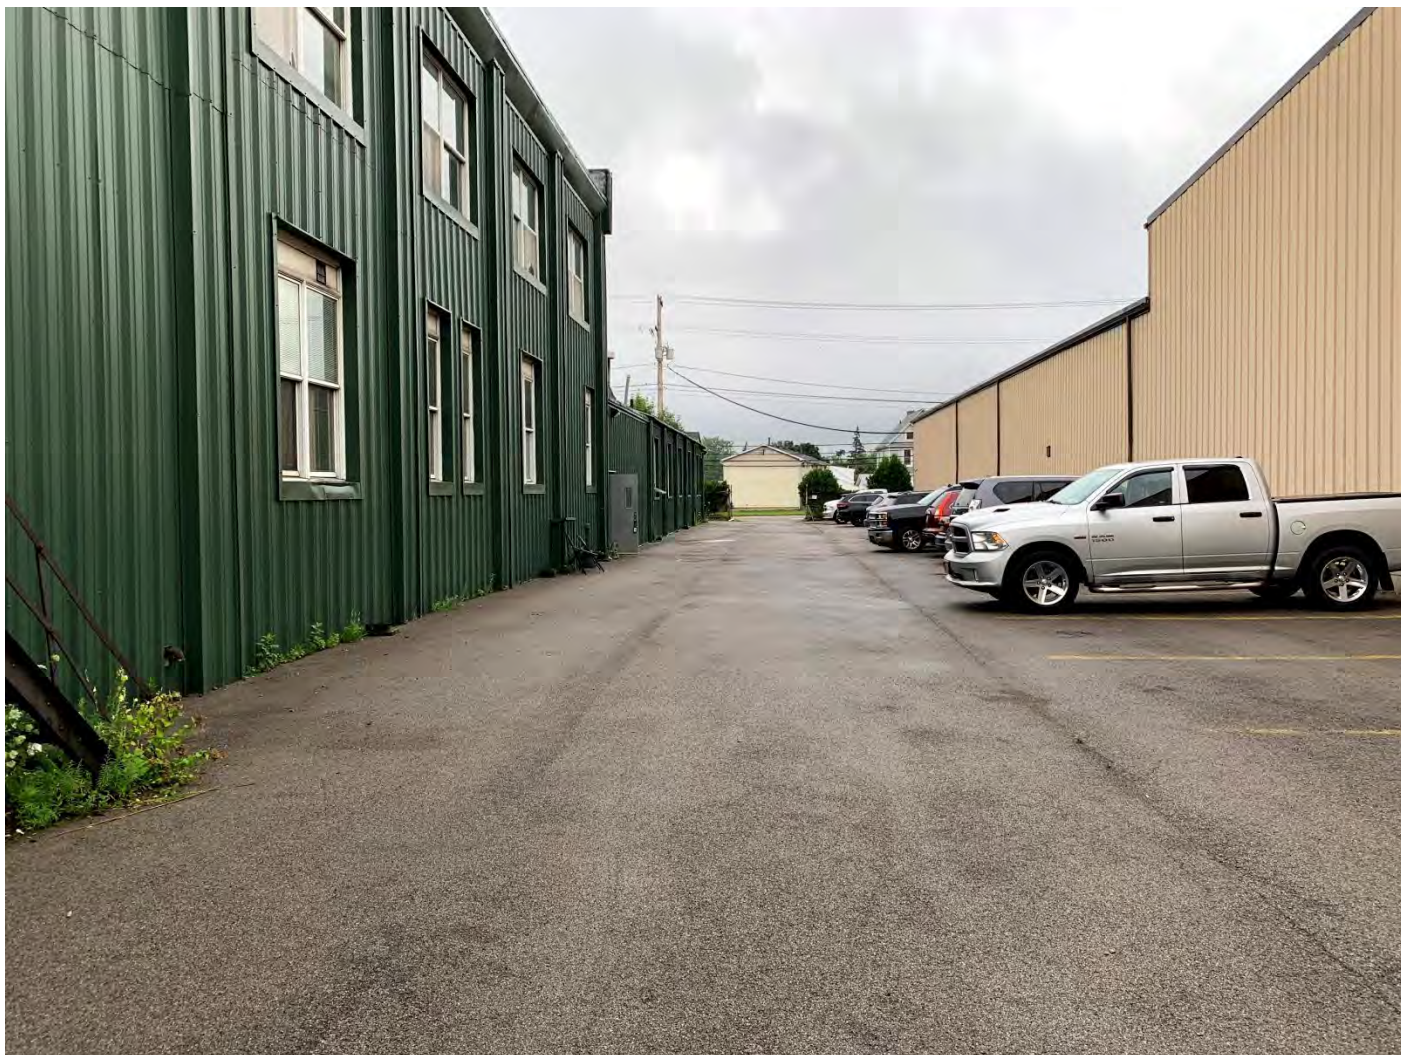
Photo 2 – Parking lot looking north.

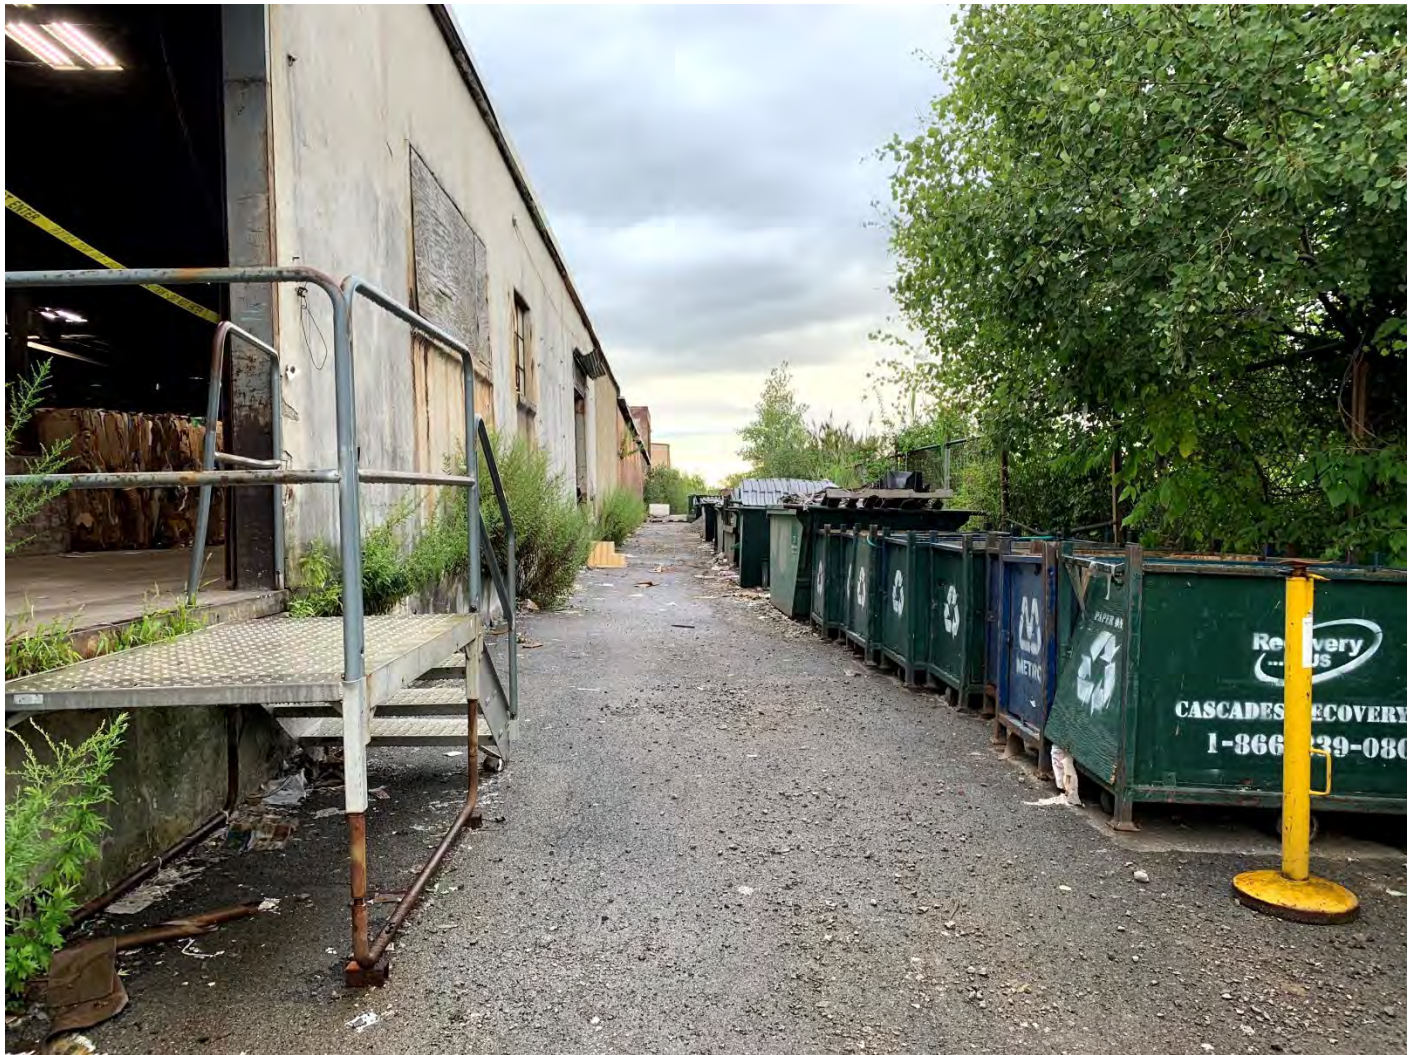
The asphalt cover on the Former Rail Siding was generally free of cracks and deterioration with no protruding vegetation through the asphalt surface and appeared in good condition. Some weedy growth was observed emerging from the seam between the asphalt and building. This was pointed out to Cascade Recovery Plus personnel to remove as part of routine site maintenance. The growth is minor in nature and does not require formal corrective action or follow-up. Photos of the pavement are provided in Appendix B.

Photo 3 – Former rail siding looking east.

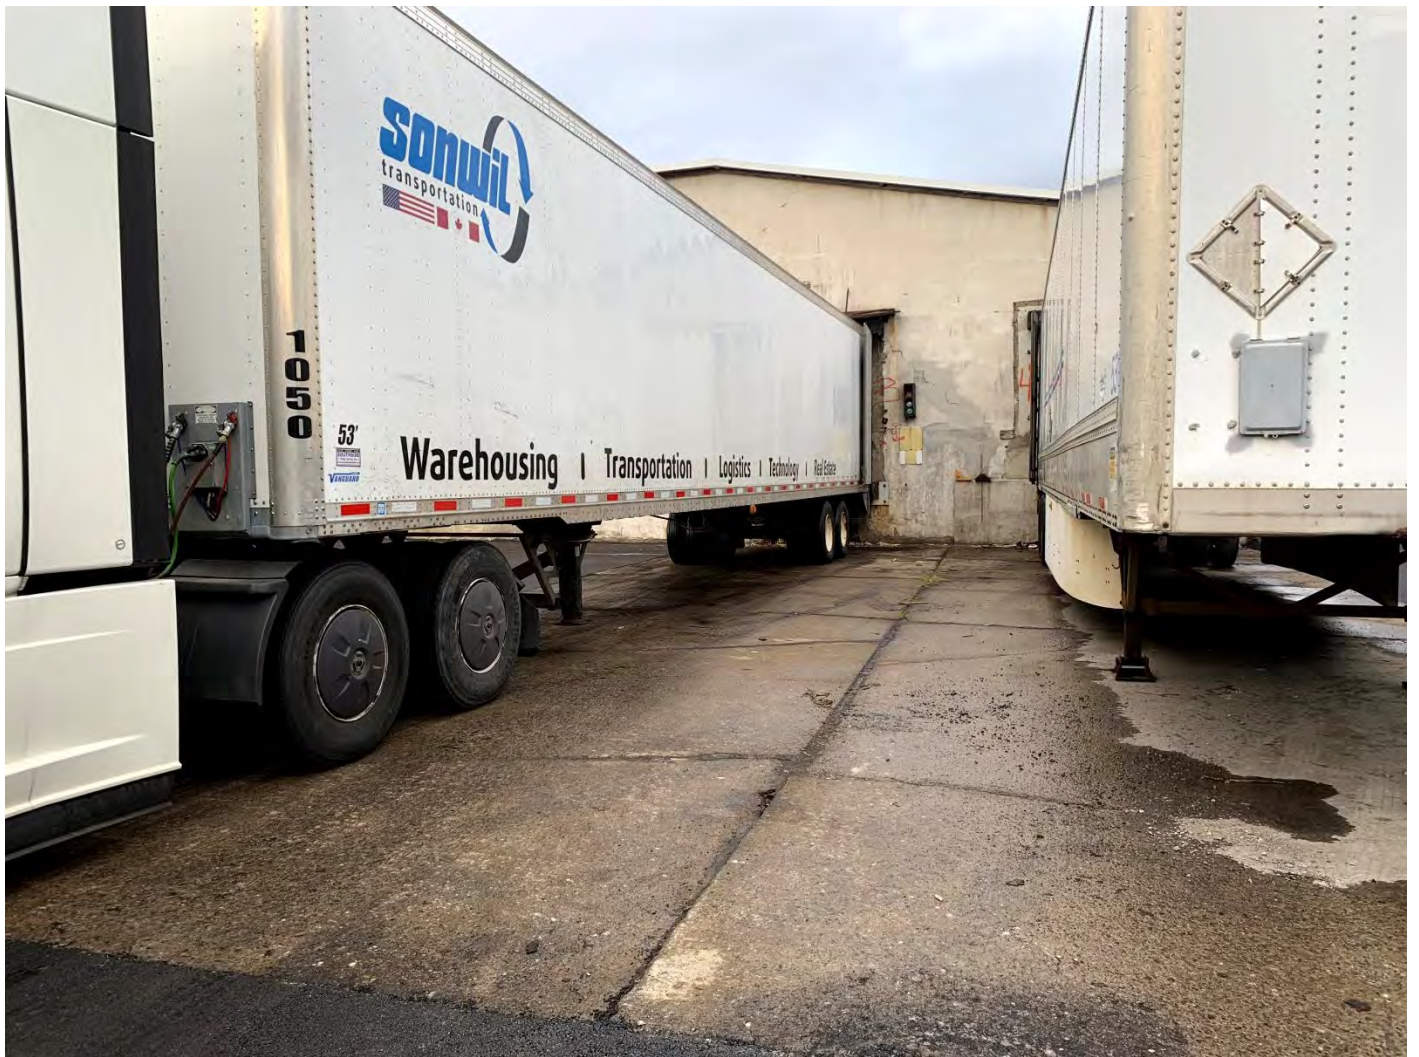
Cracks and evidence of former missing concrete pieces were observed on the concrete dock apron system; however, these were either filled with asphalt cold patch, tar sealant, or in the case of the center dock/apron, a section was

paved over with asphalt to prevent further water intrusion and damage from freeze/thaw cycles. While the tipping floor dock (center dock/apron area) and back dock (south dock/apron area) concrete aprons may eventually require replacement, the asphalt filling/paving and tar sealing are sufficient to prevent potential exposure to underlying contaminated soil. Photos of the concrete aprons are provided in Appendix B.

Photo 4 – South concrete apron looking east.

While no corrective action is immediately necessary, continued routine monitoring and maintenance of the concrete aprons is required in lieu of replacement.

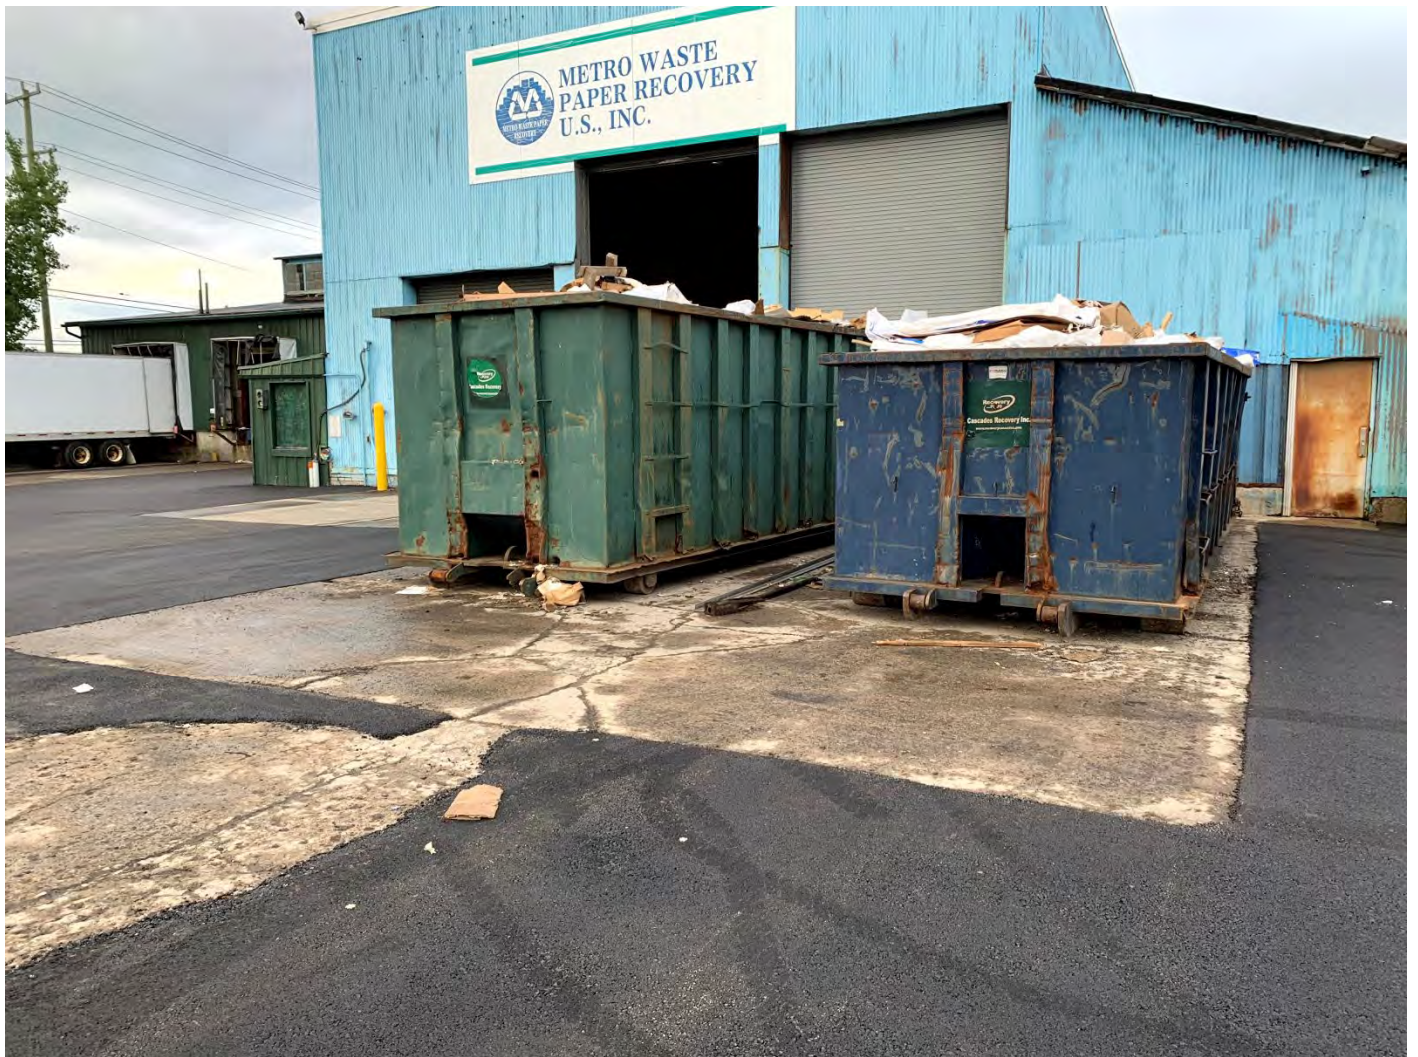
Photo 5 – Building Apron Concrete System (central portion) looking east-northeast. Surface cracks are sealed.

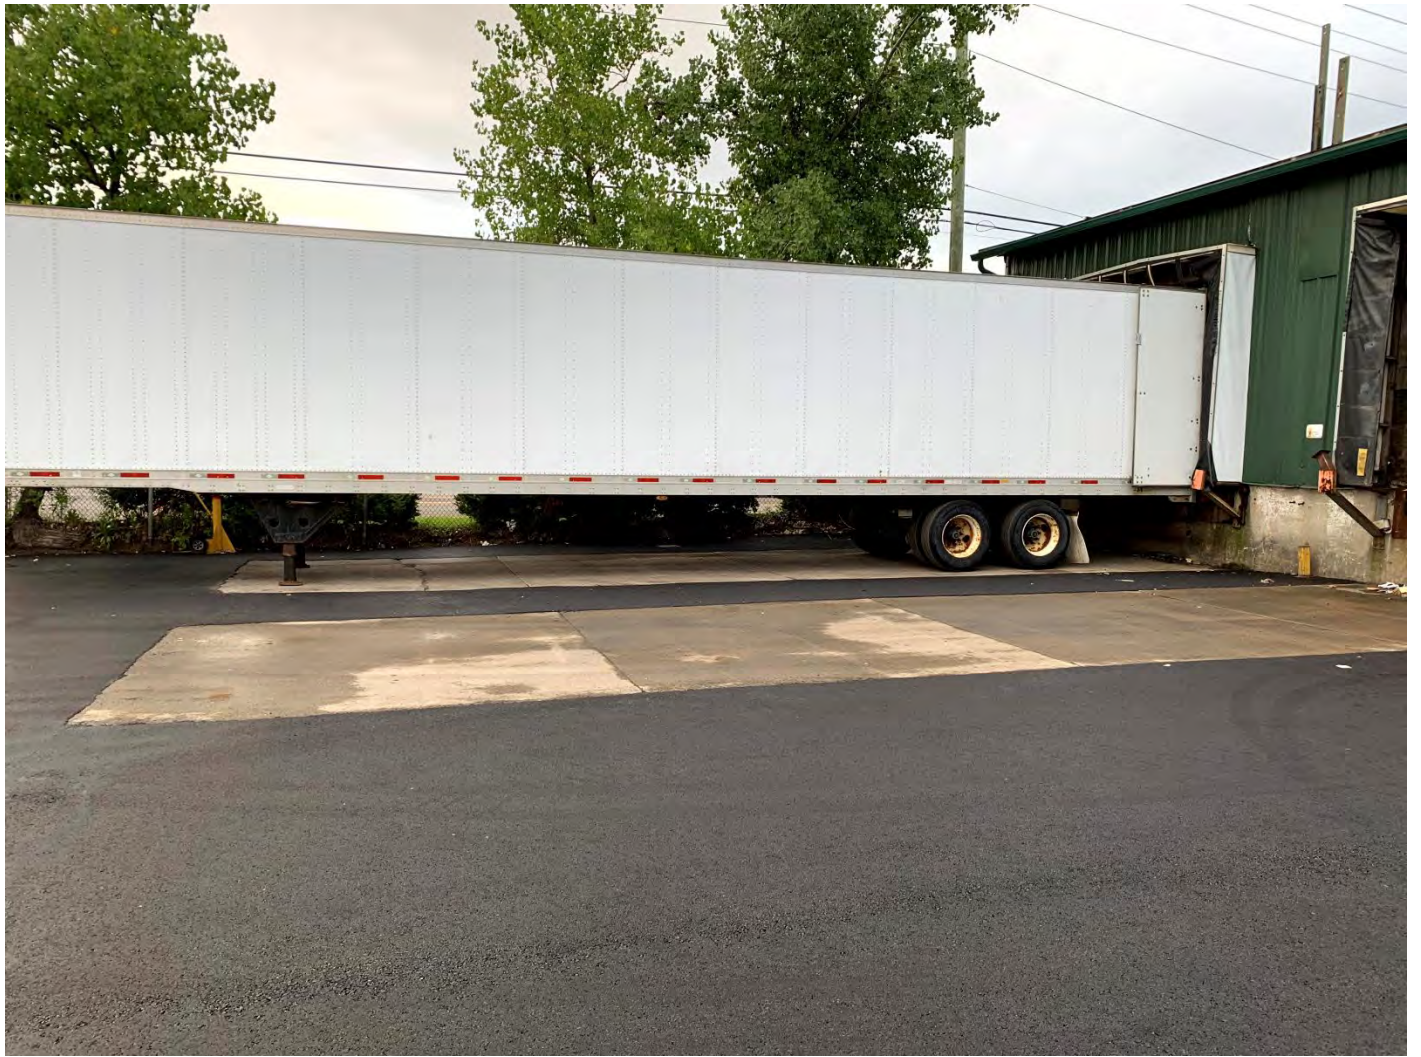
The building foundation and apron concrete were visually inspected for cracks and deterioration. The floor within the building is solid with no open penetrations. The building foundation is in good condition. Some weedy growth was observed emerging from the seam between the asphalt and building in the parking lot and former rail siding as noted above. This was pointed out to Cascade Recovery Plus personnel to remove as part of routine site maintenance. The growth is minor in nature and does not require formal corrective action or follow-up.

Photo 6 – North concrete aprons looking north.

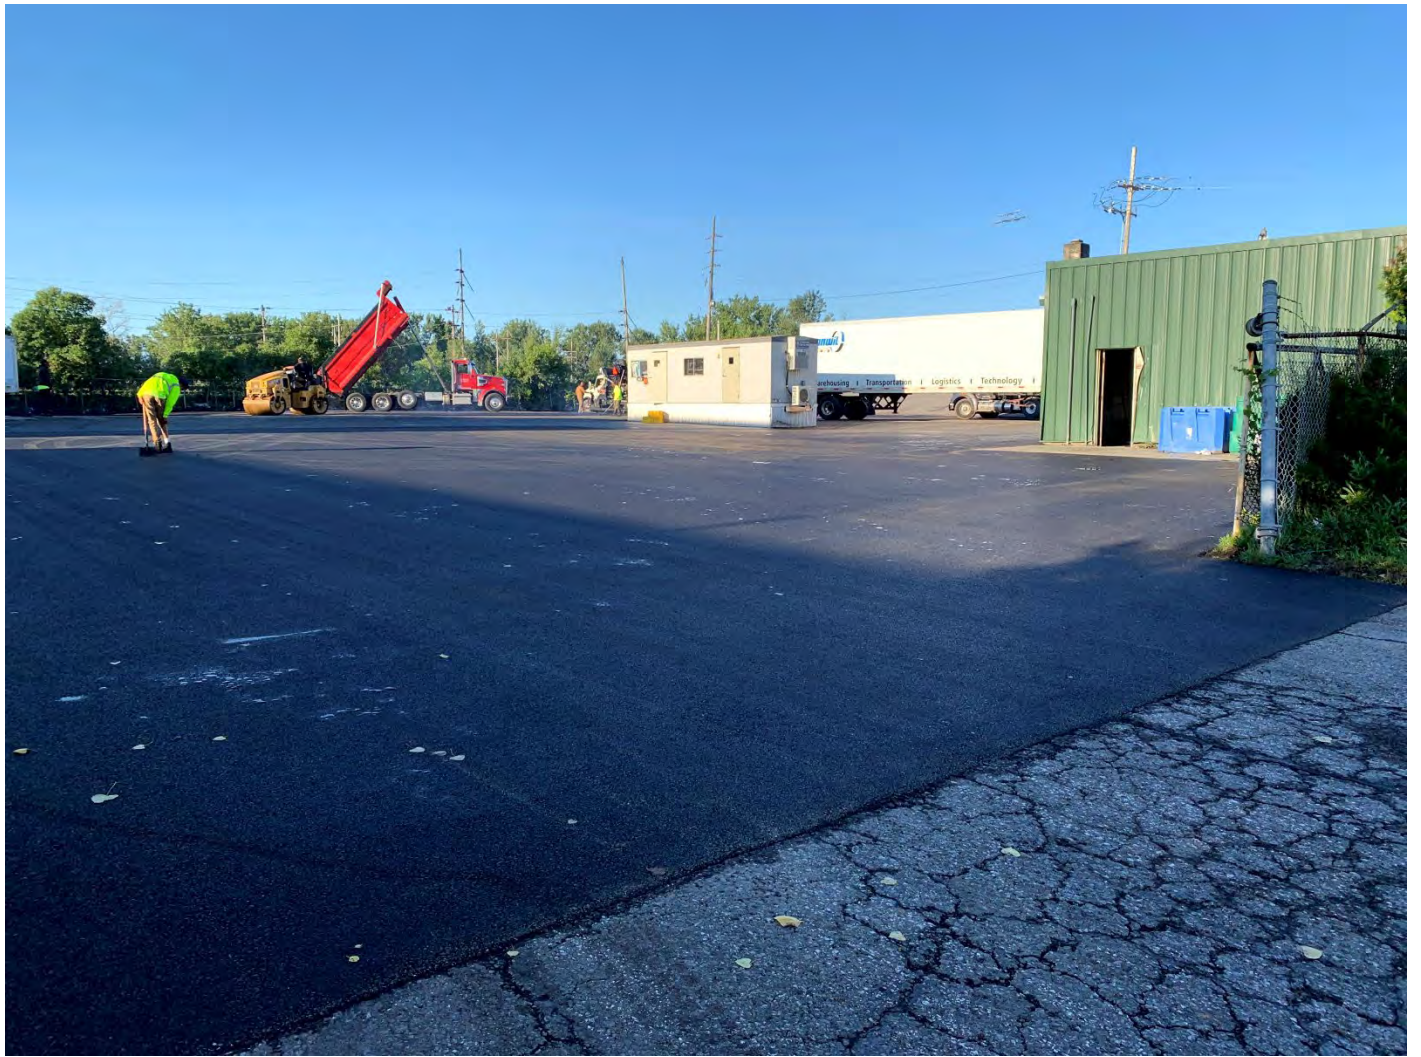
The Trucking Yard was milled and resurfaced between August 5 and August 7, 2024. Thomann Asphalt of Lancaster, New York completed milling and repaving of the trucking yard on behalf of Cascades. The top 1.5 inches of asphalt were milled. Where cracking extended through the upper layer of asphalt, primarily south and east of the scalehouse trailer, the asphalt was milled to the stone subbase, the subbase compacted, and up to an additional 4.5 inches of Type 3 binder placed to level the area. The entire trucking yard was then repaved with 1.5 inches of new Type 6 asphalt top course. Other than milled asphalt, no subbase stone or soil was removed from the site and no other backfill material was imported. Asphalt millings were transported to the asphalt plant, New Enterprise Stone & Lime Co., Inc., in Cheektowaga, NY for recycling. Receipts are provided in Appendix C. Photos of the trucking yard are provided in Appendix B.

Photo 7 – Trucking yard looking southwest.

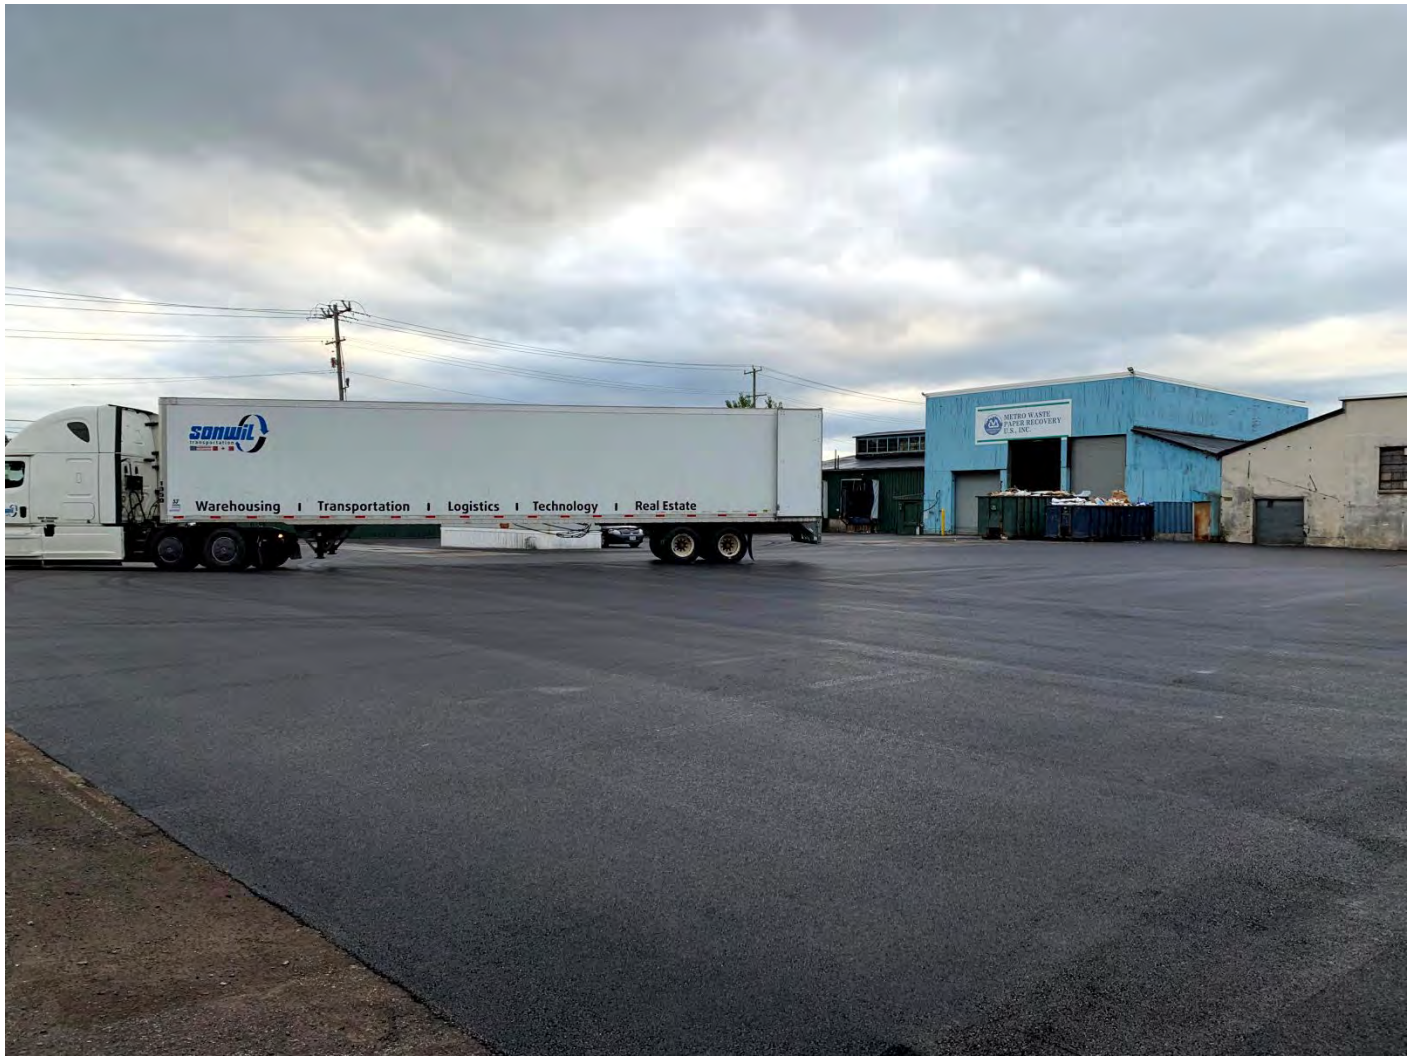
Photo 8 – Trucking yard looking northeast.

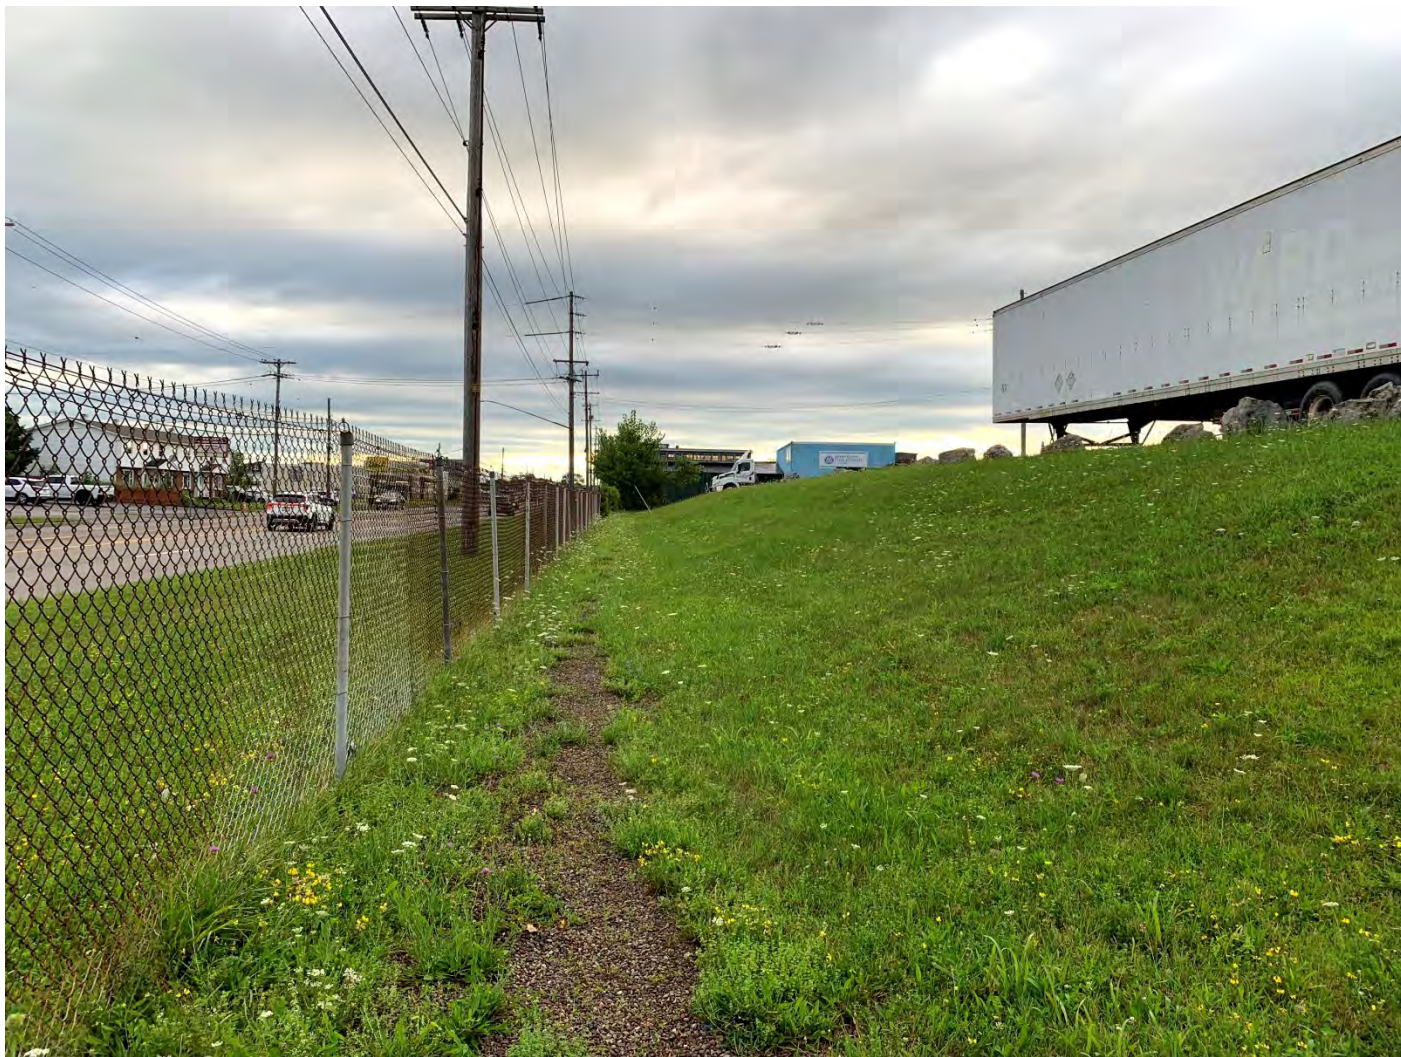
The GCL and soil cover system was visually inspected as part of the annual comprehensive Site inspection. No areas of subsidence, erosion, or exposed GCL were observed. At the time of the inspection, the grass was approximately 2 inches in length and was regularly maintained. Photos of the GCL and soil cover are provided in Appendix B.

Photo 9 – GCL and Soil Cover System looking east along north slope.

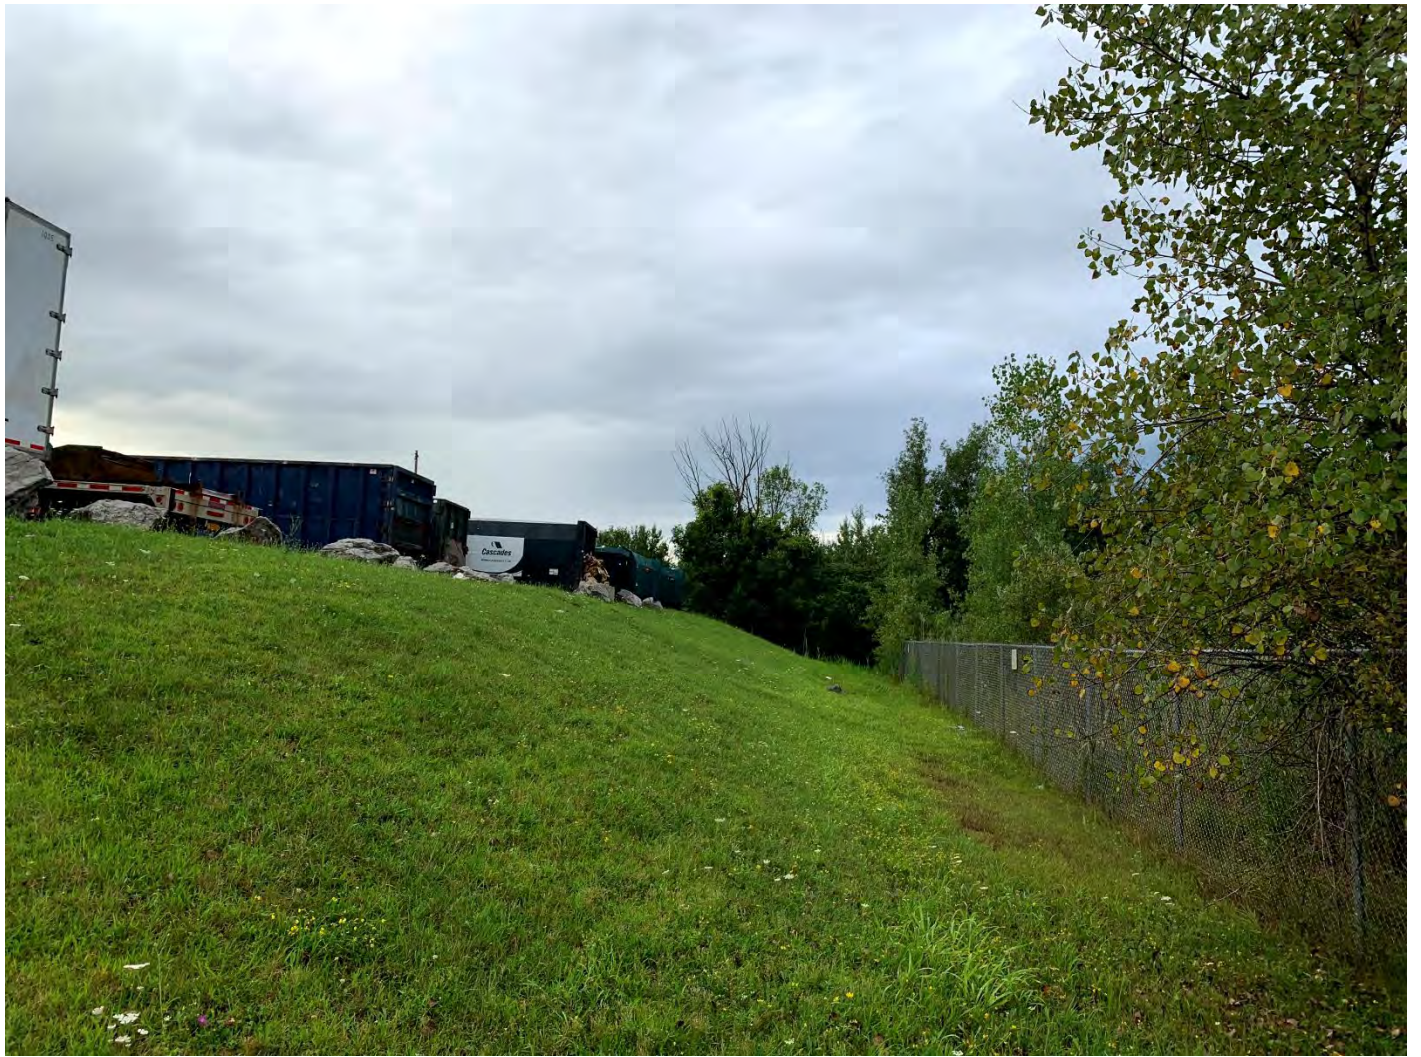
Photo 10 – GCL and Soil Cover System looking south along west slope.

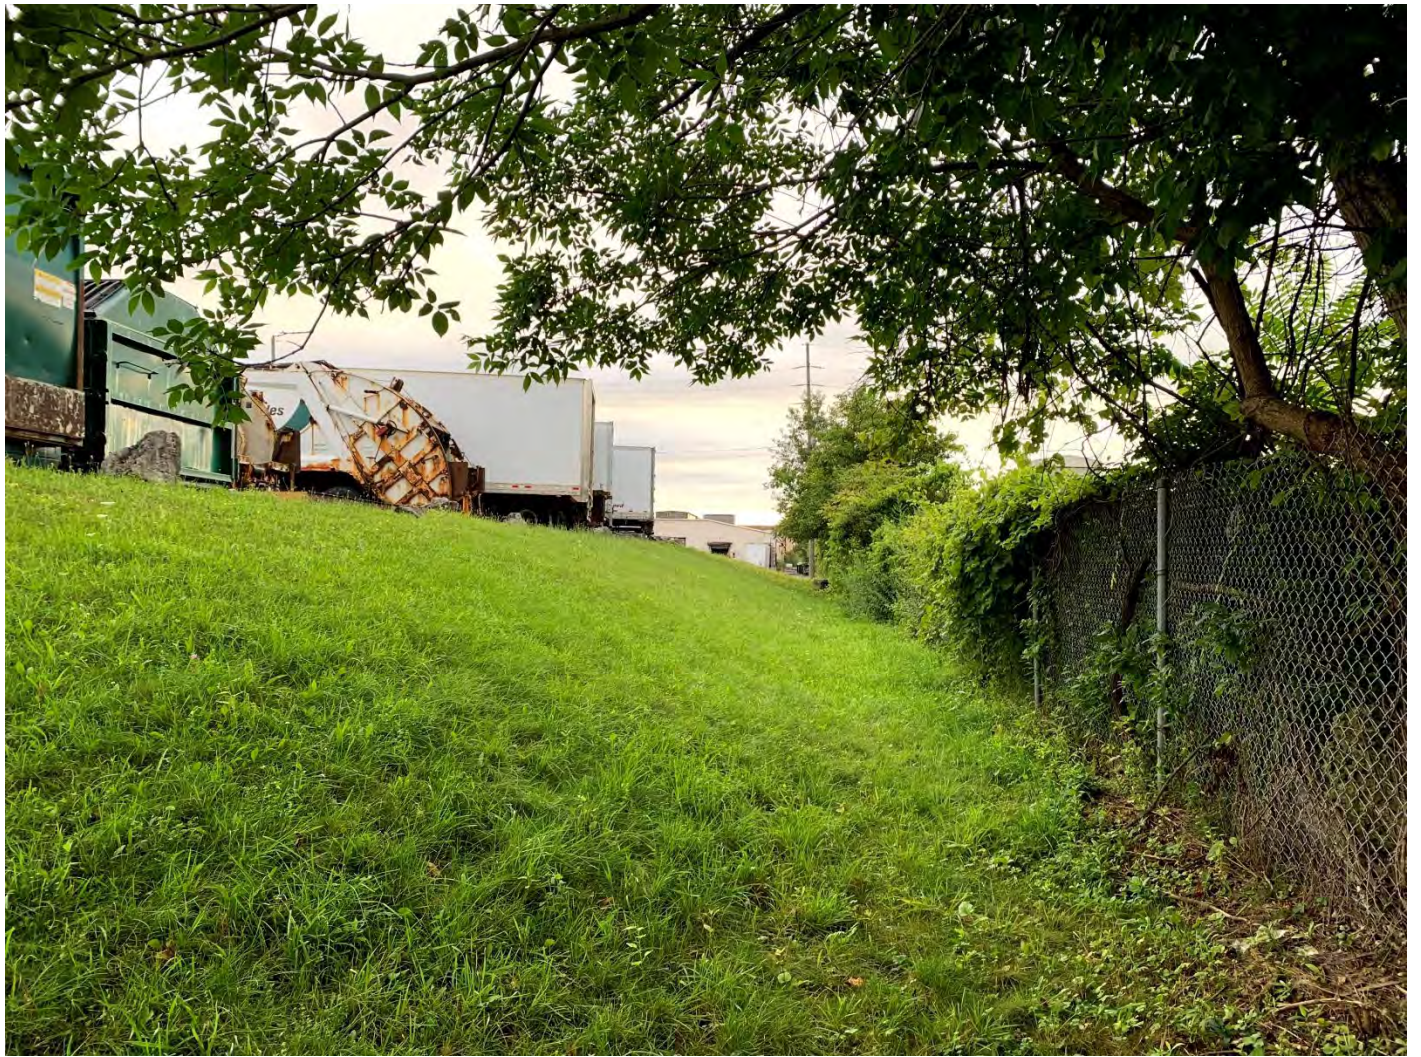
Photo 11 – GCL and Soil Cover System looking east along south slope.

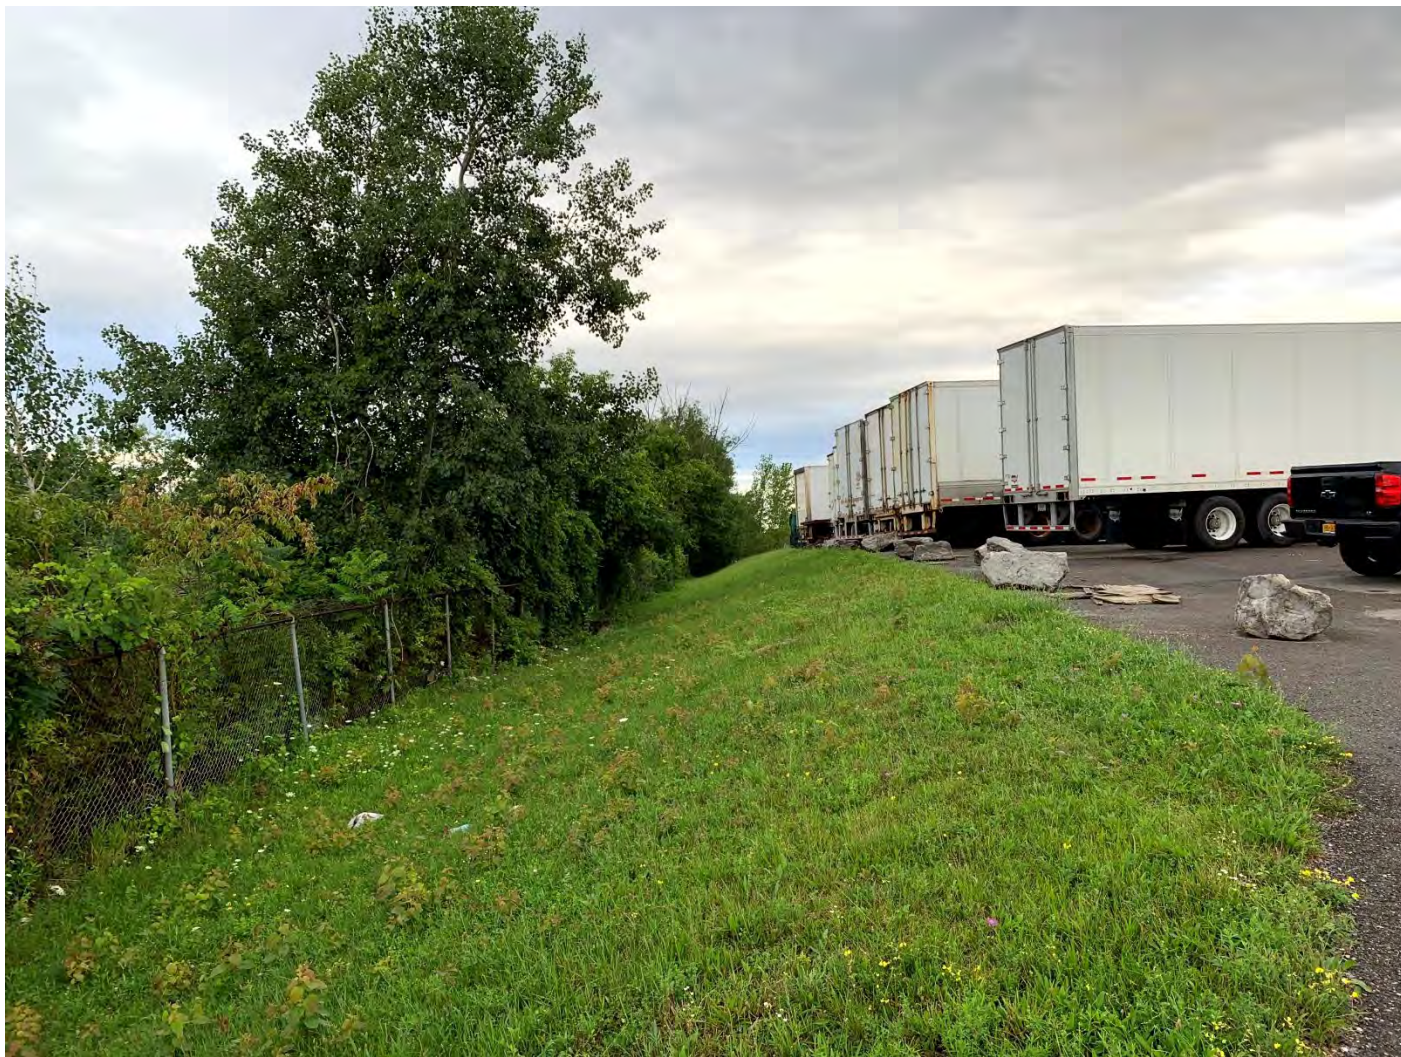
Photo 12 – GCL and Soil Cover System looking west along south slope.

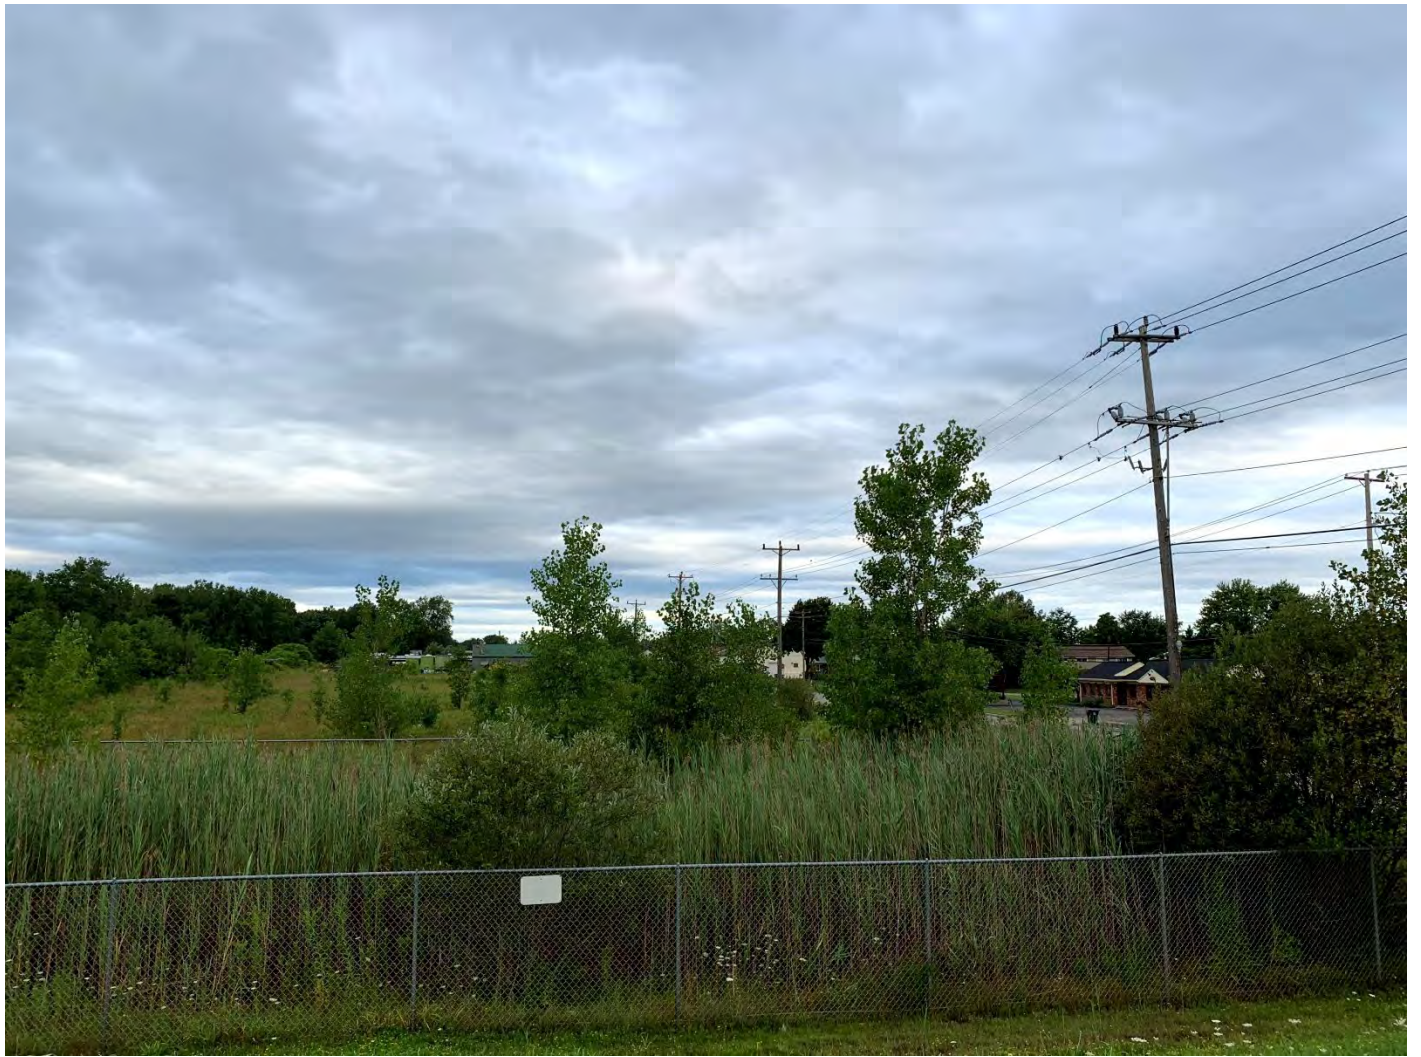
The detention pond was inspected semiannually by Cascades staff and as part of the annual comprehensive Site inspection by GHD. Little to no standing water was present in the pond at the time of the Site inspection. Significant plant growth is present within the pond, primarily invasive phragmites. Some individual and small clusters of phragmites were observed growing outside the stone perimeter of the pond. No other debris was observed, and the outlet pipes were open. No evidence of erosion was observed along the banks of the pond. The outlet pipes from the pond were generally clear of obstructions. Photos of the detention pond are provided in Appendix B.

Photo 13 – Looking west toward pond.

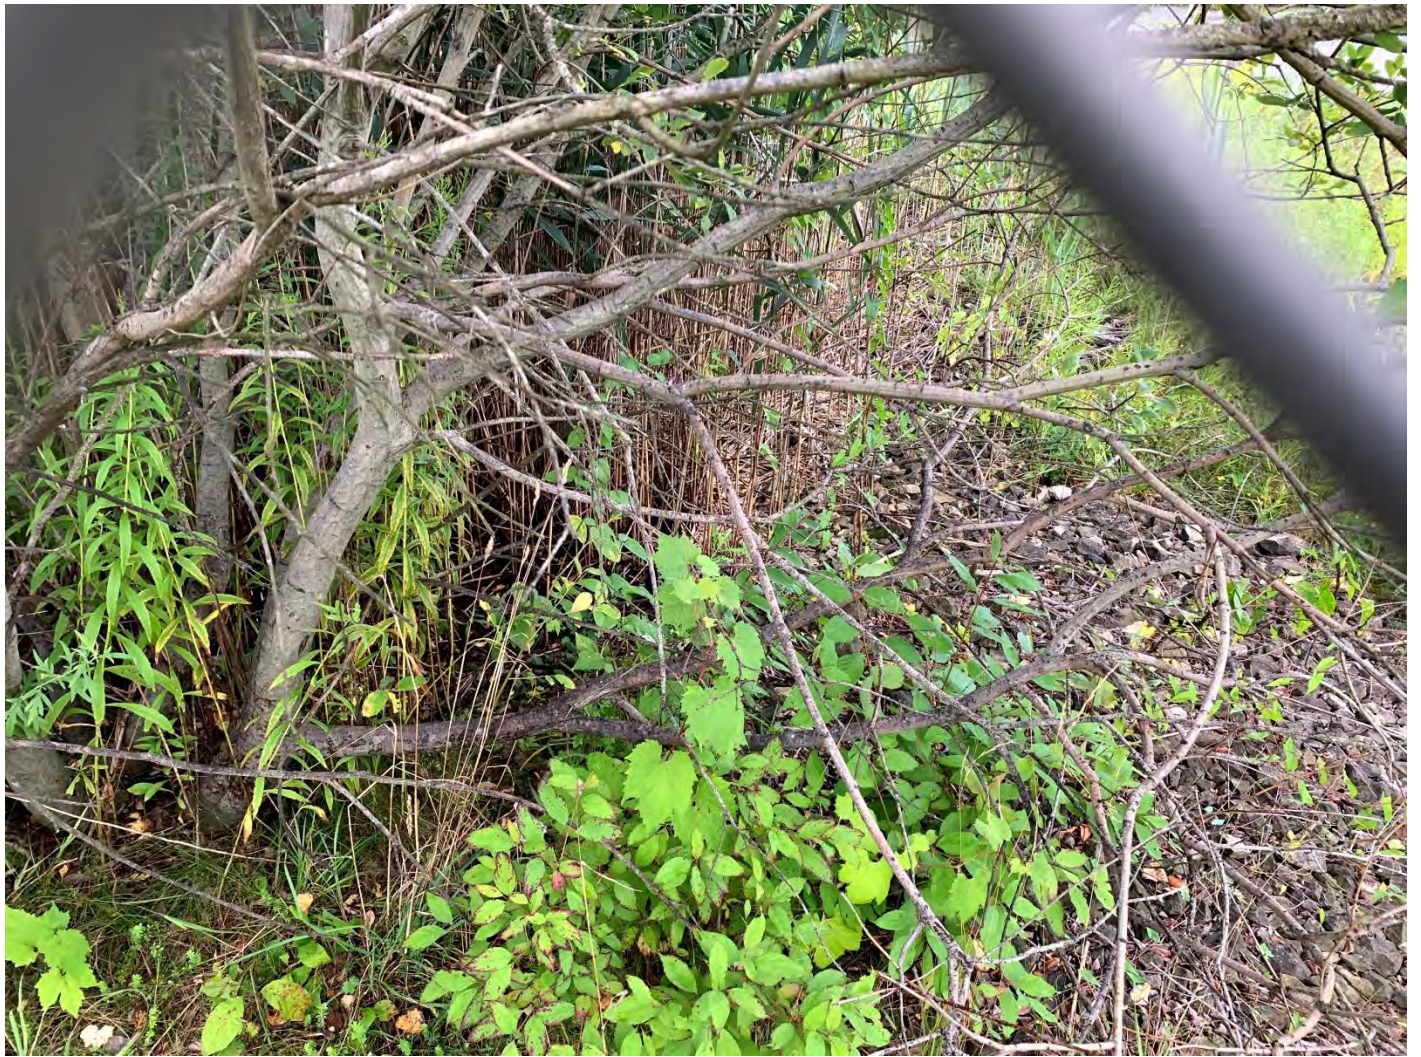
Photo 14 – Looking over outlet pipes of pond.
