**Annual Periodic Review Report, Former NL Industries Site No. C915200**

**Former NL Industries Foundry, NYSDEC  
Site No. C915200**

<b>Project name</b>		Cascades 2024 PRR					
<b>Document title</b>		2024 Periodic Review Report   Former NL Industries Foundry, NYSDEC Site No. C915200					
<b>Project number</b>		12615780					
<b>File name</b>		12615780-RPT2-2024 PRR.docx					
Status Code	Revision	Author	Reviewer		Approved for issue		
			Name	Signature	Name	Signature	Date
S4	0	Kathryn Ploss	K. Galanti

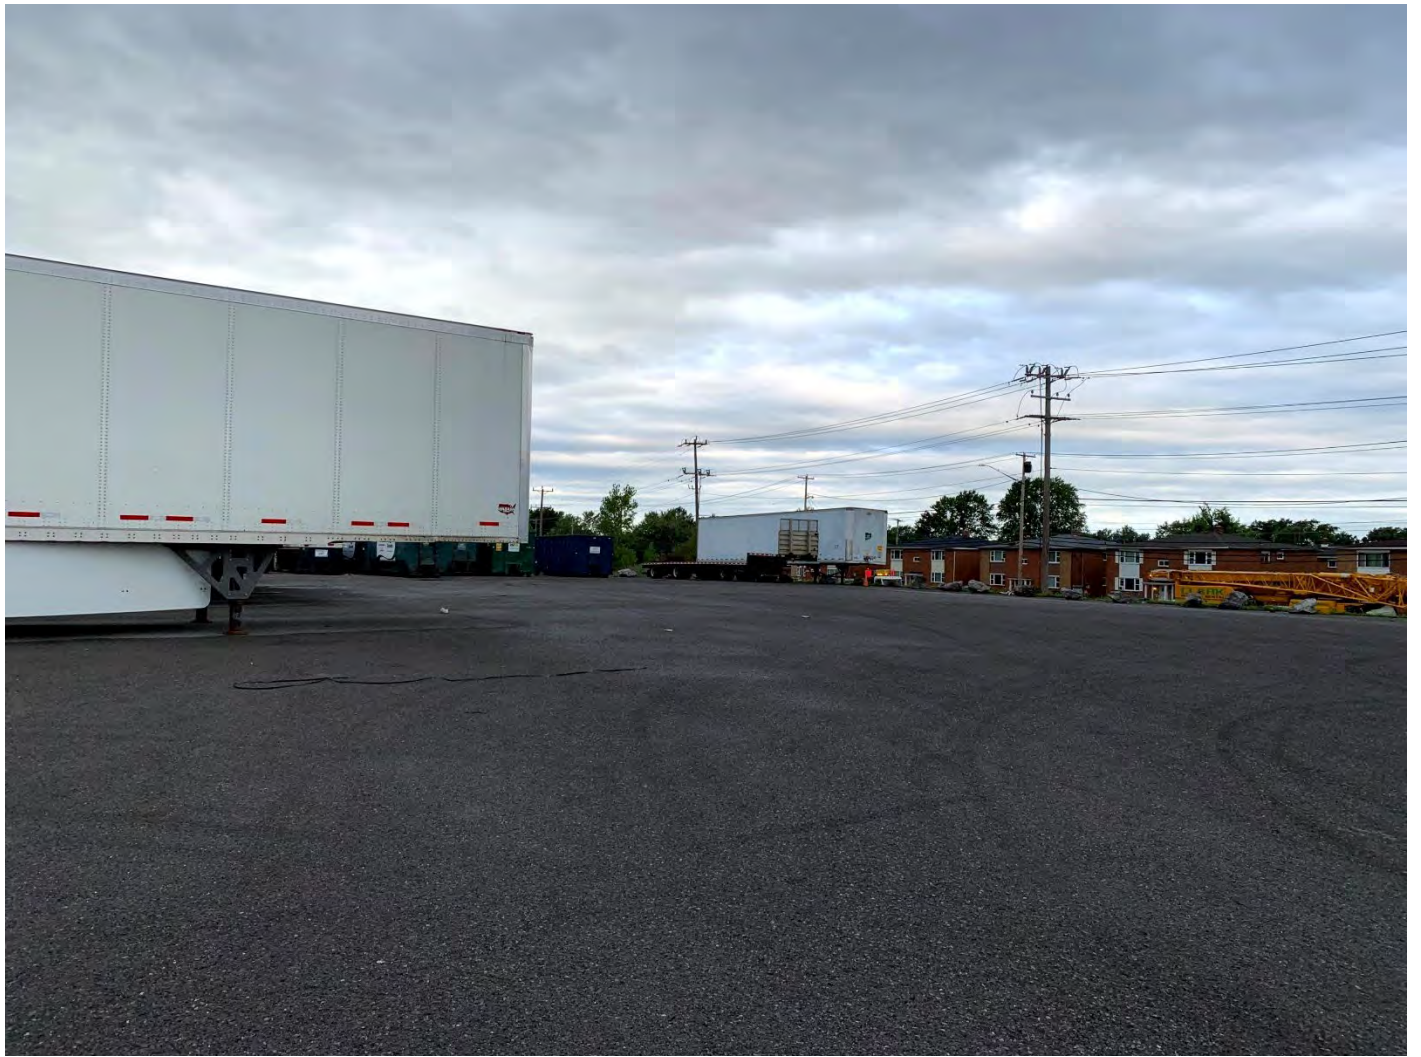
The GCL and asphalt cover system was visually inspected as part of the annual comprehensive Site inspection. No areas of subsidence or exposed GCL were observed. Minor surface indentations caused by tractor-trailer supports were noted in the asphalt, consistent with past years. The indentations were approximately 0.25 to 0.5 inch in depth, but do not affect the integrity of the cap. Photos of the GCL and asphalt cover are provided in Appendix B.

Photo 15 – Looking northwest across GCL/asphalt cover.

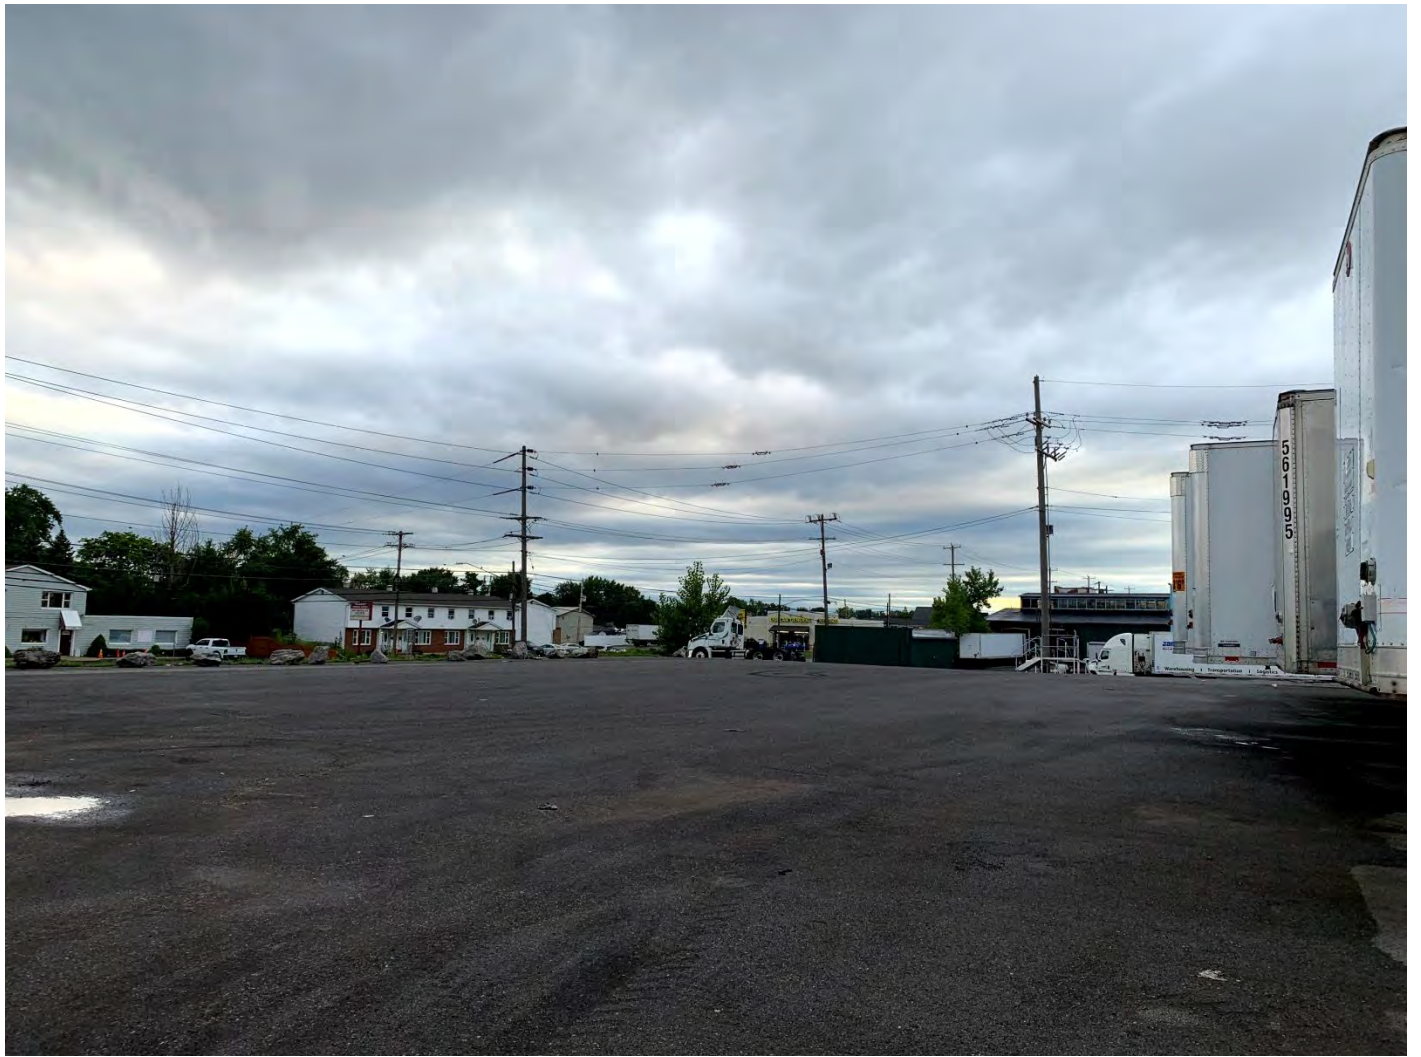
Photo 16 – Looking northeast across GCL/asphalt cover.

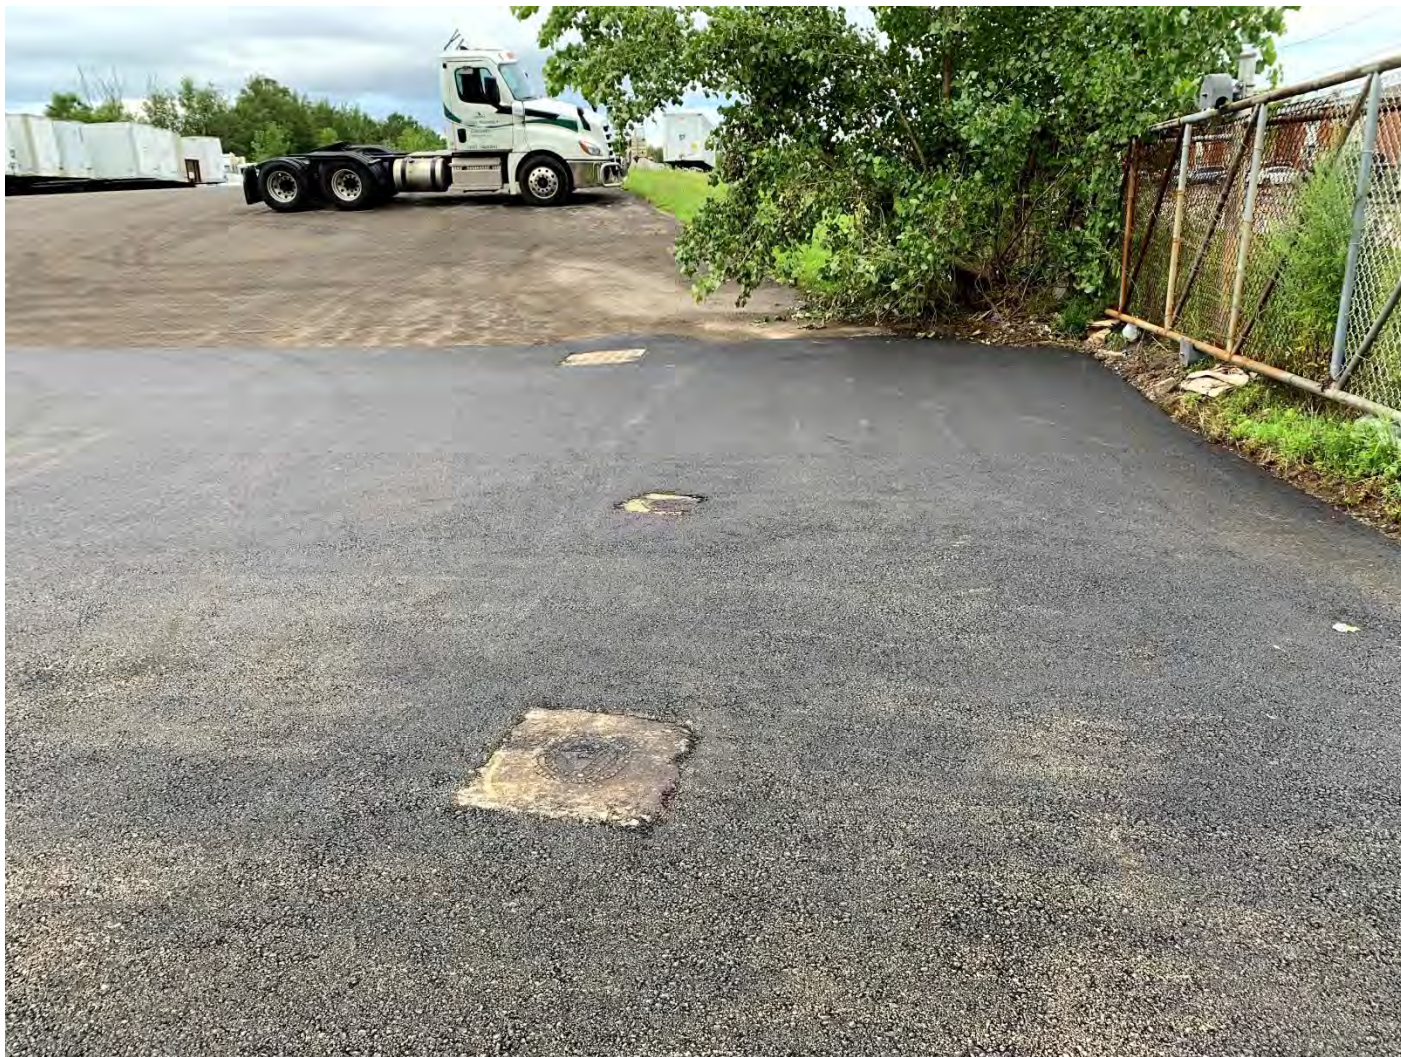
Photo 17 – Looking west across trucking yard entrance at monitoring wells.

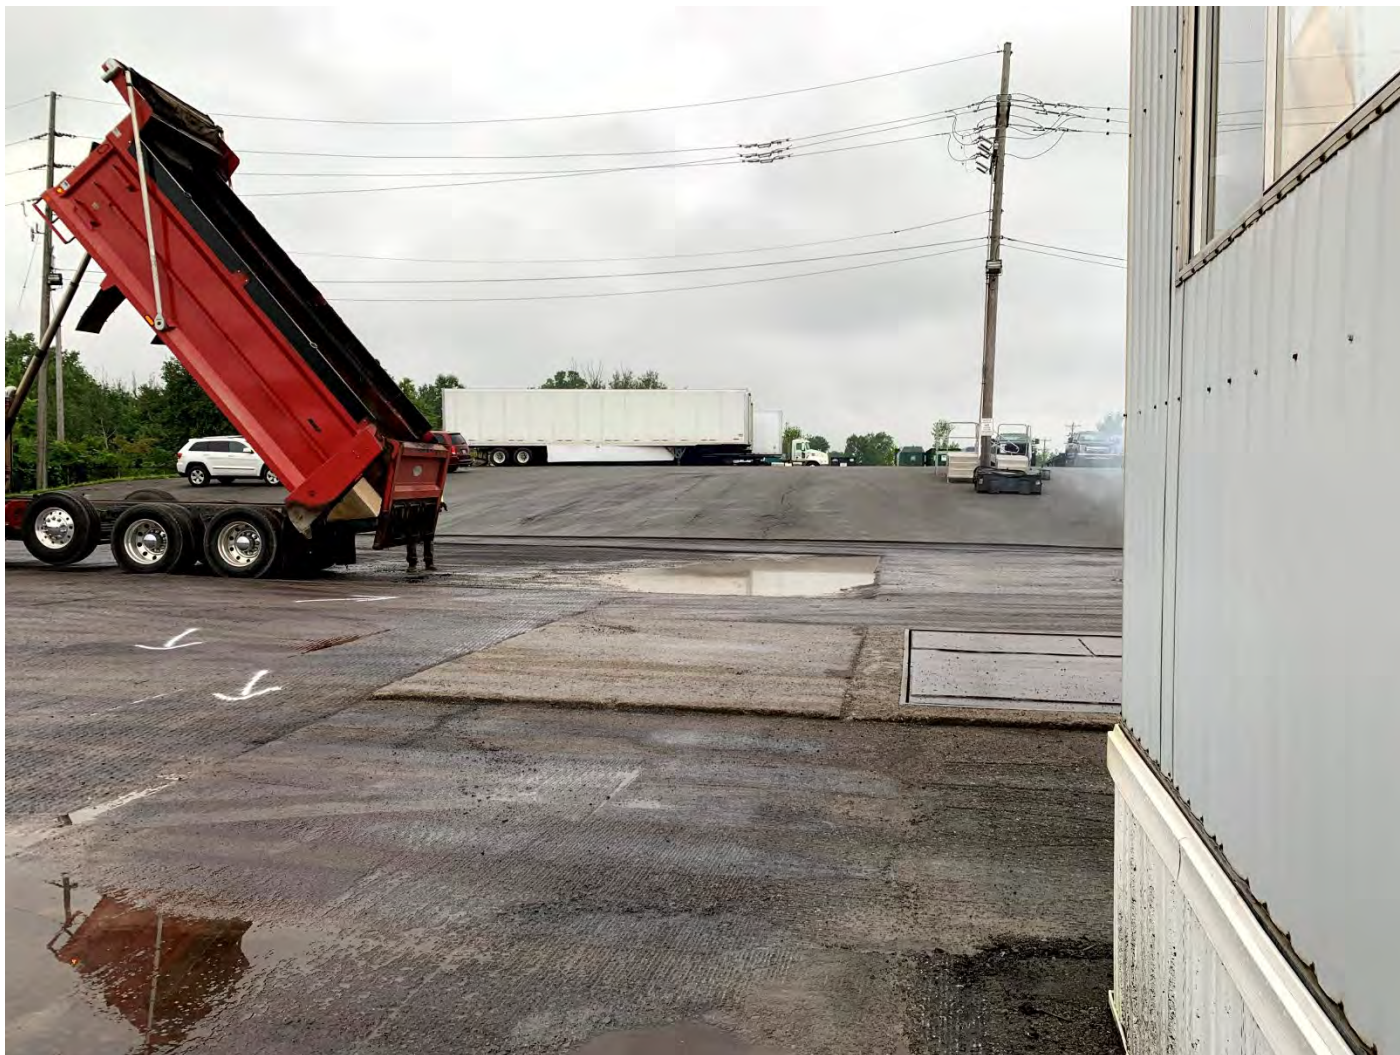
The Trucking Yard was milled and resurfaced between August 5 and August 7, 2024. Thomann Asphalt of Lancaster, New York completed milling and repaving of the trucking yard on behalf of Cascades. The top 1.5 inches of asphalt were milled. Where cracking extended through the upper layer of asphalt, primarily south and east of the scalehouse trailer, the asphalt was milled to the stone subbase, the subbase compacted, and up to an additional 4.5 inches of Type 3 binder placed to level the area. The entire trucking yard was then repaved with 1.5 inches of new Type 6 asphalt top course. Other than milled asphalt, no subbase stone or soil was removed from the site and no other backfill material was imported. Asphalt millings were transported to the asphalt plant, New Enterprise Stone & Lime Co., Inc., in Cheektowaga, NY for recycling. Receipts are provided in Appendix C. Photos of the trucking yard are provided in Appendix B.

Photo 17 – Looking west across trucking yard at the resurfacing of the trucking yard

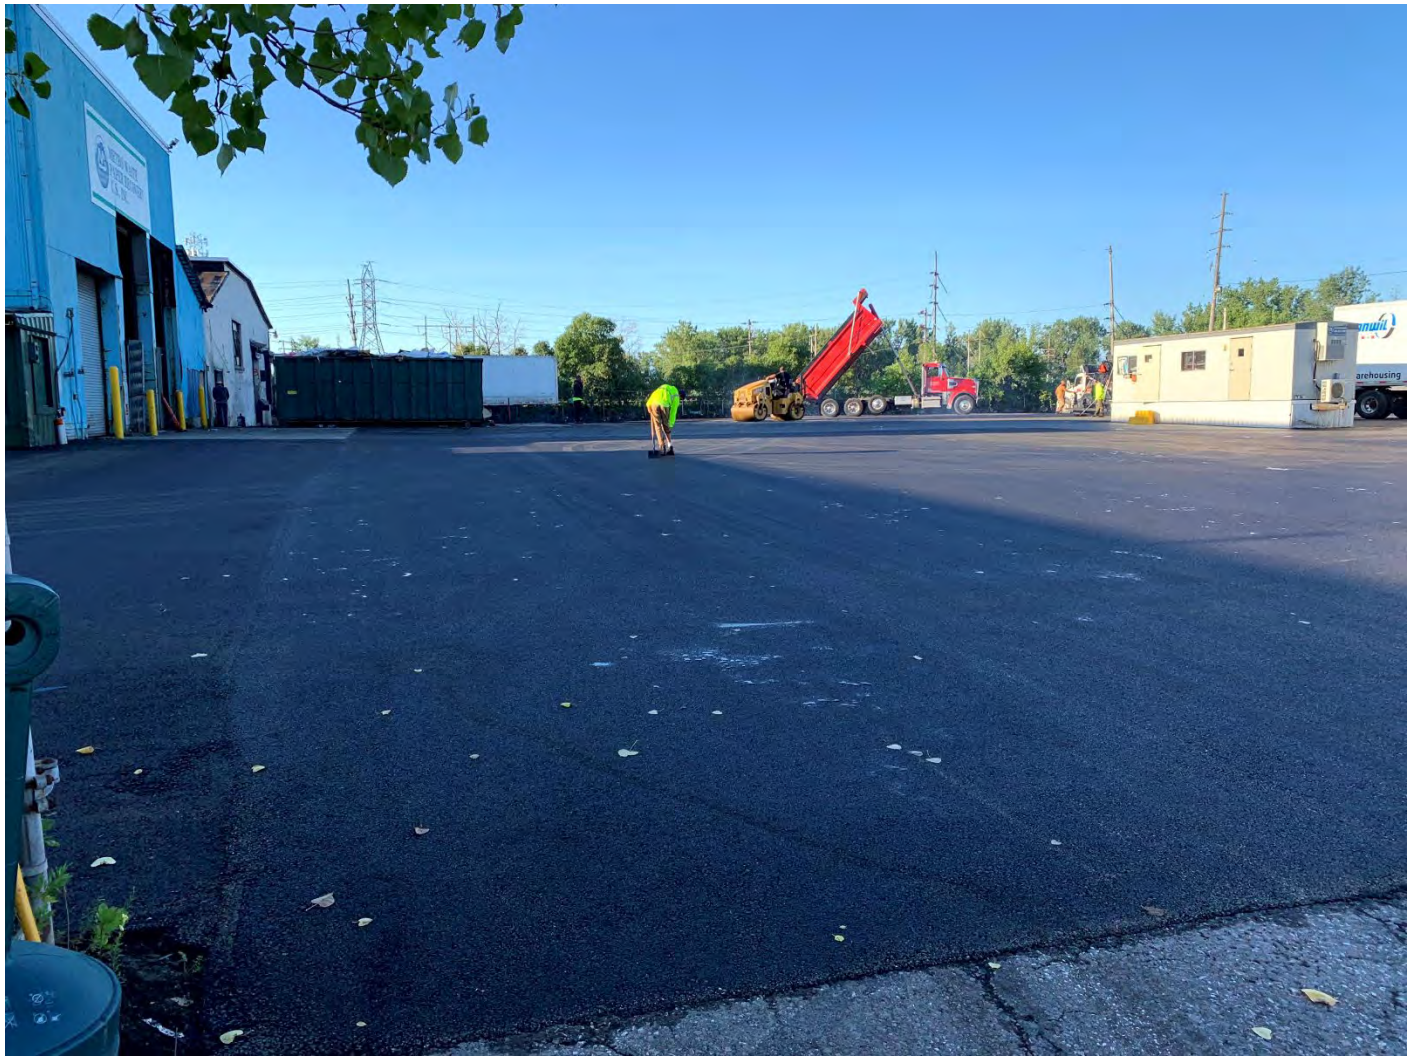
Photo 19 – Looking south across trucking yard at the resurfacing of the trucking yard
