Mr. Chad Staniszewski  
Mr. Eugene Melnyk  
New York State Department of Environmental Conservation  
270 Michigan Avenue  
Buffalo, NY 14203  
**OU-2 Site Walk**  
**NYSDEC Site No. C915201C**

Elk Street Commerce Park, LLC  
600 Elk St., Buffalo, NY

OU2  
COVER AREAS  
Project 3617-16-7397  
Figure 1

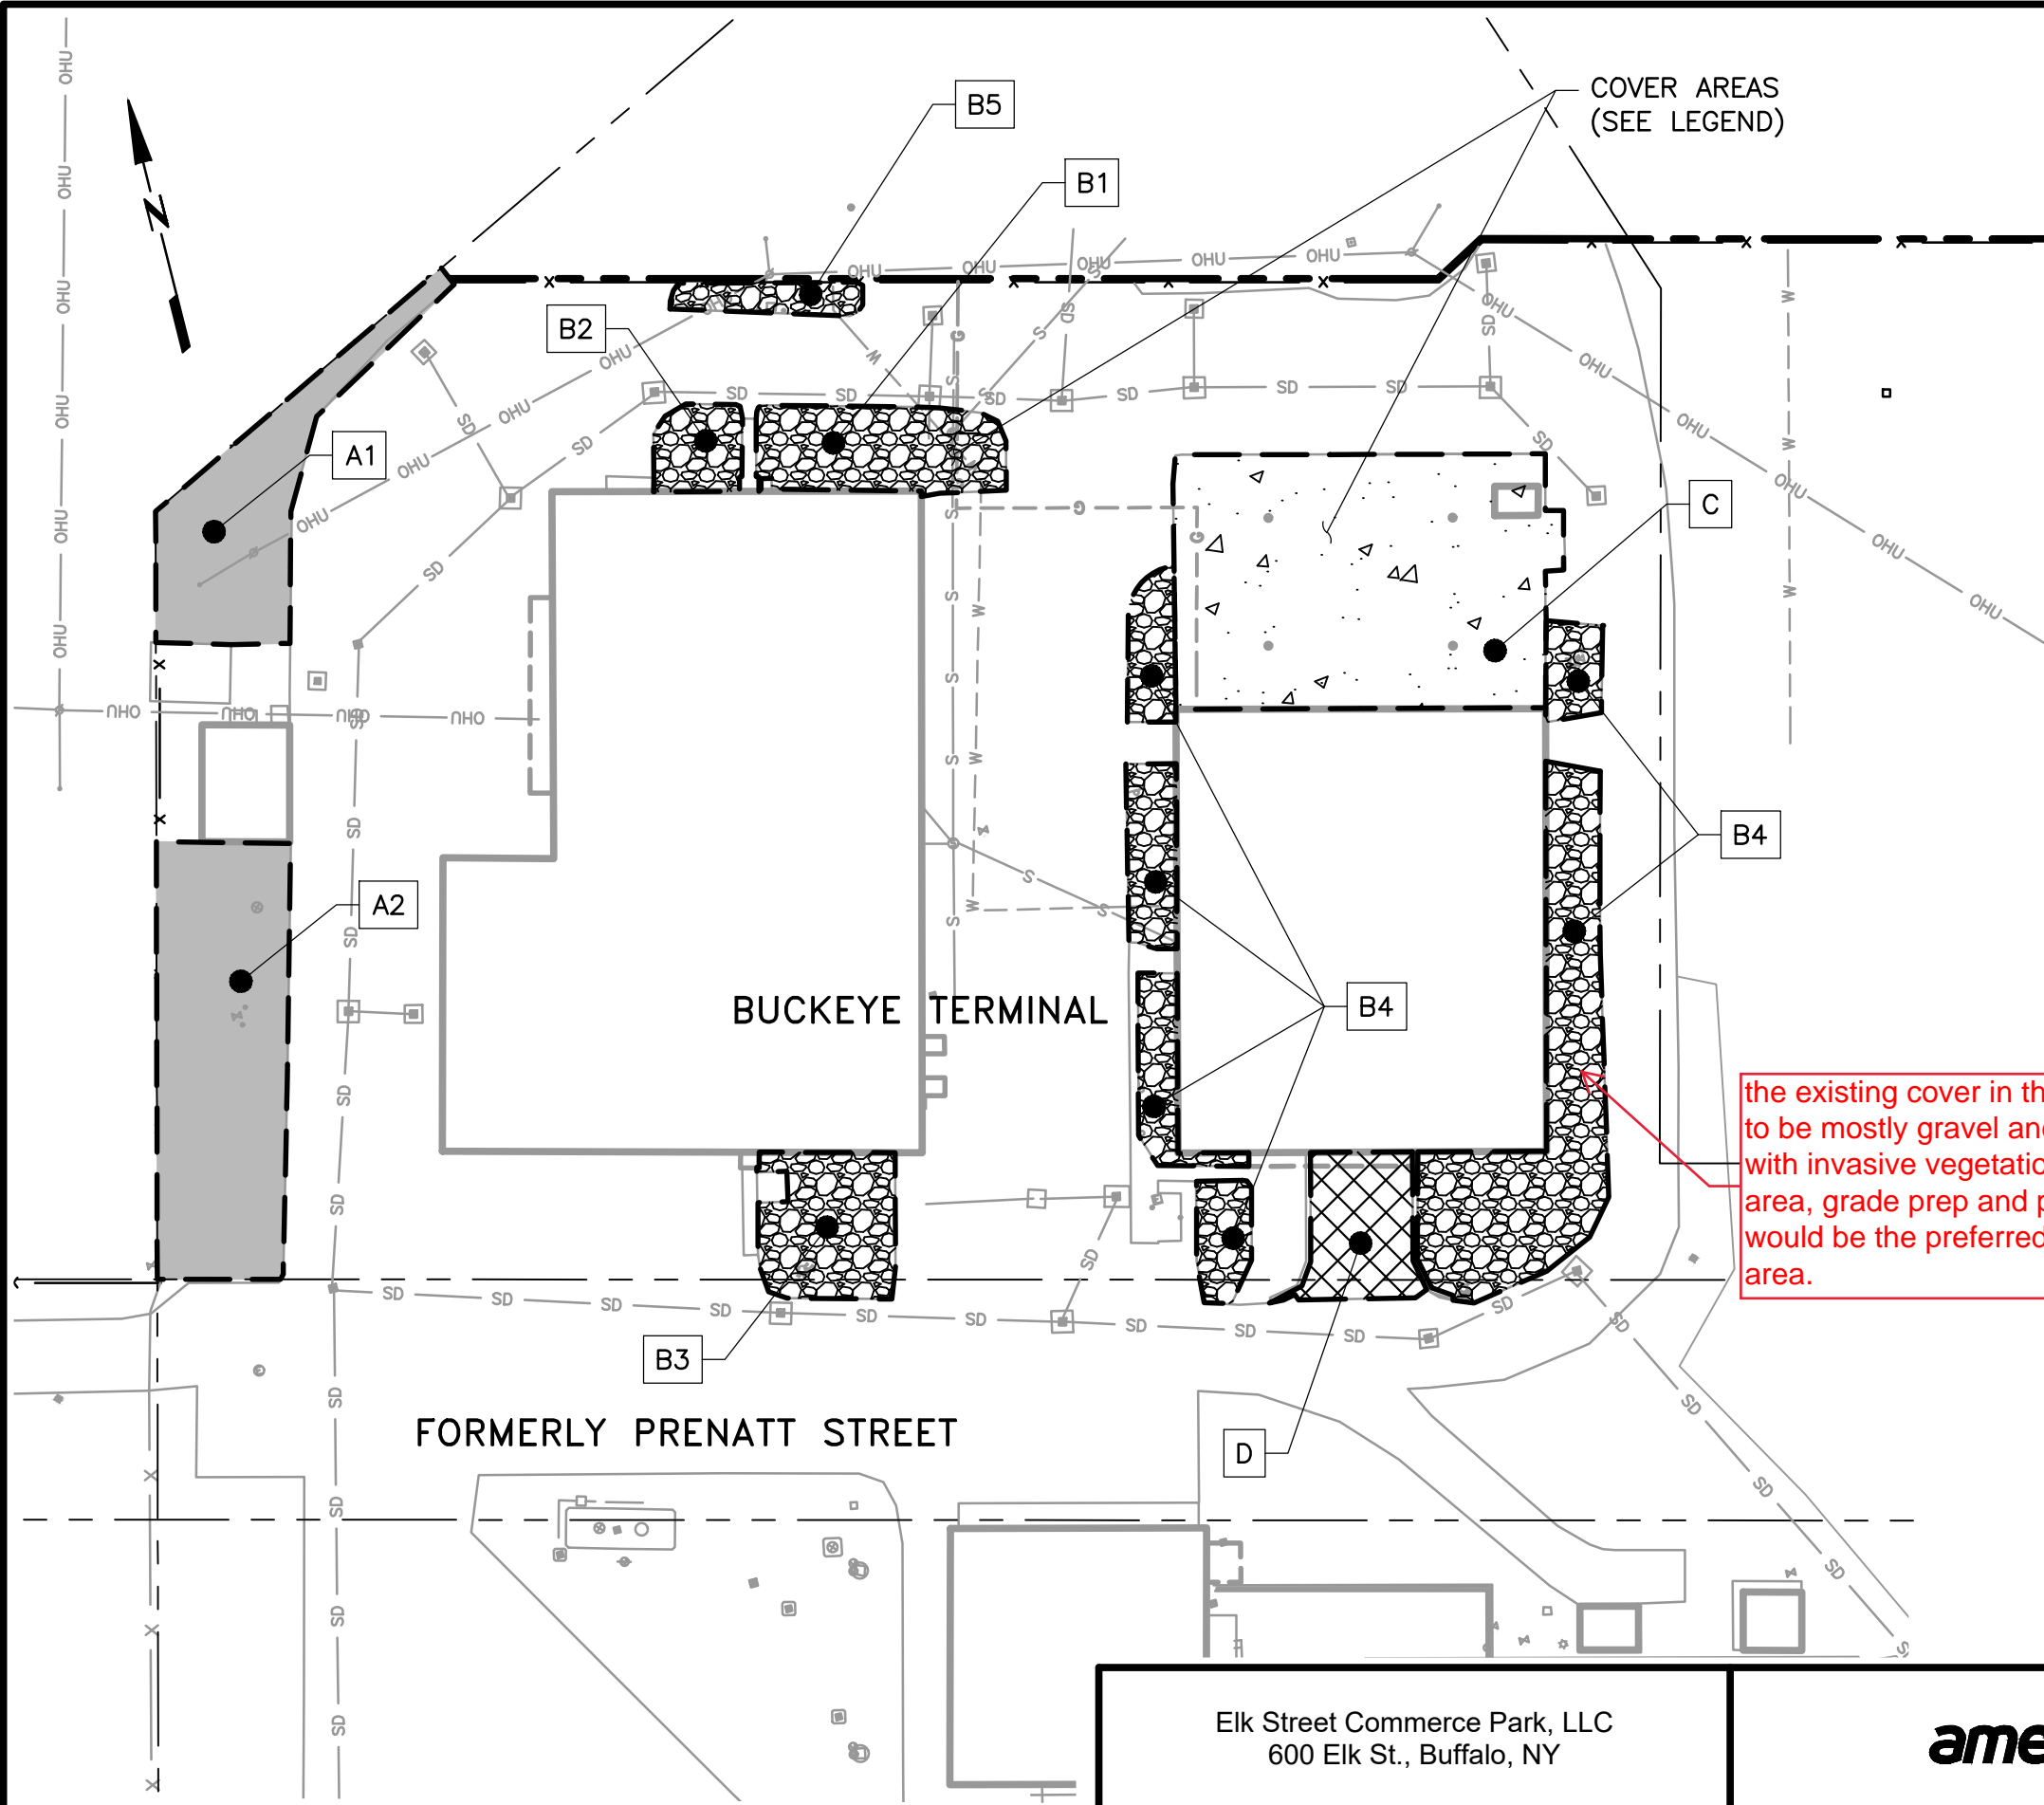
A permeable cover consisting of gravel only is not acceptable as it would promote infiltration. A permeable cover could remain in this area provided the cover consisted of 12 inches of "verified clean" soil to maintain a green area for aesthetics. Otherwise a low perm cover such as an asphalt cover is suggested to minimize infiltration.

the existing cover in this area appears to be mostly gravel and is overgrown with invasive vegetation. Clearing the area, grade prep and placing asphalt would be the preferred cover in this area.

A-REMOVE MATERIAL AND PLACE 2.5" BINDER COURSE AND 1.5" TOP COURSE
-

B-REMOVE MATERIAL AND PLACE 12" CRUSHED STONE
-

C-INSPECT AND SPOT REPAIR CONCRETE
-

D-REMOVE DEBRIS AND SEDIMENT AND BACKFILL WITH SITE MATERIALS AND PLACE 2.5" BINDER COURSE AND 1.5" TOP COURSE
