2021 Periodic Review Report

ExxonMobil Oil Former Buffalo Terminal OU-2 West
45 Orlando Street, Buffalo, New York
NYSDEC Site No. C915201C

May 2021

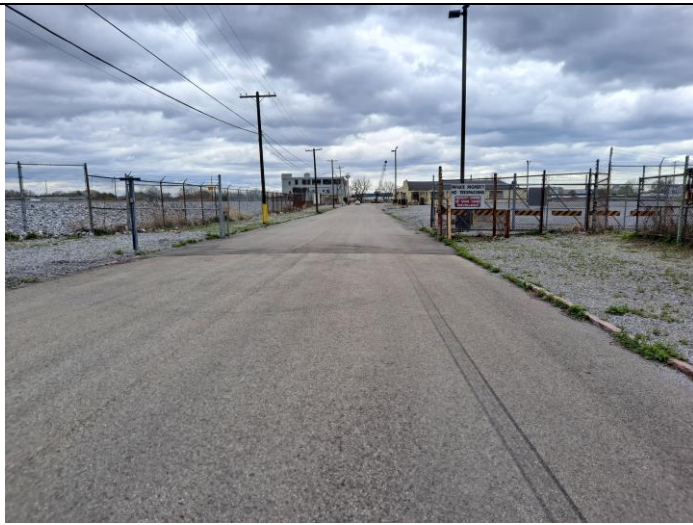
Site driveway from Elk Street facing south

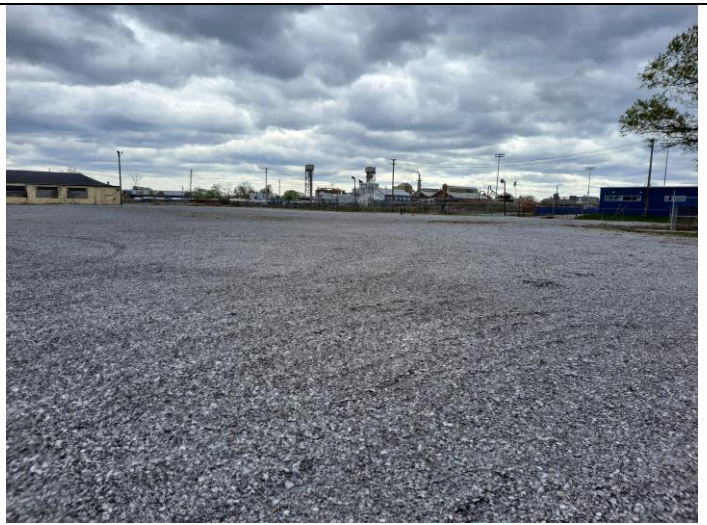
Gravel cover on north portion of Site from northeast corner facing southwest

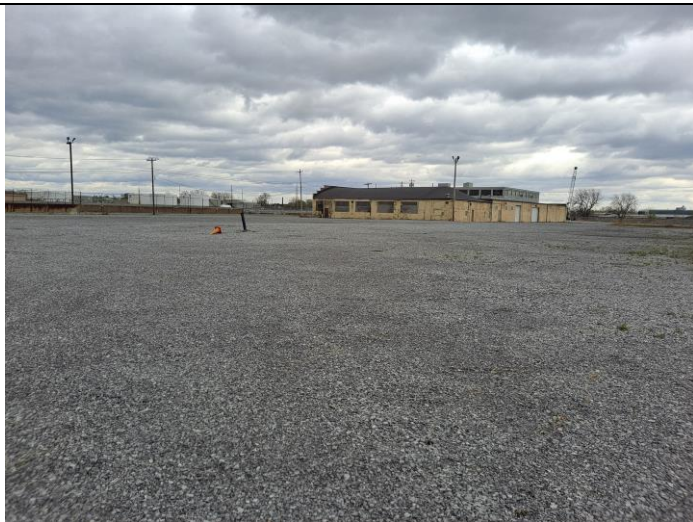
Site from northwest corner facing southeast

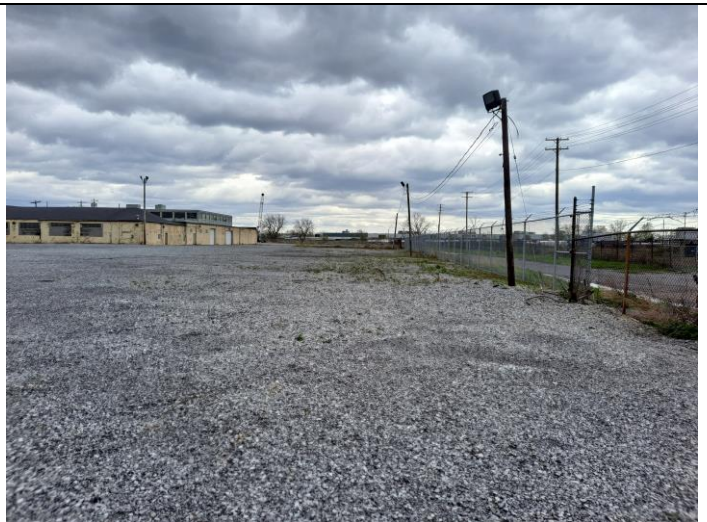
West Site boundary from northwest corner facing south

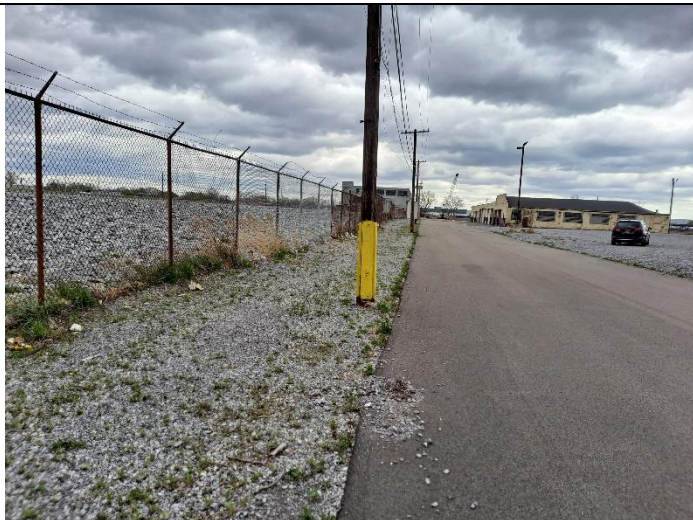
East Site boundary from northeast corner facing south

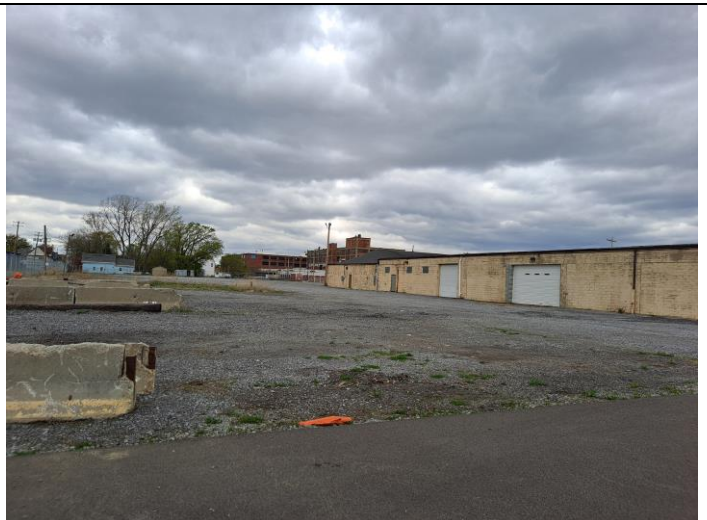
Southwest portion of Site and west side of Site Building

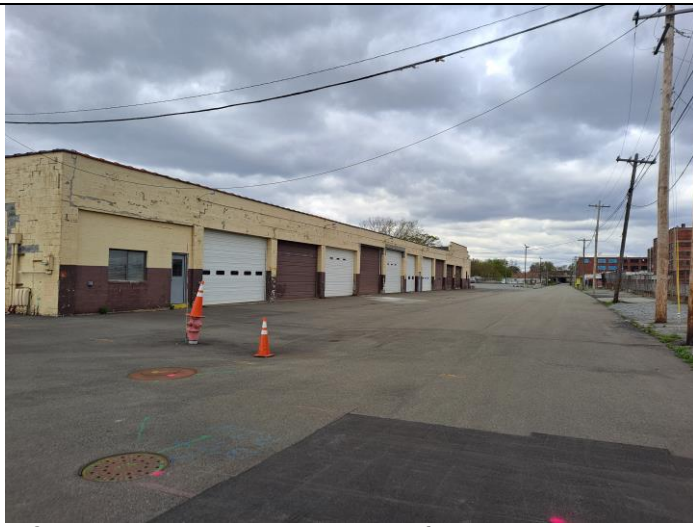
Site Building and asphalt driveway from southeast corner facing north

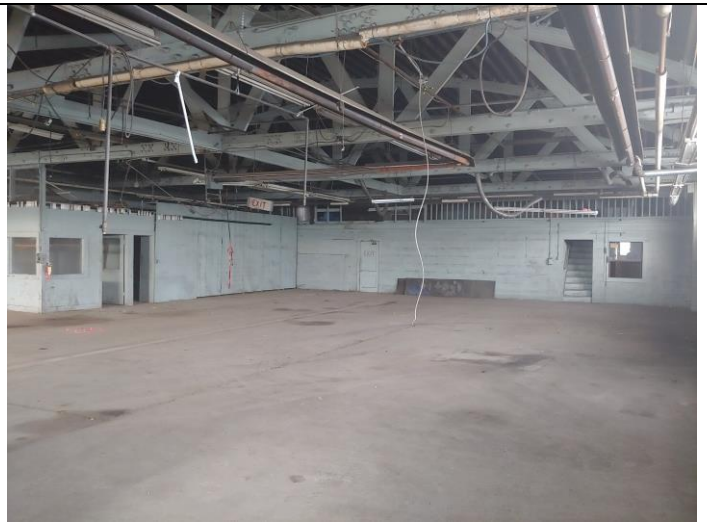
Site Building interior

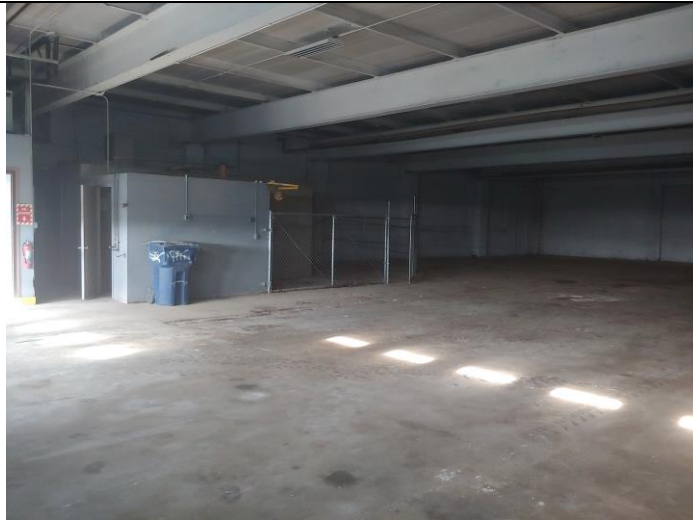
Site Building interior
