Clean Capital/Inovateus Liner Repair QA/QC Report

503 Elk Street
Buffalo, New York 14210
Elk Street Commerce Park
Elk Street Solar
NYSDEC Site No. C915201D

LaBella Project No. 2211232

February 6, 2024

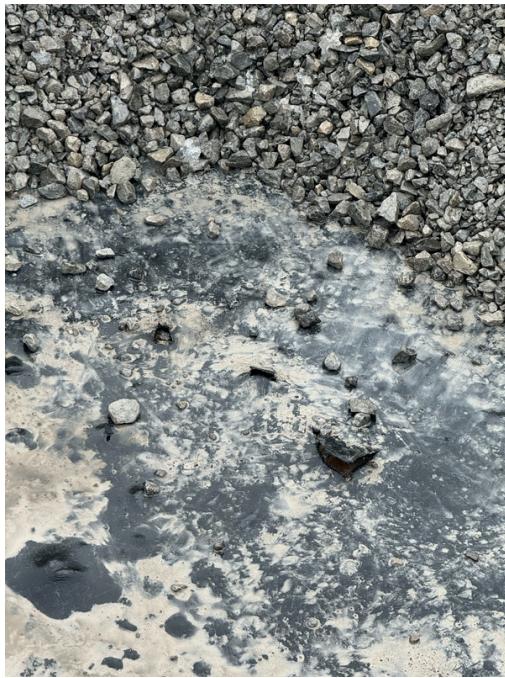
Photo 1: Additional damage to geomembrane

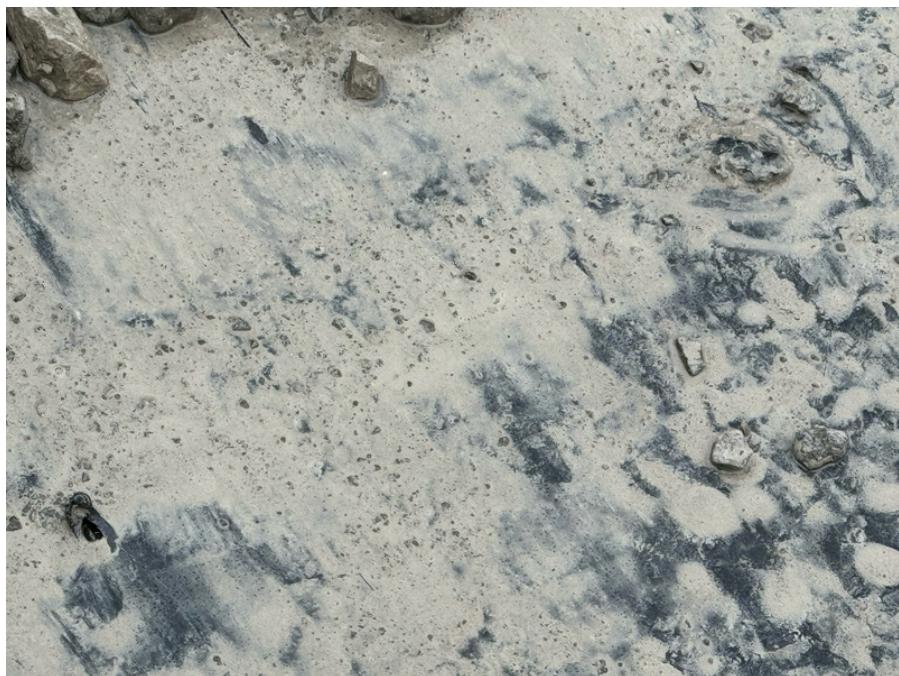
Photo 2 : Additional geomembrane damage

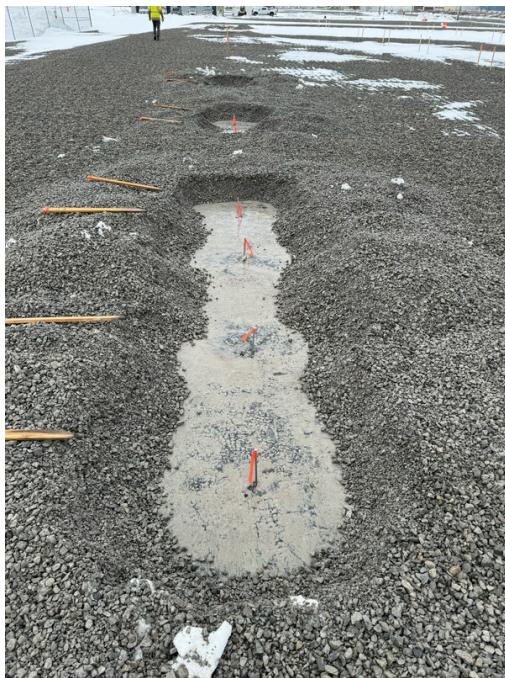
Photo 3 : Completed gravel removal

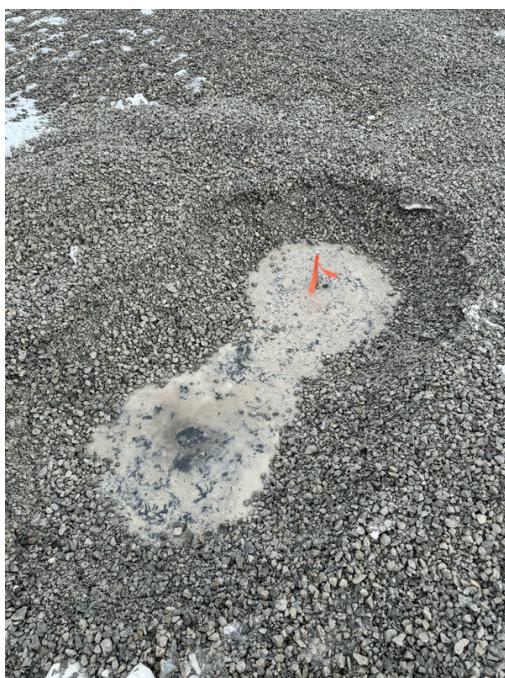
Photo 4 : Completed gravel removal

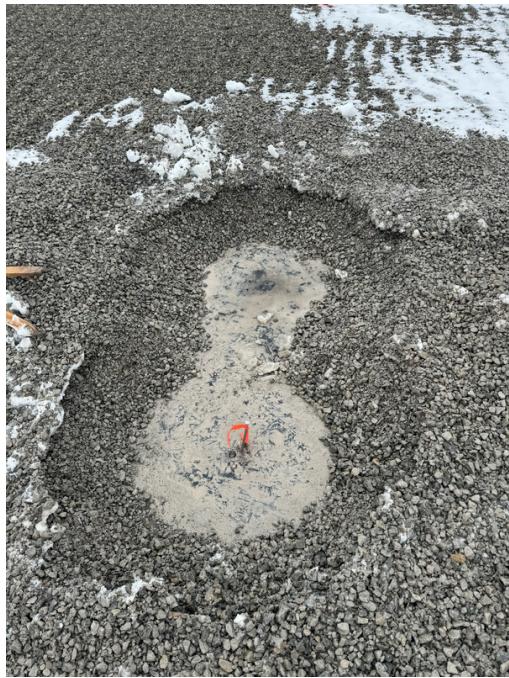
Photo 5 : Completed gravel removal

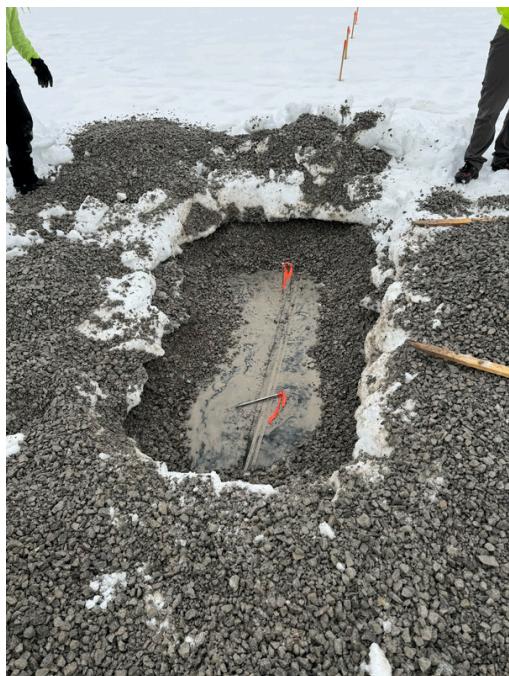
Photo 6 : Completed gravel removal

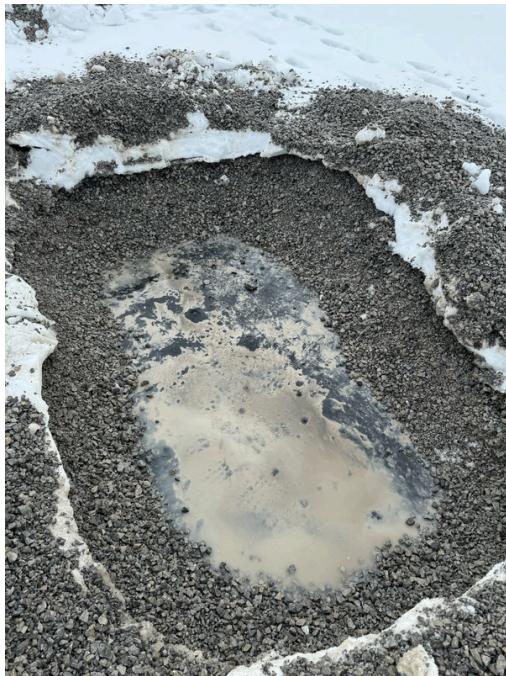
Photo 7 : Completed gravel removal with additional damage

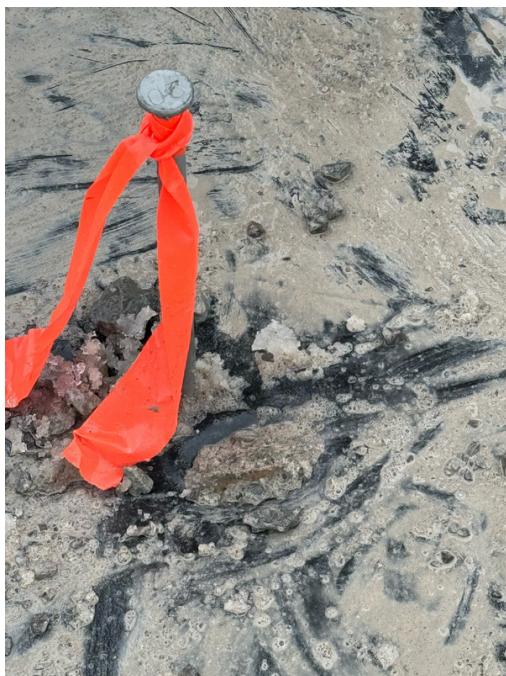
Photo 8 : Lath stuck in hole

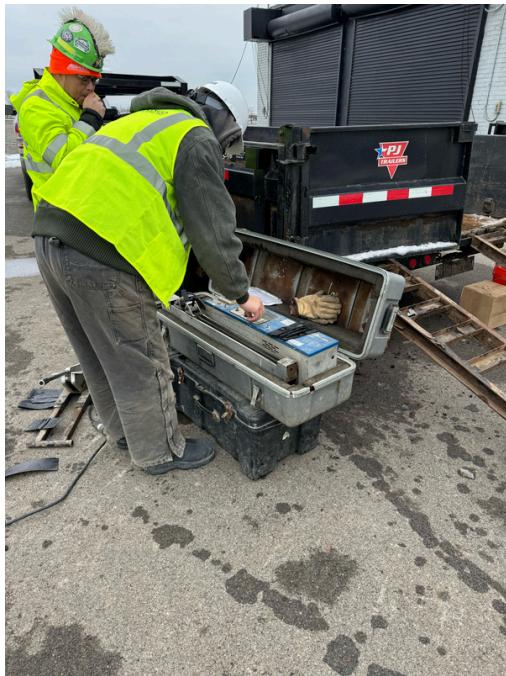
Photo 9 : Peal and Shear testing

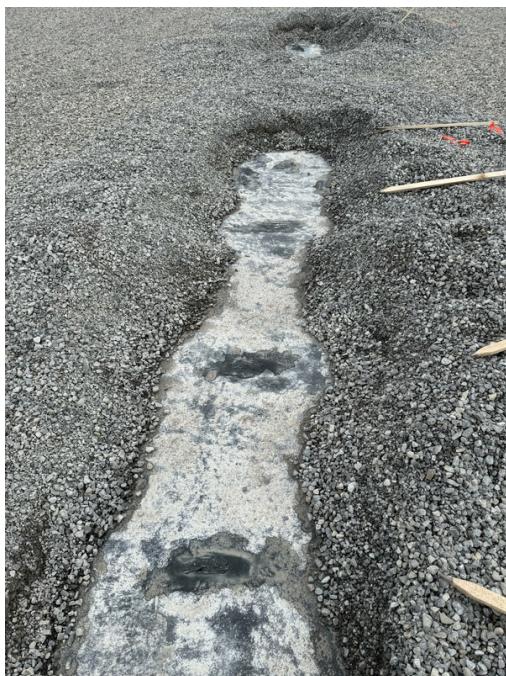
Photo 10 : Representative bead repairs

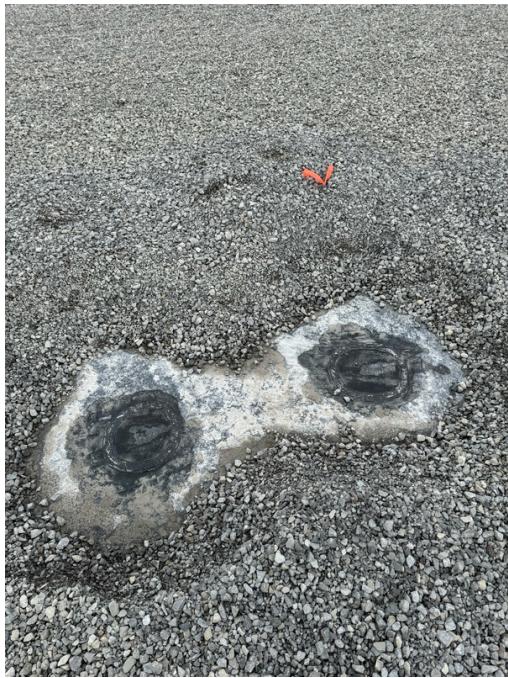
Photo 11 : Representative patch repairs

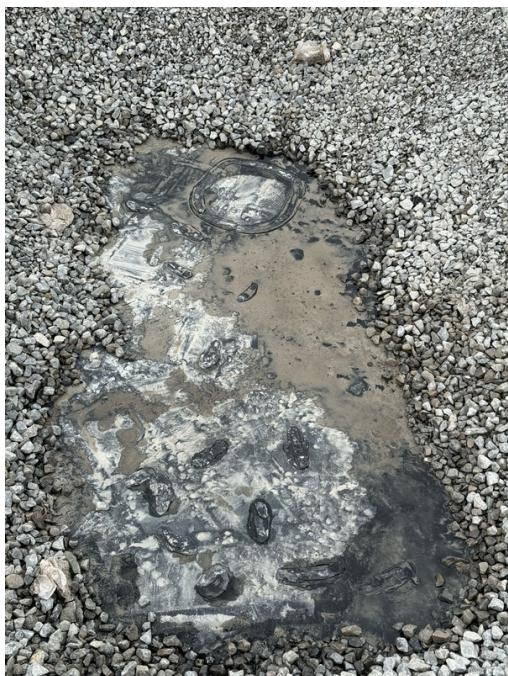
Photo 12 : Representative repair work

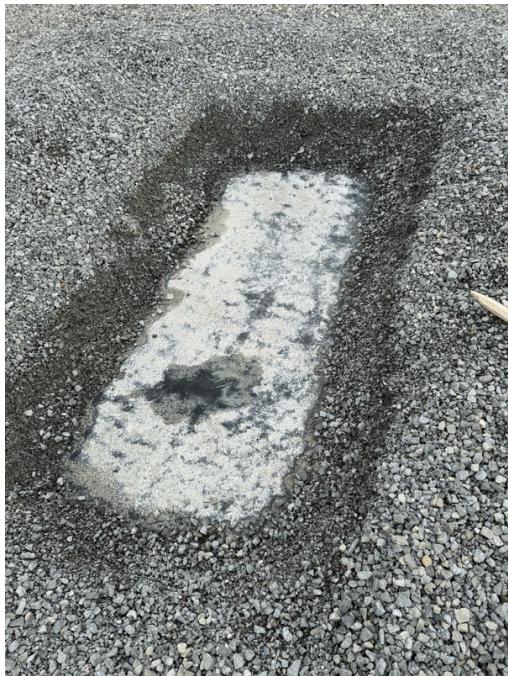
Photo 13 : Representative repair work

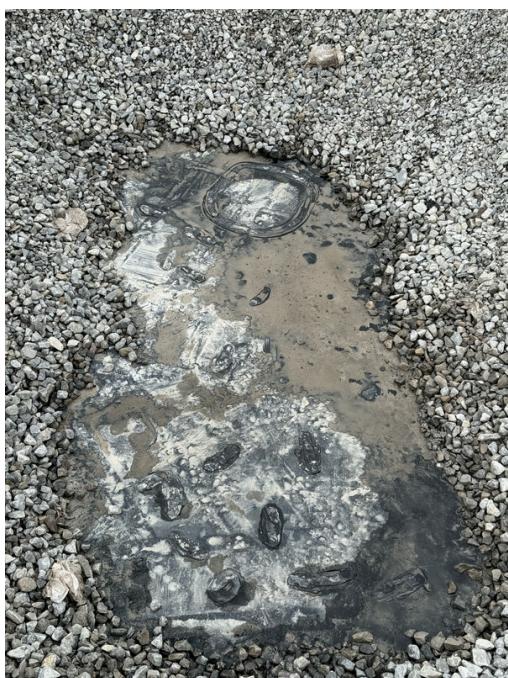
Photo 14 : Representative repair work
