Re: Annual Environmental Inspection Report  
Cobey, LLC Site, BCP Site #C915202  
Buffalo, New York

# ENVIRONMENTAL INSPECTION FORM

Cobey Annual Inspection of Site Cover System

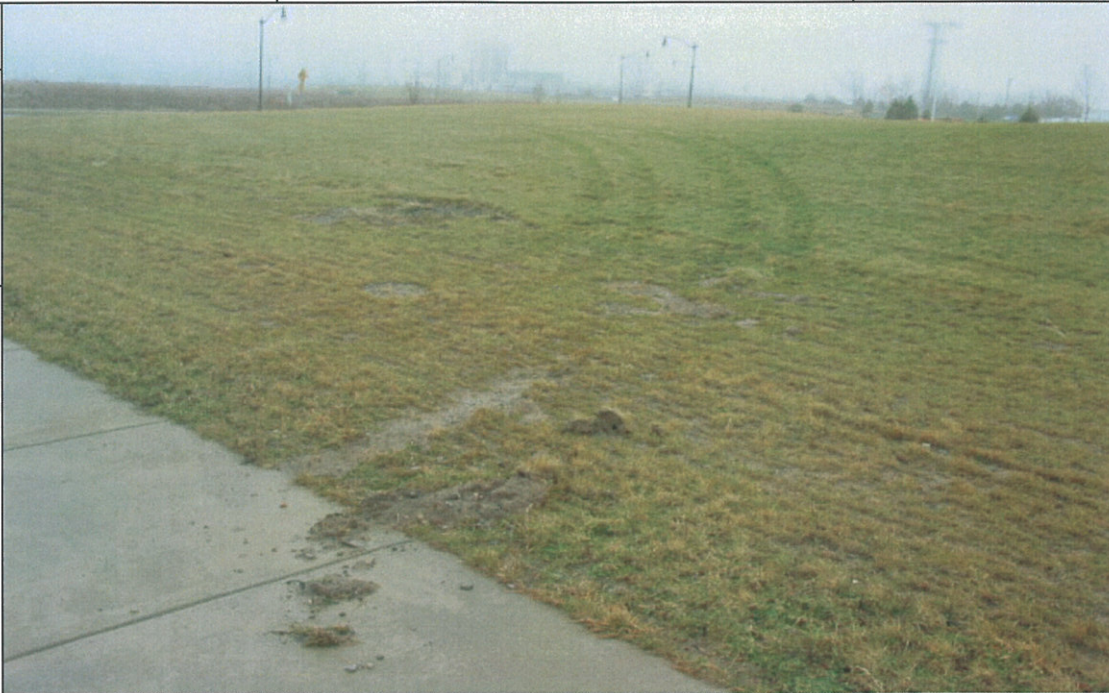
**Description:**Vehicle ruts from  
trespassing driver.

<sup>(1)</sup> Vehicles/ATVs have made tracks and ruts at a few locations (See Photos 1 and 2). Recommend covering with top soil and reseeding.

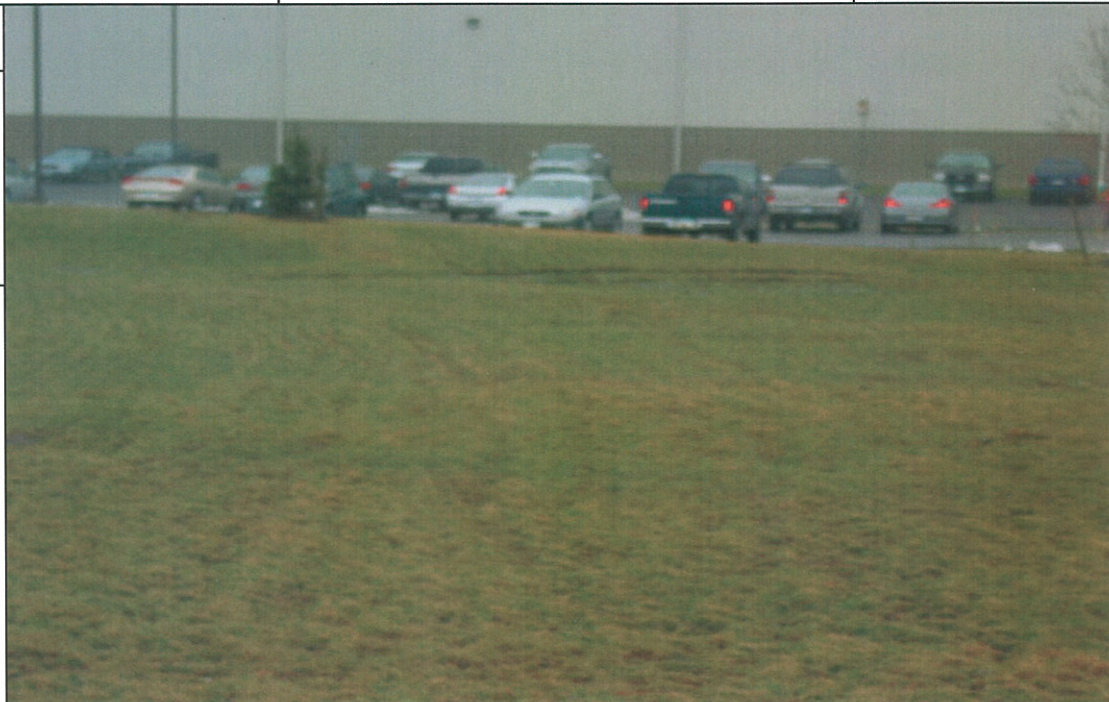
2

**Description:**Vehicle ruts from  
trespassing driver.

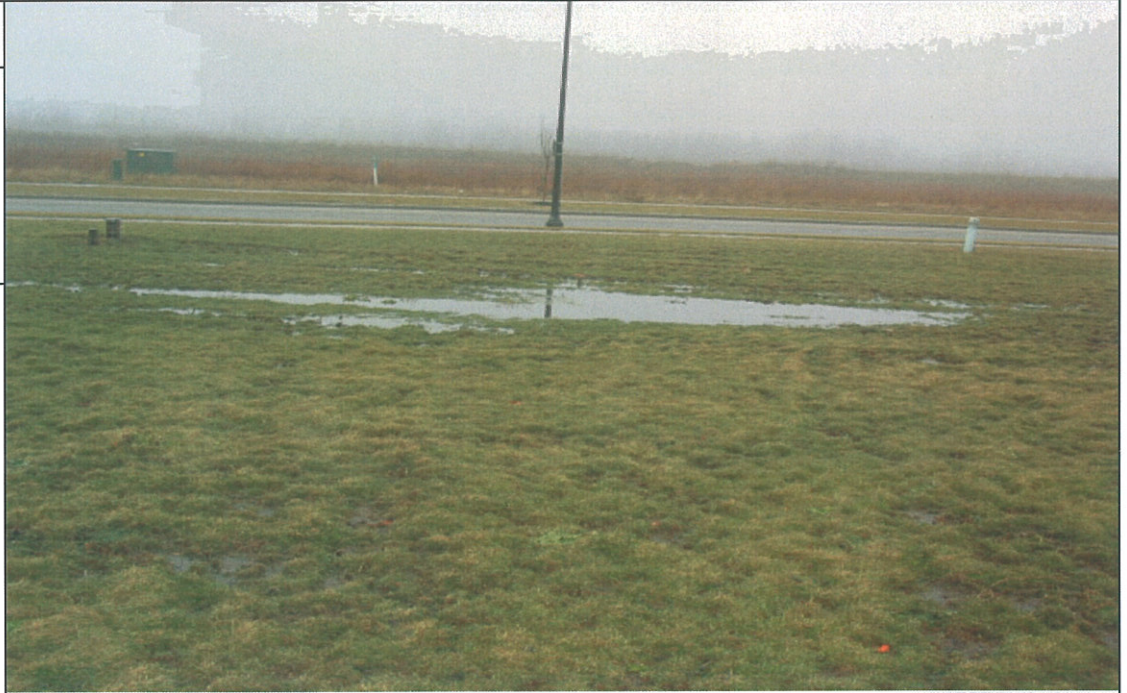
3

Minor ponding from recent snow melt.

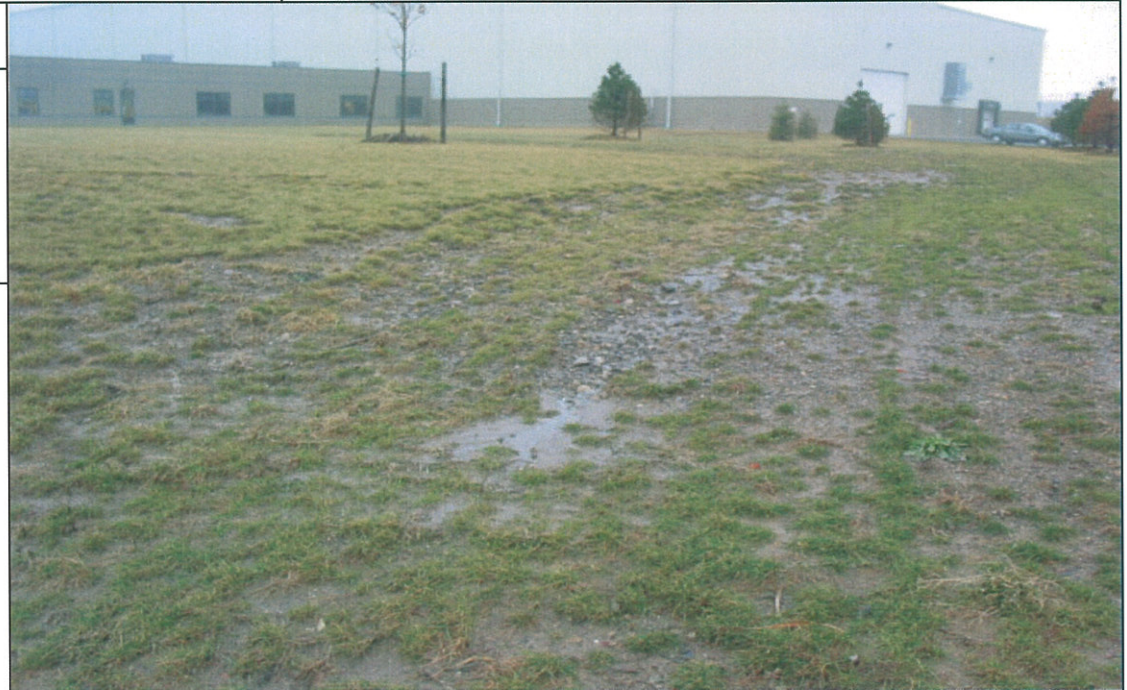
4

Soil erosion from storm water runoff.

<sup>(2)</sup> Minor ponding observed from recent significant snow melt (see Photo 3), minor erosion from channeled runoff at northwest area of site, see photo #4. Recommend adding top soil and reseeding. Minor erosion from vehicles cutting corners of pavement, see photos # 5 and 6, recommend placing large boulders at inside turns to prevent vehicles from cutting corners. Grass cover impacted at eastern edge of paved loading area where wooden pallets and shipping containers are stored, see photo #7. Recommend improved "house keeping" practices in this area.

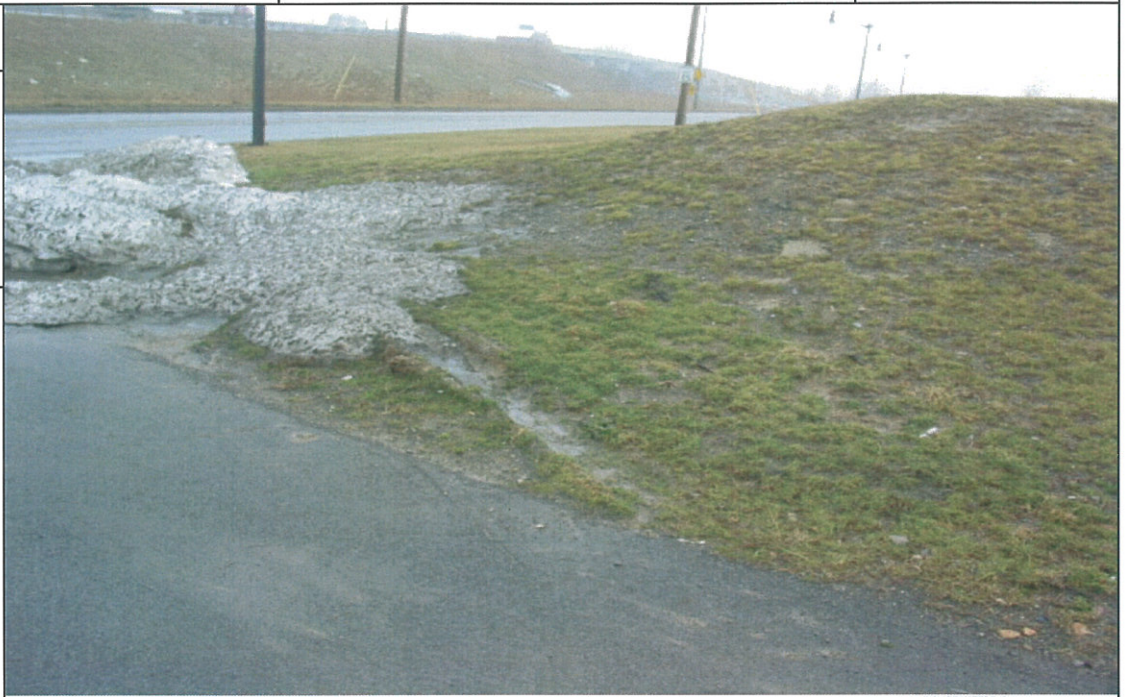
5

Tire ruts/grass erosion from vehicles cutting the corner at western service entrance.

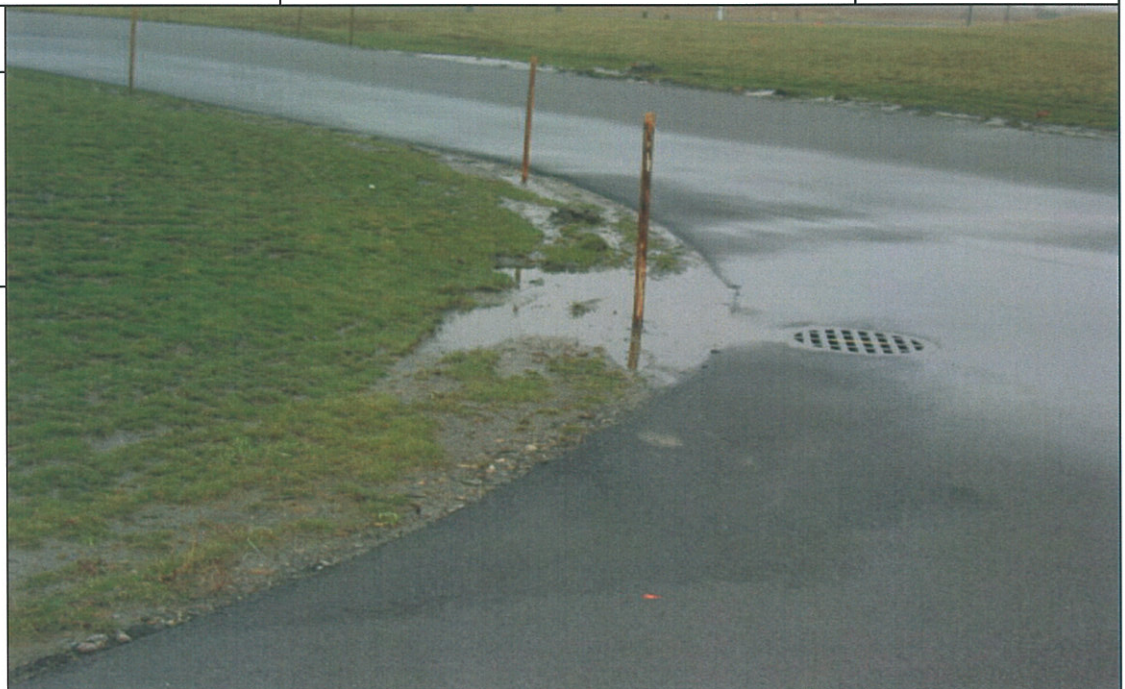
6

Tire ruts/grass erosion from vehicles cutting the corner at eastern service entrance.

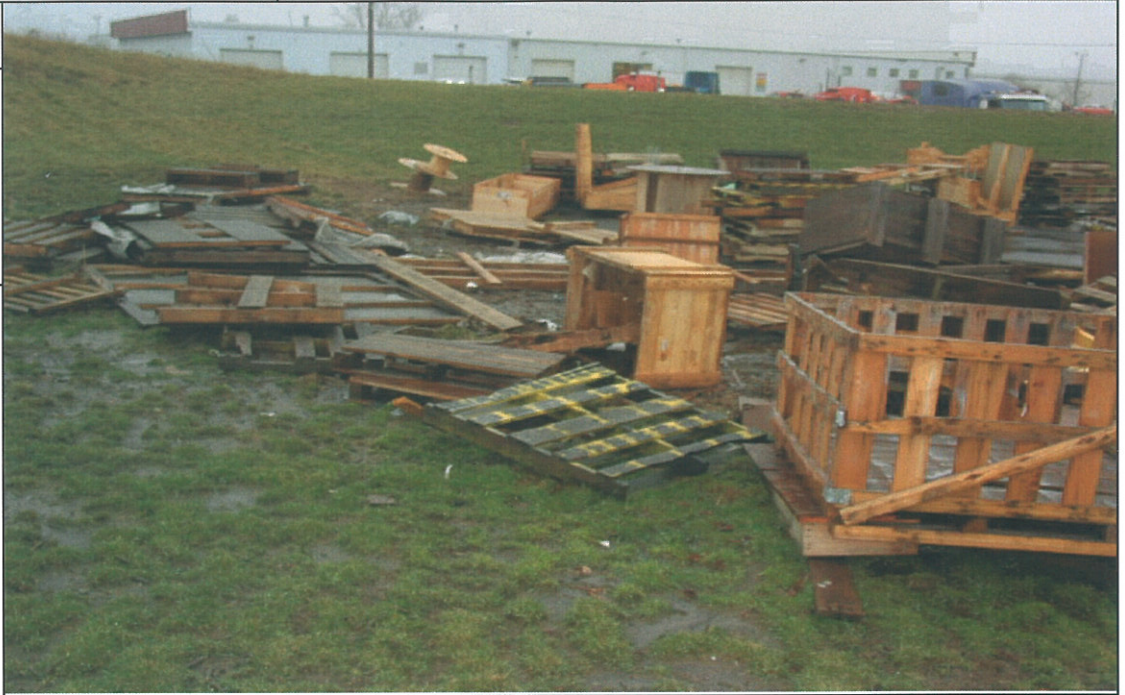
7

Soil erosion/grass removed from storage of wooden pallets and shipping containers.

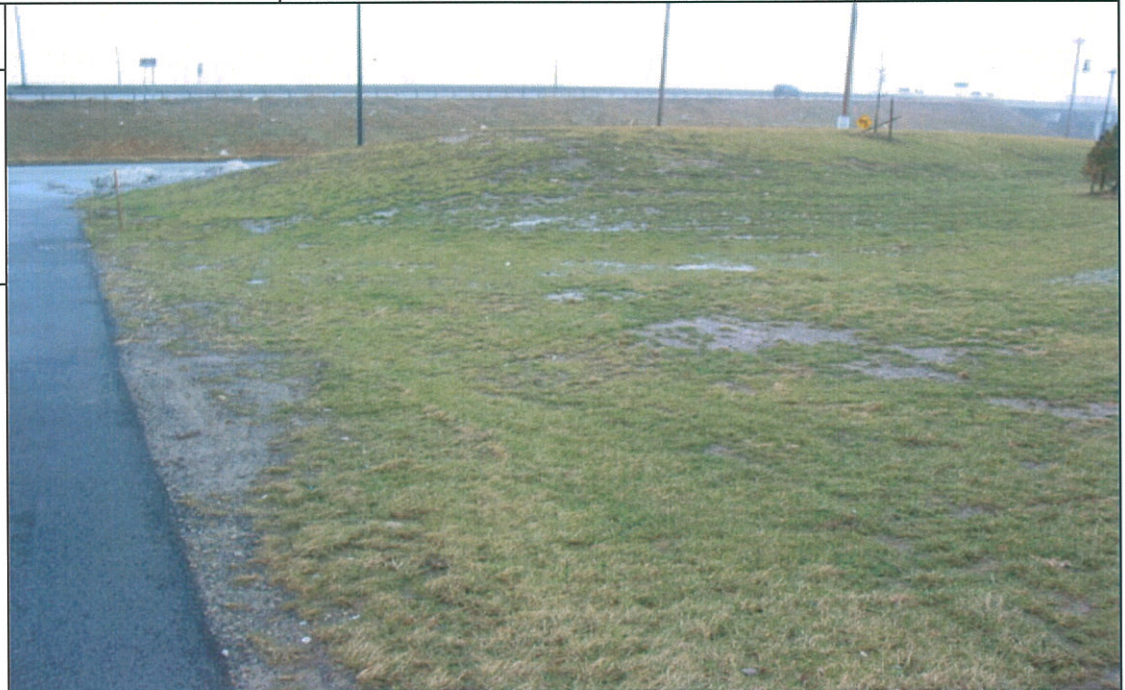
8

Bare areas of soil cover system in need of top soil and reseeded.

<sup>(3)</sup> There are areas with incomplete grass cover that require additional top soil and seed, see Photos 8, 9, 10, and 11 for some examples. Recommend adding top soil and reseeding.

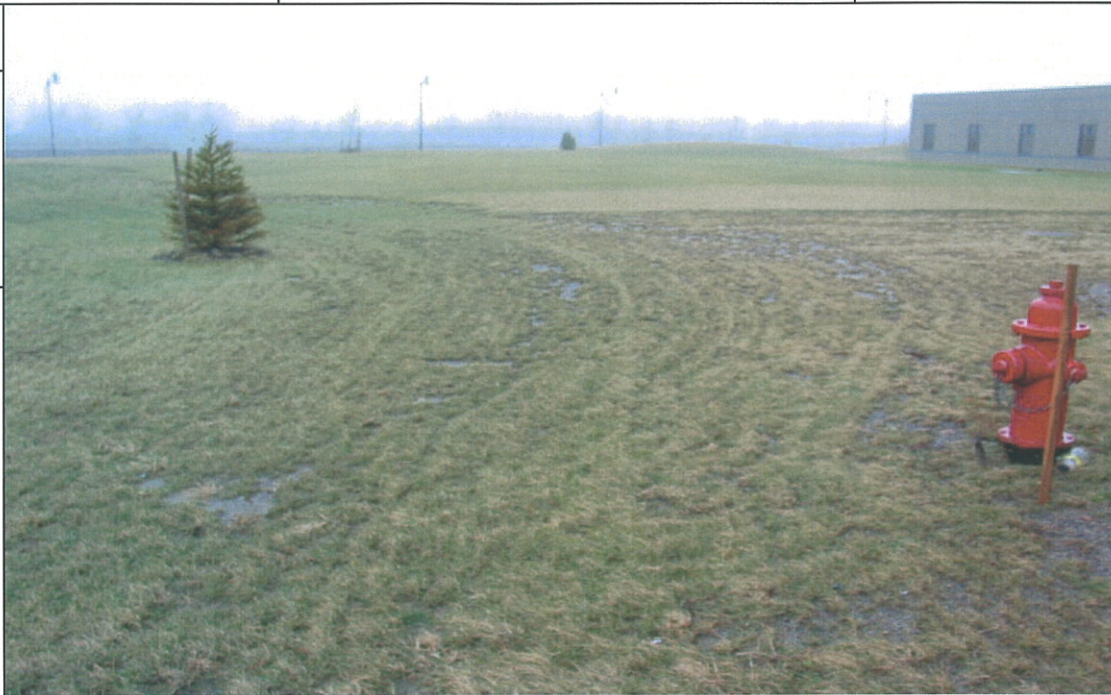
9

Bare areas of soil cover system in need of top soil and reseeding.

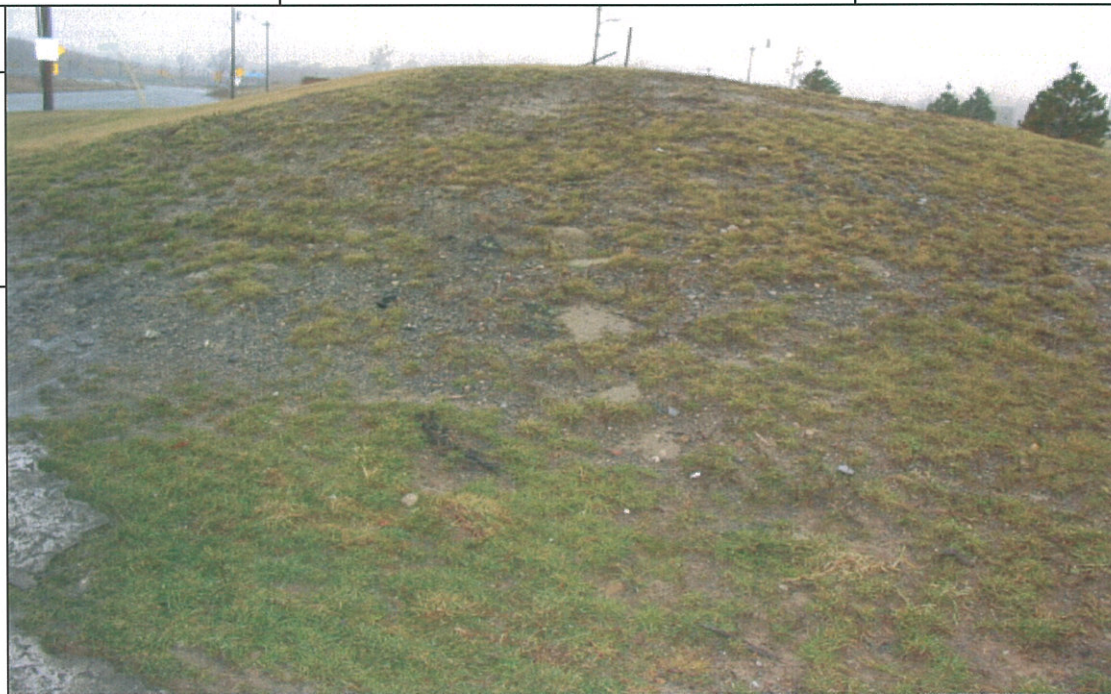
10

Bare areas of soil cover system in need of top soil and reseeding.

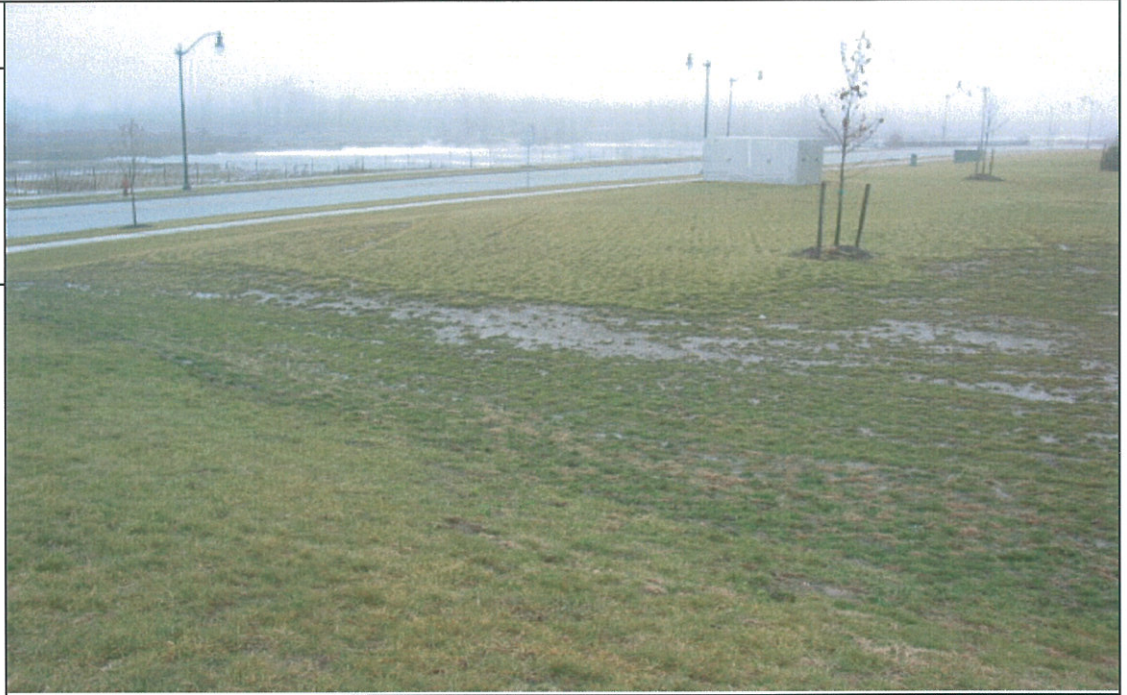
11

Bare areas of soil cover system in need of top soil and reseeding.

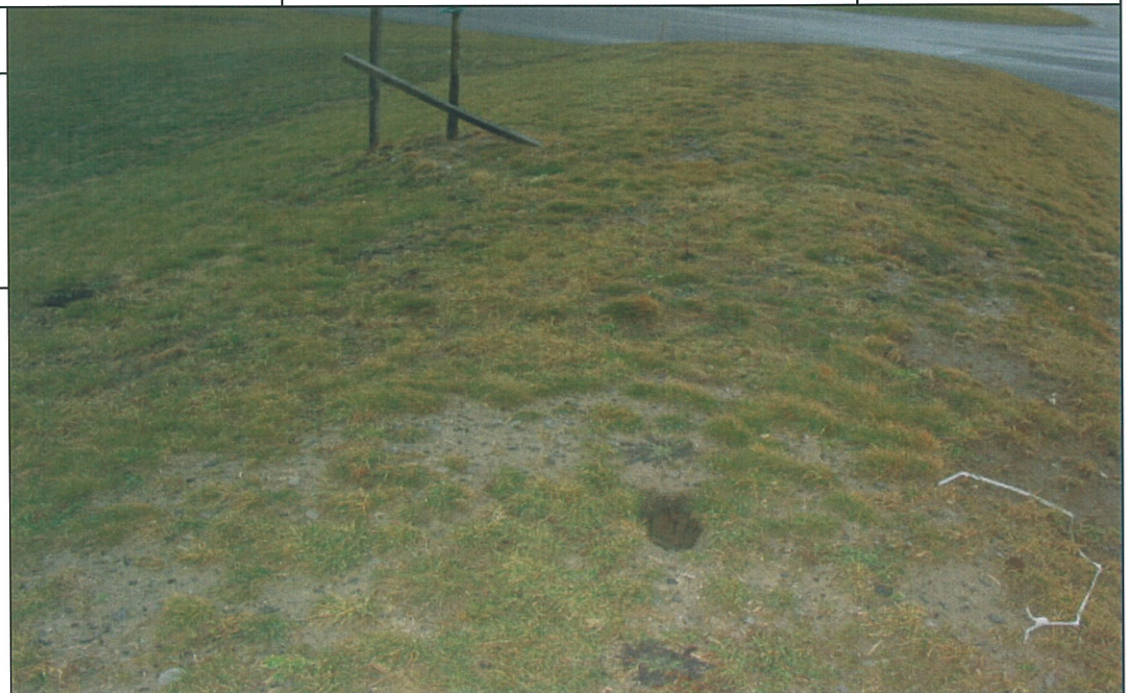
12

Woodchuck holes in western site berm.

<sup>(4)</sup> At least three woodchuck holes were observed on the top of the western site berm, see Photo 12. Recommend trapping and relocation of woodchuck(s) and filling holes with top soil and seeding.
