Re: 2009 Periodic Review Report
Cobey, LLC Site, BCP Site #C915202
Buffalo, New York

Periodic Review Report

Cobey, LLC Site

BCP Site #C915202

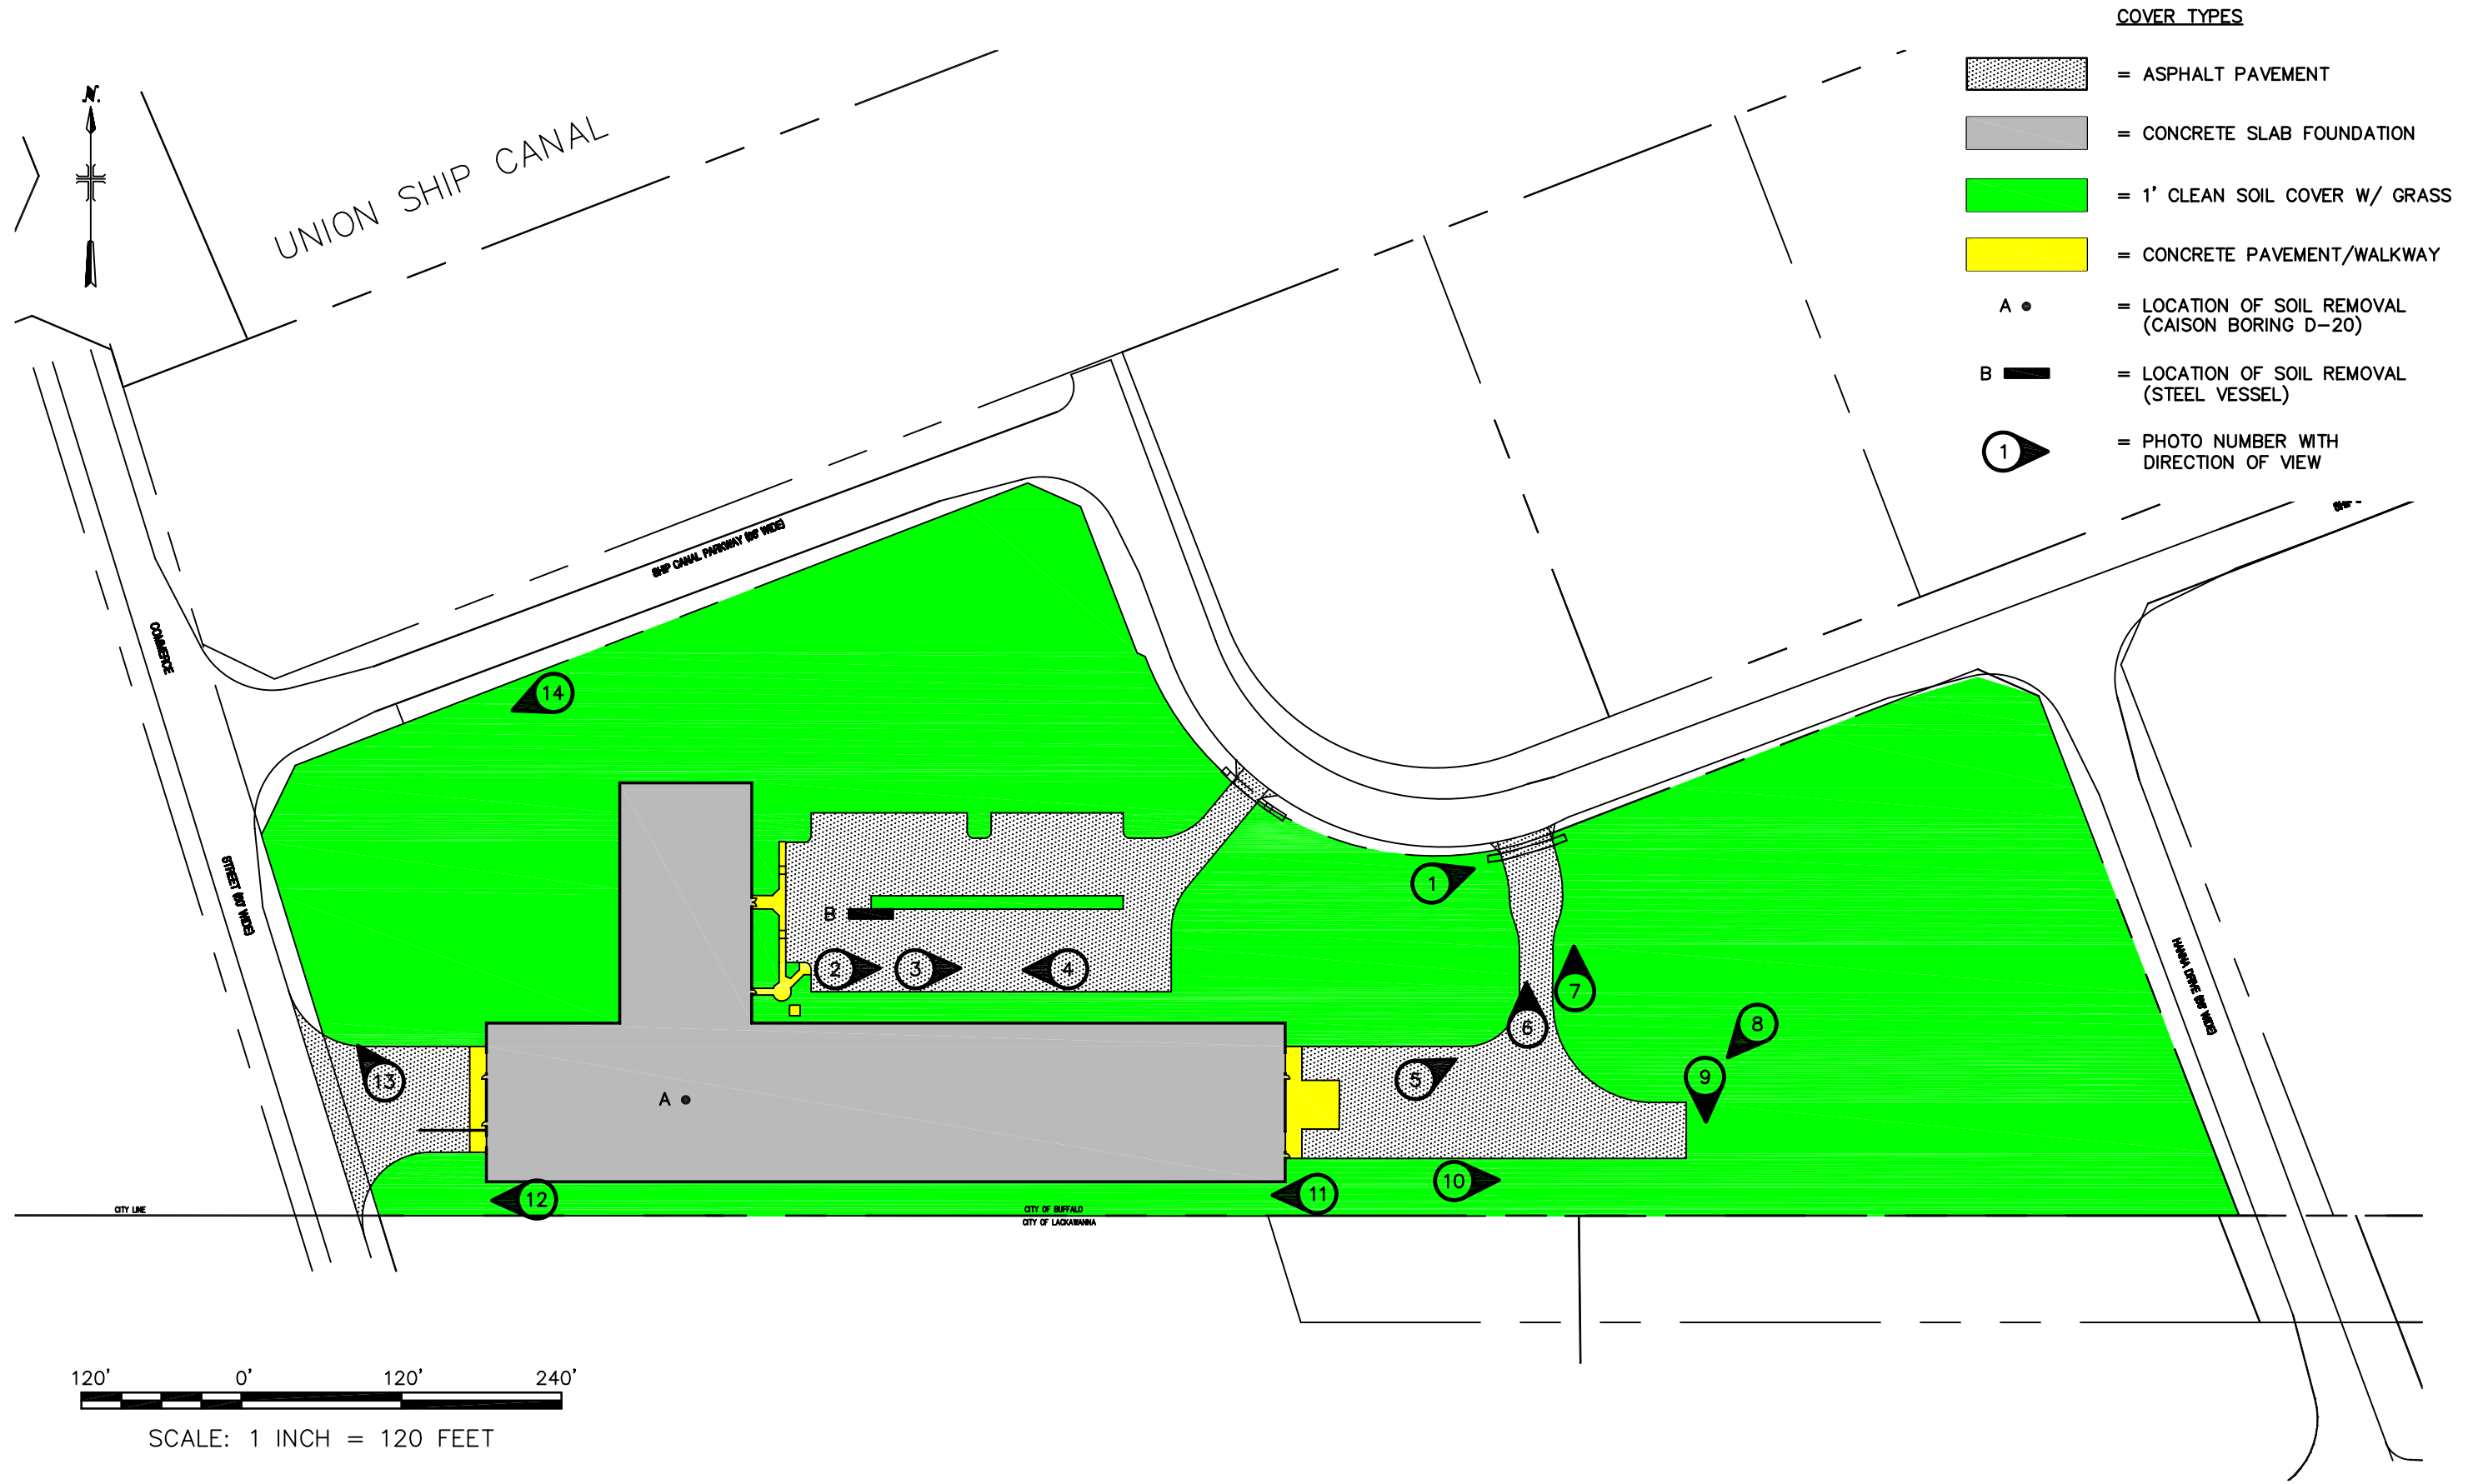
FIGURE 2-2

During advancement of the Cobey building foundation footers using a caisson drill, oily soil/fill material was observed at one of the caisson borings identified as location D-20. The impacted soil/fill was stockpiled, characterized, and disposed of offsite with NYSDEC approval at a permitted landfill. The location of where the impacted soil/fill was encountered is illustrated as point A on Figure 2-2.

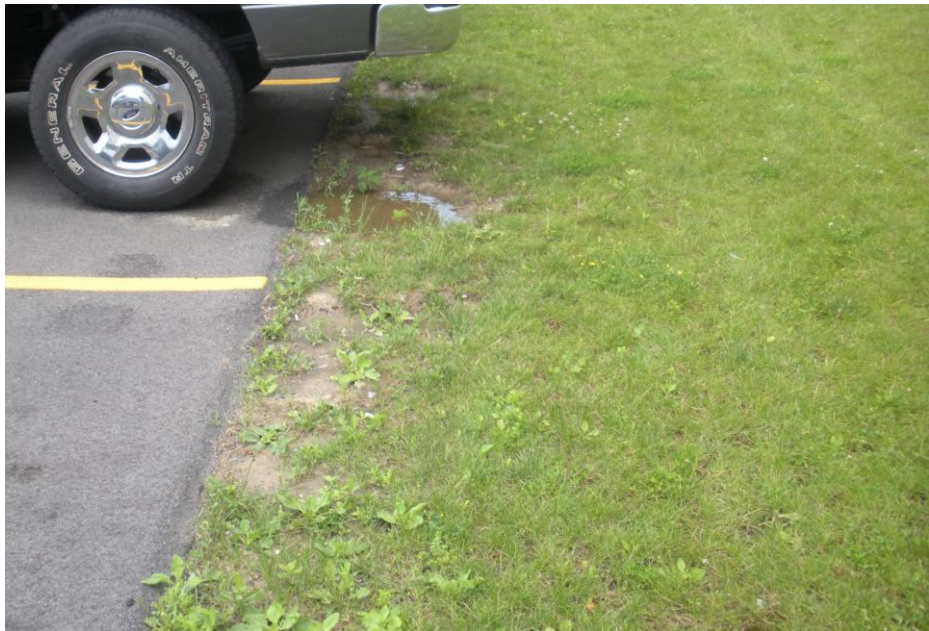
Project: Cobey Annual Inspection of Site Cover System		Location: Buffalo, New York	Project No. 6245-001
Photo No. 3	Date: 7-2-2009

⁽¹⁾ Minor erosion from vehicles cutting corners of pavement, see photos # 3 through #7, recommend placing parking curbs and large boulders at pavement edge and inside turns to prevent vehicles from driving off paved surfaces and causing damage. Grass cover impacted at eastern edge of paved loading area where wooden pallets and shipping containers are stored, see photo #9. Recommend adding top soil and reseeding in this area.

Direction Photo Taken: East			
Description: Minor rutting from vehicle tires driving off paved surfaces.

- Placing parking curbs and/or permanent barriers at the pavement edge and inside turns to prevent vehicles from driving off paved surfaces and causing damage to vegetative cover.

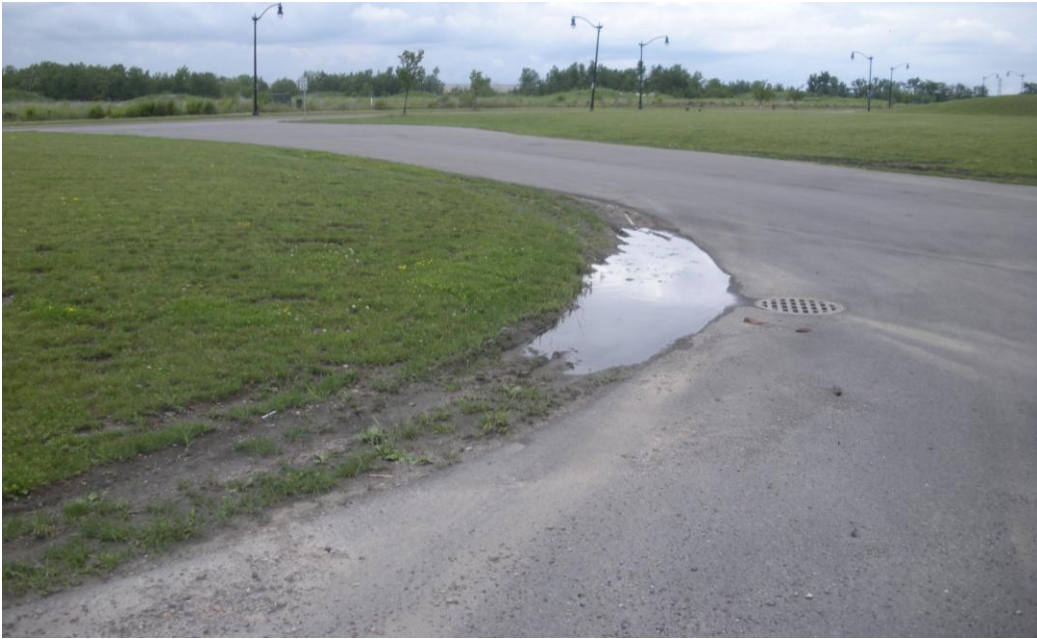
Project: Cobey Annual Inspection of Site Cover System		Location: Buffalo, New York	Project No. 6245-001
Photo No. 5	Date: 7-2-2009

Direction Photo Taken: Northeast			
Description: Tire ruts/grass erosion from vehicles cutting the corner at eastern service entrance.

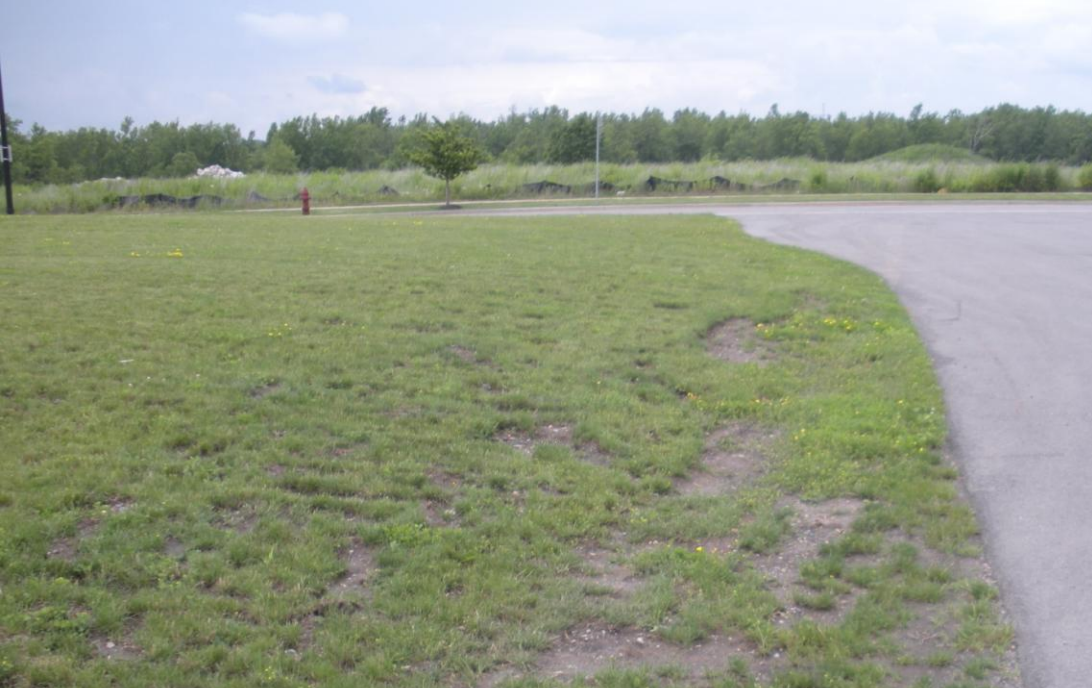
Project: Cobey Annual Inspection of Site Cover System		Location: Buffalo, New York	Project No. 6245-001
Photo No. 6	Date: 7-2-2009

⁽²⁾ There are areas with incomplete grass cover due to poor quality topsoil conditions, see photos 6, 9, 13, and 14 for some examples. Recommend adding top soil and reseeding.

Direction Photo Taken: North			
Description: Bare areas of soil cover system in need of top soil and reseeding, and tire ruts/grass erosion from vehicles cutting the corner at eastern service entrance.

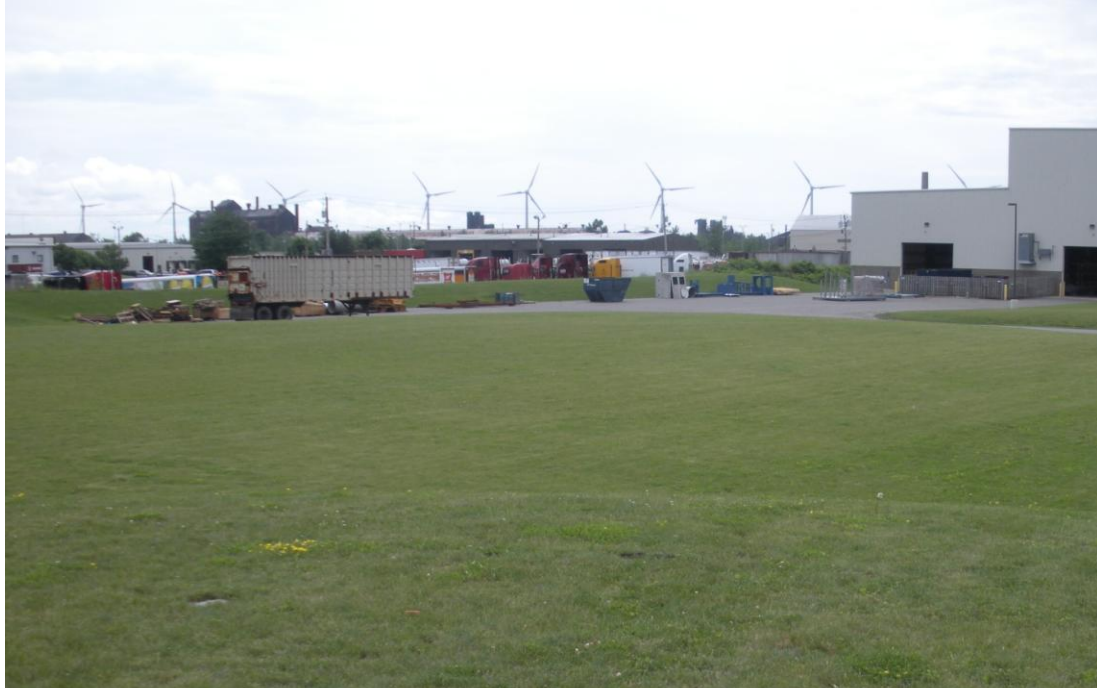
Project: Cobey Annual Inspection of Site Cover System		Location: Buffalo, New York	Project No. 6245-001
Photo No. 8	Date: 7-2-2009

Direction Photo Taken: Southwest			
Description: View of soil cover system

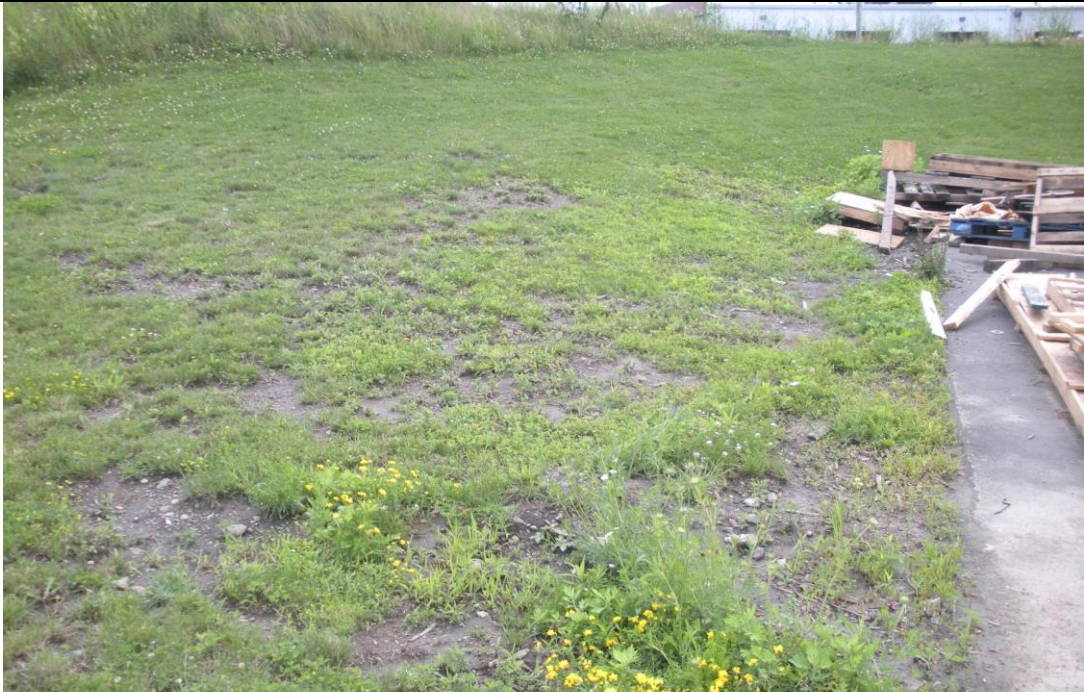
Project: Cobey Annual Inspection of Site Cover System		Location: Buffalo, New York	Project No. 6245-001
Photo No. 9	Date: 7-2-2009

Direction Photo Taken: Northeast			
Description: Soil erosion/grass removed from storage of wooden pallets and shipping containers. Bare areas of soil cover system in need of top soil and reseeded.

- Adding top soil and reseeding grass cover impacted at eastern edge of paved loading area where wooden pallets and shipping containers are stored, see photo #9.
- Adding top soil and reseeding grass cover in several areas due to poor quality topsoil conditions; see photos 6, 9, 13, and 14 in Appendix B.
- Backfill and reseed minor holes and rutted areas identified along south side of Cobey building and paved area along south side of east loading dock, see photos 10, 11, and 12.

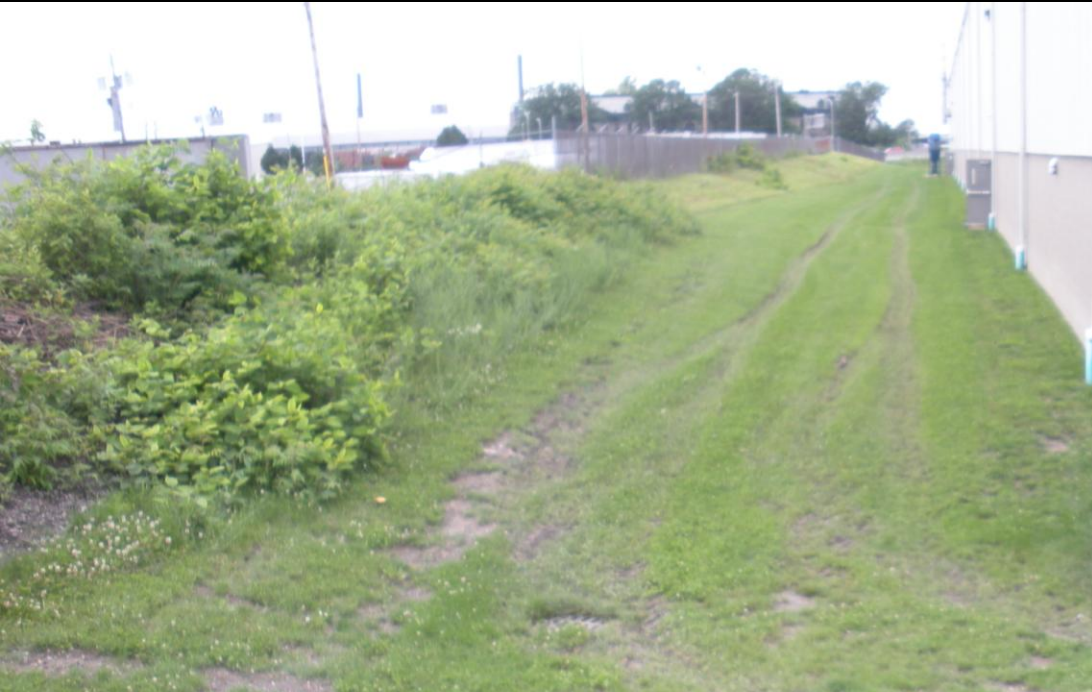
Project: Cobey Annual Inspection of Site Cover System		Location: Buffalo, New York	Project No. 6245-001
Photo No. 11	Date: 7-2-2009

⁽³⁾ Minor rutting and surface disturbance from heavy equipment driving along south side of building and snow removal activities along south side of east loading dock paved area. Recommend filling holes with top soil and seeding. See photos # 10, 11 and 12.

Direction Photo Taken: West			
Description: Tire ruts along south side of building.
