Re: Periodic Review Report
Cobey, LLC Site, BCP Site #C915202
Buffalo, New York

Periodic Review Report

Cobey, LLC Site

BCP Site #C915202

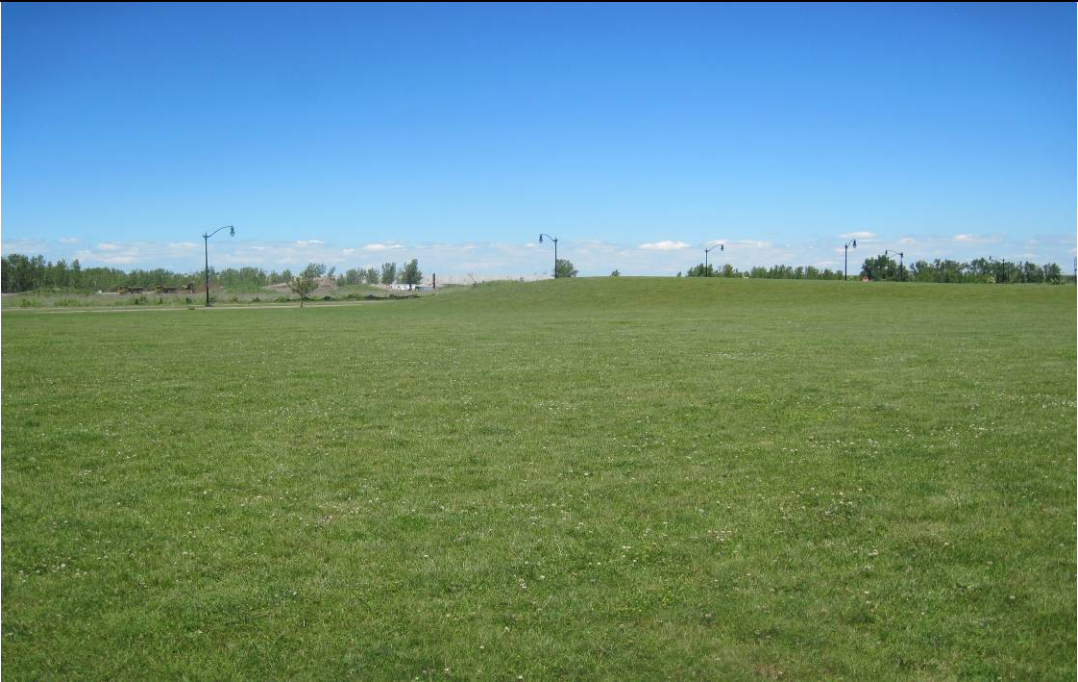
Project: Cobey Annual Inspection of Site Cover System		Location: Buffalo, New York	Project No. 6245-001
Photo No. 5	Date: 06-11-10

Direction Photo Taken: Northeast			
Description: Green space / soil cover system eastern portion of site.

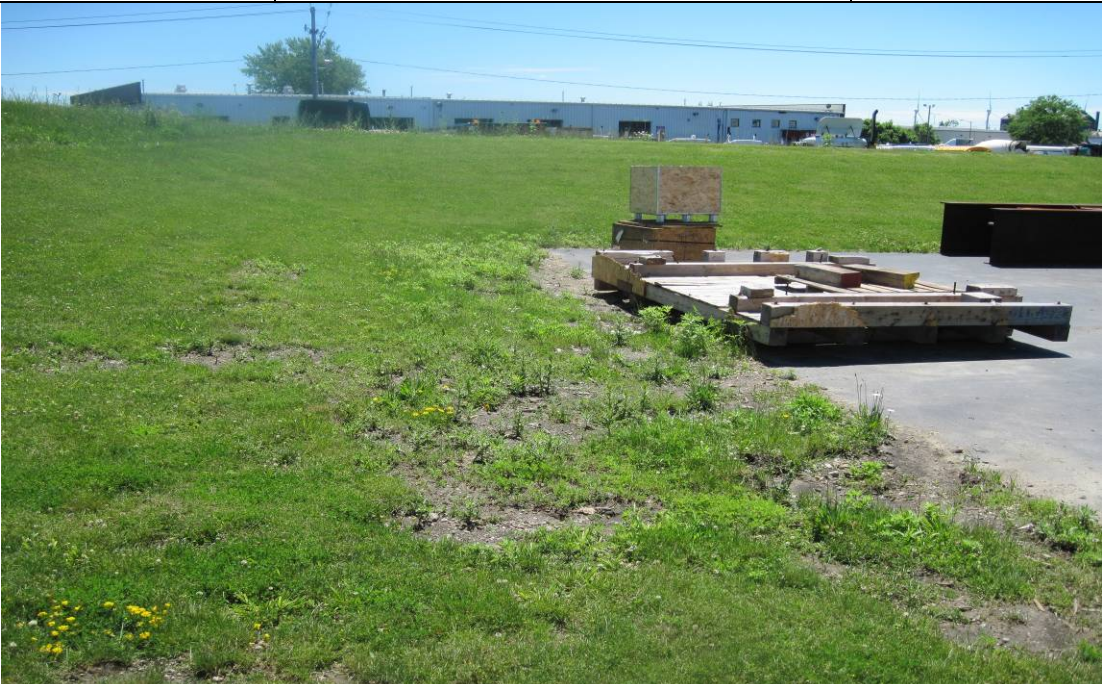
Project: Cobey Annual Inspection of Site Cover System		Location: Buffalo, New York	Project No. 6245-001
Photo No. 6	Date: 06-11-10

Direction Photo Taken: South			
Description: Area previously noted as having poor vegetative cover, vegetative cover showing improvement since 2009.

- Enhancement of the top soil and reseeded with grass at eastern edge of paved loading area where wooden pallets and shipping containers were previously stored, see photo #6.
- Enhancement of the top soil and reseeded with grass at several areas due to poor quality topsoil conditions; see photos 2, 3, 4, 6, 10, and 12 in Appendix B.

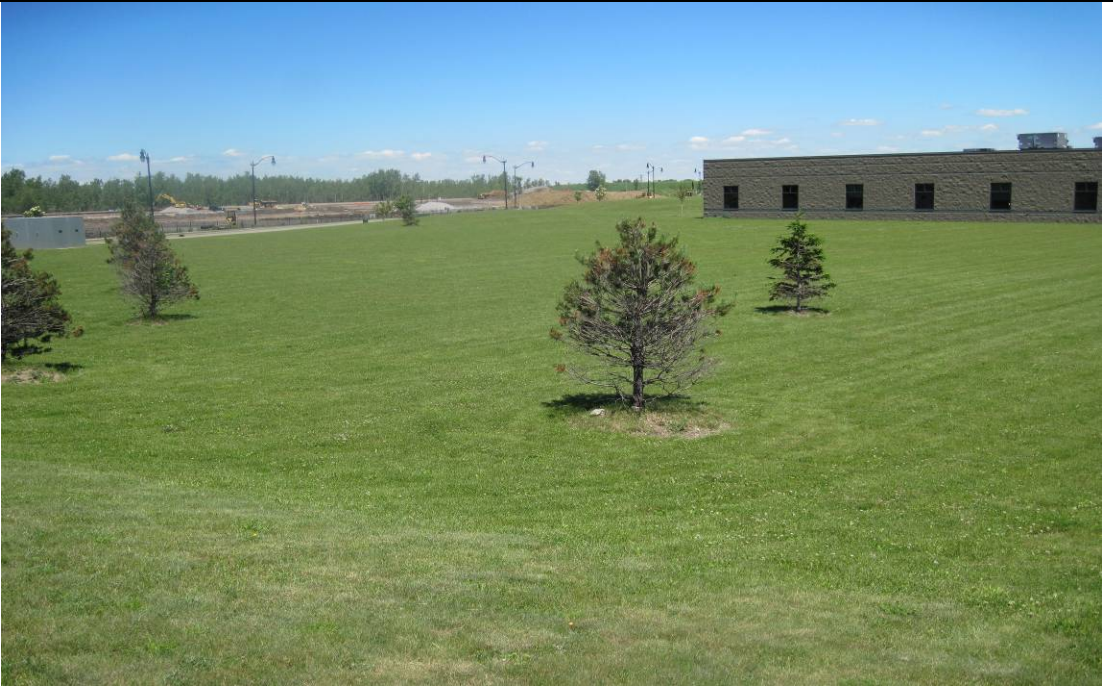
Project: Cobey Annual Inspection of Site Cover System		Location: Buffalo, New York	Project No. 6245-001
Photo No. 11	Date: 06-11-10

Direction Photo Taken: East			
Description: Soil cover system west of building.
