Periodic Review Report

**Cobey, LLC Site
Buffalo, New York
BCP Site #C915202**

September 2011

SITE COVER SYSTEM
2011 INSPECTION PHOTOS

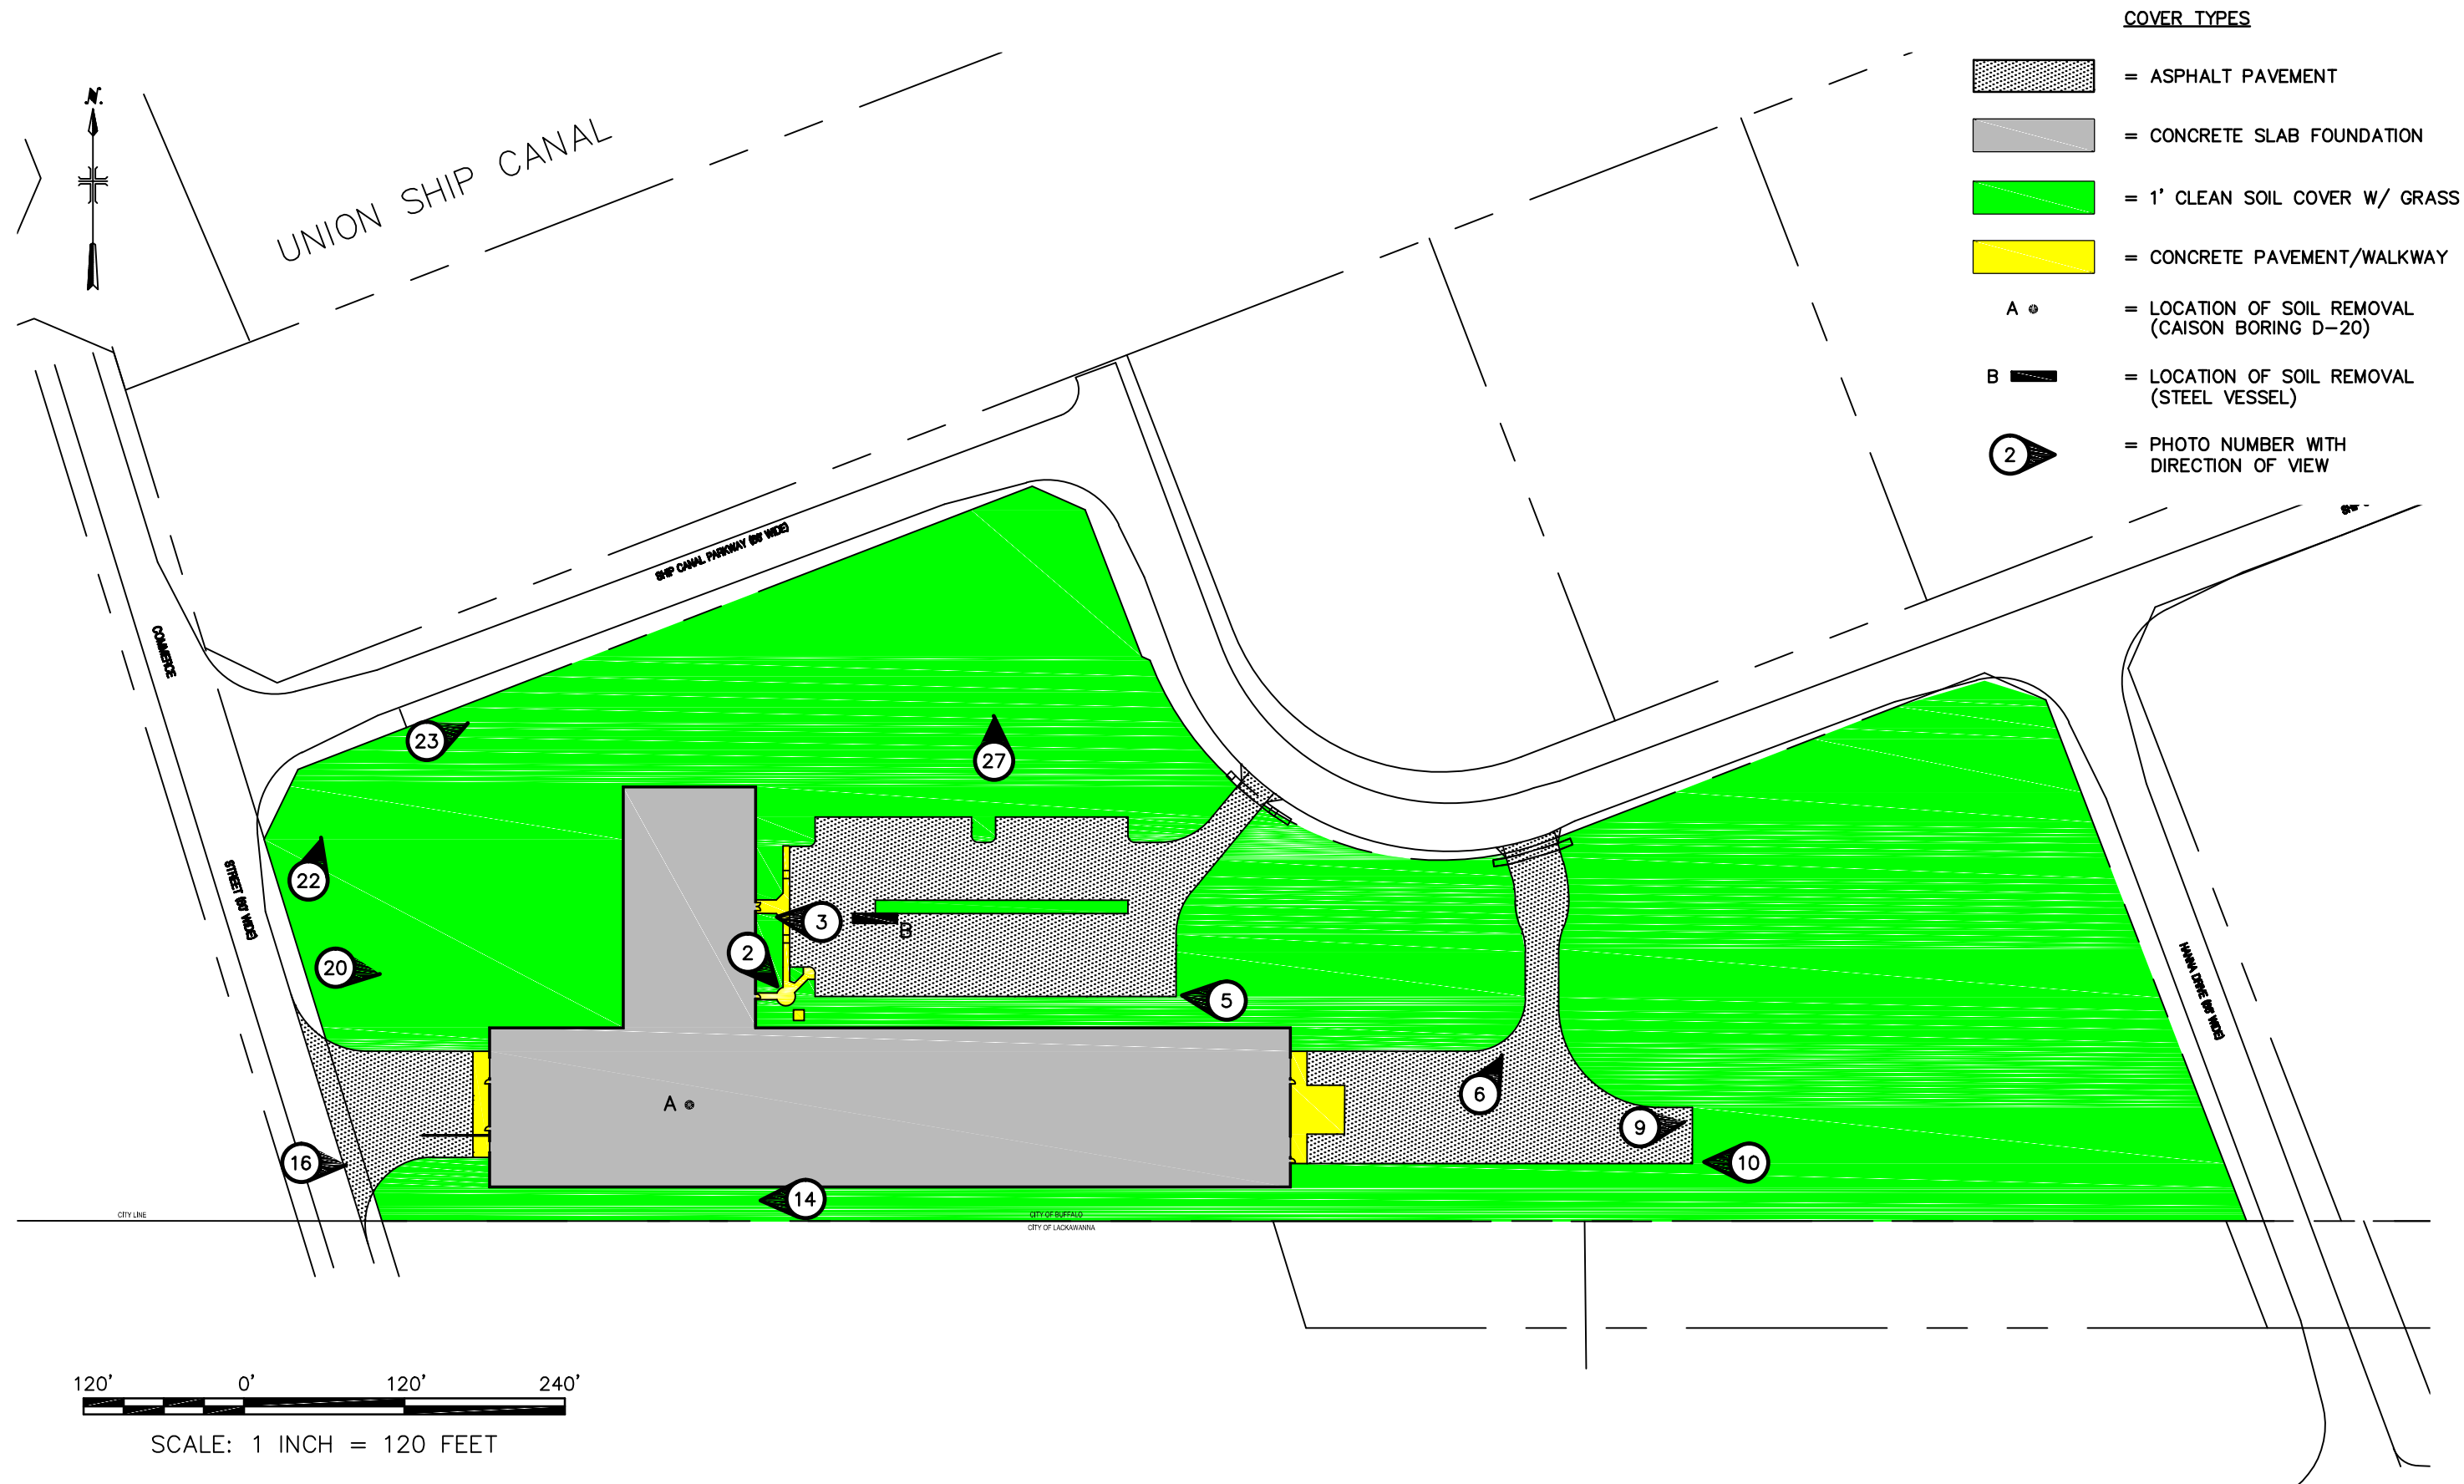
ARCADIS
AUGUST 2011
FIGURE 3

The cover system inspection indicates that the various cover system components are in-place and functioning as intended. A few areas of the existing soil cover system require minor action to prevent the functionality and effectiveness of the cover system from being compromised over time. Based on the results of this annual periodic inspection, as well as the preceding three annual inspections which confirm a cover system in good condition that is well maintained, a change in the frequency of inspection and PRR submittals is recommended. A tri-annual inspection period is recommended. As provided in the Site Management Plan, the Site owner is obligated to comply with the Soil/Fill Management Plan, the Operation, Monitoring, and Maintenance Work Plan, and the Environmental Easement.

- Placing a permanent barrier at the pavement edge along the turn of the main entrance to prevent vehicles from driving off paved surfaces and causing damage to vegetative cover.
- Removal of wooden pallets and other debris from the grass followed by enhancement of the top soil and reseeded this area at the southern edge of the eastern paved loading area, see photo #10.
- Enhancement of the top soil and reseeded with grass at the few remaining areas north and northwest of the office building due to poor quality topsoil conditions; see photo 022 in Appendix B.
