Subject:
Period Review Report
Cobey, Inc. Site, BCP Site #C915202
Buffalo, New York

Periodic Review Report

Cobey, Inc. Site
Buffalo, New York
BCP Site #C915202

ENVIRONMENTAL INSPECTION FORM

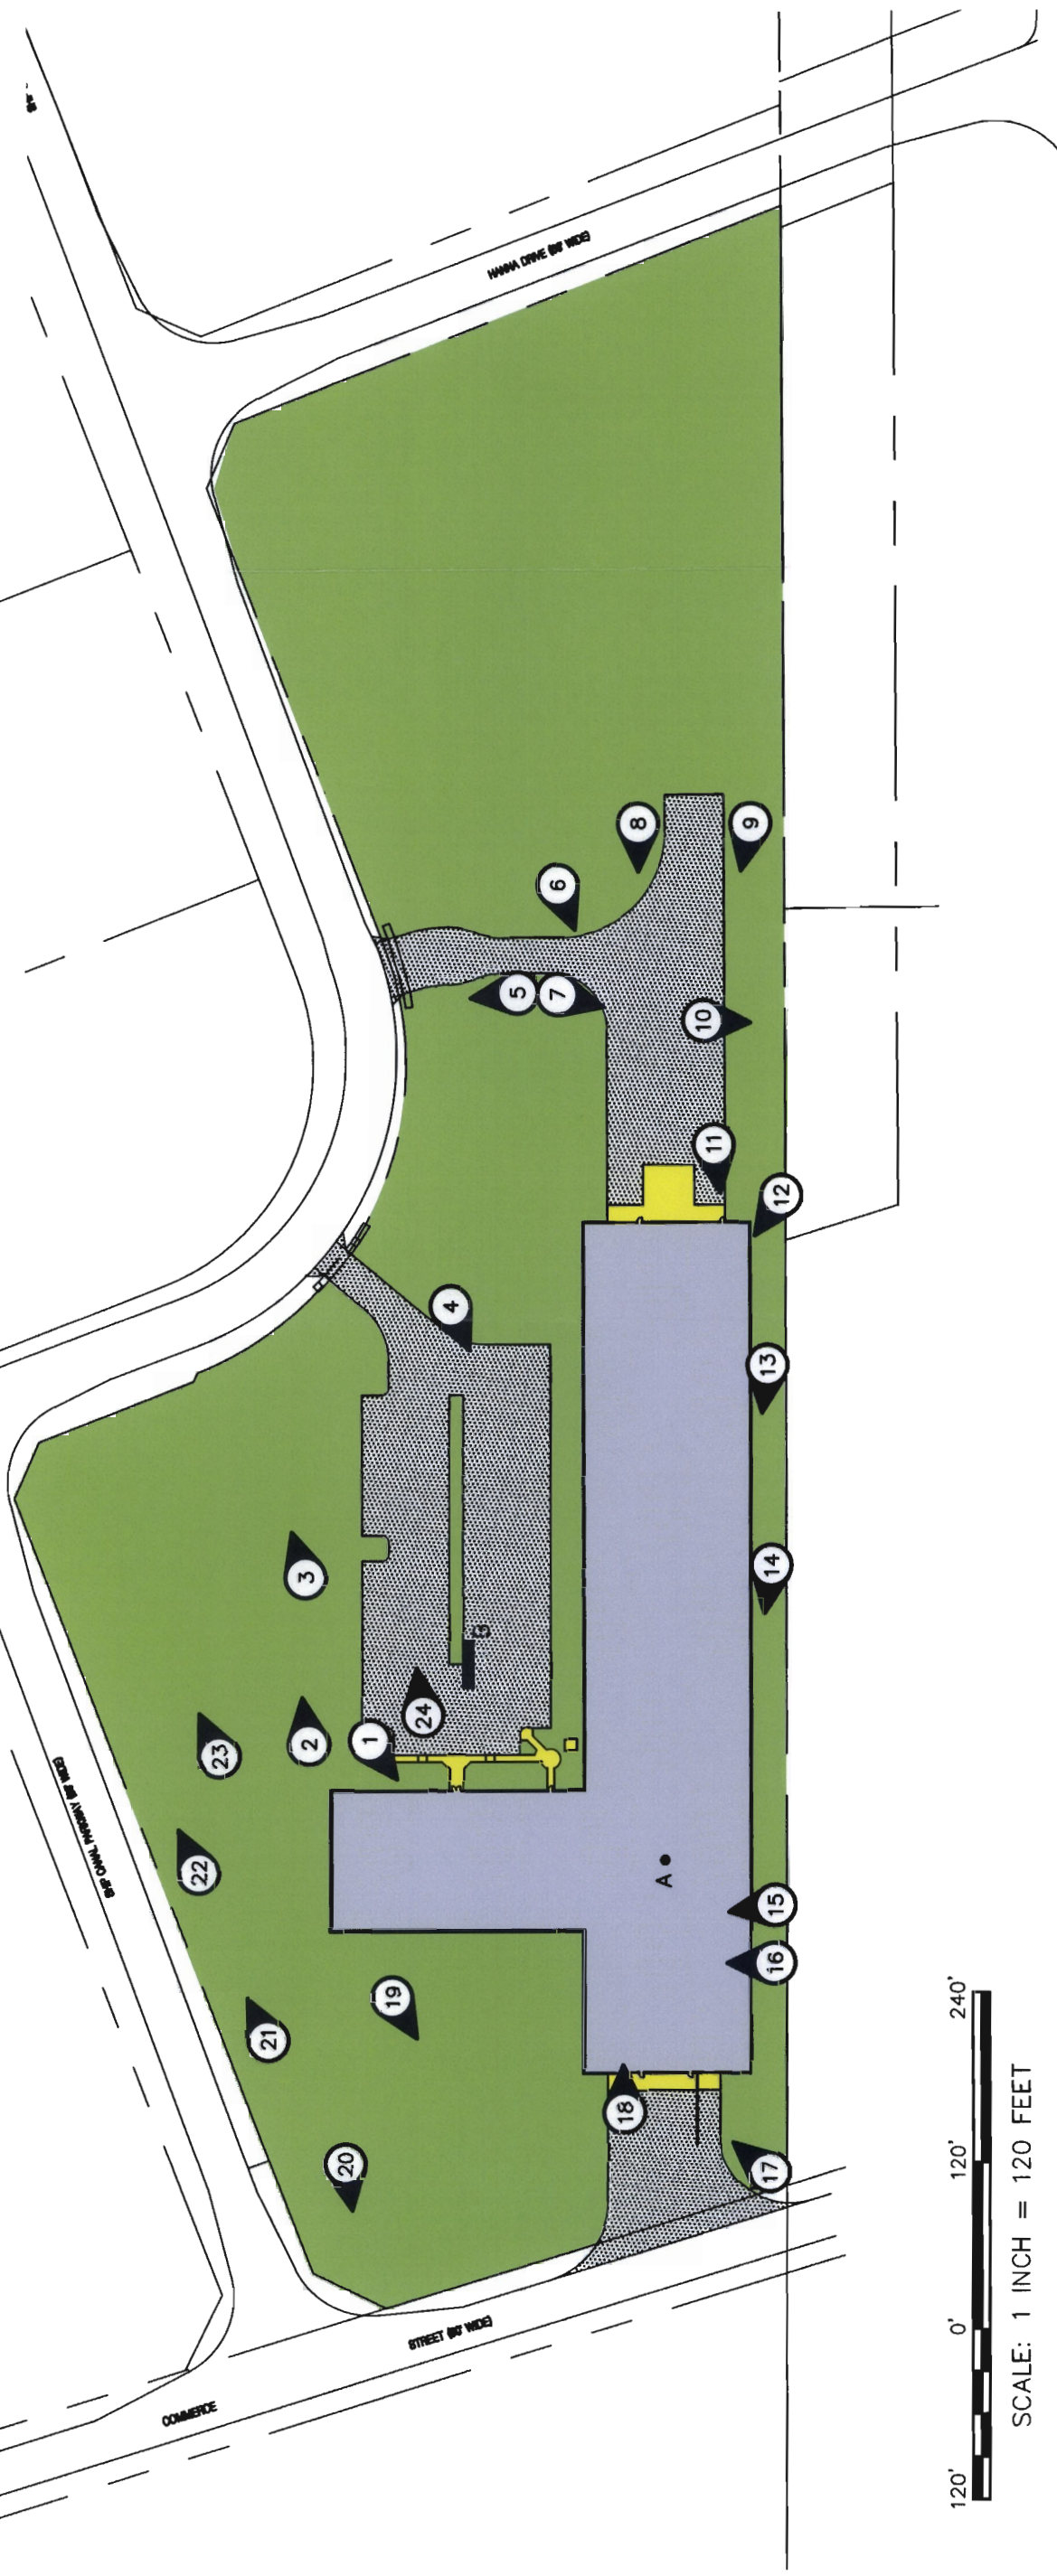
FIGURE 3

During advancement of the Cobey building foundation footers using a caisson drill, oily soil/fill material was observed at one of the caisson borings identified as location D-20. The impacted soil/fill was stockpiled, characterized, and disposed of offsite with NYSDEC approval at a permitted landfill. The location of where the impacted soil/fill was encountered is illustrated as point A on Figure 3.

was approximately 51 tons. Figure 3 illustrates the approximate location from where the vessel and related impacted soil/fill were removed. A combined total of 67.68 tons of impacted soil were removed and disposed off-Site at a permitted landfill. The removal work was completed with NYSDEC oversight and approval.

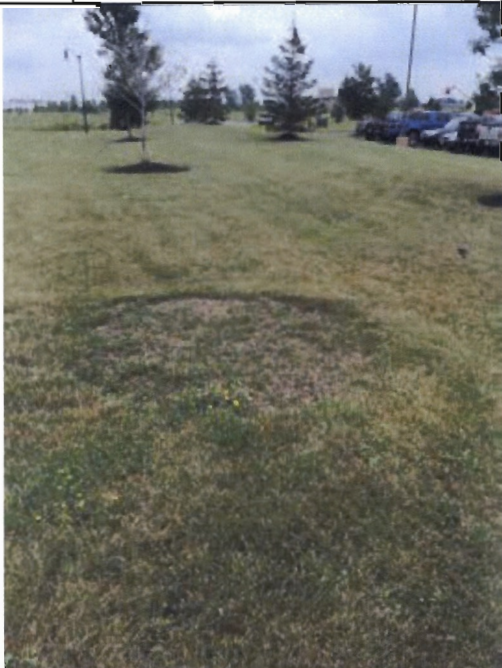
Project: Cobey, Inc. Site – Tri-Annual Site Cover System Inspection		Location: Buffalo, New York	Project No. 06245001.0001
Photo No. 003	Date: 07-14-14

Direction Photo Taken: East			
Description: One of three area of incomplete grass cover due to high stone content soil north of main parking lot.

- Providing additional pavement or placing a permanent barrier at the pavement edge along the turn of the entrance to the east loading dock to prevent vehicles from driving off paved surfaces and causing damage to vegetative cover. Refer to photo nos. 005 through 007 in Appendix B.
- Removing equipment and other debris from the grass adjacent to the east loading dock area followed by enhancement of the top soil and lawn re-seeding of the southern edge of the east loading dock paved area. Refer to photo nos. 009 and 010 in Appendix B.
- Enhancing the top soil and lawn re-seeding at the few areas along the south edge of the building and north areas of the main parking lot due to poor quality topsoil conditions. Refer to photo nos. 003, 012, 013, 015, and 016 in Appendix B.

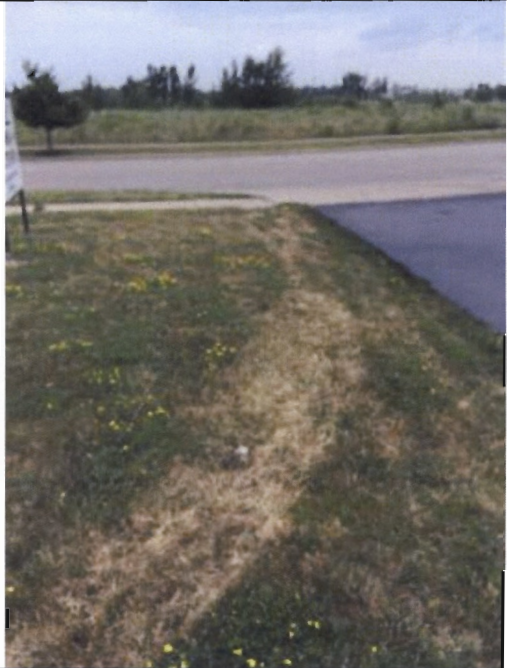
Project: Cobey, Inc. Site – Tri-Annual Site Cover System Inspection		Location: Buffalo, New York	Project No. 06245001.0001
Photo No. 005	Date: 07-14-14

- (1) Minor erosion/rutting from vehicles cutting corners of pavement. Refer to photo nos. 005 through 007. AUS recommended to Cobey to provide new paving or place a large boulder/barrier at the pavement edge of this turn to prevent vehicles from driving off of paved surfaces and prevent possible cover damage.
- (2) There are a few bare/sparse areas of grass cover due to poor topsoil conditions. Refer to various photos. AUS recommended to Cobey to provide quality top soil and lawn seeding in these areas.

Direction Photo Taken: North			
Description: Damaged grass cover from traffic cutting corner at east loading dock entrance.

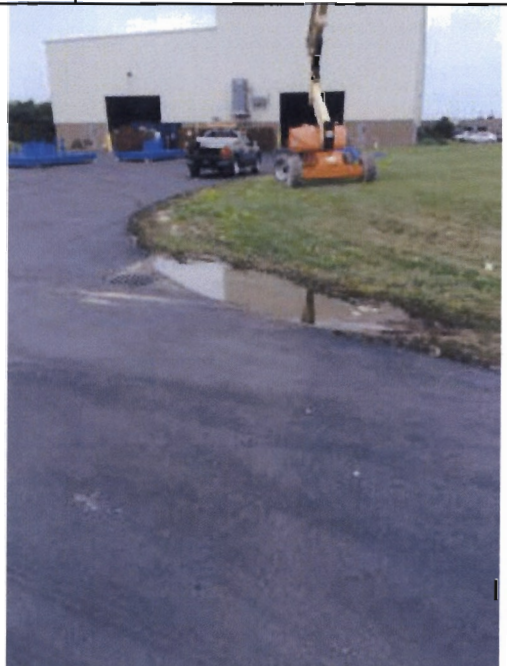
Project: Cobey, Inc. Site – Tri-Annual Site Cover System Inspection		Location: Buffalo, New York	Project No. 06245001.0001
Photo No. 006	Date: 07-14-14

Direction Photo Taken: West			
Description: Damaged grass cover from traffic cutting corner at east loading dock.

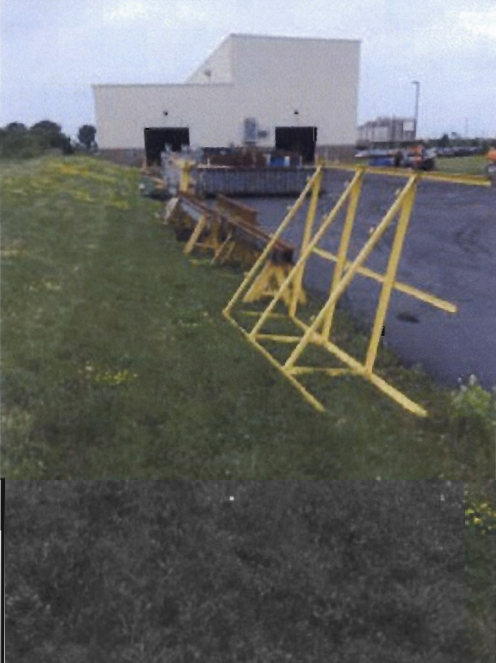
Project: Cobey, Inc. Site – Tri-Annual Site Cover System Inspection		Location: Buffalo, New York	Project No. 06245001.0001
Photo No. 009	Date: 07-14-14

Direction Photo Taken: West			
Description: Grass cover impacted by equipment and debris at east loading dock.

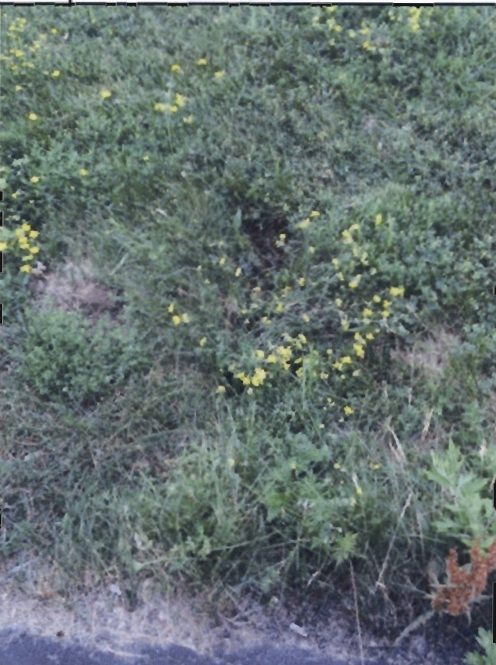
Project: Cobey, Inc. Site – Tri-Annual Site Cover System Inspection		Location: Buffalo, New York	Project No. 06245001.0001
Photo No. 010	Date: 07-14-14

Direction Photo Taken: South			
Description: Small rut off paved area to the south of the east loading dock.

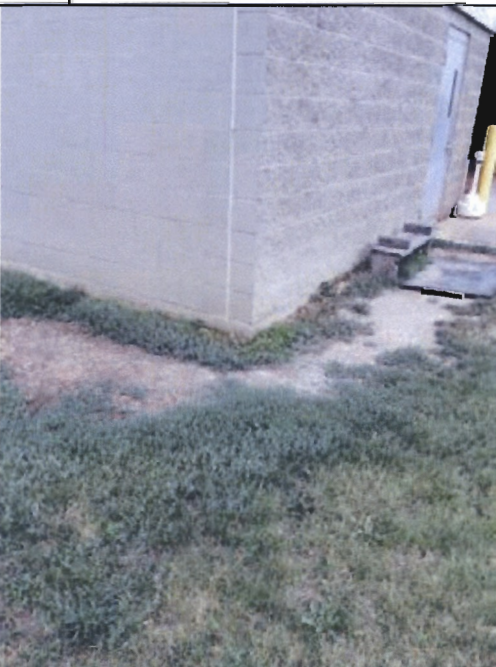
Project: Cobey, Inc. Site – Tri-Annual Site Cover System Inspection		Location: Buffalo, New York	Project No. 06245001.0001
Photo No. 012	Date: 07-14-14

Direction Photo Taken: Northwest			
Description: Bare/sparse grass cover at the southeast corner of the building.

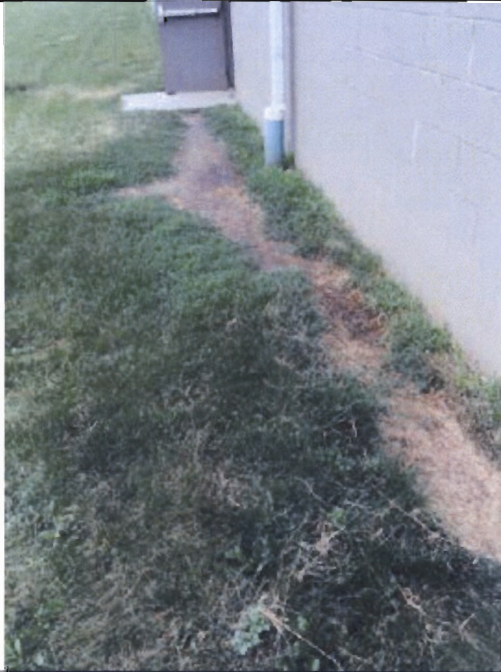
Project: Cobey, Inc. Site – Tri-Annual Site Cover System Inspection		Location: Buffalo, New York	Project No. 06245001.0001
Photo No. 013	Date: 07-14-14

Direction Photo Taken: West			
Description: Bare/sparse grass cover along the south edge of the building.

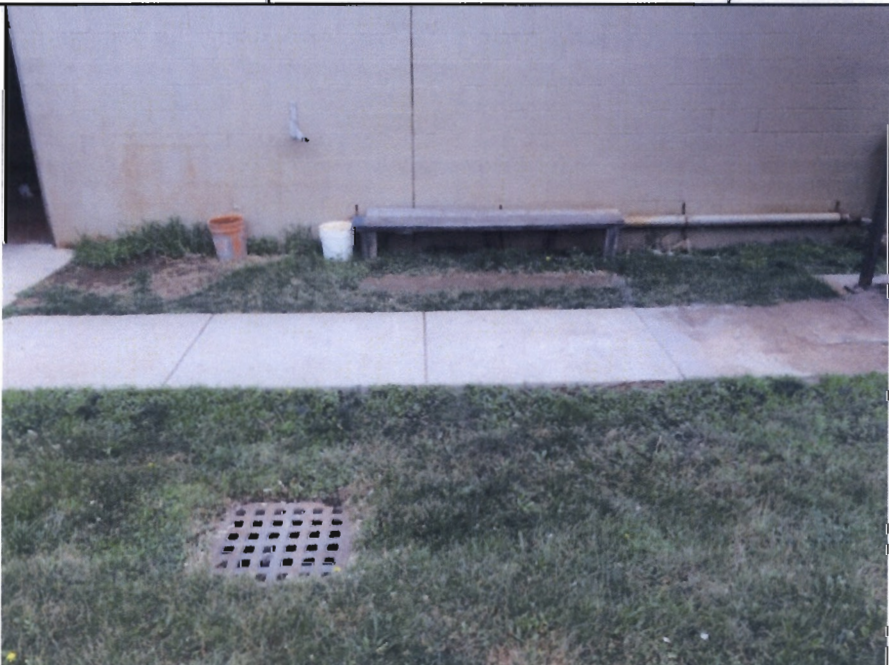
Project: Cobey, Inc. Site – Tri-Annual Site Cover System Inspection		Location: Buffalo, New York	Project No. 06245001.0001
Photo No. 016	Date: 07-14-14

Direction Photo Taken: North			
Description: Bare/sparse grass cover along the south edge of the building.
