Subject:  
Periodic Review Report  
Cobey, Inc. Site, BCP Site #C915202  
Buffalo, New York

## PERIODIC REVIEW REPORT

Cobey, Inc. Site  
Buffalo, New York  
BCP Site #C915202

June 20, 2017

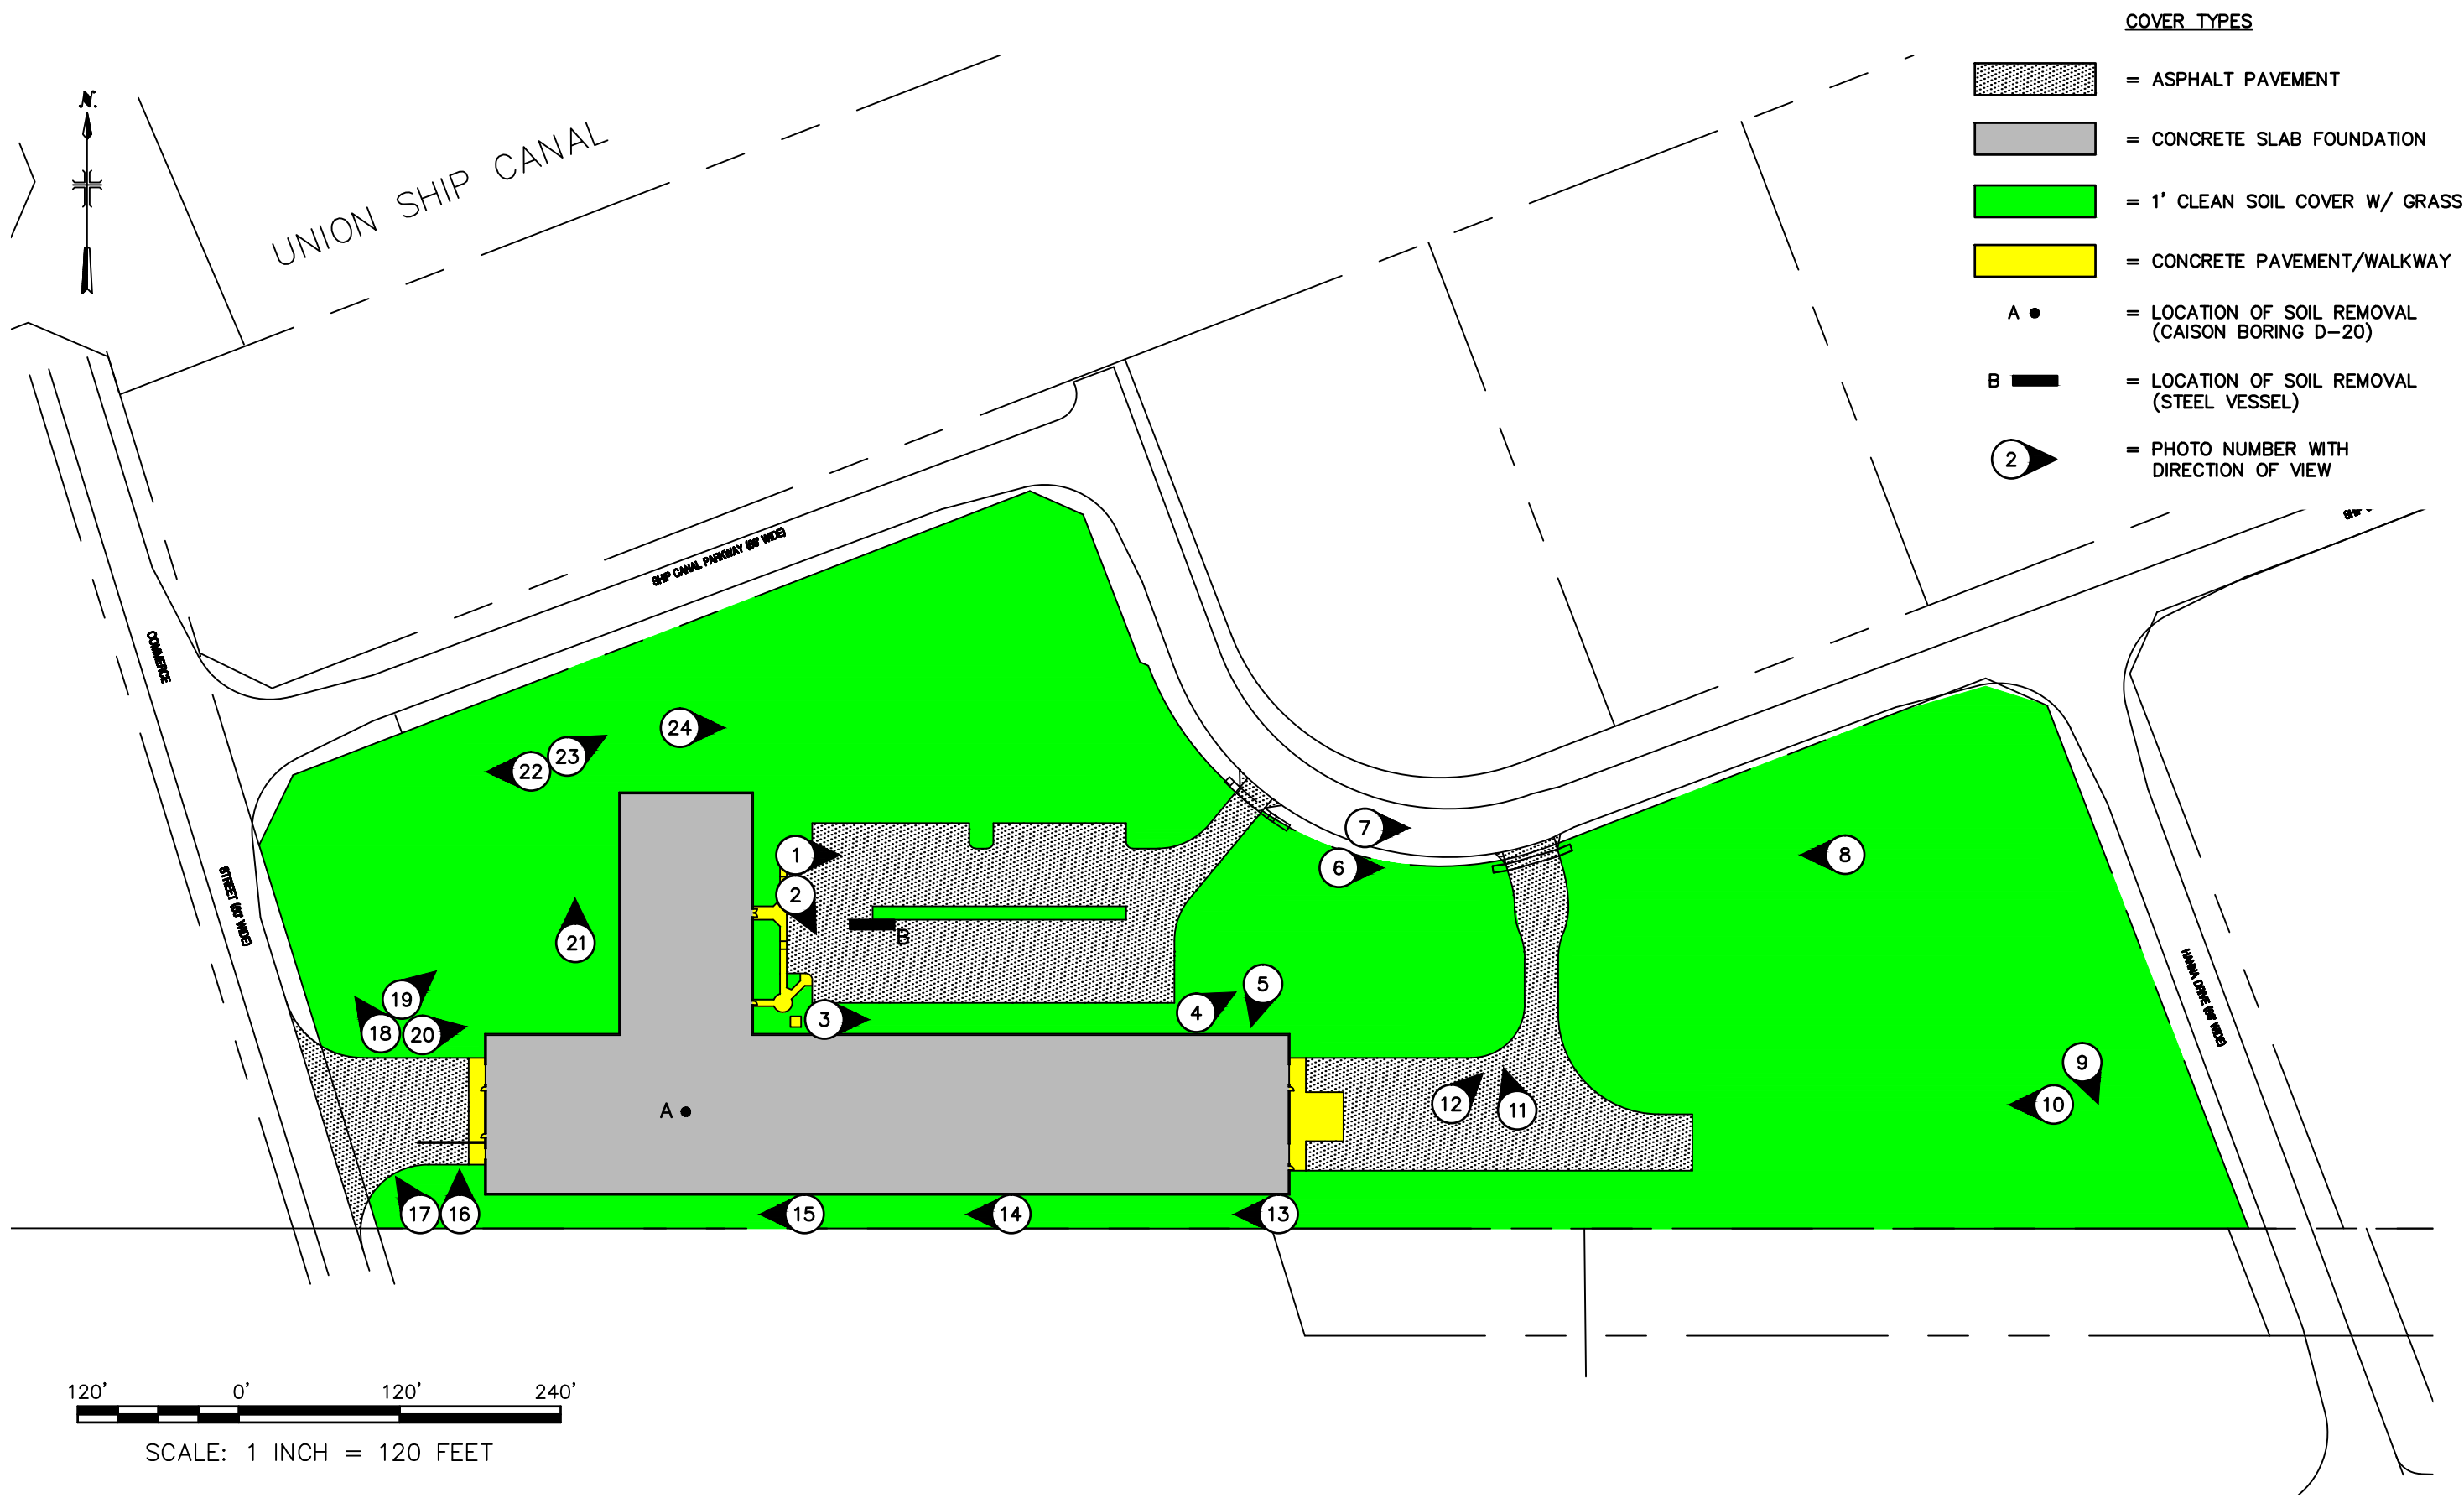
SITE COVER SYSTEM  
2017 INSPECTION PHOTOS

During advancement of the Cobey building foundation footers using a caisson drill, oily soil/fill material was observed at one of the caisson borings identified as location D-20. The impacted soil/fill was stockpiled, characterized, and disposed of offsite with DEC approval at a permitted landfill. The location of where the impacted soil/fill was encountered is illustrated as point A on Figure 3.

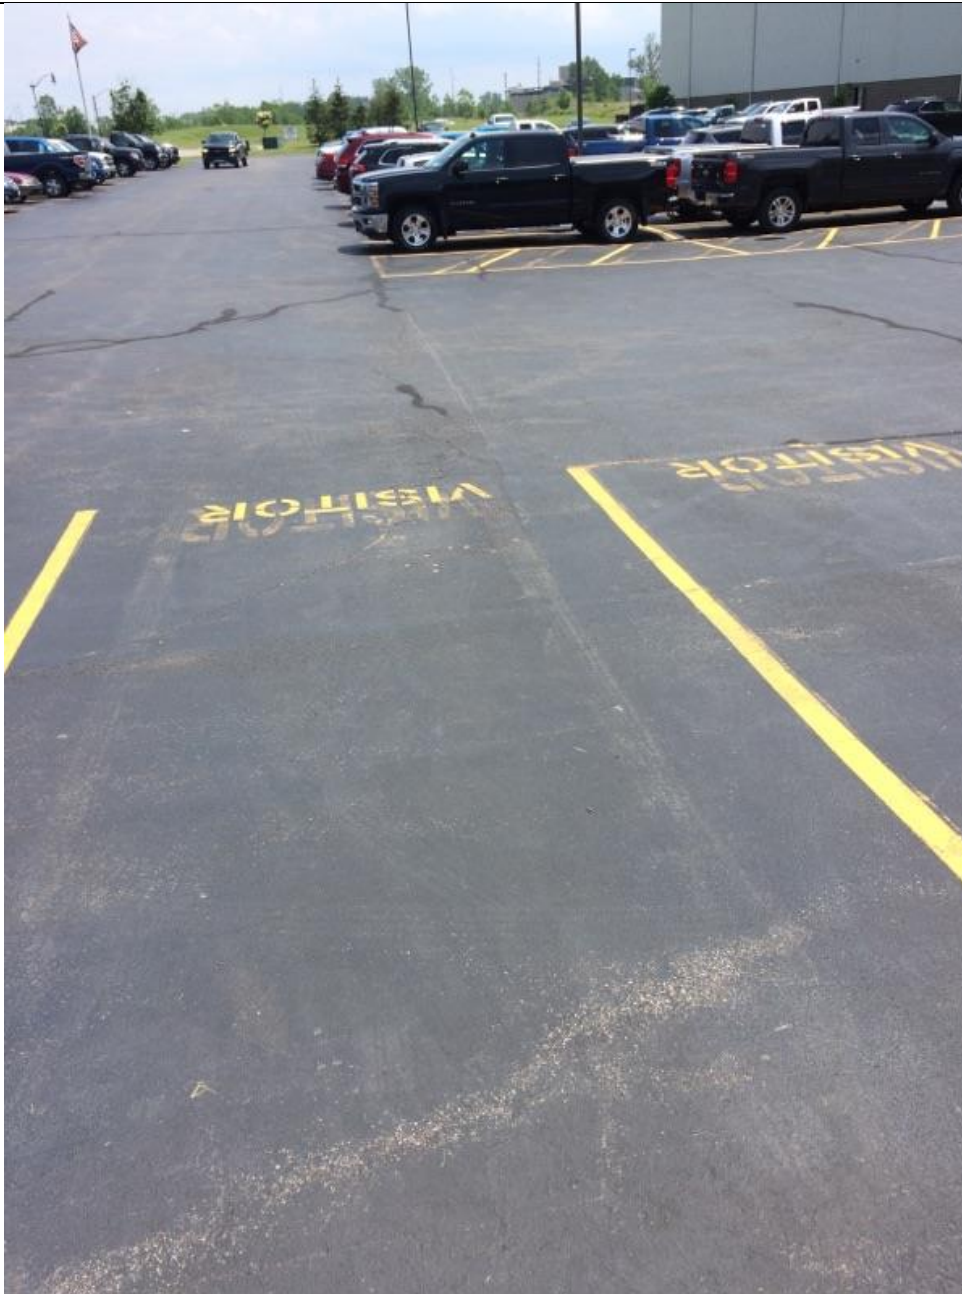
### Photograph: 1

Asphalt pavement in main parking lot.

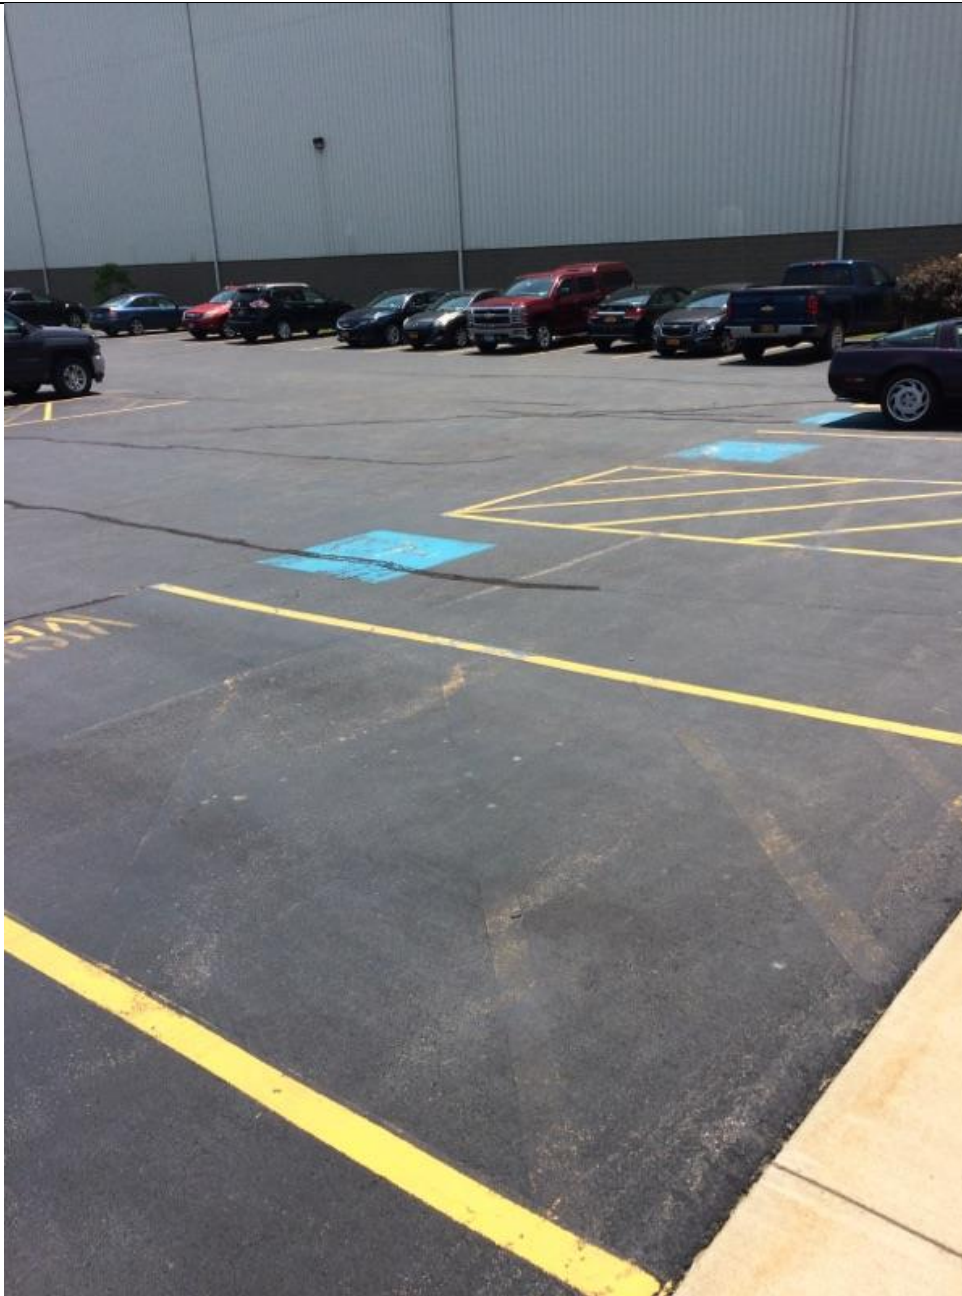
### Photograph: 2

Asphalt pavement in main parking lot.

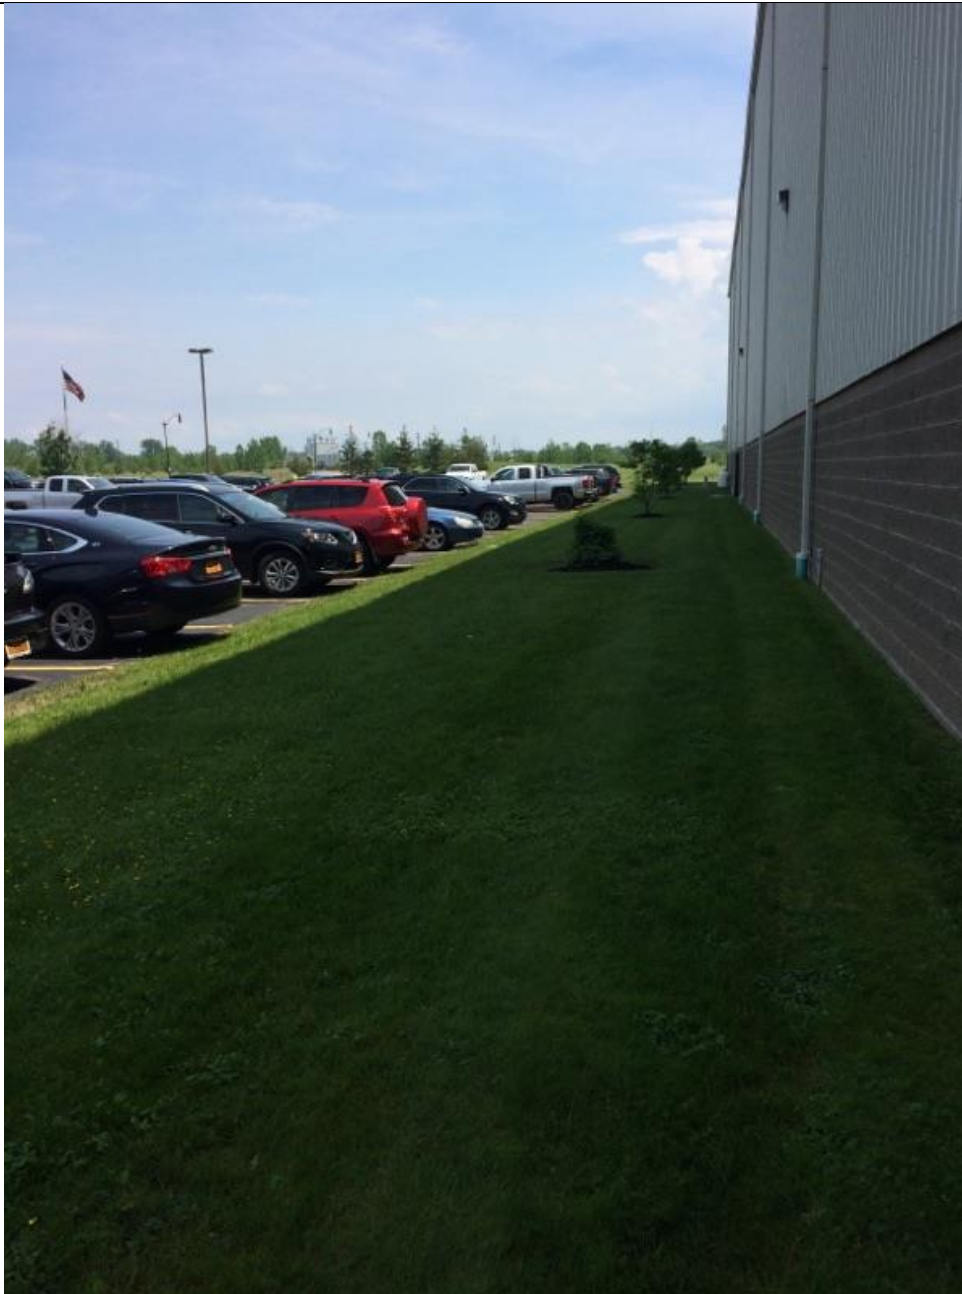
### Photograph: 3

Grass cover south of main parking lot, along north side of building.

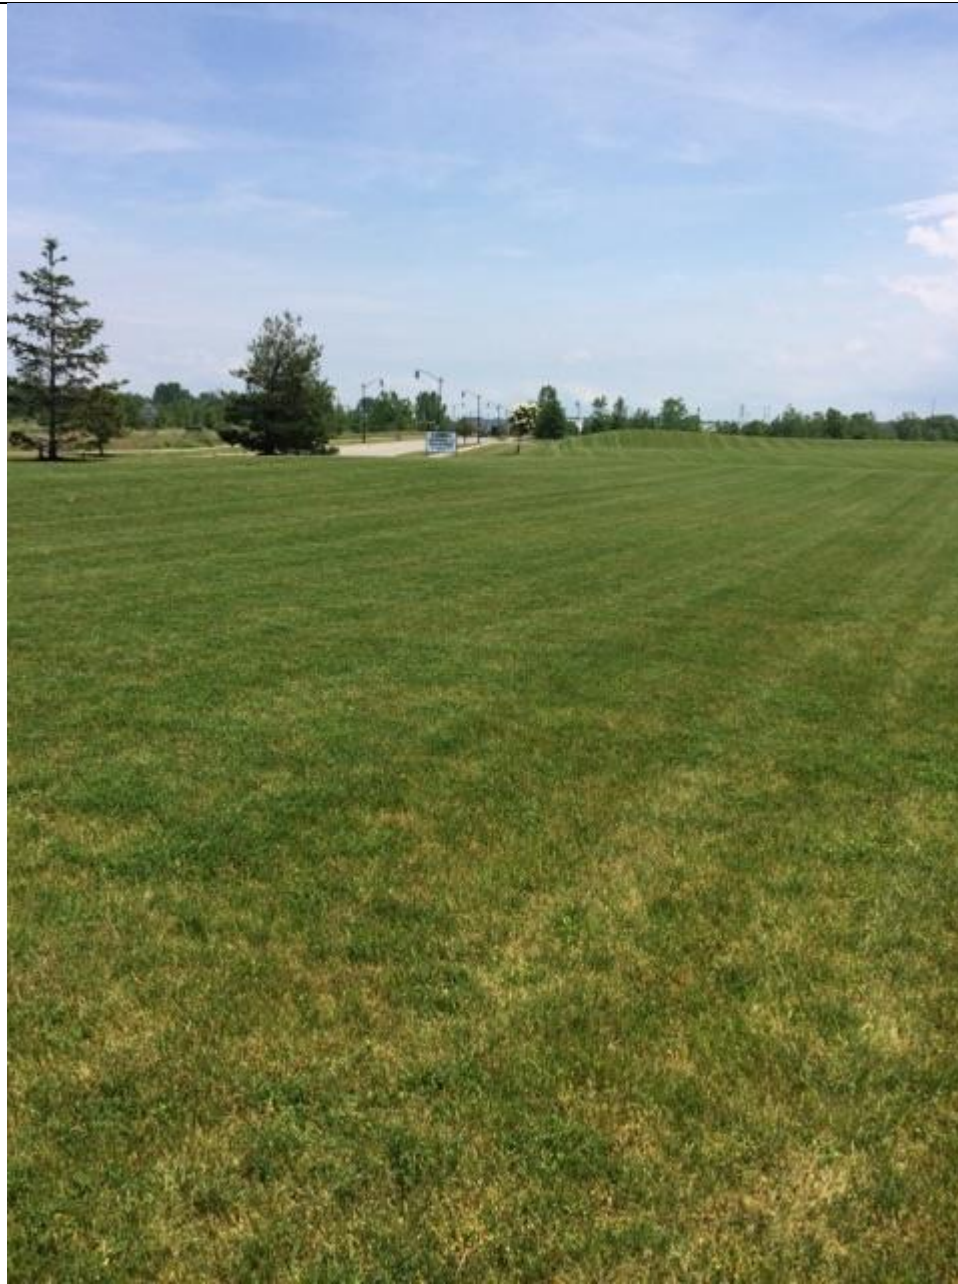
### **Photograph: 4**

Landscaped area to the east of main parking lot.

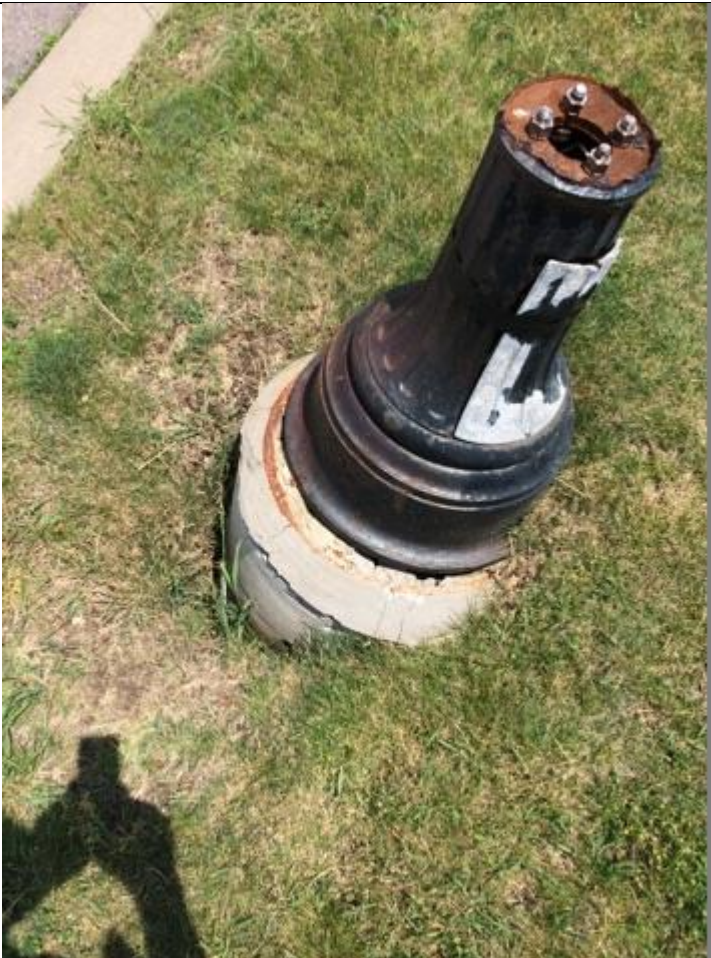
<p><b>Photograph: 6</b></p> <p><b>Description:</b> Broken light post located south of main parking lot entrance.</p> <p><b>Direction of photo:</b> East</p> <p><b>Photograph taken by:</b> J. Williams</p> <p><b>Date:</b> 6/15/2017</p>
--	--

- Request that the City of Buffalo repair/replace the damaged light pole along Ship Canal Parkway between the main Cobey parking lot entrance and the east loading dock entrance. It appears that the light pole was damaged, perhaps by vehicular traffic, and the concrete foundation of the light pole has been partially uprooted, exposing lower layers of fill. Refer to photo no. 6 in Appendix B.
- Repair damaged monitoring wells to the south of the main parking lot (photo no. 5 in Appendix B) and the west of the building (photo no. 21 of Appendix B).
- Providing additional pavement or placing a permanent barrier (e.g., boulder or bollard) at the pavement edge along the turn of the entrance to the east loading dock to prevent vehicles from driving off paved surfaces and causing damage to vegetative cover. Refer to photo nos. 11 and 12 in Appendix B.

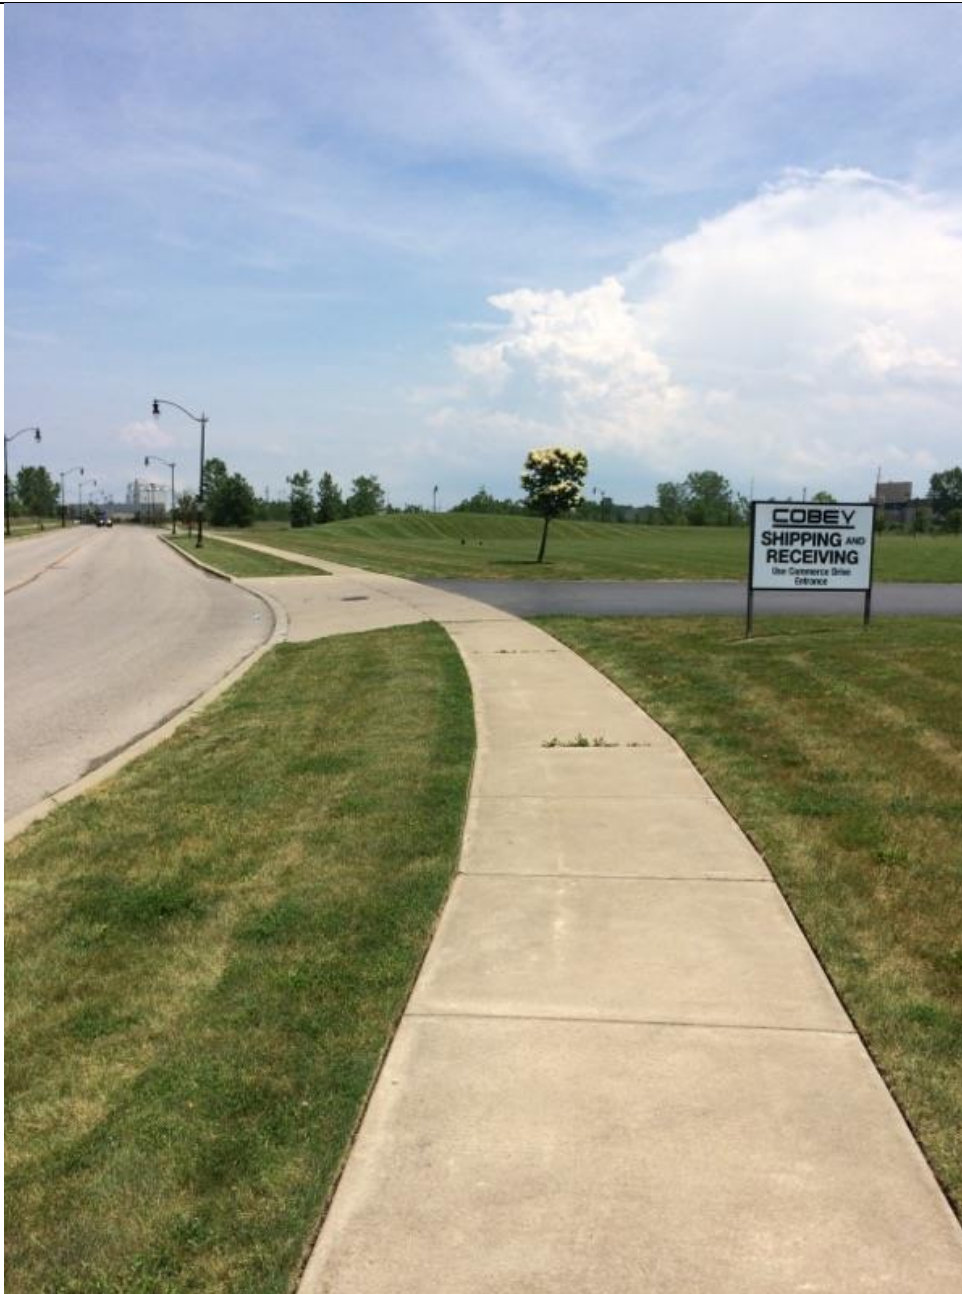
### Photograph: 7

Sidewalk and landscaped area adjacent to east loading dock entrance.

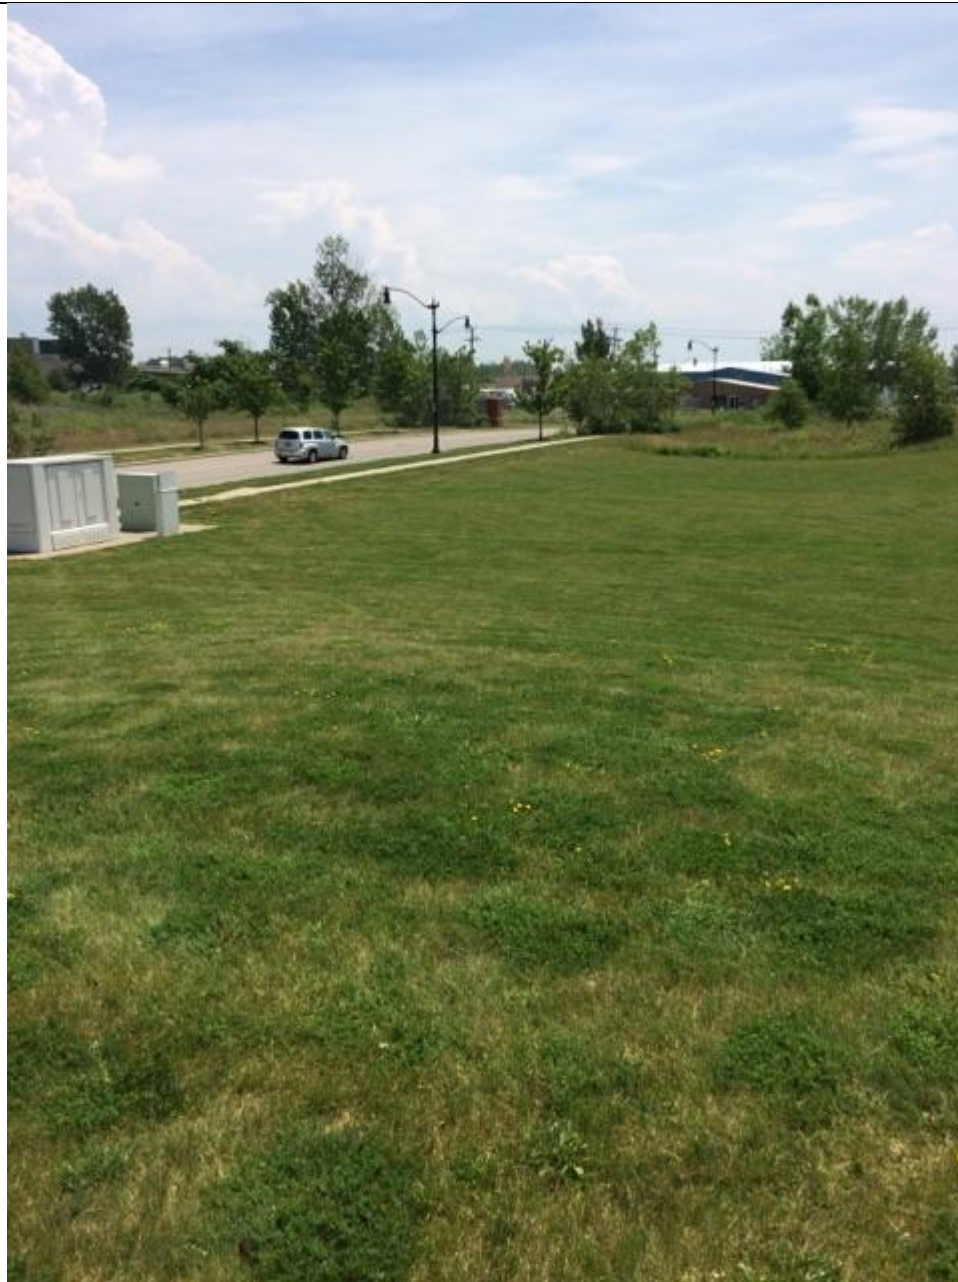
### **Photograph: 9**

Landscaped area along Hanna Drive on east side of Cobey site.

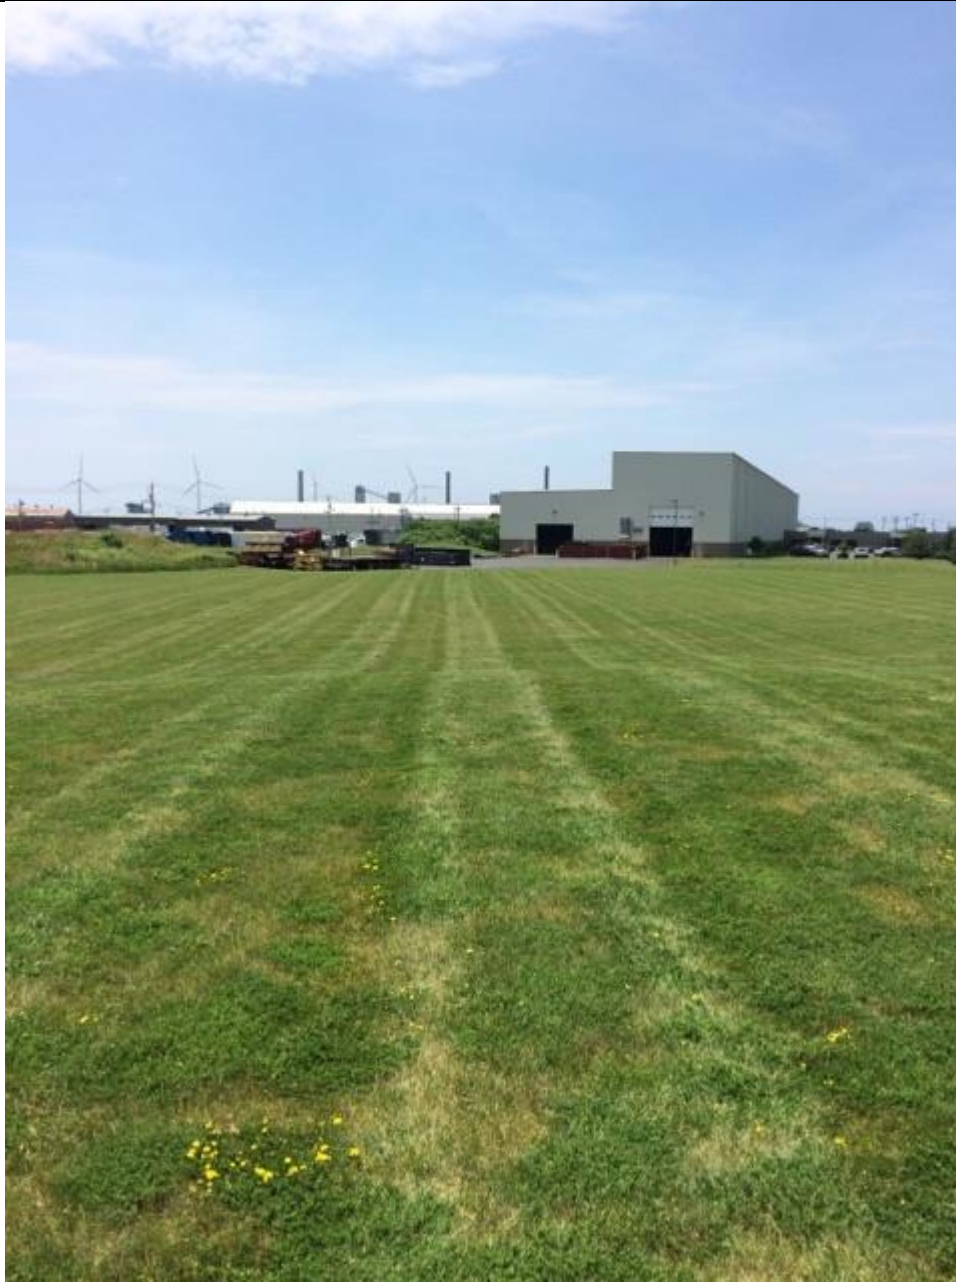
### **Photograph: 10**

Landscaped area on  
east side of Cobey site.

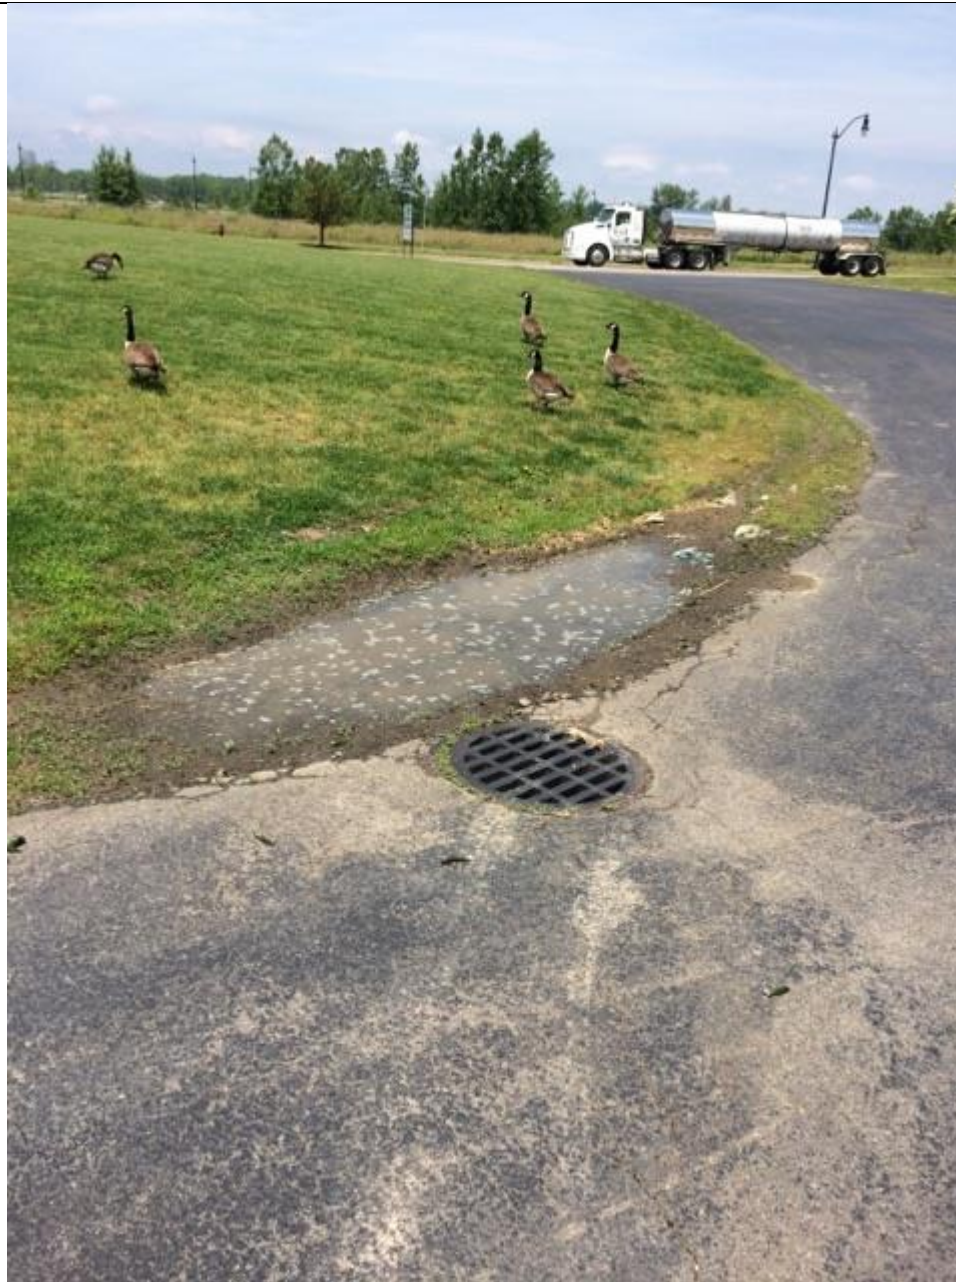
### Photograph: 11

Damaged grass cover  
from traffic cutting  
corner at east loading  
dock.

- (1) Minor erosion/rutting from vehicles cutting corners of pavement. Refer to photo nos. 11 and 12. Arcadis recommends that Cobey provide additional paving or place a large boulder/bollard at the pavement edge of this turn to prevent vehicles from driving off of paved surfaces to prevent cover damage.

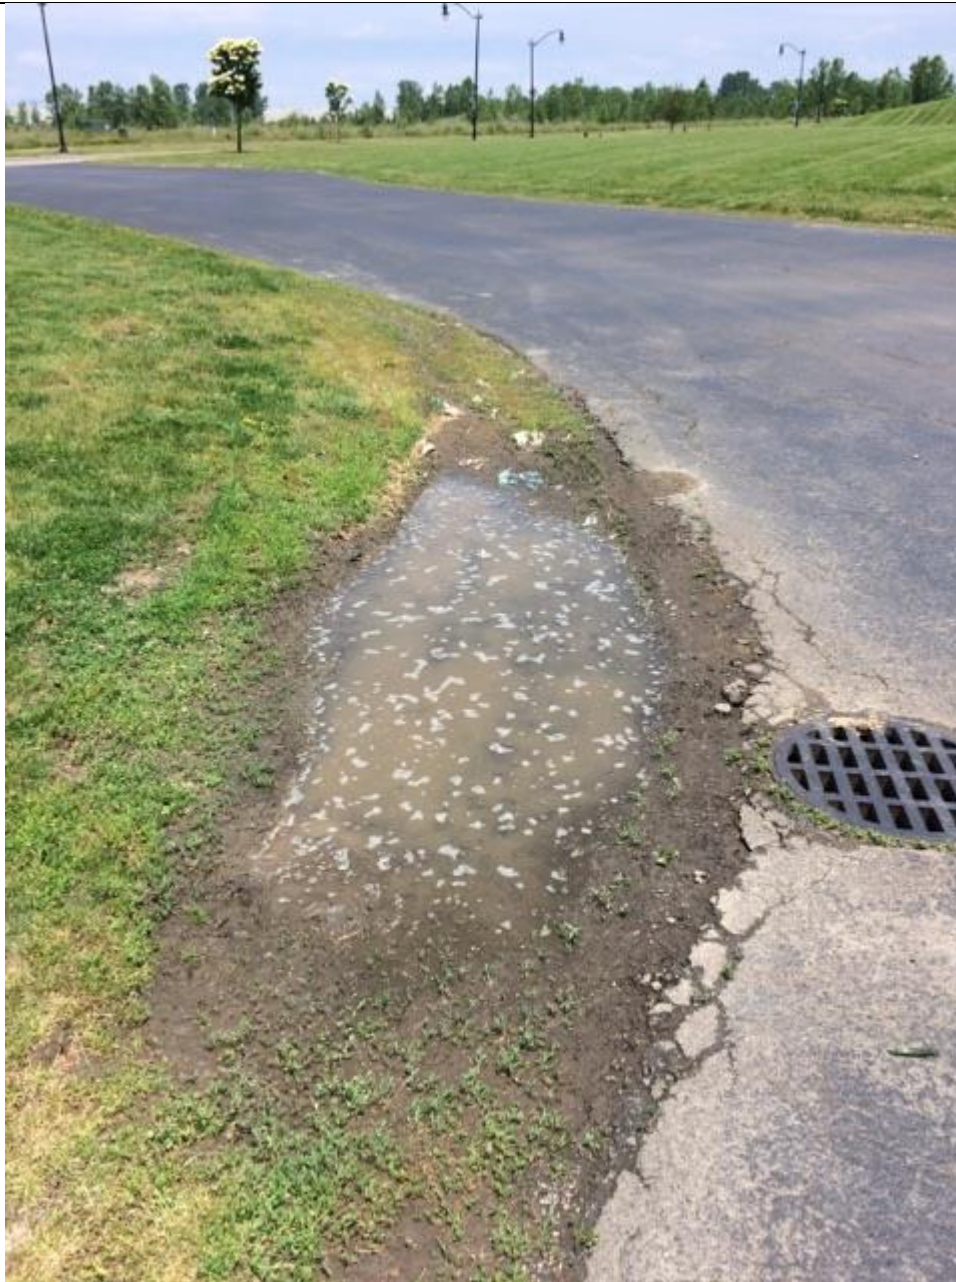
### Photograph: 12

Damaged grass cover  
from traffic cutting  
corner at east loading  
dock.

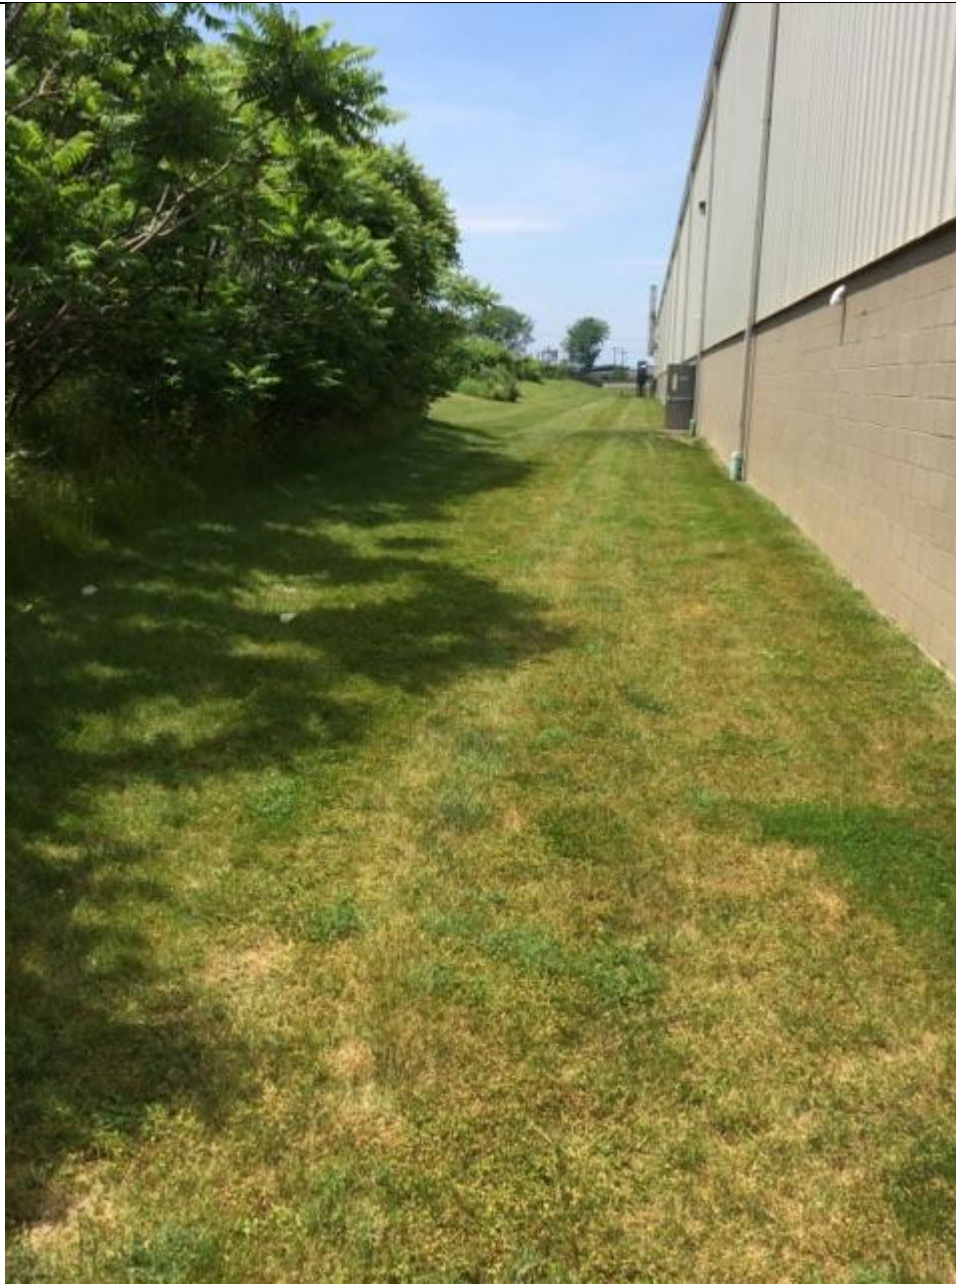
### Photograph: 13

Grass cover along south edge of the building.

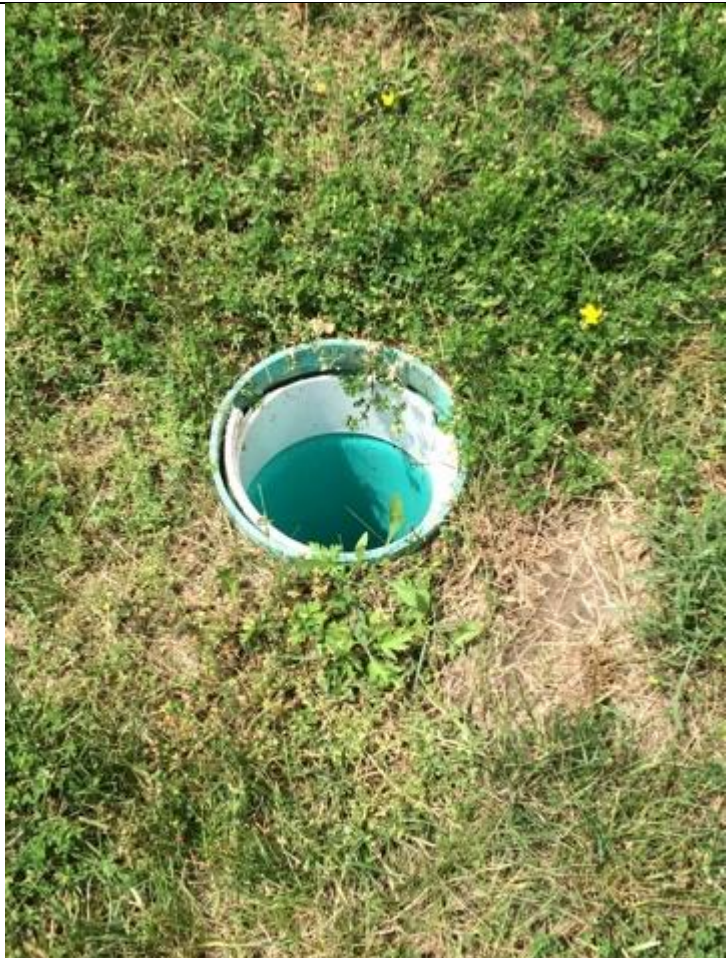
<p><b>Photograph: 15</b></p> <p><b>Description:</b> Uncapped storm drain cleanout.</p> <p><b>Direction of photo:</b> West</p> <p><b>Photograph taken by:</b> J. Williams</p> <p><b>Date:</b> 6/15/2017</p>
--	---	--

- Provide caps on the two cleanout drains on the storm sewer located to the south of the building. Refer to photo nos. 14 and 15 in Appendix B.

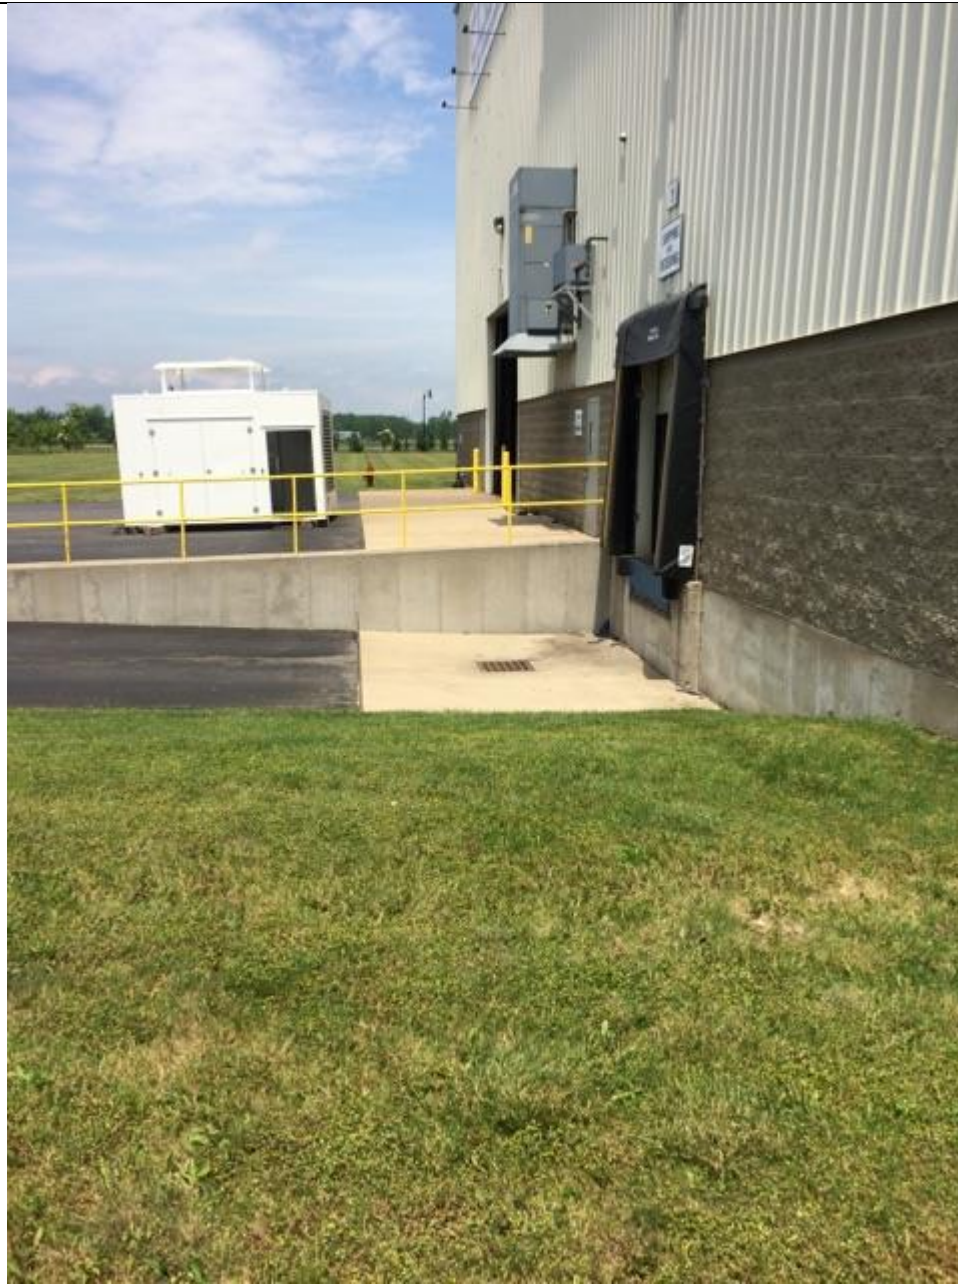
### Photograph: 16

Asphalt pavement and grass cover at west loading dock.

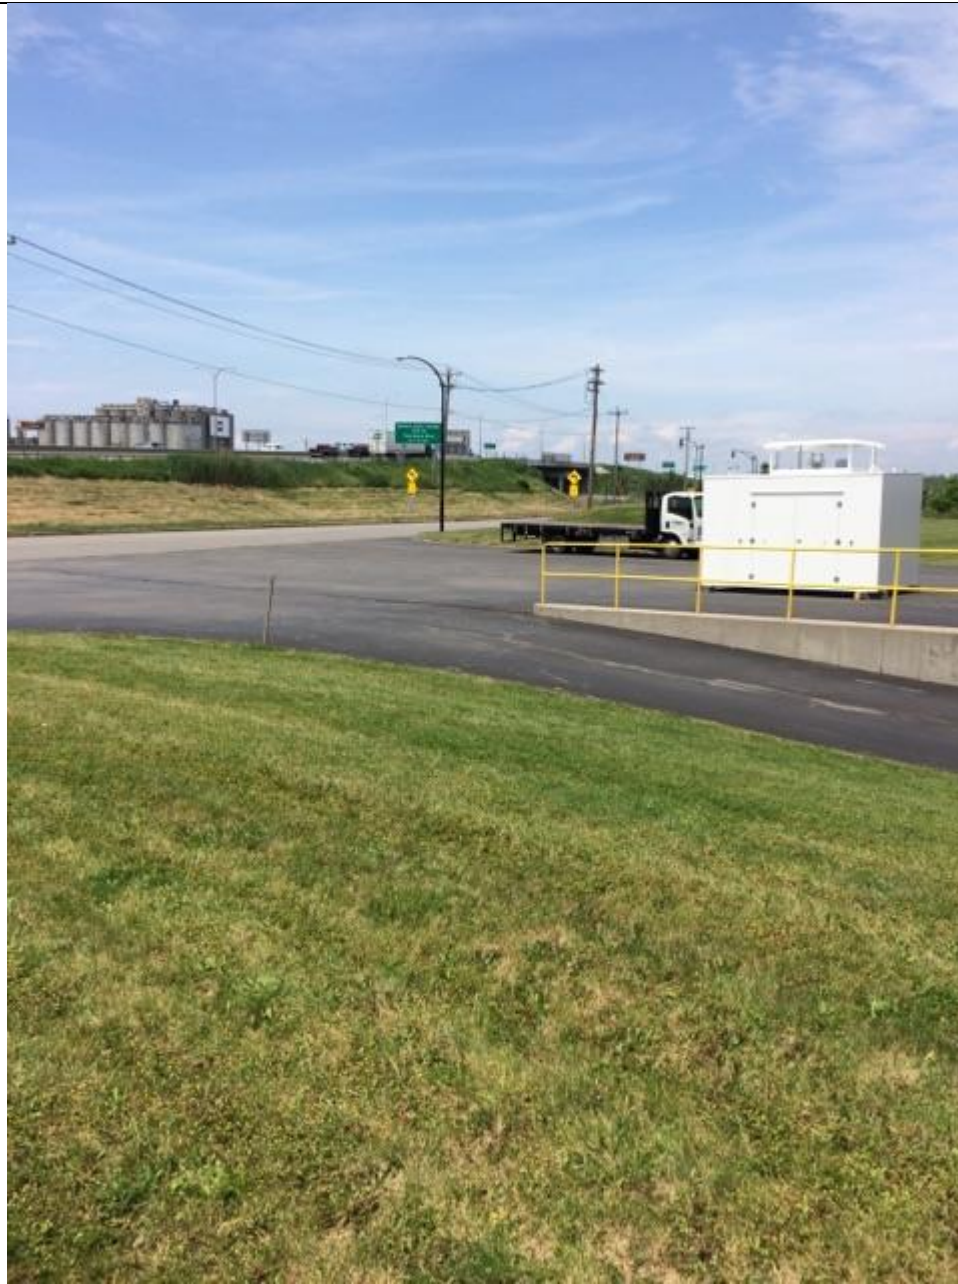
### **Photograph: 17**

Asphalt pavement and grass cover at west loading dock.

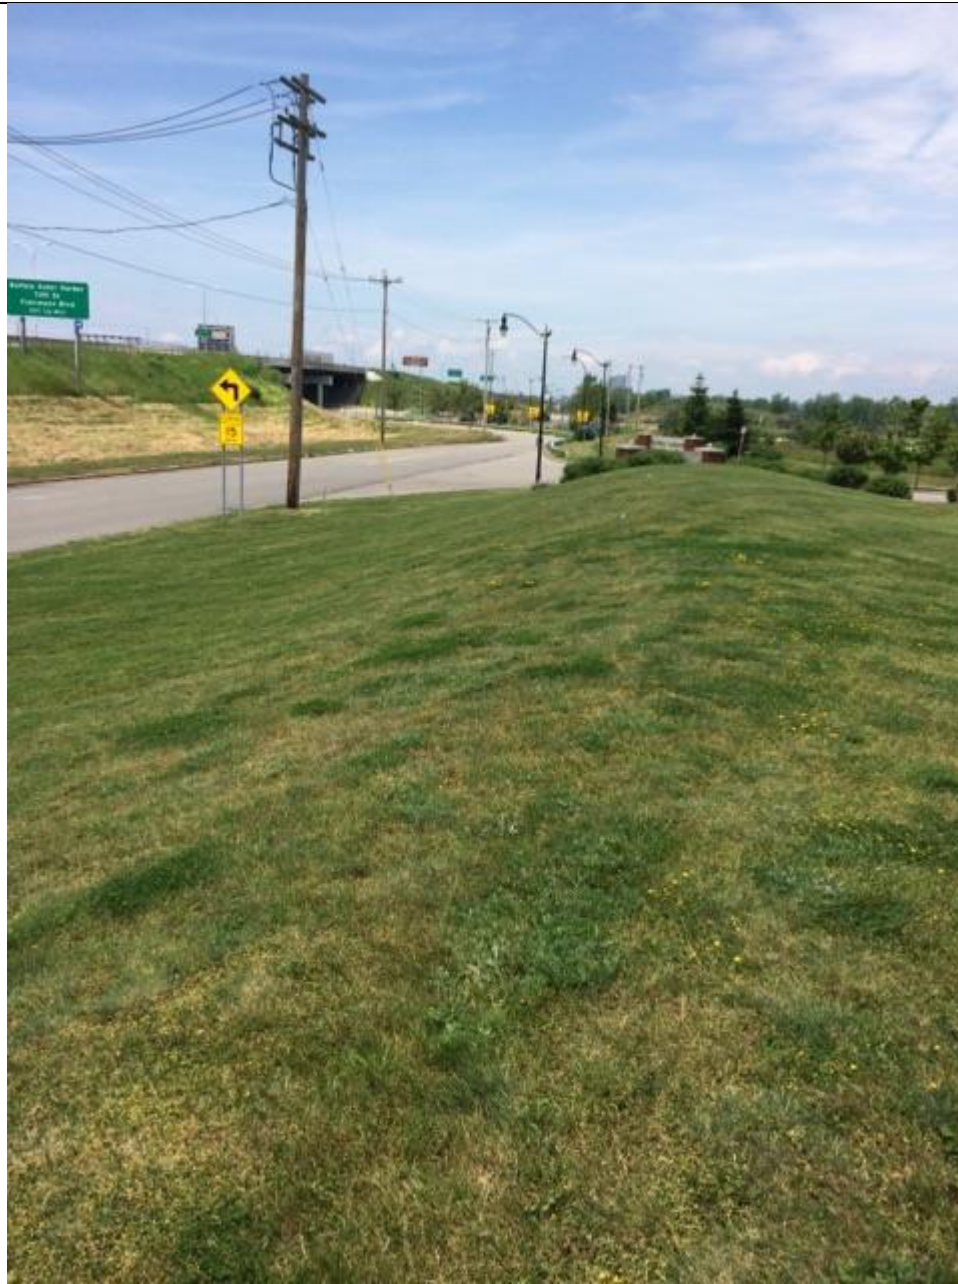
### **Photograph: 18**

Grass cover to the west of the building along Commerce Street.

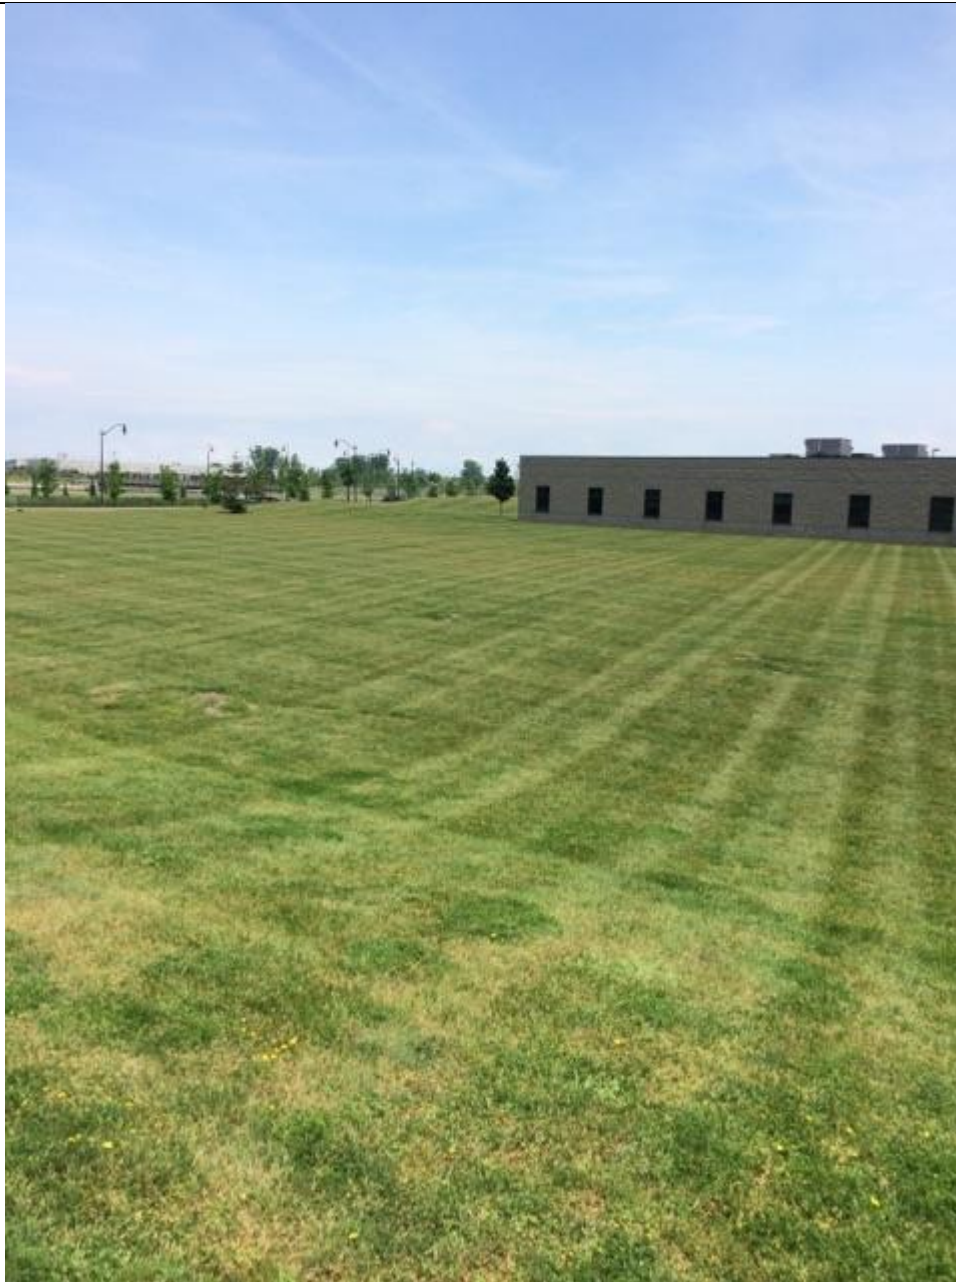
**Photograph: 19**

Landscaped area on west side of Cobey site.
