Subject:  
Periodic Review Report  
Cobey, Inc. Site, BCP Site #C915202  
Buffalo, New York

## PERIODIC REVIEW REPORT

Cobey, Inc. Site  
Buffalo, New York  
BCP Site #C915202

June 20, 2017

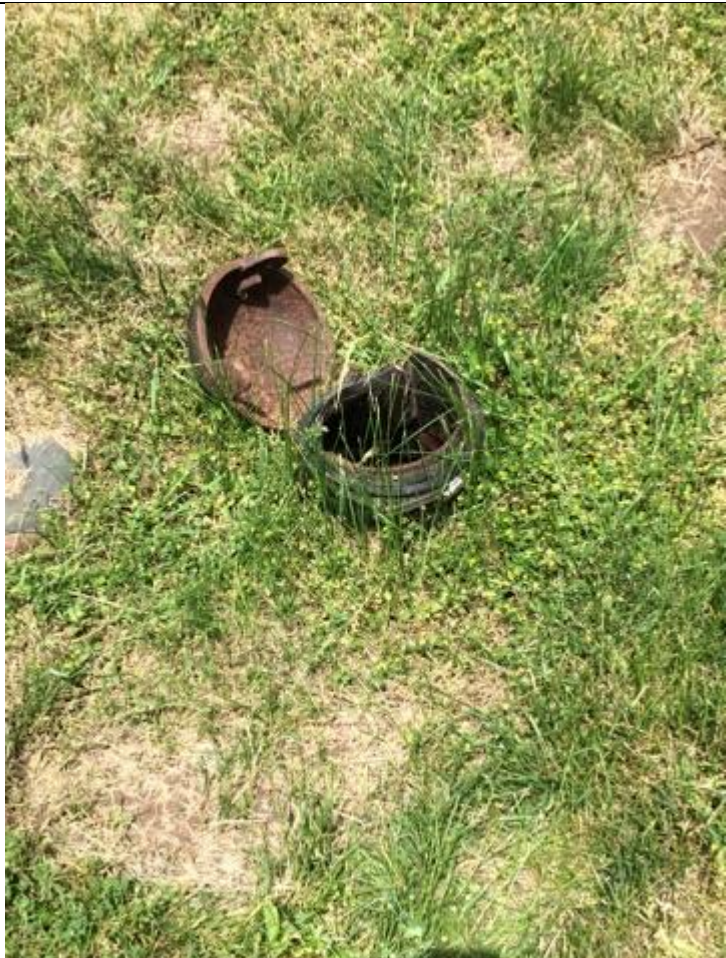
<p><b>Photograph: 21</b></p> <p><b>Description:</b> Damaged monitoring well on west side of building.</p> <p><b>Direction of photo:</b> North</p> <p><b>Photograph taken by:</b> J. Williams</p> <p><b>Date:</b> 6/15/2017</p>
--	---	--
