Subject:
Periodic Review Report
Cobey, Inc. Site, BCP Site #C915202
Buffalo, New York

PERIODIC REVIEW REPORT

Cobey, Inc. Site
Buffalo, New York
BCP Site #C915202

July 2020

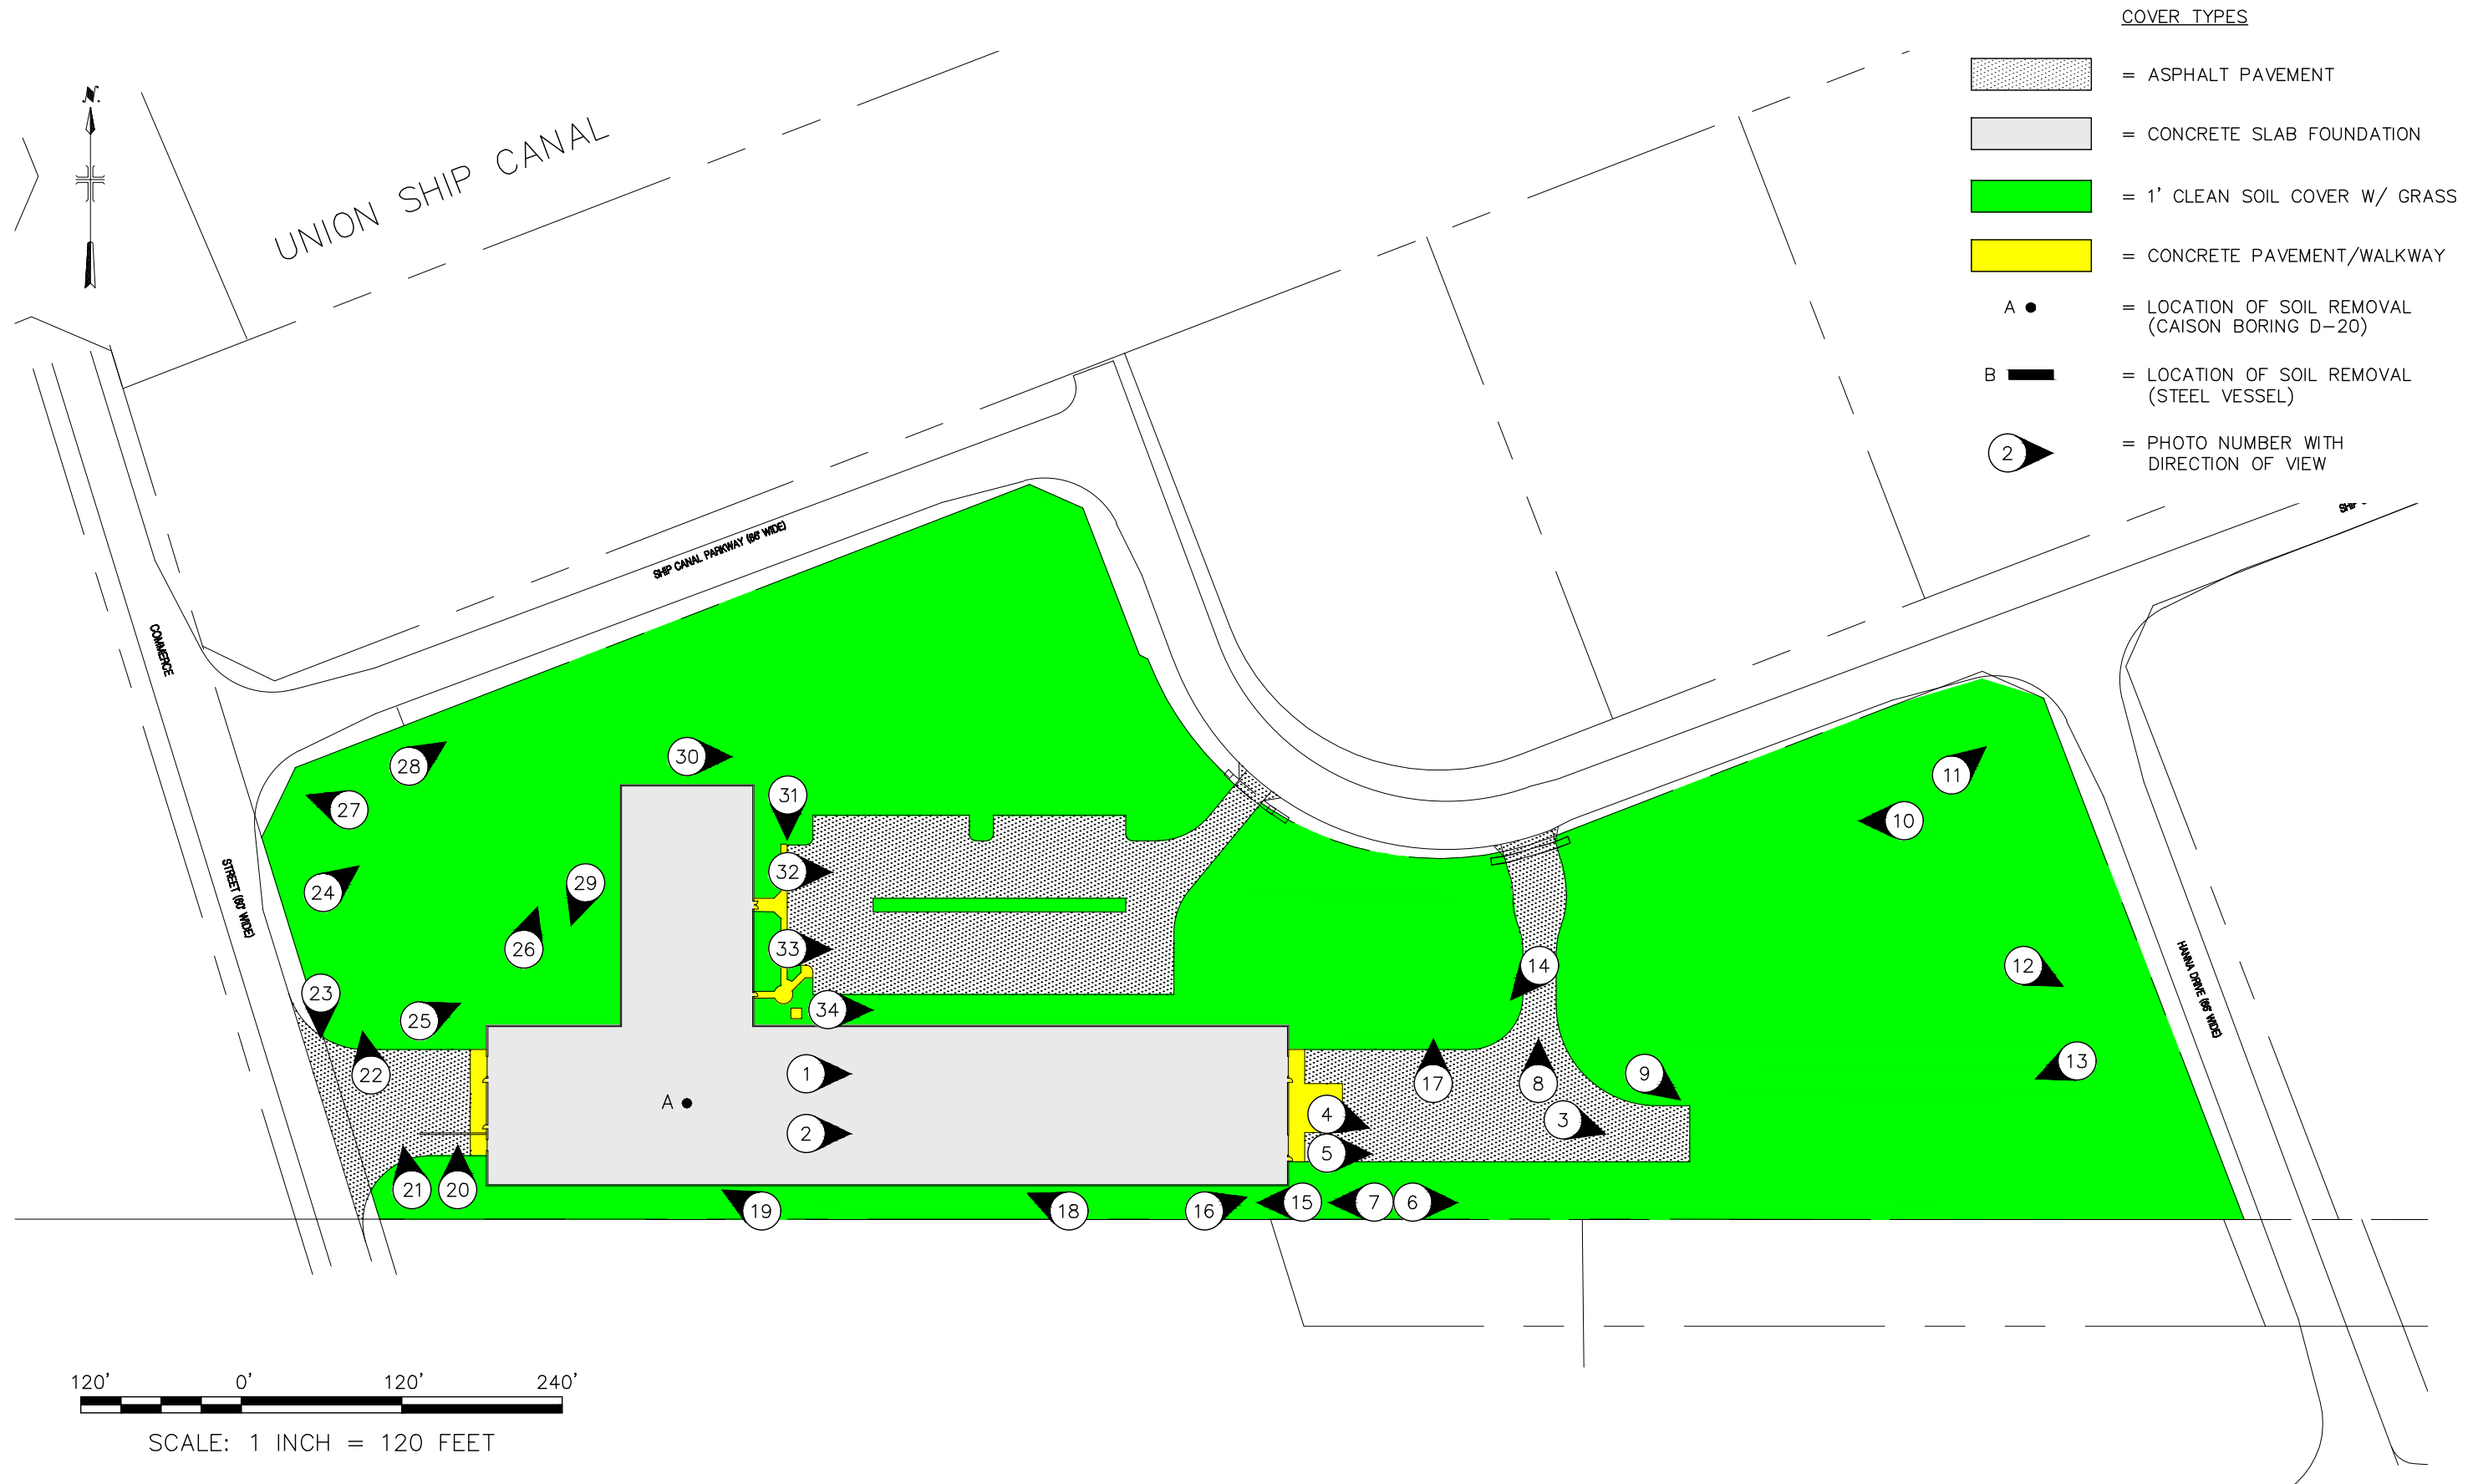
Figure 3. Site Cover System Inspection Photographs

During advancement of the Cobey building foundation footers using a caisson drill, oily soil/fill material was observed at one of the caisson borings identified as location D-20. The impacted soil/fill was stockpiled, characterized, and disposed of offsite with DEC approval at a permitted landfill. The location of where the impacted soil/fill was encountered is illustrated as point A on Figure 3.

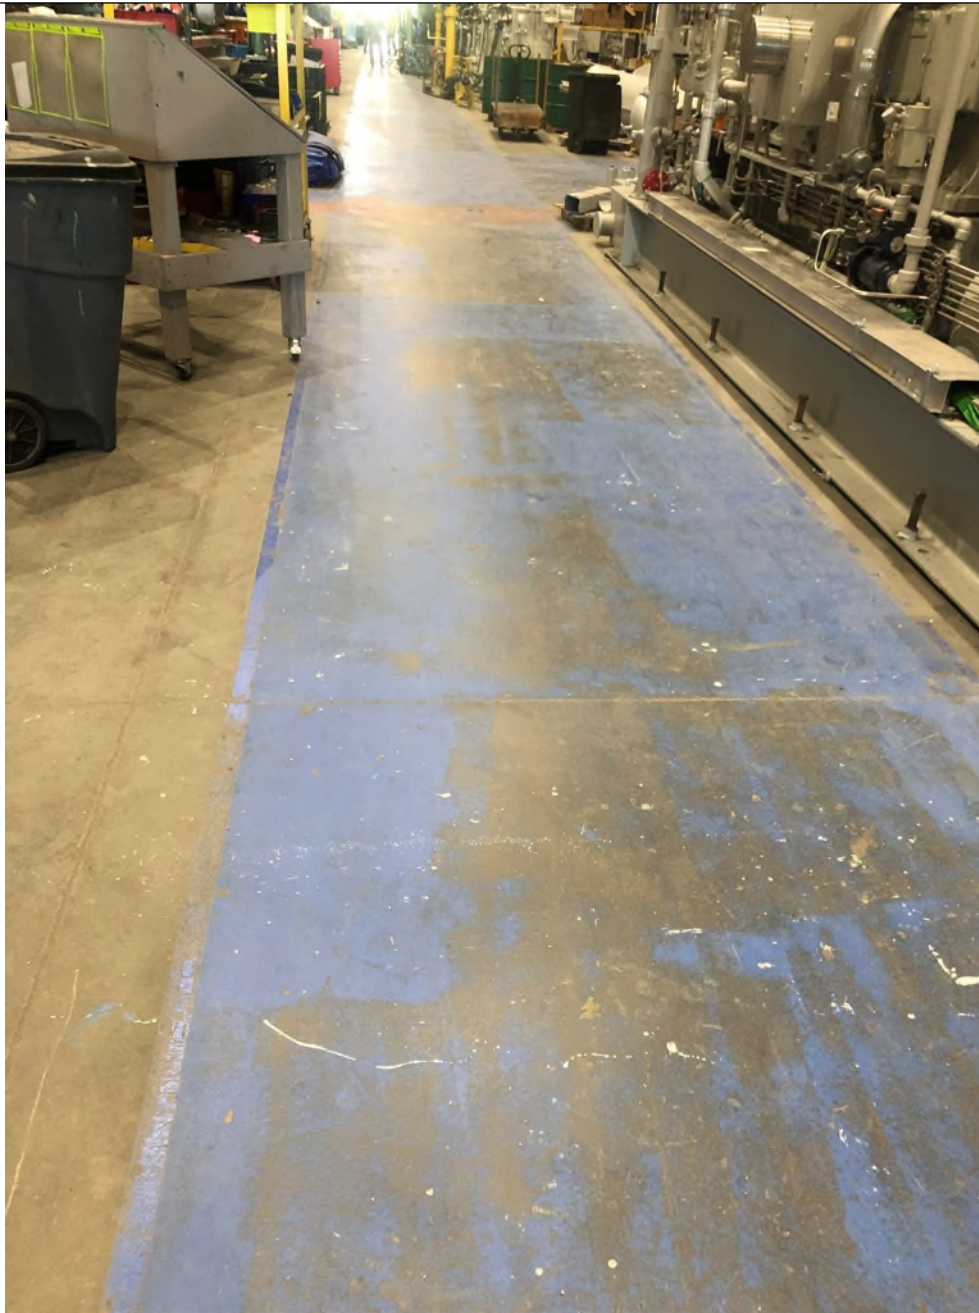
Photograph: 1

Worn paint on north side of facility floor, about to be repainted.

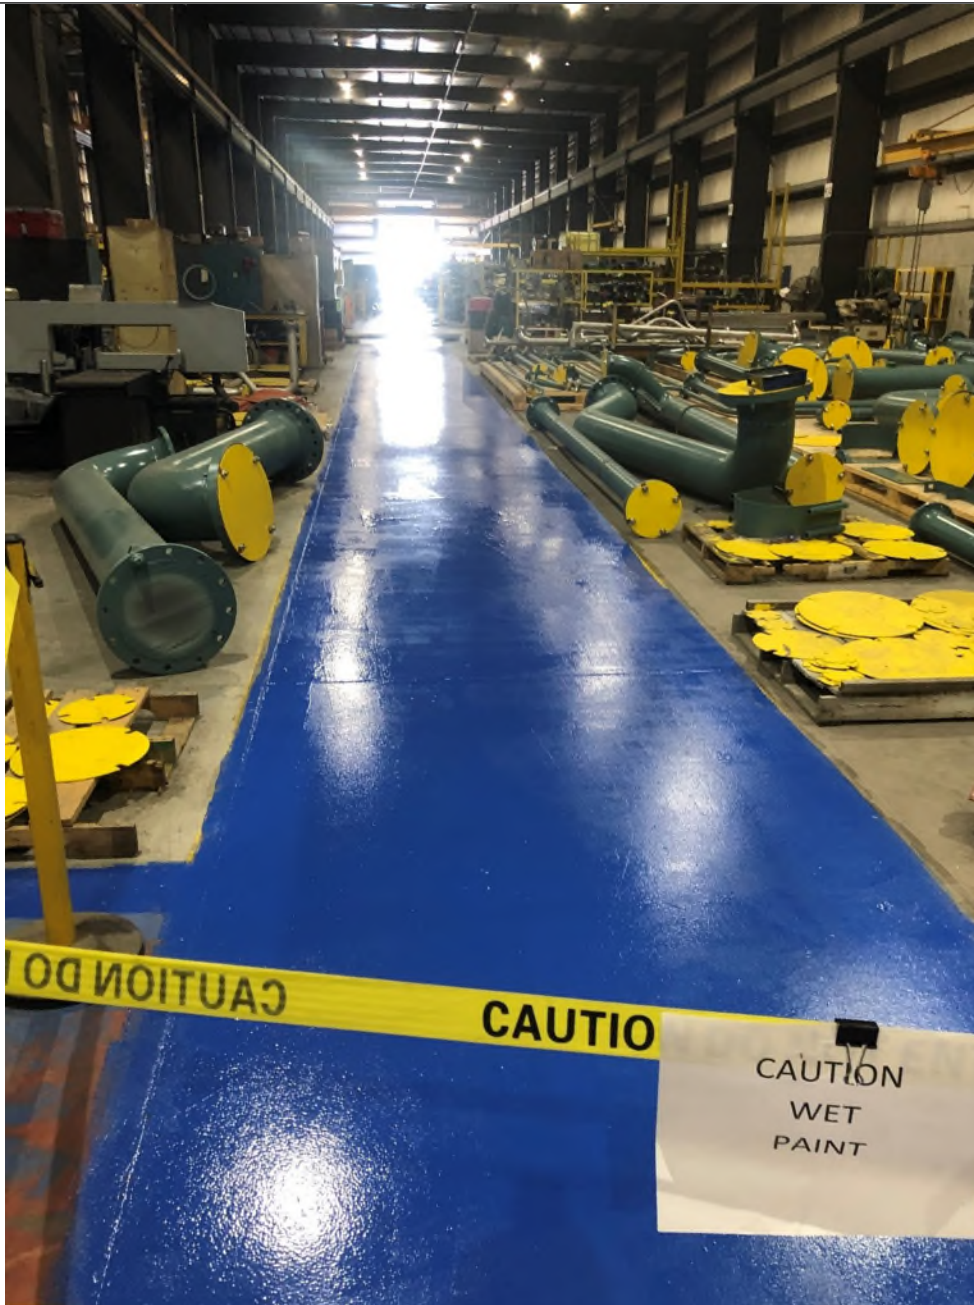
Photograph: 2

Fresh paint on the south side of facility floor.

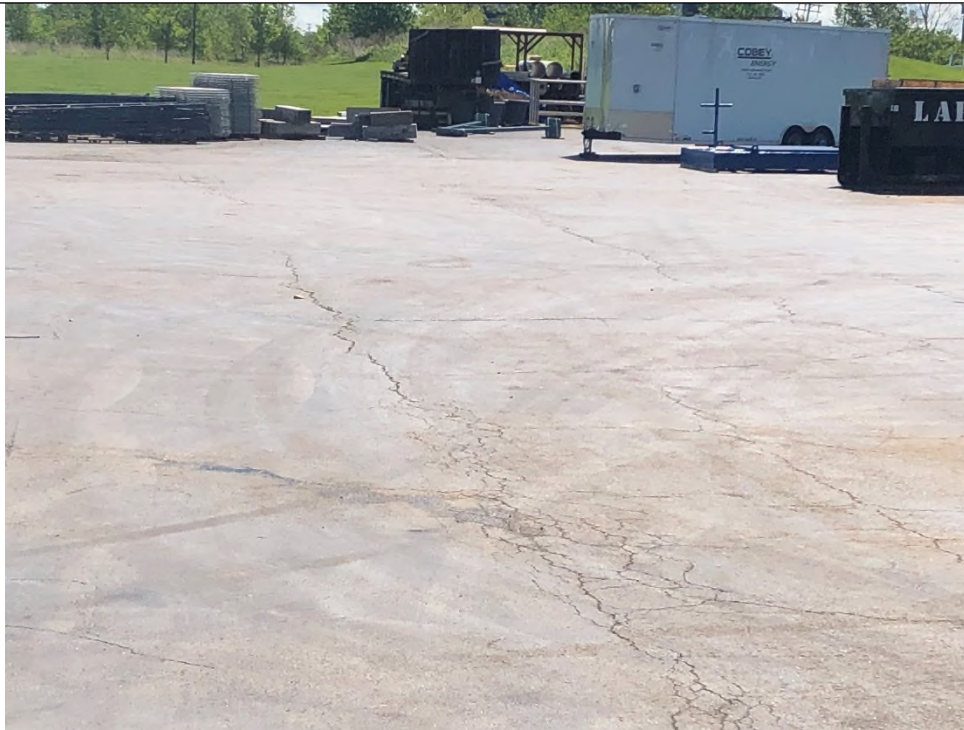
Photograph: 3

- (3) Minor cracks in pavement of parking areas. Refer to Photo Nos. 3, 4, 5, 8, 23, 32, and 33. Arcadis recommends that Cobey fill in the cracks and seal the asphalt to maintain the impermeable surface and prevent infiltration from potential spills from vehicle and equipment traffic.

Description:
Cracks in asphalt
pavement of east
loading dock.

- Filling the cracks observed in the asphalt and sealing the surface to maintain the impermeable surface and prevent infiltration from potential spills from vehicle and equipment traffic. Refer to Photo Nos. 3, 4, 5, 8, 23, 32, and 33 in Appendix B.
- Clearing silt and debris buildup around storm drain adjacent to the light pole north of the east loading dock. Refer to photo no. 18 in Appendix B.

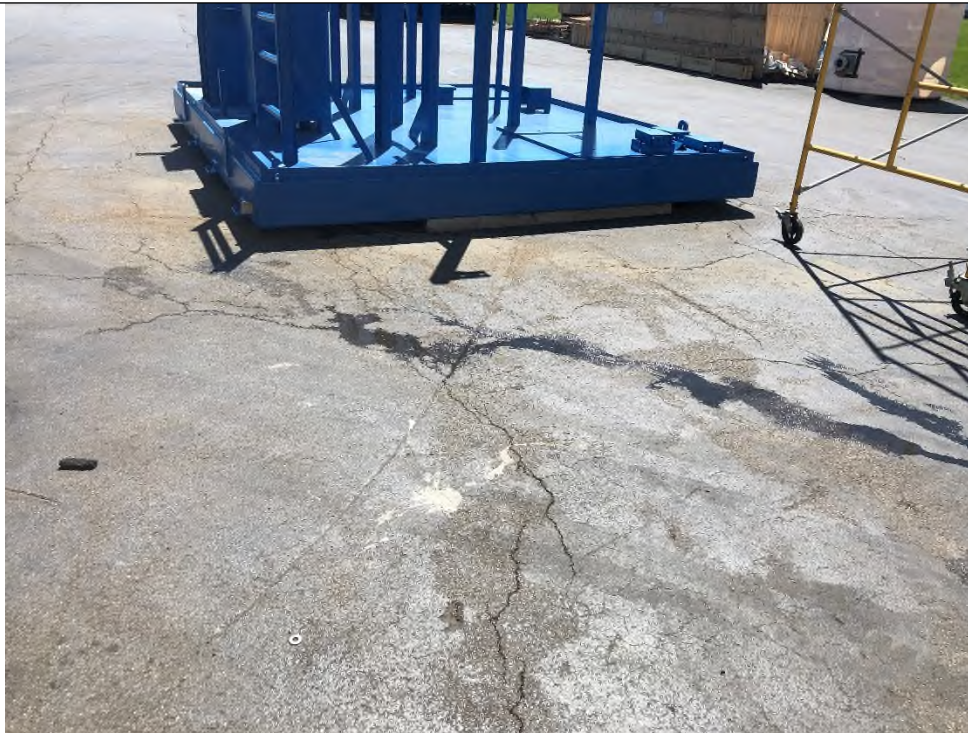
Photograph: 4

Description:
Cracks in asphalt
pavement of east
loading dock.

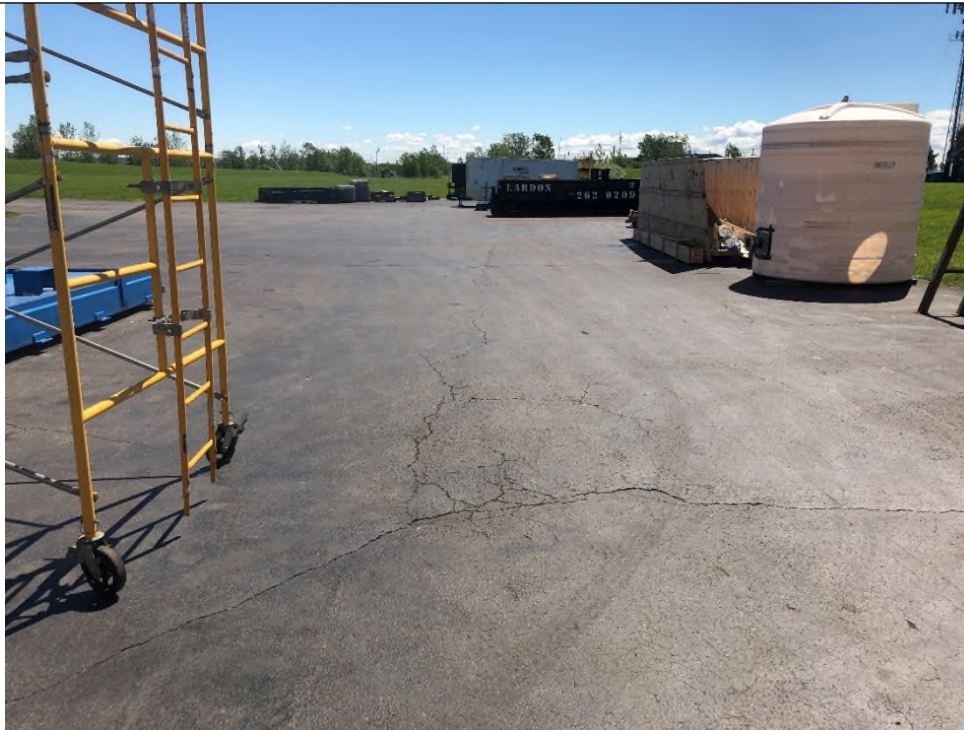
Photograph: 5

Cracks in asphalt pavement of east loading dock.

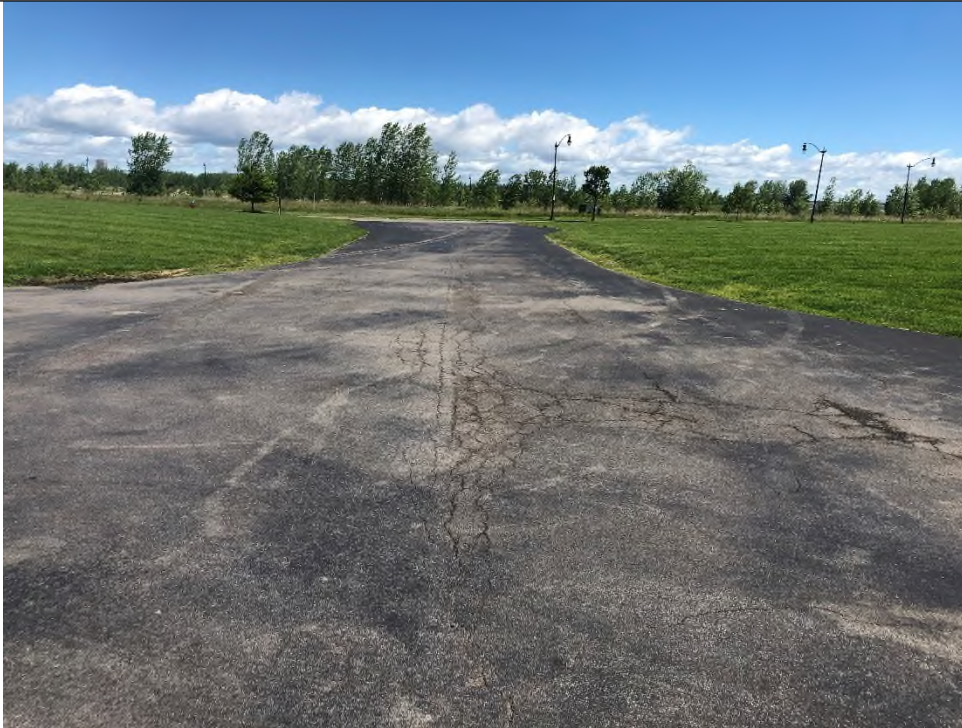
Photograph: 8

East loading dock
access from Ship Canal
Parkway.

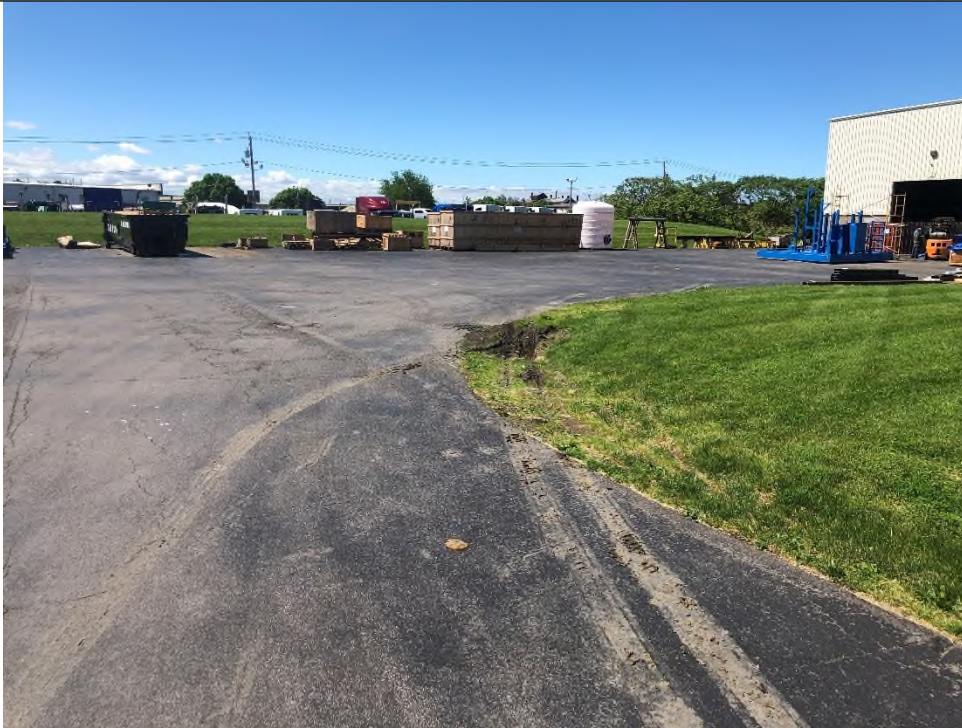
Photograph: 14

- (1) Minor erosion/rutting from vehicles cutting corners of pavement. Refer to Photo No. 14. Arcadis recommends that Cobey provide additional paving at the pavement edge of this turn to prevent vehicles from driving off paved surfaces to prevent cover damage.

Damaged grass cover
from traffic cutting
corner at east loading
dock.

- Providing additional pavement at the pavement edge along the turn of the entrance to the east loading dock to prevent vehicles from driving off paved surfaces and causing damage to vegetative cover. Refer to Photo No. 14 in Appendix B.
- Restoring vegetation or providing additional paved walking surfaces along the south side of the building near the dust collector and re-seeding around the trees located adjacent to the Ship Canal Parkway and Commerce Drive intersection. Refer to Photo Nos. 16, 18, 19, and 27 in Appendix B.

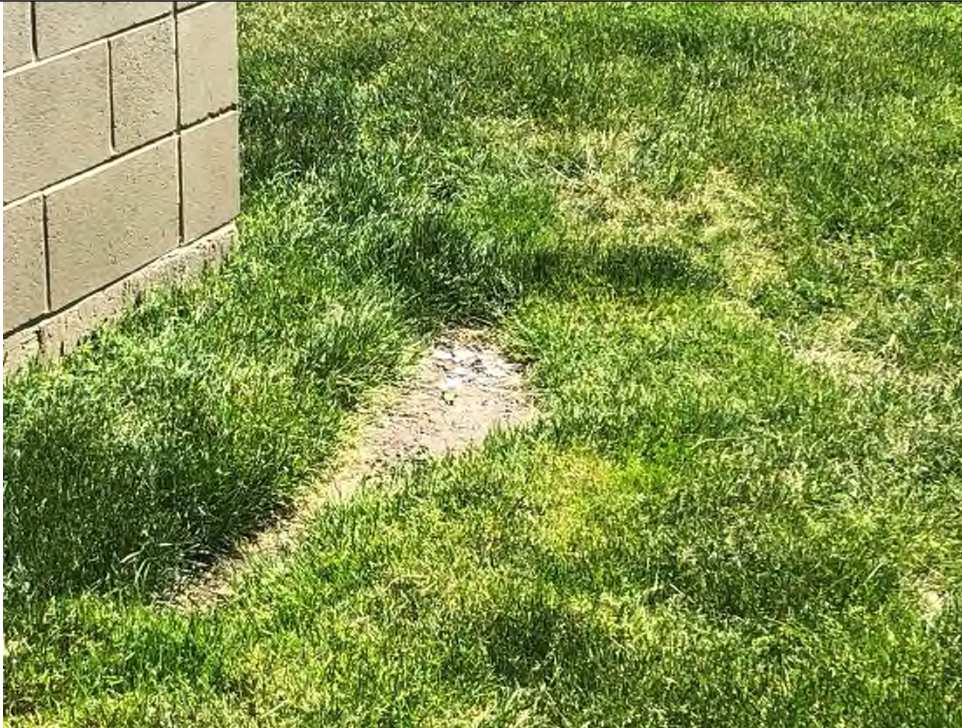
Photograph: 16

- (2) Minor worn or distressed areas of vegetation. Refer to Photo Nos. 16, 18, 19, and 27. Arcadis recommends that Cobey re-seed areas and/or provide additional paved walking paths to prevent cover damage.

Worn grass cover along southeast corner of the building.

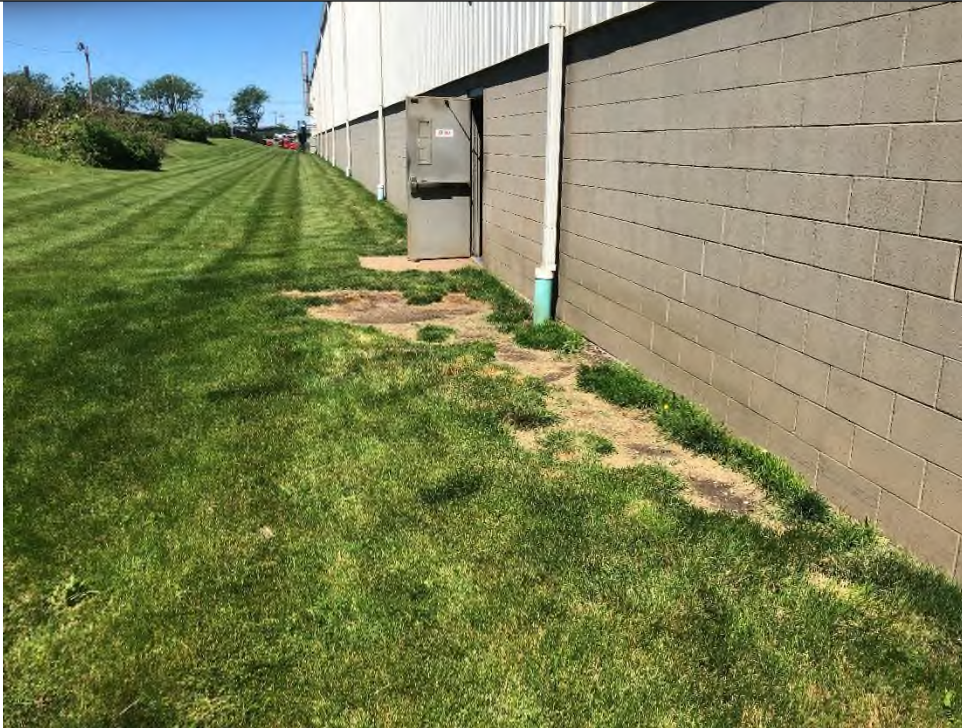
Photograph: 18

- (4) Silt and debris buildup around storm drain. Refer to Photo No. 18. Arcadis recommends that Cobey clear the silt and debris from around the storm drain to prevent clogging the storm drain and/or site material into the runoff.

Worn grass cover by the south man-door of the building.

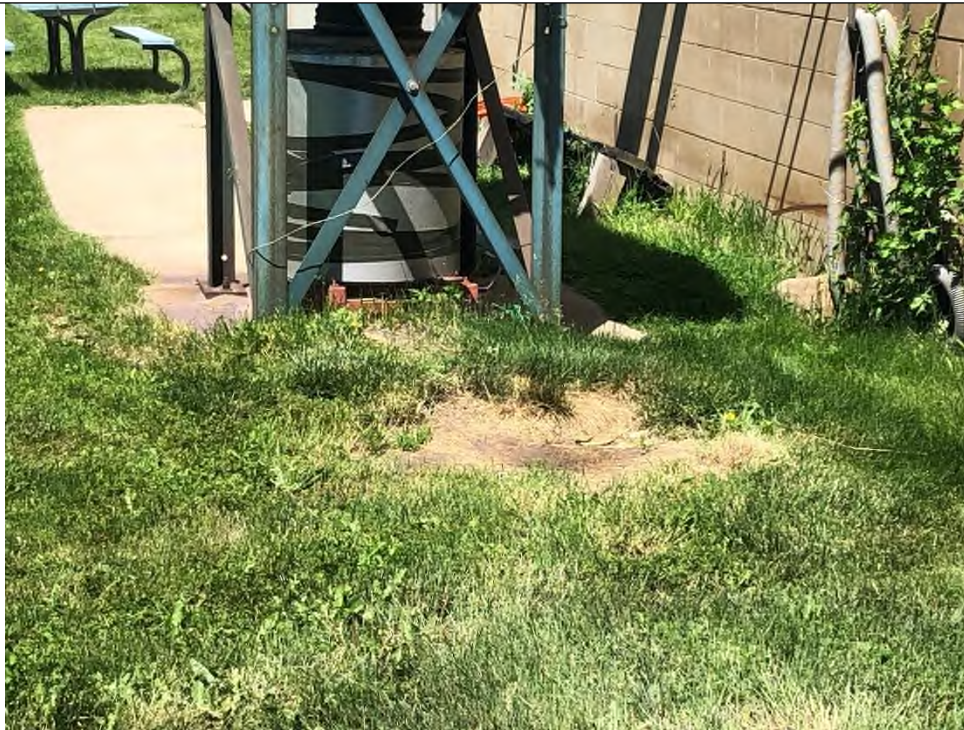
Photograph: 19

Worn grass cover by the dust collector on the south side of the building.

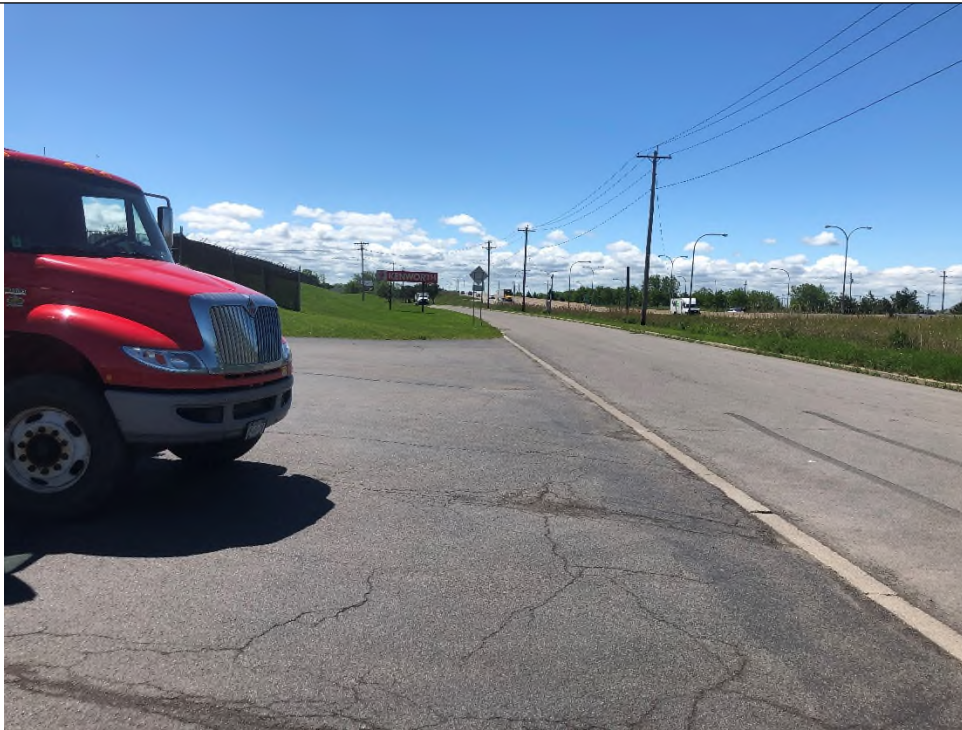
Photograph: 23

Cracks in asphalt
pavement of west
loading dock access
from Commerce Drive.

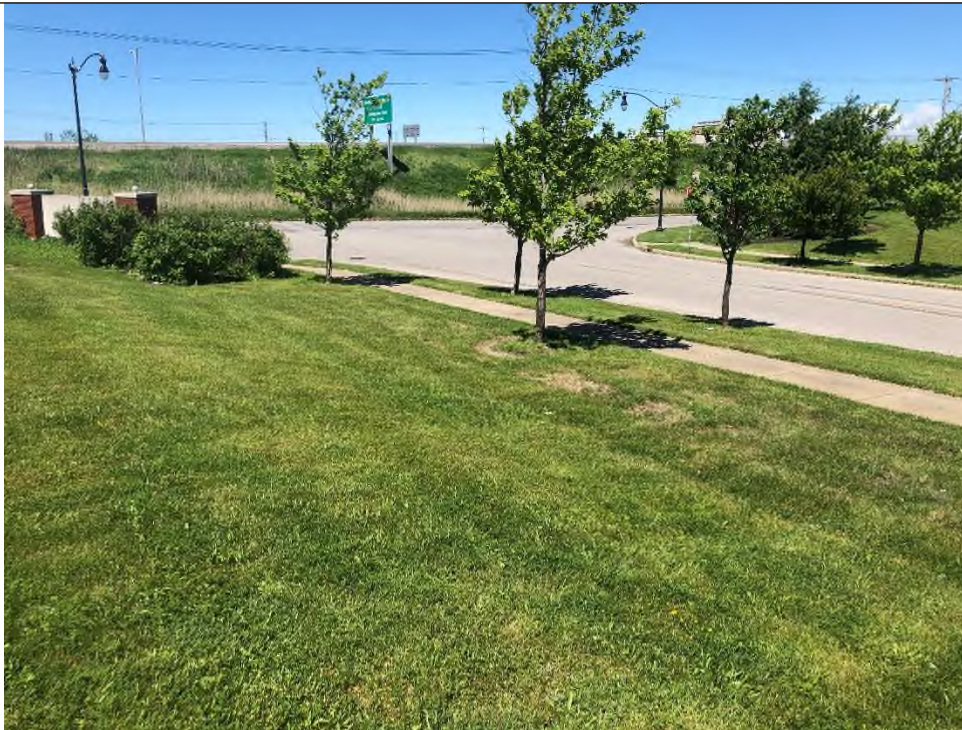
Photograph: 27

Worn grass cover along north side of Cobey Site at the corner of Ship Canal Parkway and Commerce Drive.

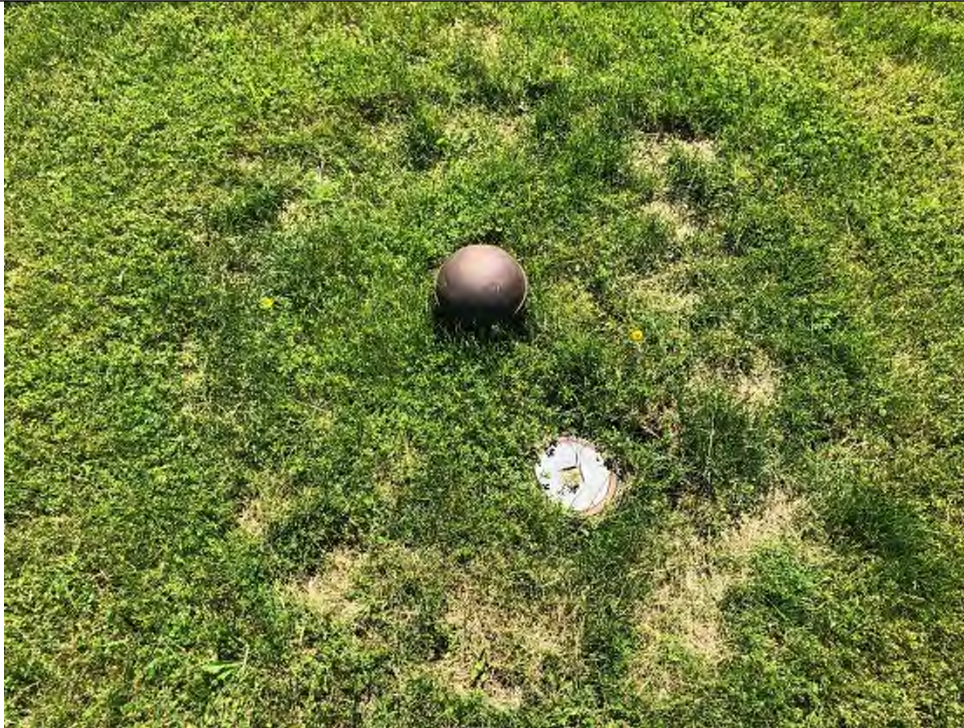
Photograph: 29

Repaired monitoring
well on west side of
building.
