1 July 2009
File No. 34858-004

Subject: HydroAir Components, Inc. Site (Formerly Steelfields Area IV)
Brownfield Cleanup Program (BCP) Site #C915204
Site Management Annual Review Report & IC/EC Certifications

Environmental Inspection Form
Operation, Monitoring, & Maintenance Work Plan

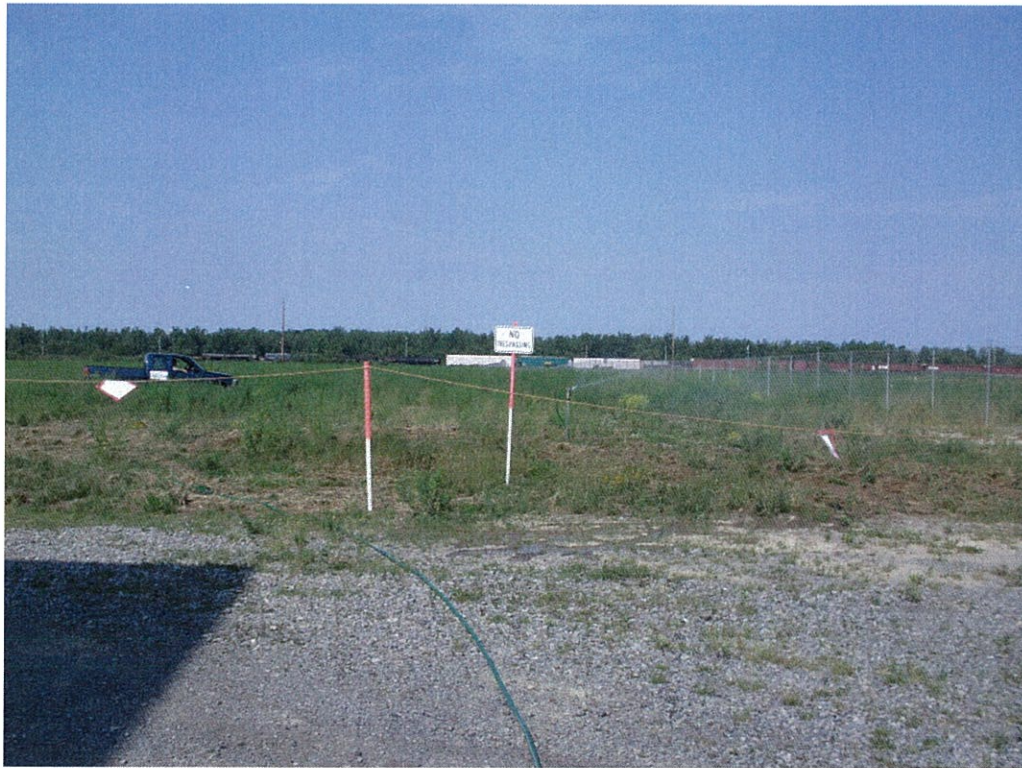
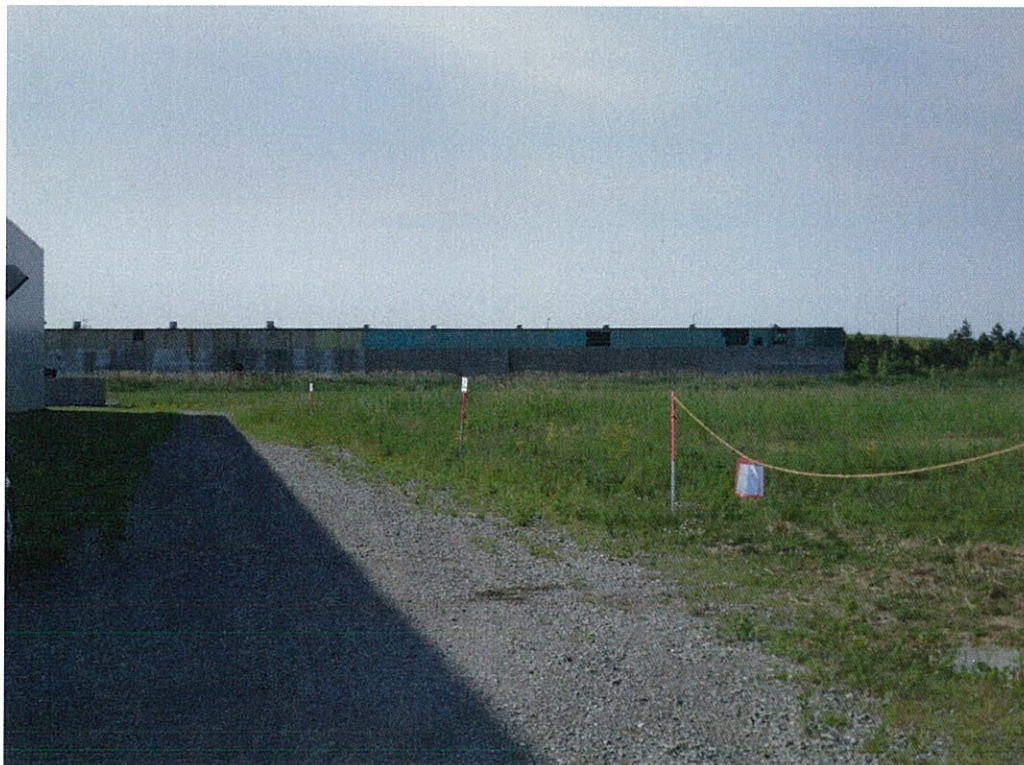
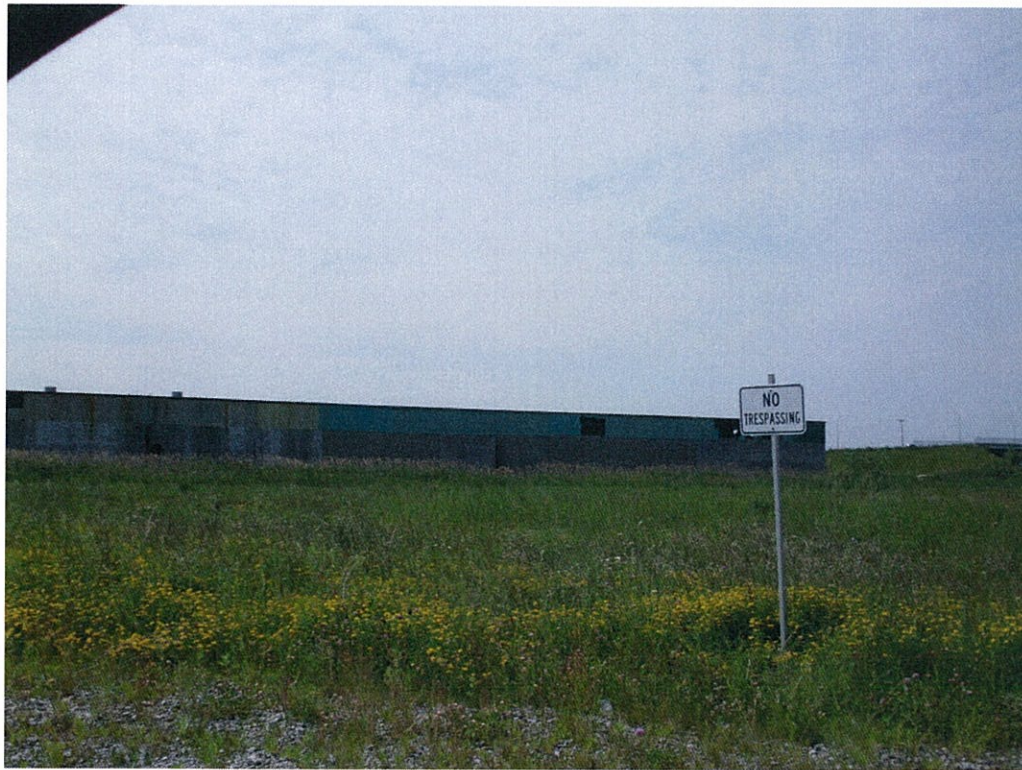
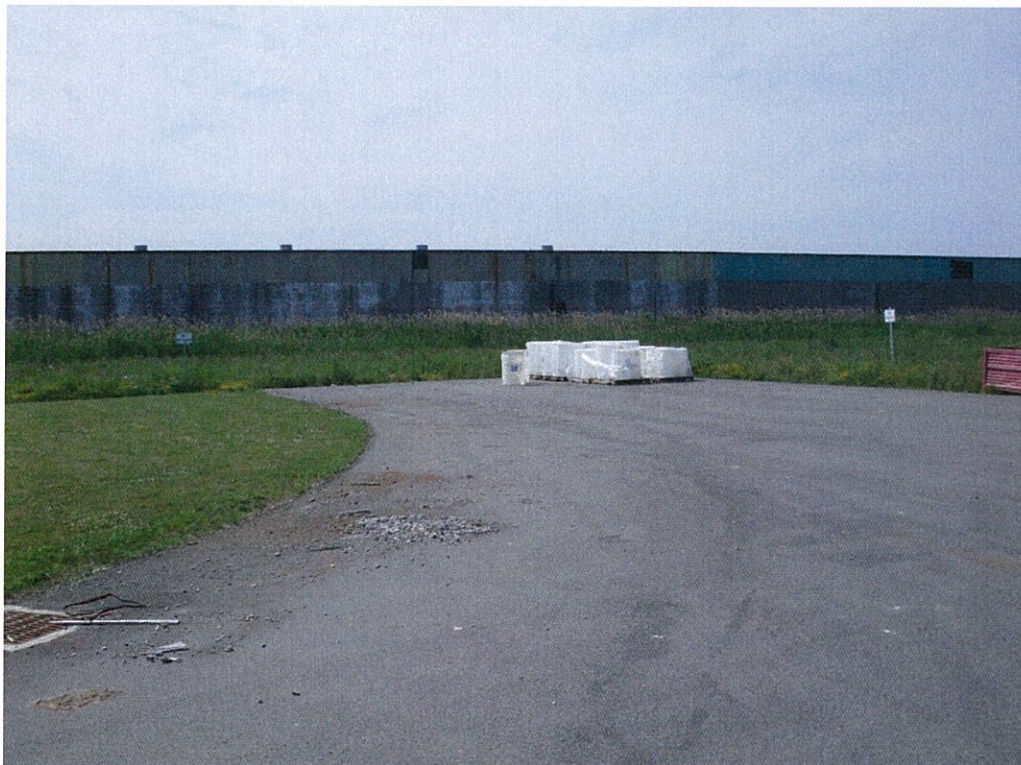
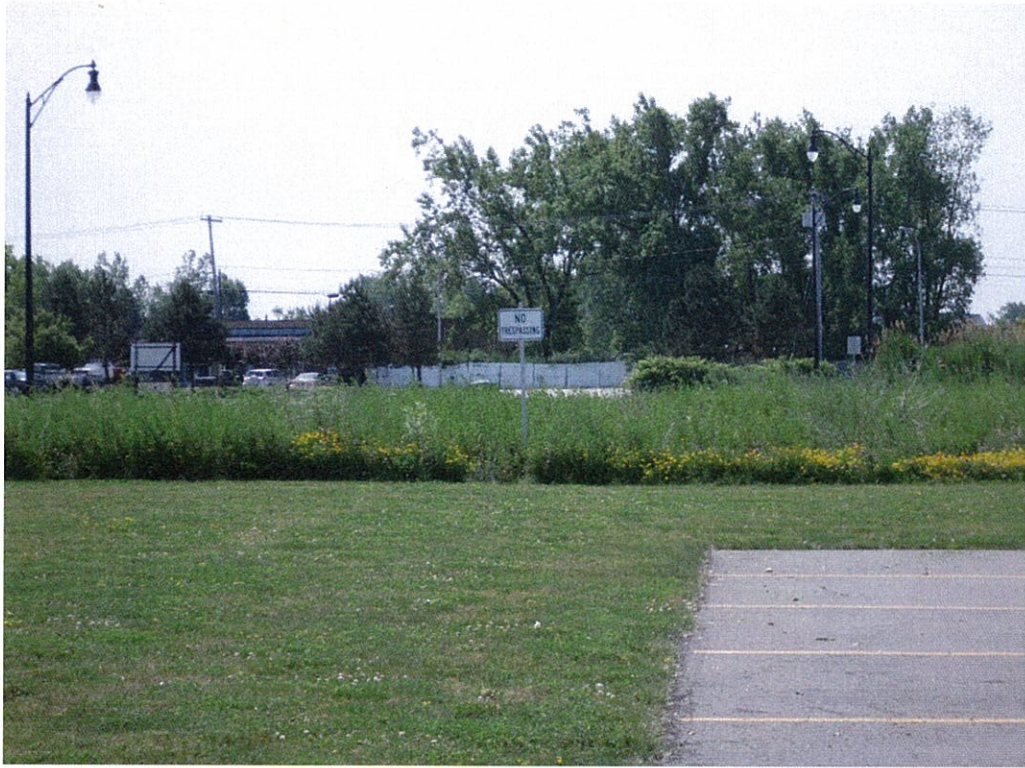
"No Trespassing" signs

To completely fence the field would be cost prohibitive and appears unnecessary based on the contaminated soil removal actions performed in the area. Installation of No Trespassing signs was recommended as a first attempt to prevent unintended vehicle access to the field. NYSDEC approval to not fence the undeveloped portions of the site from the south and east is being sought in order to allow time to see if the no trespassing signs will be sufficient to protect the soil cover from disturbance by off-road vehicles.

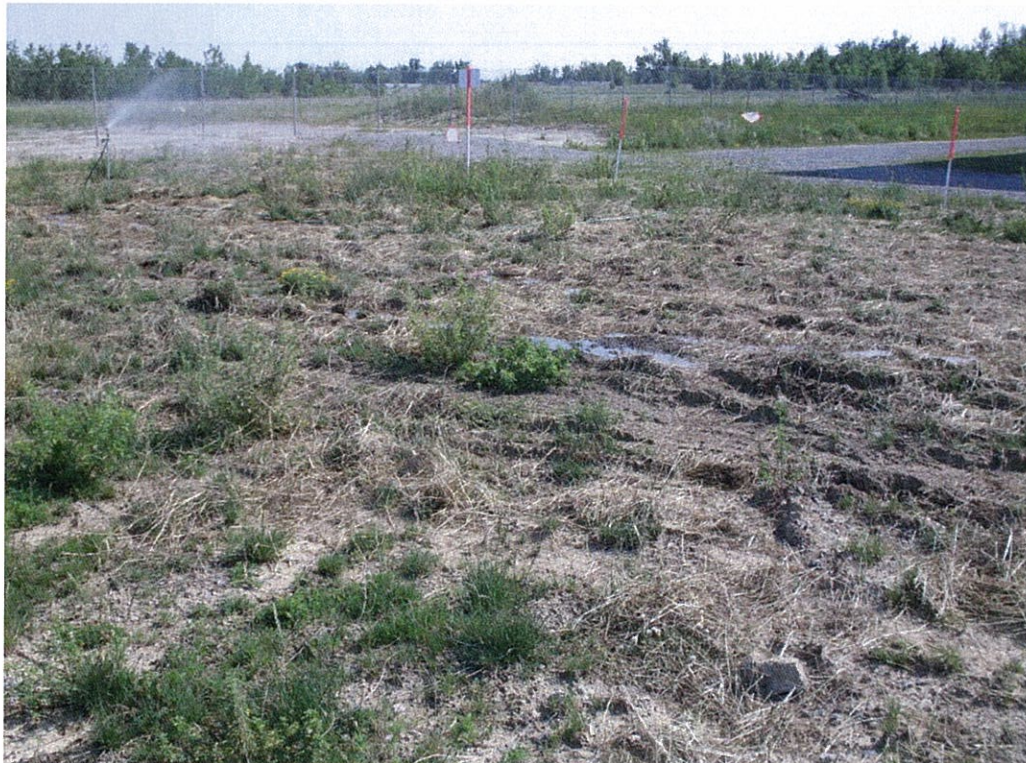
- Tire ruts were observed in the field west of the building and were reportedly caused by trespassers. Hydro Air suspects that people drive into the field in the evenings and on the weekends to observe deer and turkey.

Rolled and re-seeded vehicle ruts.

- Tire ruts in the field west of the building have been rolled and reseeded on June 22, 2009. The area is being watered.
- No Trespassing signs have been installed every 150 feet where there is no fence in the field west of the building as a first step to prevent unintended vehicle access.
- The crack in the concrete floor slab in the southwest corner of the manufacturing floor was sealed with polyurethane concrete patch on June 27, 2009.
- Investigation of elevated pH in the stormwater pond is ongoing.

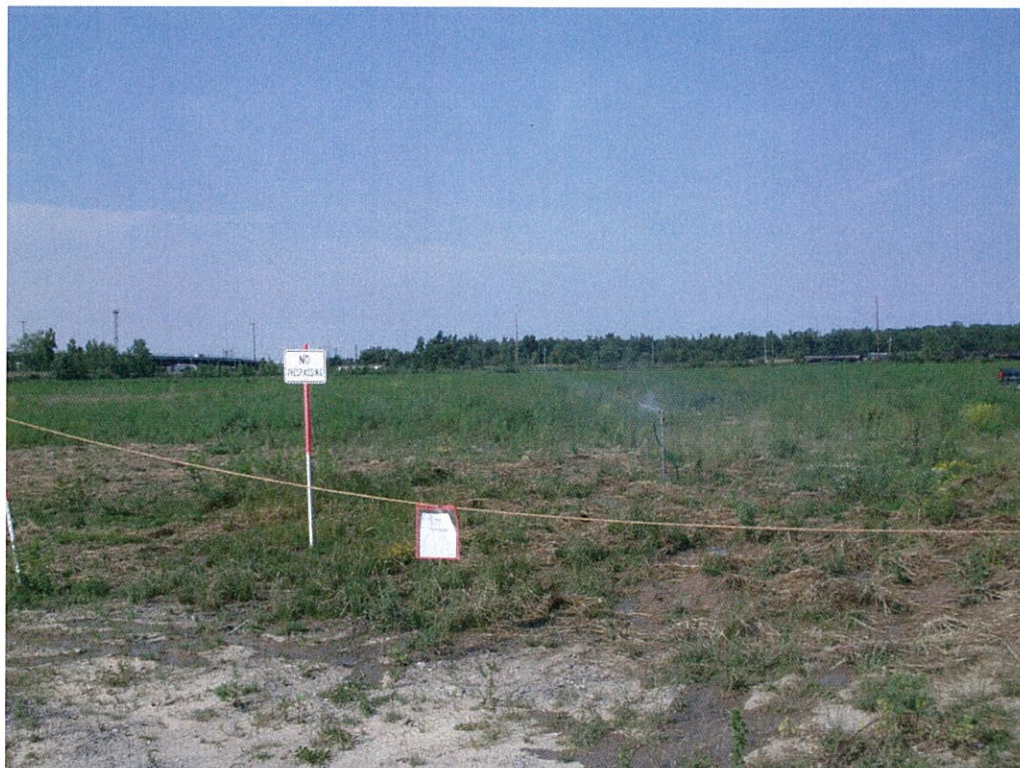
- Grass coverage in the field west of the building is sparse likely due to excessively dry conditions and quality of top soil, and apparently due to ponding in localized areas.

Watering of new grass seed.
