Subject: Hydro-Air Components Inc. Former Steelfields Area IV Parcel (Site)
Brownfield Cleanup Program (BCP) Site #C915204
Site Management Periodic Review Report &
Institutional Controls/Engineering Controls Certification

Environmental Inspection Form
Operation, Monitoring, & Maintenance Work Plan

Property Name: Hydro-Air Components (Steelfields Area IV) Project No.: 129356-002
Client: Hydro-Air Components, Inc.
Property Address: 100 Rittling Blvd. City, State: Buffalo, NY Zip Code: 14220
Property ID: 1402001321200001009121 Section: 132.12 Block: 1 Lot(s): 9.121
Preparer's Name: Glenn White Date/Time: February 2017

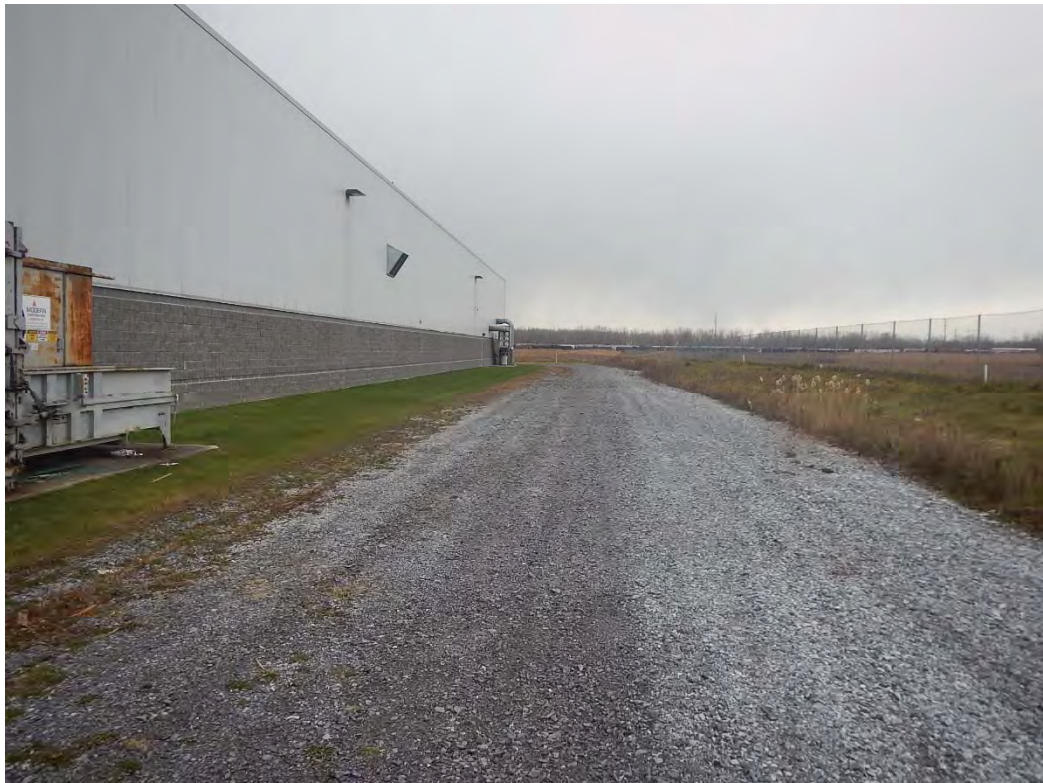
Prior to 2012, evidence of surfacing groundwater in the gravel cover areas on the northern end of the site was evident. This site cover system engineering control was enhanced in 2012; additional gravel (9 to 11 inches) was added to the northern portion of the access road to inhibit the surfacing of alkaline groundwater in the area. HydroAir has monitored the continual efficacy of the gravel cover area throughout 2016 and has not observed any evidence of alkaline water surfacing in these areas.

December 2016 – View of gravel drive along northern side of building.

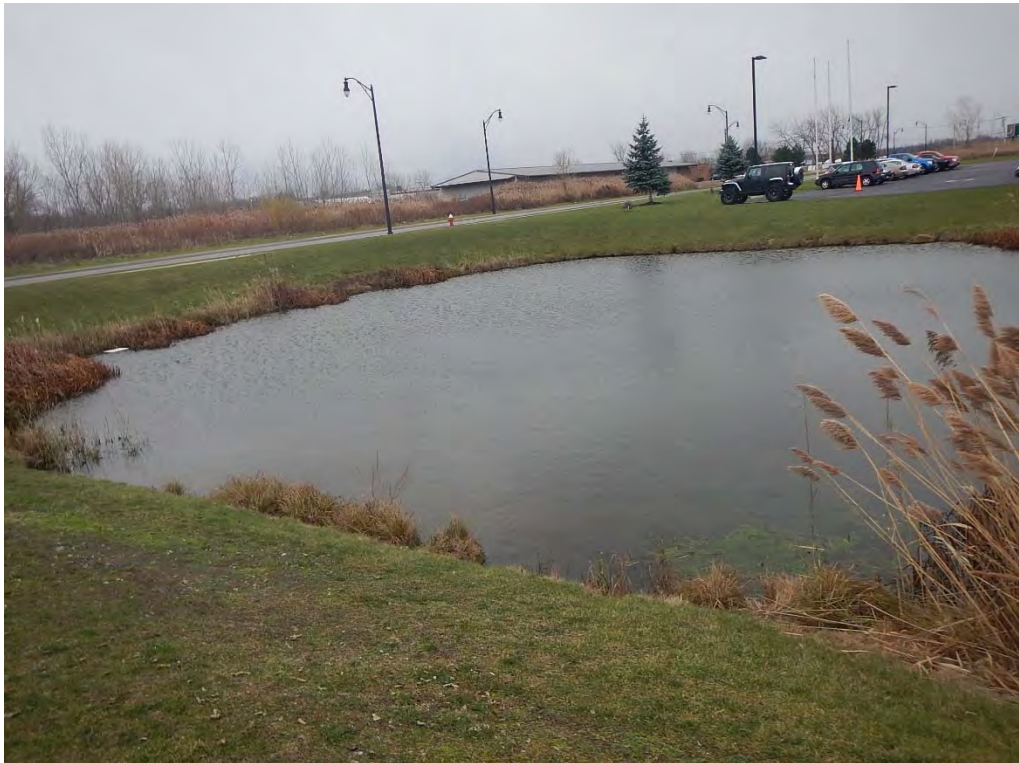
December 2016 – View from northern side of retention pond looking southeast across pond.

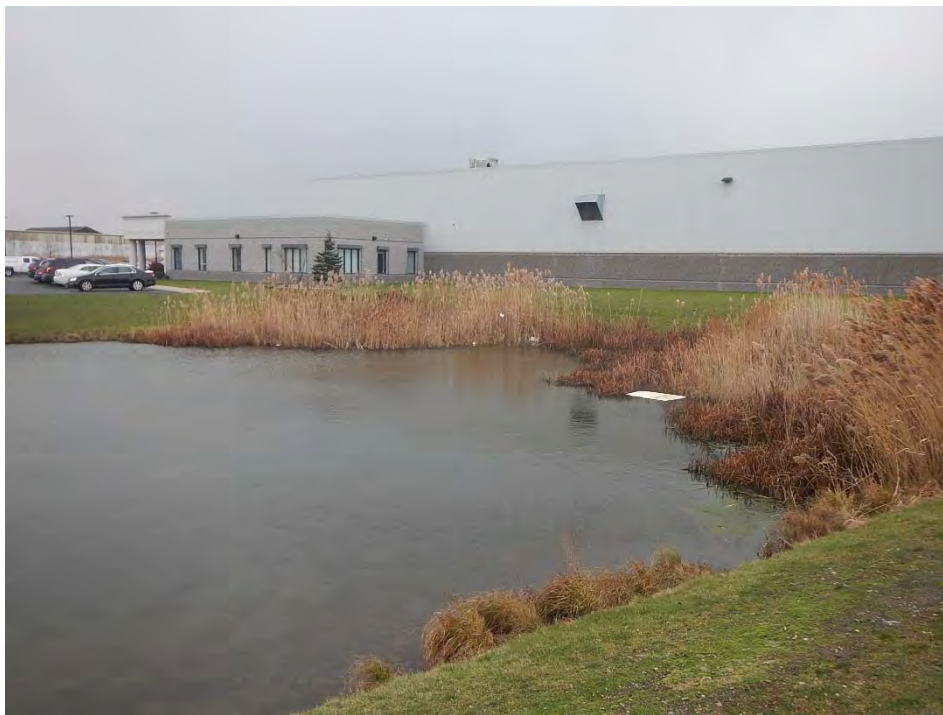
December 2016 – View from northeastern corner of pond looking southwest towards main plant.

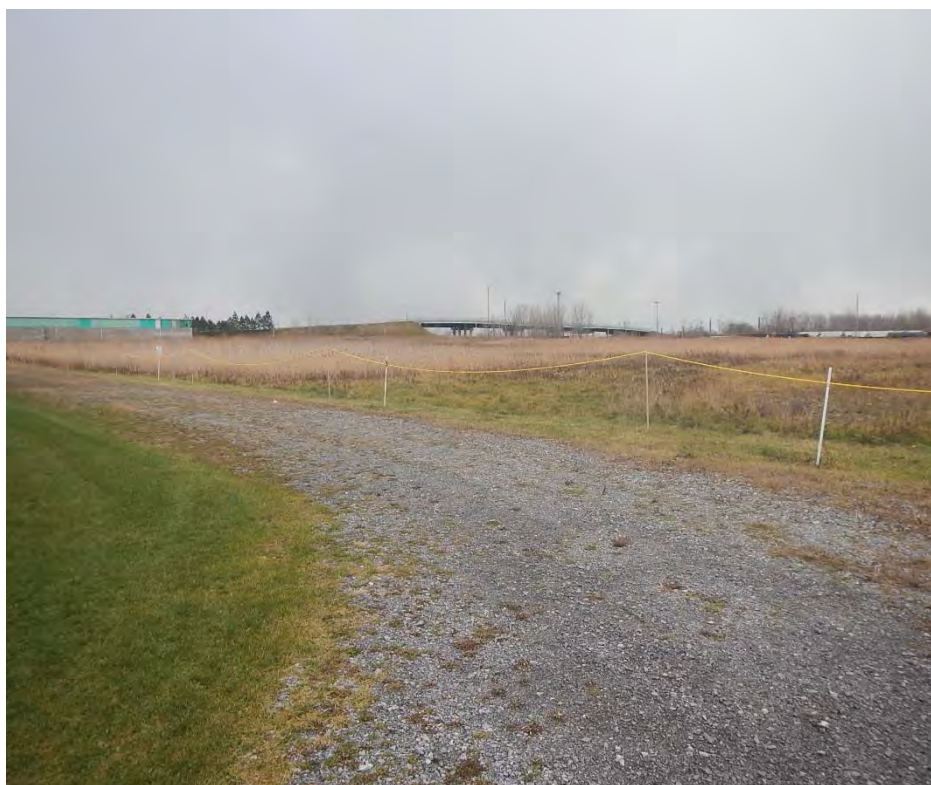
Ponding had been observed after installation of the soil cover in 2007. As requested by NYSDEC, French drains were installed in May 2008 and appear to have improved conditions. Ponding water was not observed during the annual inspection nor was it reported by HydroAir throughout the year. Some wetland vegetation continues to grow in the western interior of the site as evidenced in photographs taken in December 2016. (See attached photos). HydroAir recently observed trespassing of ATVs onto the western grass areas of the site (utilizing site as access to railroad). A breach in the perimeter fence shared with the railroad has also been observed and documented. Rutting was not observed during the December 2016 site visit, however, HydroAir is committed to stop the trespassing and any potential disturbance to the site vegetative cover and has repaired the breach in the fence. In addition, HydroAir will be installing an additional fence or solid barricade along the 850 feet at the back of its facility running towards Tiffit street to prevent further trespassing.

December 2016 – View from northwestern corner of main plant looking west towards grass-covered areas along western side of site.

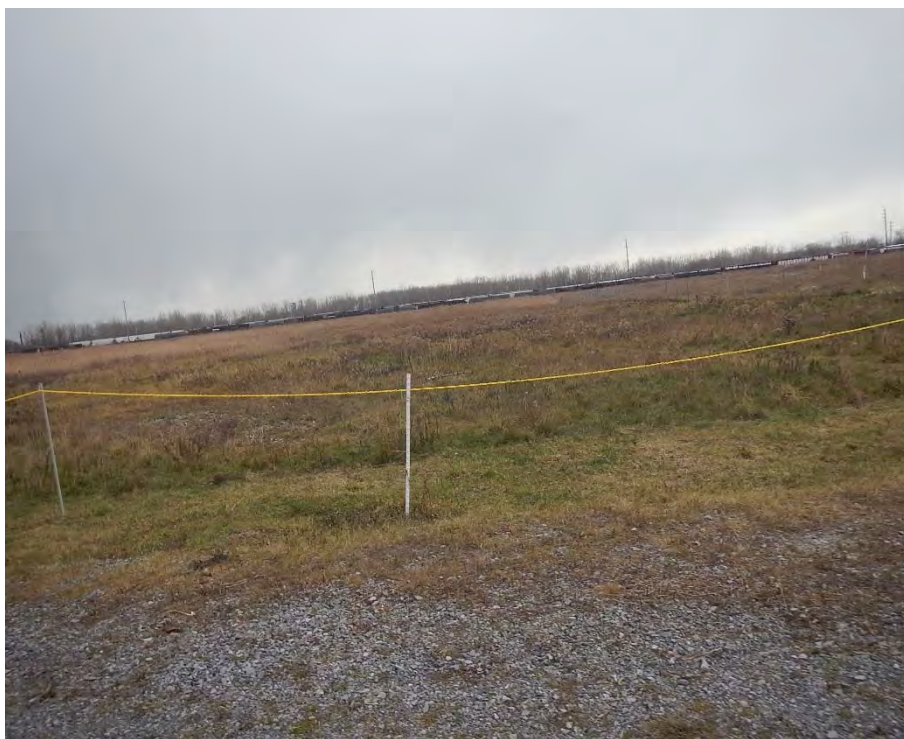
December 2016 – View from central-western side of plant looking west towards vegetative cover areas.

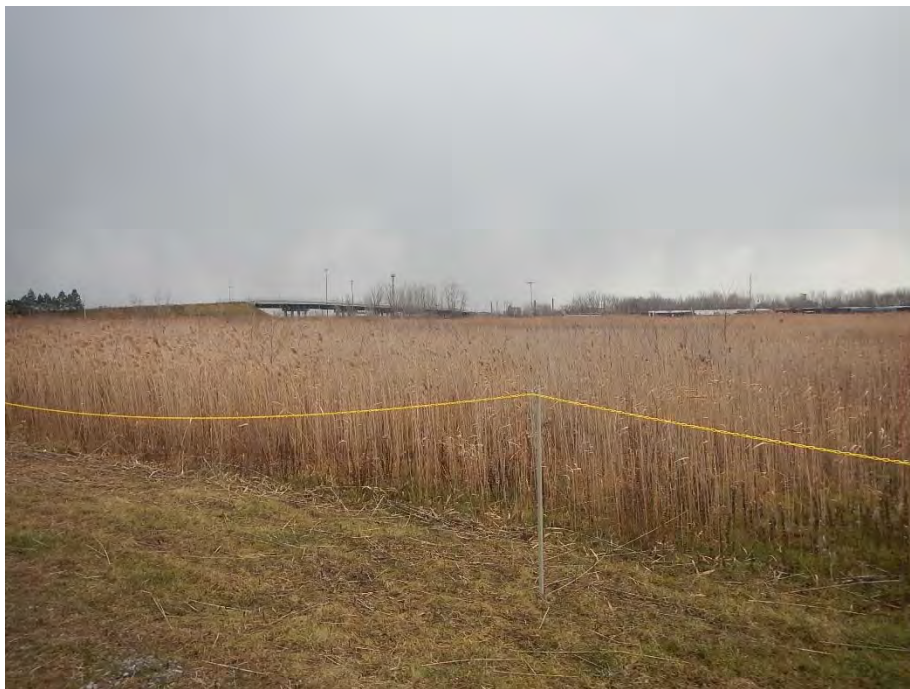
December 2016 – View from southwestern corner of plant looking southwest towards vegetative cover areas.

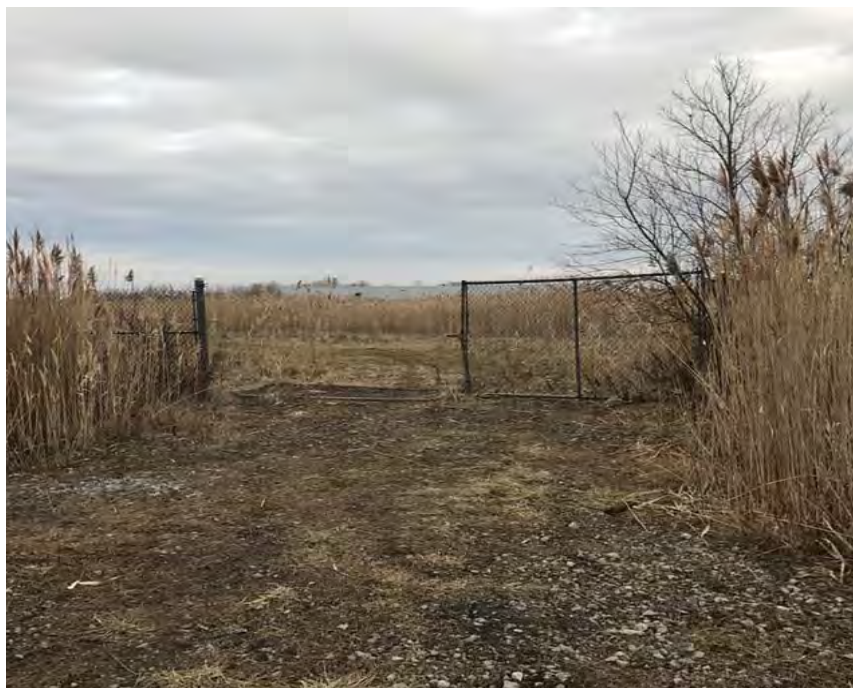
January 2017 – View of Breach observed in perimeter fence shared with railroad. HydroAir has since repaired this breach (see below) and will be installing additional fence or barricade along rear of its facility to prevent further site trespassing.

| If not, please note: <u>Site is partially fenced, breach in fence observed (since repaired).</u> | | | |

Please note any irregularities/ changes in site access and security: While no trespassing signs and security cameras have deterred trespassers in the past, HydroAir has noted recent trespassing outside of business hours by ATVs onto the vegetated areas of the western side of the site and as a result they have repaired an observed breach in the perimeter fence and will be installing an additional fence or solid barricade at the rear of facility along approx 850 feet of the property.

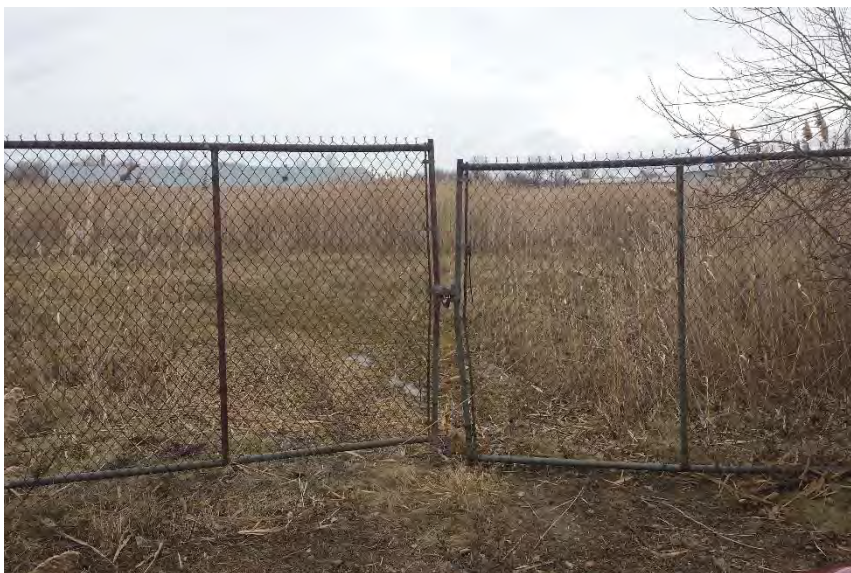
February 2017 – View of perimeter fencing where former breach was repaired.
