12 February 2018 File No. 129356-003

Subject: Hydro-Air Components, Inc. Property (Former Steelfields Area IV Parcel Site)

Brownfield Cleanup Program (BCP) Site #C915204 Site Management Periodic Review Report &

Institutional Controls/Engineering Controls Certification

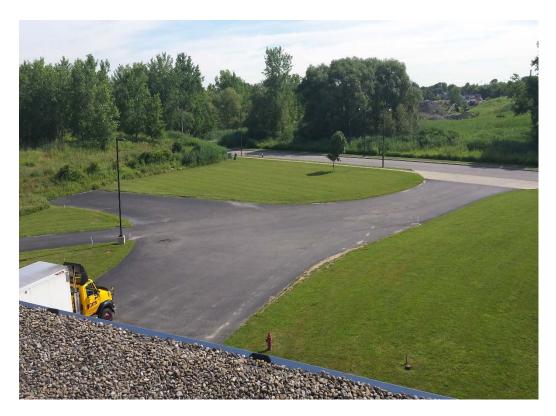
Subsequent to corrective measures that were put into place on 1 December 2012 (per the Corrective Measures Work Plan, approved 29 December 2011 by the Department), water has not accumulated in the northeastern loading dock area. The reconfiguration of the loading dock pump system (setting to automatic pumping and raising the float set-point enabled sufficient pumping to maintain dry conditions and has sufficiently prevented the surfacing of groundwater in the area. HydroAir has continued to monitor the efficacy of these controls regularly throughout 2017.

July 2017-View from roof looking towards northeastern corner of site (loading dock areas)

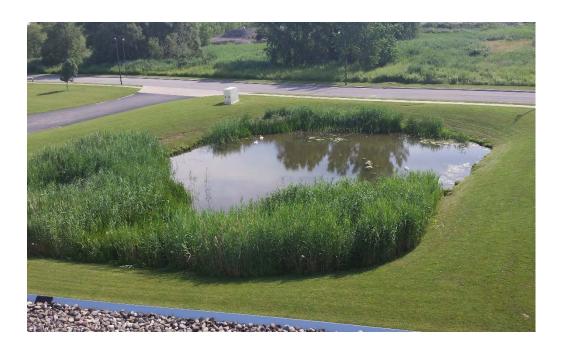
July 2017 – View from roof looking east towards site retention pond.

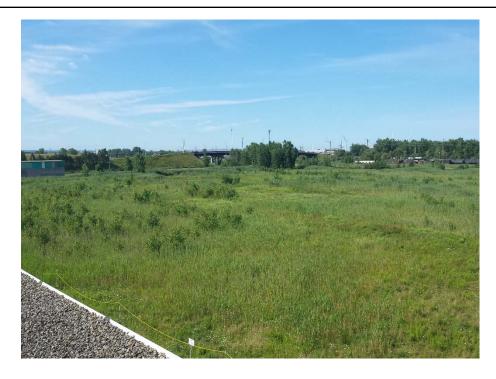
July 2017-View from roof looking southwest towards western areas of site with maintained site vegetative cover.

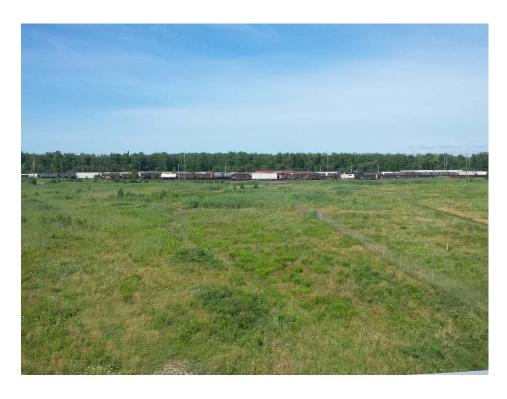
Ponding had been observed after installation of the soil cover in 2007. As requested by NYSDEC, French drains were installed in May 2008 and appear to have improved conditions. Ponding water was not observed during the annual inspection nor was it reported by HydroAir throughout the year. Some wetland vegetation continues to grow in the western interior of the site as evidenced in photographs taken in the summer of 2017. (See attached photos). Over the course of the prior year (2016), HydroAir had observed after-hours trespassing of ATVs into the western grass areas of the site (utilizing site to access the adjacent railroad right-of-way). A breach in the perimeter fence shared with the railroad corridor was also observed and subsequently repaired. Earlier this year, HydroAir noted further occurrences of individuals on ATVs accessing these areas of the site as well as breaking several locks on the perimeter fence in order to continue accessing the railroad corridor. In June 2017, HydroAir security confronted the trespassers and after discussions with these individuals no further trespassing has been observed. Rutting was not observed during the December 2017 site visit, and HydroAir remains committed to prevent trespassing and potential disturbances to the site vegetative cover and if any additional trespassing is observed, HydroAir will consider additional site controls and/or security measures, including placing cement blocks to prevent vehicle access to these areas.

$\textit{July 2017-View from roof looking west towards grass-covered areas along western \textit{side of site}.}$

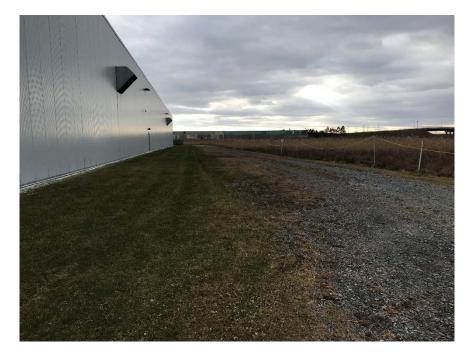
$December\ 2017-View\ from\ northeastern\ corner\ of\ site\ building\ looking\ west\ along\ site\ access\ road.$

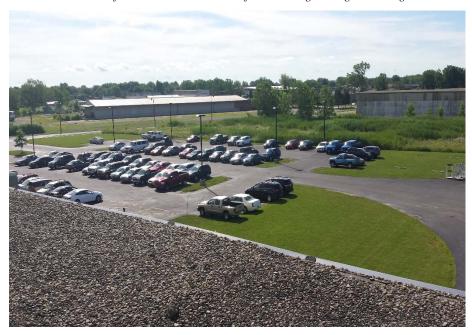
July 2017-View from southwestern corner of plant looking south towards parking lot areas.

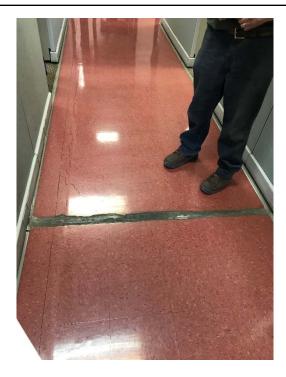
December 2017 – View of floor within server area of building. Photo of 2017 crack repair area.

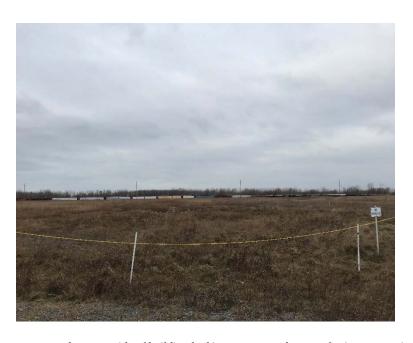
trespassing of ATVs entering the vegetated areas along the western edge of the site. These trespassers were approached by HydroAir security this year and following discussions with these individuals, no further of evidence of trespassing has been observed.

December 2017 – View from access road on west side of building looking west towards area of prior trespassing. No rutting or damage to vegetative cover observed during December 2017 inspection.
