13 February 2019  
File No. 129356-004

Subject: Hydro-Air Components, Inc. Property (Former Steelfields Area IV Parcel Site)  
Brownfield Cleanup Program (BCP) Site #C915204  
Site Management Periodic Review Report &  
Institutional Controls/Engineering Controls Certification

Property Name: Hydro-Air Components (Steelfields Area IV) Project No.: 129356-004  
Client: Hydro-Air Components, Inc.  
Property Address: 100 Rittling Blvd. City, State: Buffalo, NY Zip Code: 14220  
Property ID: 1402001321200001009121 Section: 132.12 Block: 1 Lot(s): 9.121  
Preparer's Name: Glenn White Date/Time: February 2019

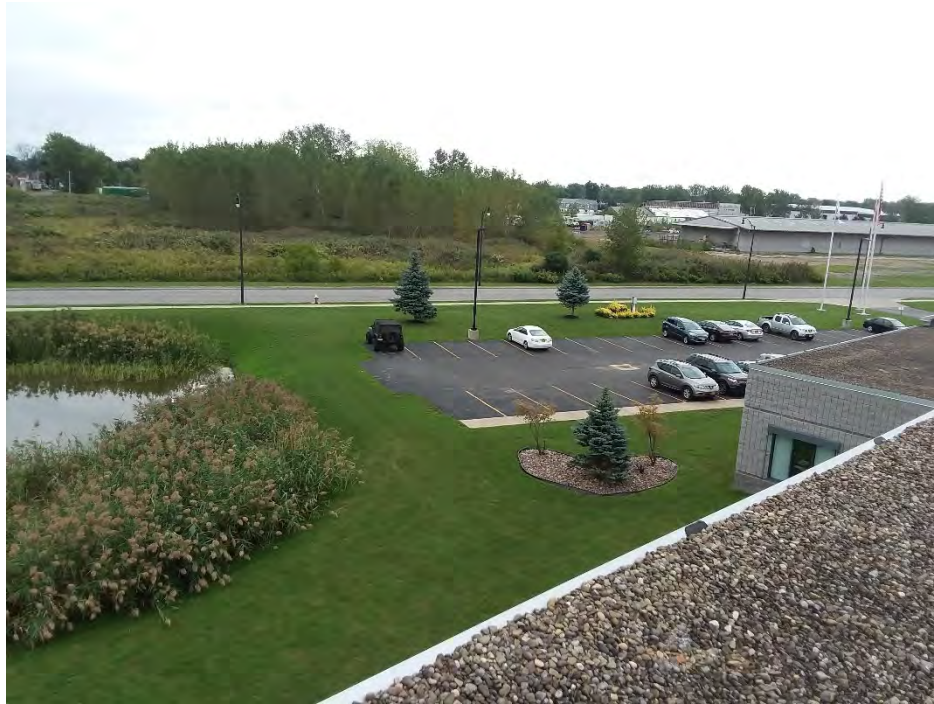
*September 2018 – View from eastern side of building roof, looking southeast.*

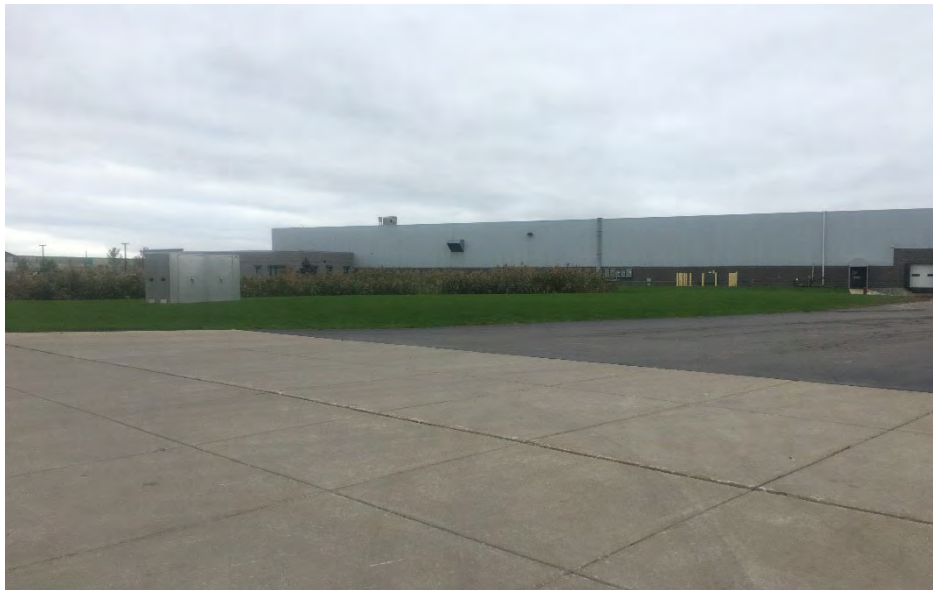
*October 2018 – View from northeastern corner of the site looking southwest towards stormwater retention pond.*

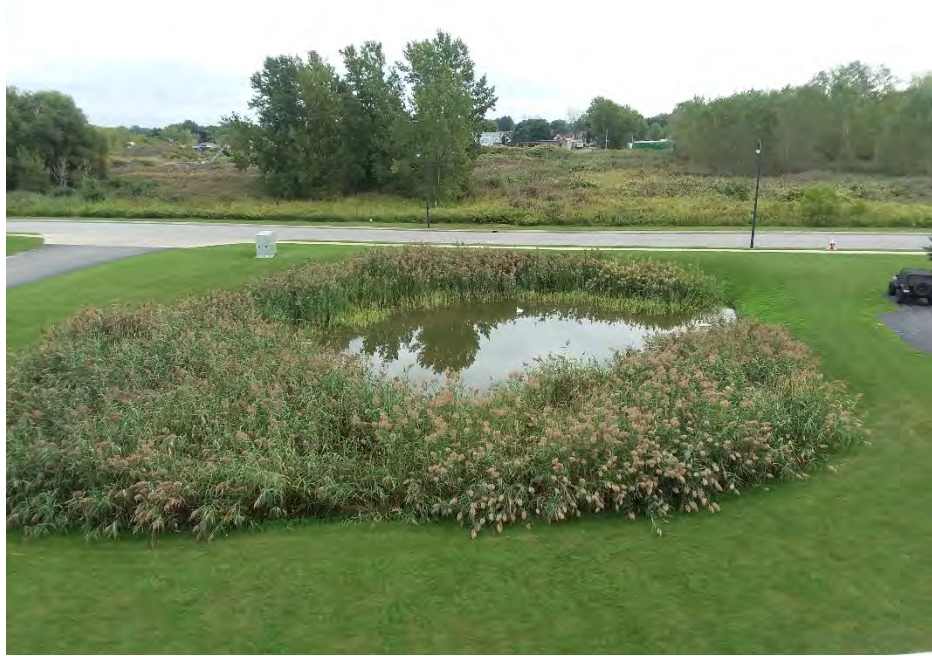
*September 2018 – View from eastern side of building roof, looking at stormwater retention pond.*

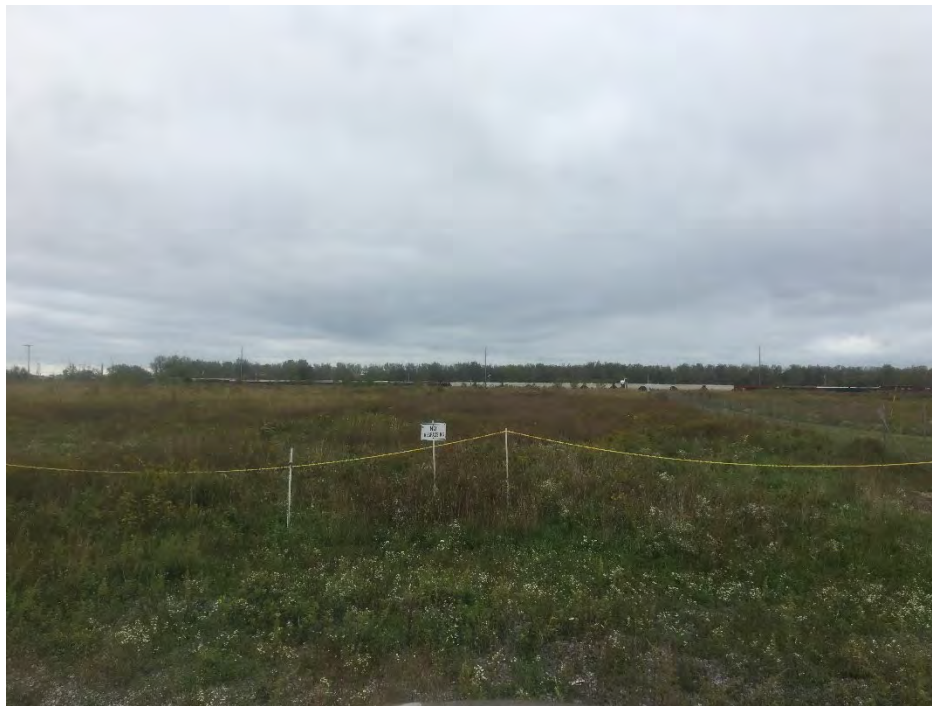
Ponding had been observed after installation of the soil cover in 2007. As requested by NYSDEC, French drains were installed in May 2008 and appear to have improved conditions. Ponding water was not observed during the annual inspection nor was it reported by HydroAir throughout the year. Some wetland vegetation continues to grow in the western interior of the site as evidenced in photographs taken in the 2018. (See attached photos). Over the prior few years (2016-2017), HydroAir had observed after-hours trespassing of ATVs into the western grass areas of the site (utilizing site to access the adjacent railroad right-of-way). A breach in the perimeter fence shared with the railroad corridor was also observed and subsequently repaired. In June 2017, HydroAir security confronted the trespassers and after discussions with these individuals no further trespassing has been observed. No evidence of trespassing and/or rutting was observed during the December 2018 site visit, and HydroAir remains committed to prevent trespassing and potential disturbances to the site vegetative cover. If additional trespassing is observed, HydroAir will consider modifications to site controls and/or security measures, (for example, placing cement blocks to prevent vehicle access to these areas).

*October 2018 – View from access road west of plant building looking west towards western vegetated portions of the site.*

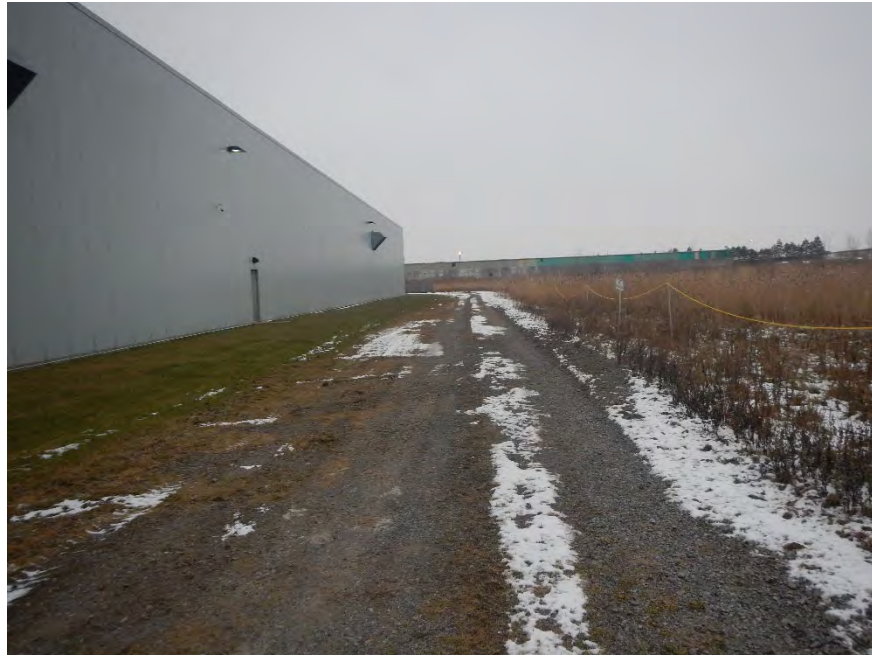
*December 2018 – View from northwestern corner of site building looking south along snow covered site access road.*

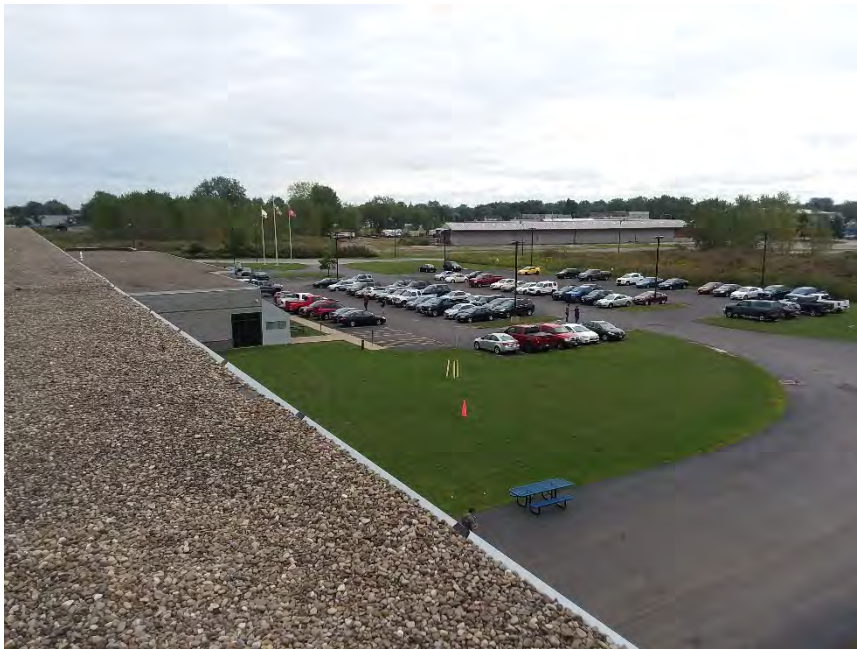
*September 2018 – View from southern side of plant roof looking southeast towards parking lot areas.*

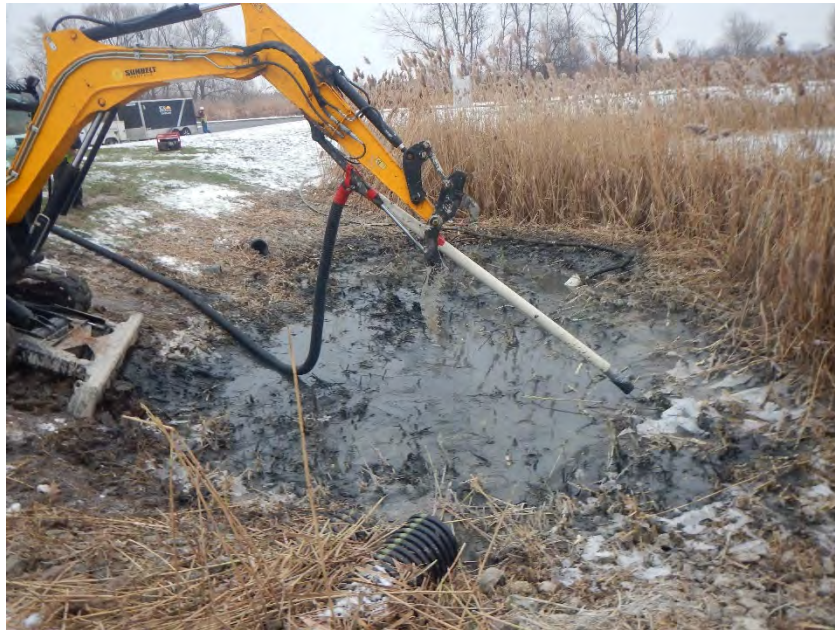
A contractor was mobilized to the site between 10-11 December 2018 to clean out an accumulation of high pH material that had precipitated into the northern embayment of the stormwater retention pond. As required, the week prior to this work the NYSDEC was notified of the cleanout activities. Vegetative growth (phragmites) was removed with heavy equipment and staged on plastic sheeting adjacent to the pond to drain excess water back into the pond. The drained vegetation was then placed into a roll off container and prepped for removal to a NYSDEC-permitted landfill. The following day, the contractor pumped excess water from the northern embayment back into the main pond. After the water was sufficiently drawn down, a vacuum truck was mobilized to the site to clear the accumulated material from the base of the embayment. The precipitated material was estimated to be approximately 1 to 1 ½ feet deep. Approximately 4 tons were removed from the embayment and this material was also then transported to a NYSDEC-permitted landfill.

*December 2018 – View looking east towards stormwater pond northern embayment. (Embayment being cleaned out).*

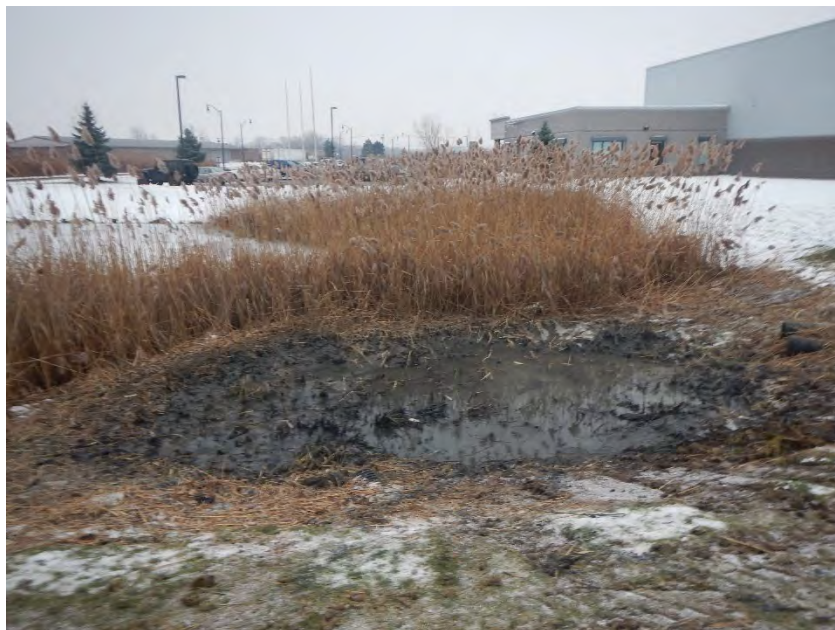
During the 2018 northern pond embayment cleanout activities conducted in December 2018 (see attachment to page 1 of 3), some minor rutting was caused by heavy equipment in the vegetated (grass) areas surrounding the pond. It was agreed upon that restoration of these areas would be conducted in the Spring of 2019, at the start of the growing season. The rutting was temporarily graded off. The site cover/fill was not compromised and the rutting was limited only to the top few inches of the cover.

*December 2018 – View looking south towards northern embayment following cleanout activities.*

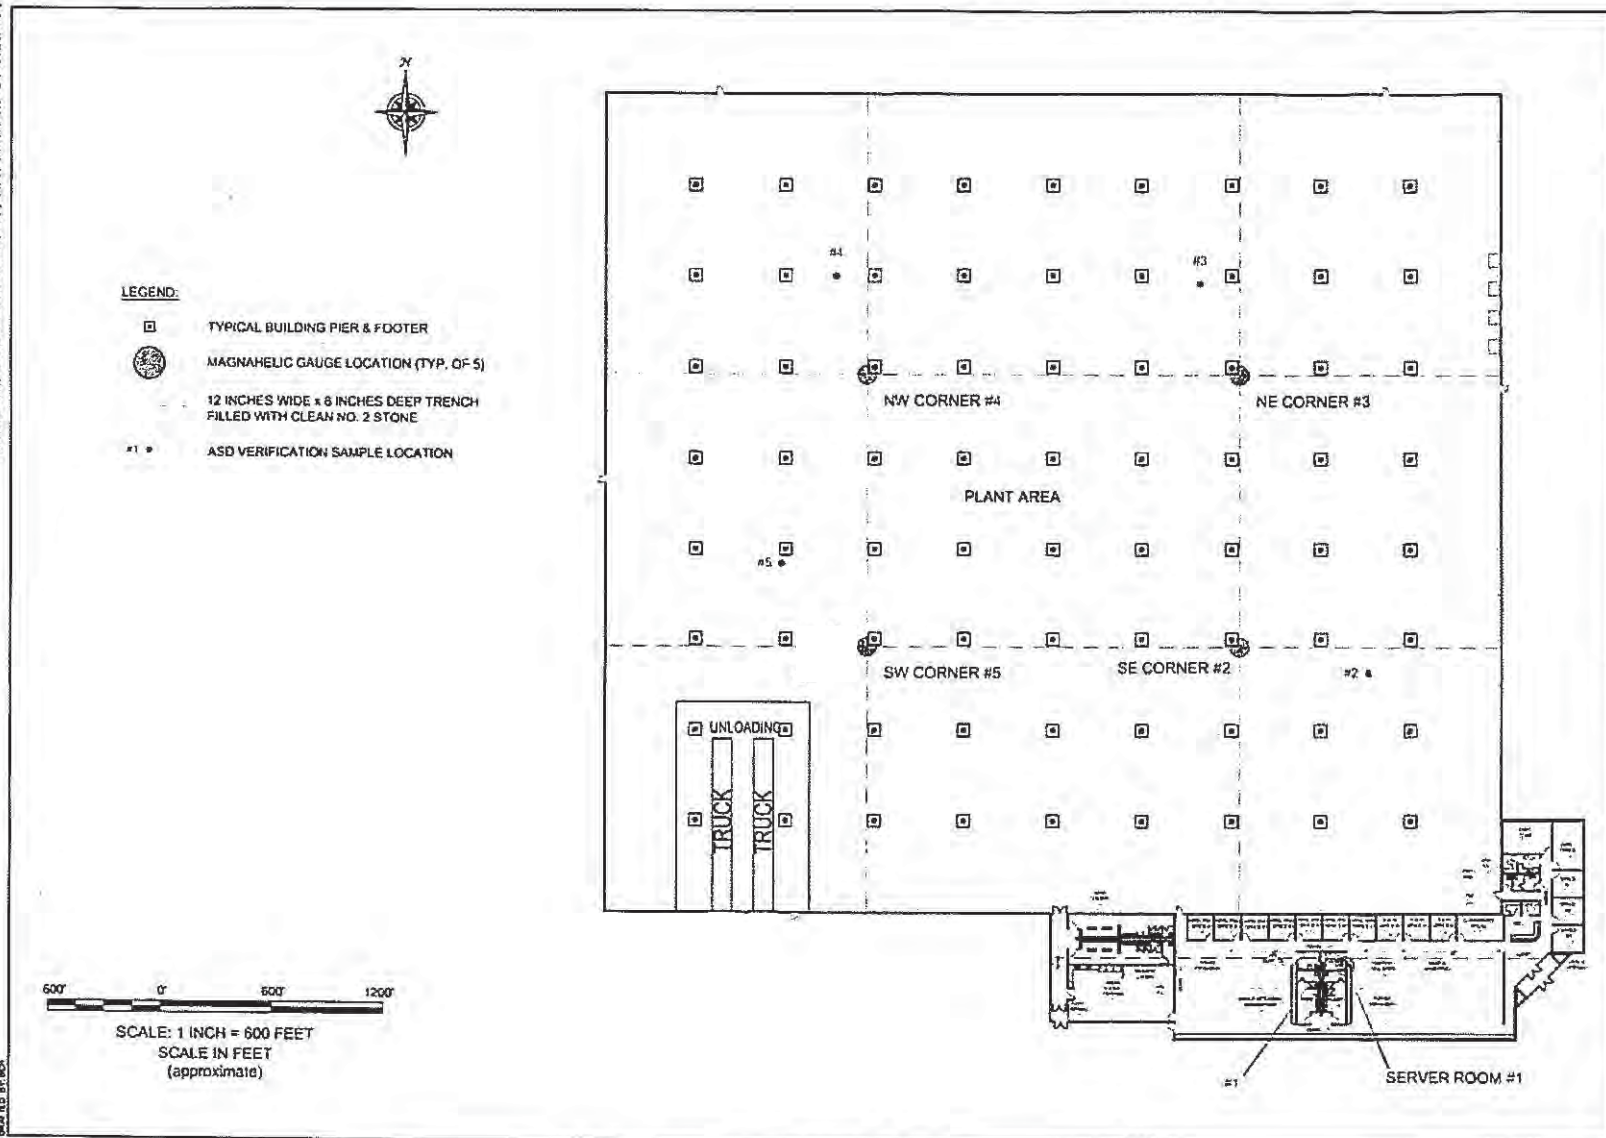
# ASD SYSTEM & POST-INSTALLATION SAMPLE LOCATIONS

Air tubing connected to the magnahelic gauge located in the NE corner of building was replaced in March 2018 after it was discovered the previously installed tubing had a leak, leading to lower readings.
