NEW YORK STATE DEPARTMENT OF ENVIRONMENTAL CONSERVATION

Trip Report

Site Name: Steelfields Area IV (C915204).

Date of Visit: 4/29/2025

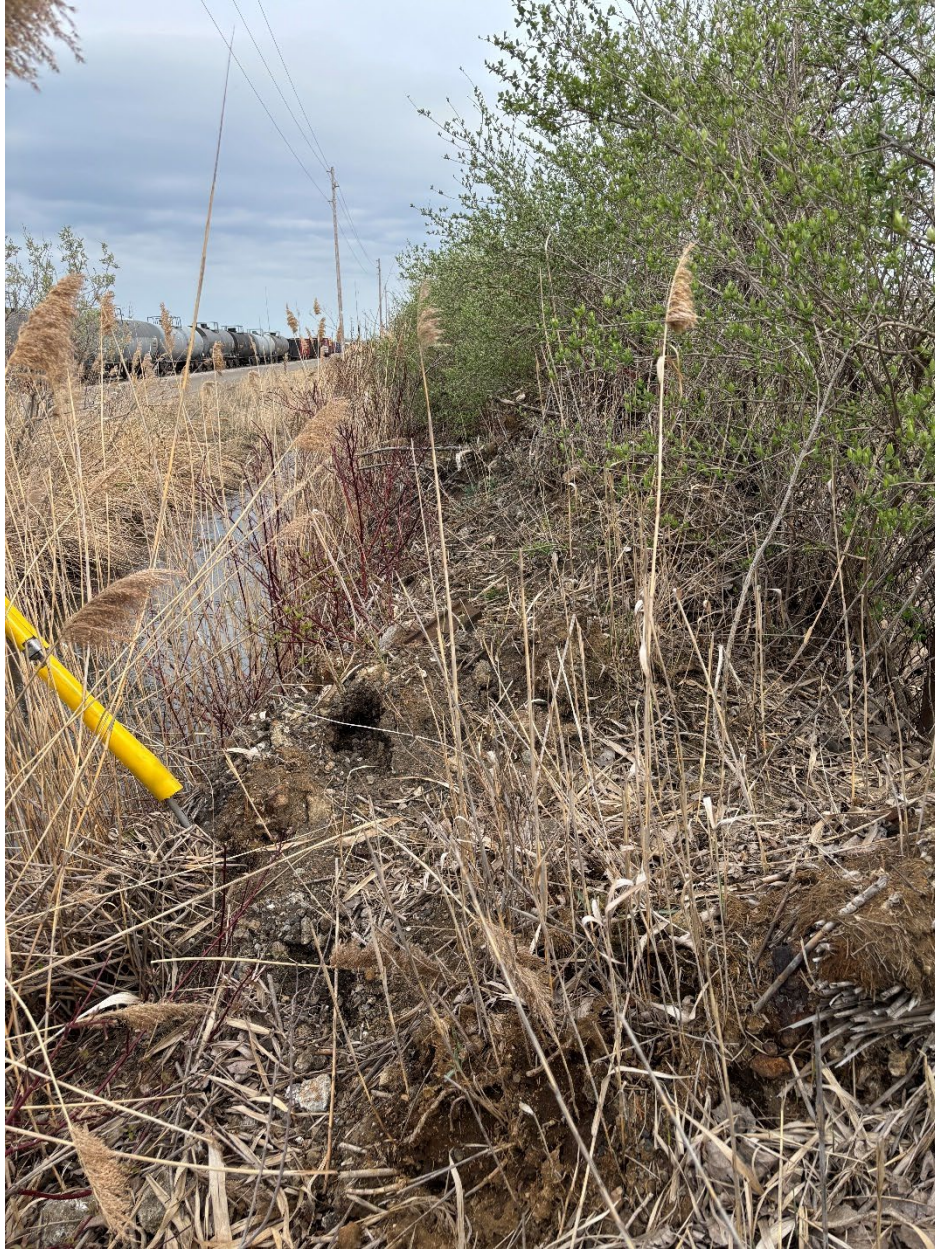
The ERS utilized the Ludlum 2241 ratemeter paired with the 44-10 NaI Probe to survey a windrow of material along the rail line that contained slag and other fill material. Due to the overgrown vegetation the ERS was only able to survey certain sections along the entire windrow.

1. Overgrown vegetation along the survey area

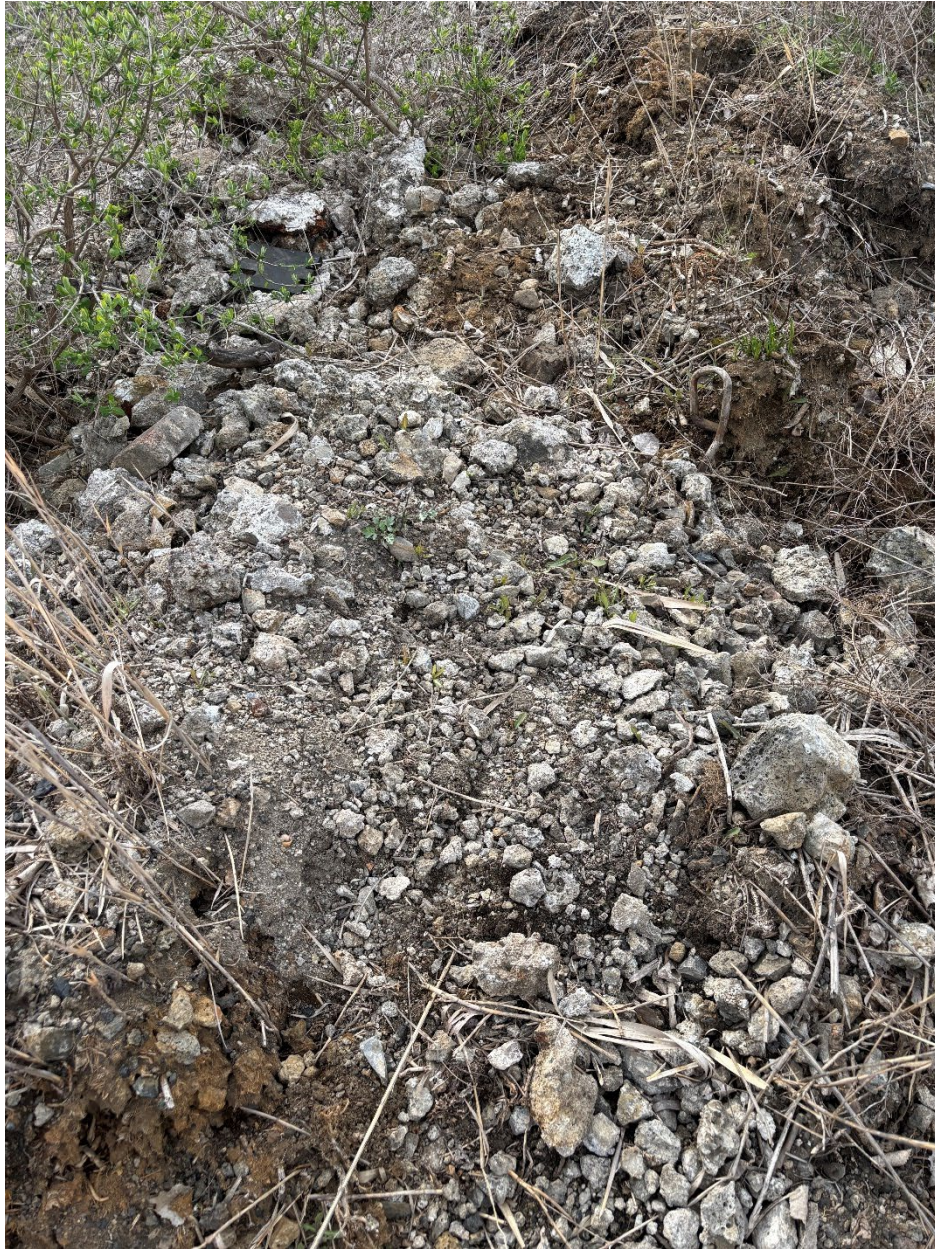
2. Example of exposed fill material encountered along windrow

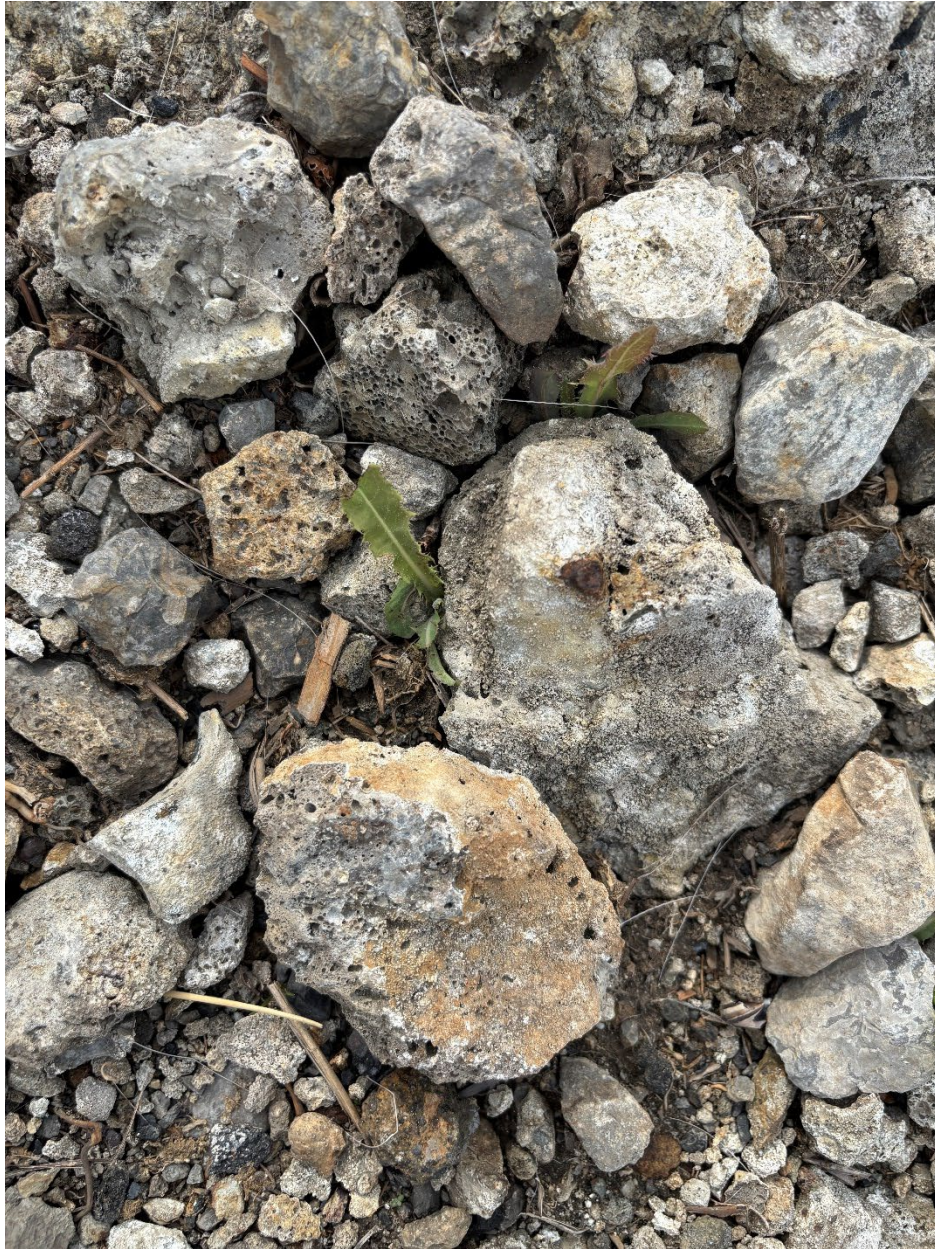
3. Close up photo of slag-like material encountered during the survey

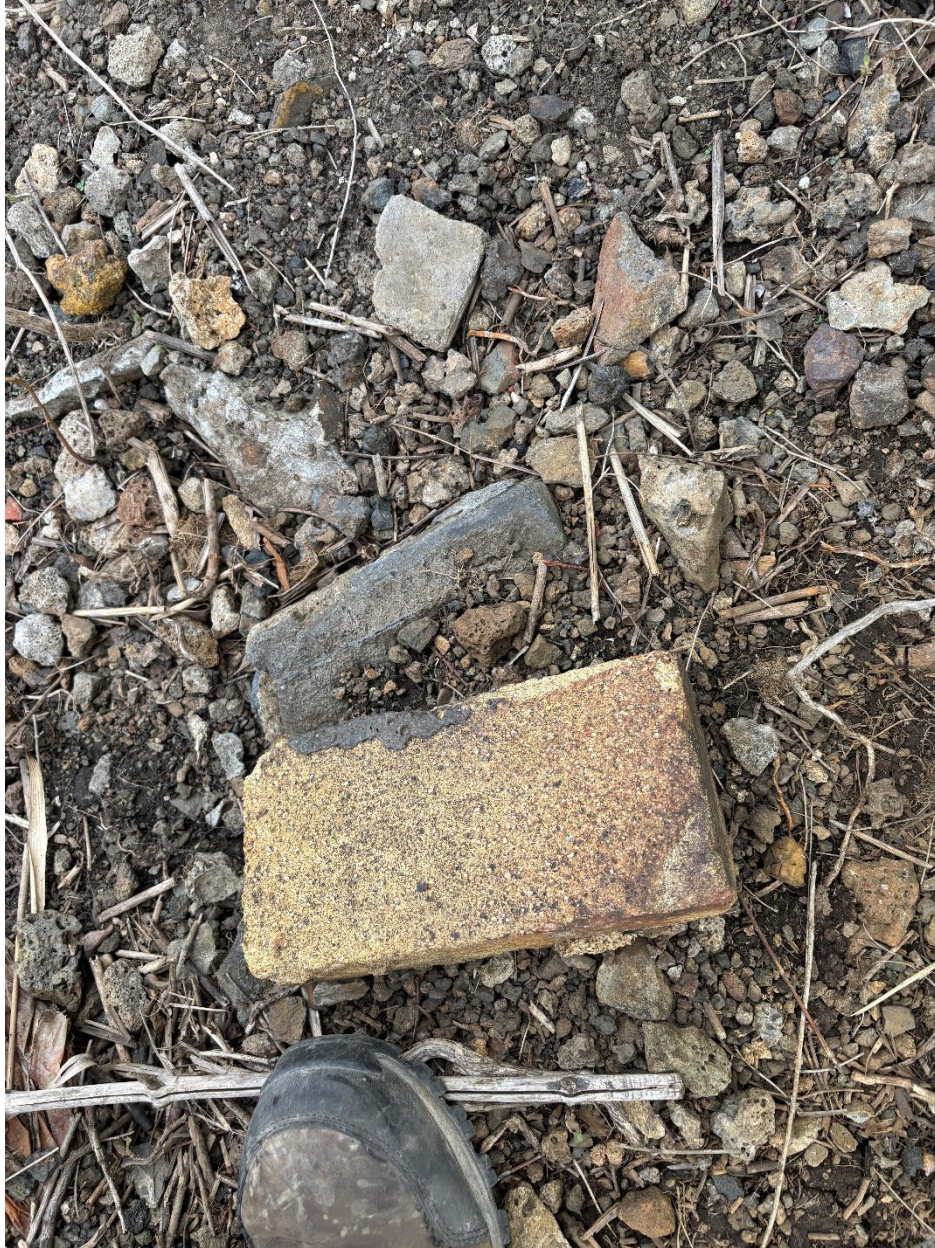
4. Close up photo of the “yellow brick” found sporadically along the windrow

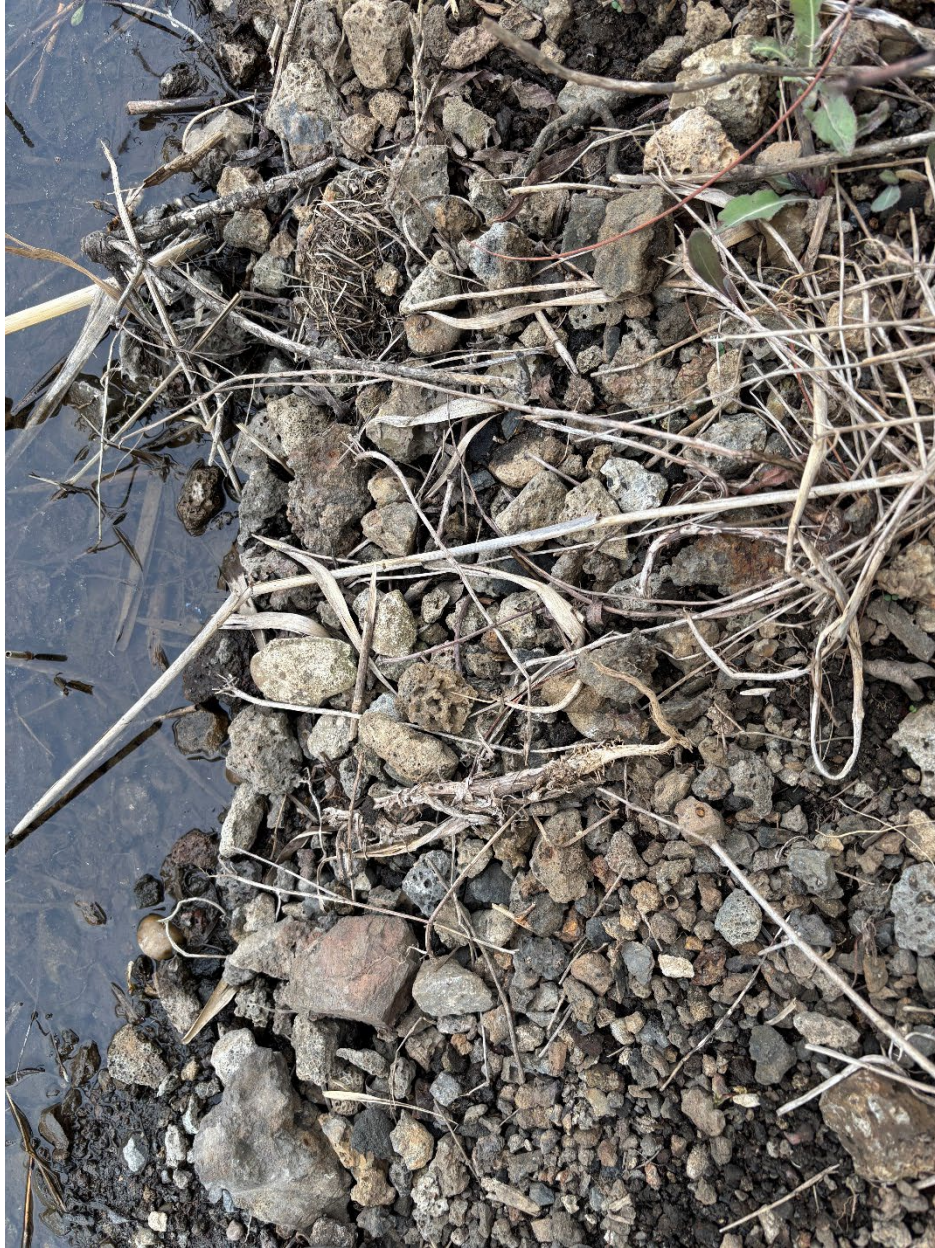
5. Close up photo of a local exceedance above 10 kcpm

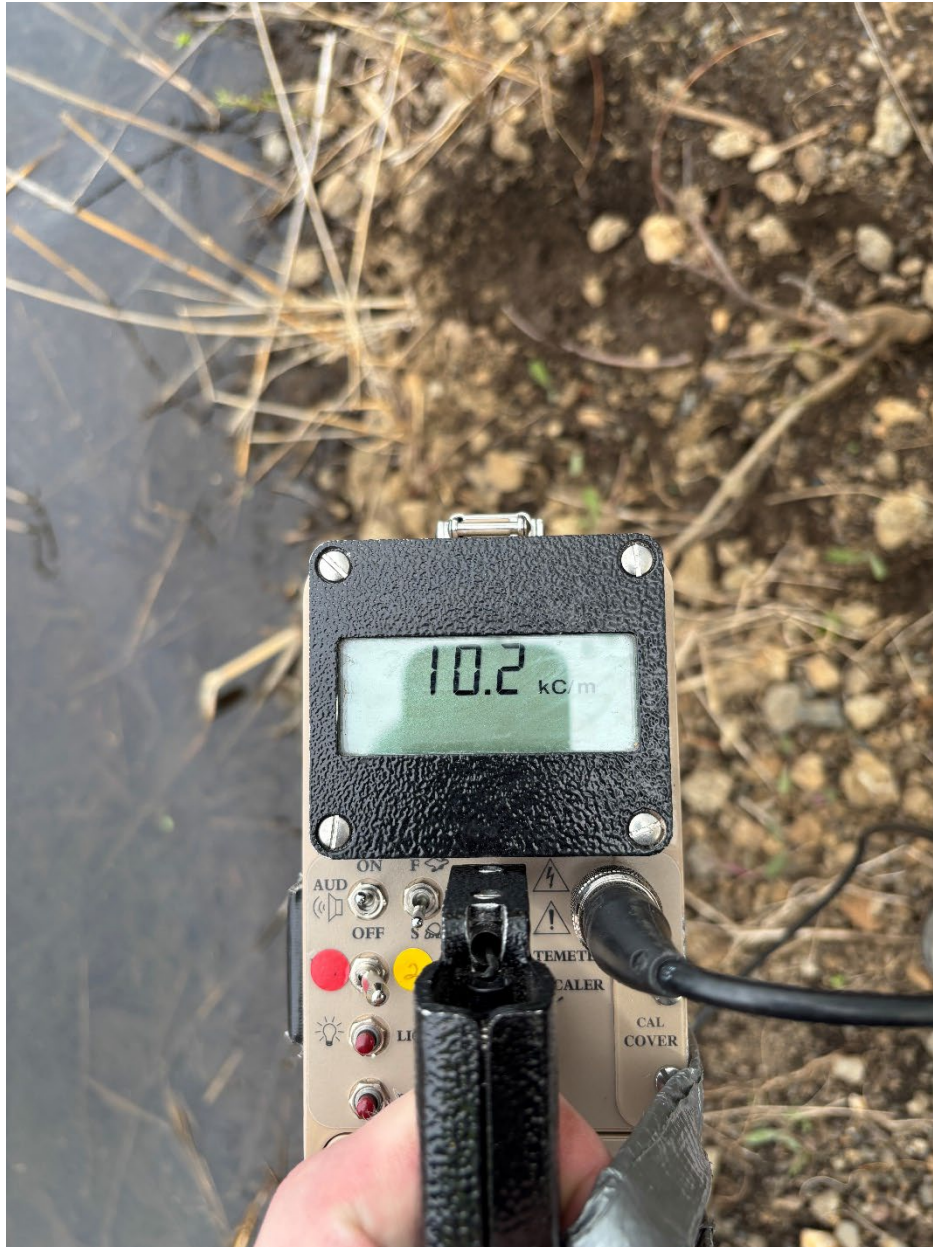
6. Photo of the ratemeter while surveying the local exceedance mentioned above
