Re: Pierce Arrow Development Project

Brownfield Cleanup Program Application

Supplement to: Application to NYS Brownfield Cleanup Program Former Pierce Arrow Manufacturing Site 255 Great Arrow Way, Buffalo, New York

PIERCE ARROW REDEVELOPMENT SITE
SUMMARY OF ENVIRONMENTAL CONDITIONS BUILDING W AREA

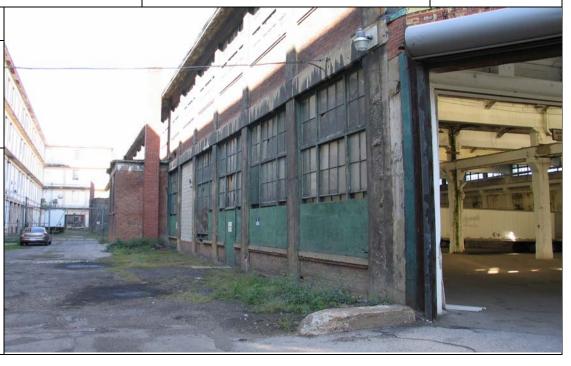
1

Building B – South outer wall of building.

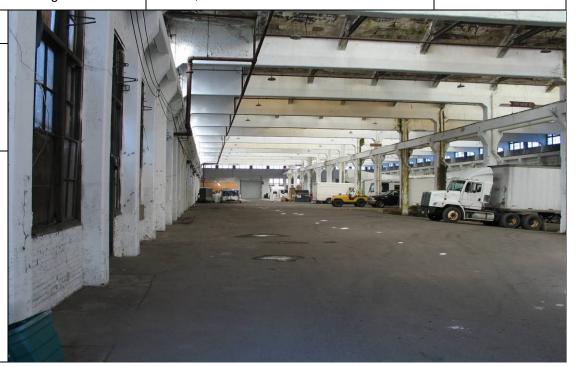
Building B - Inside south wall.

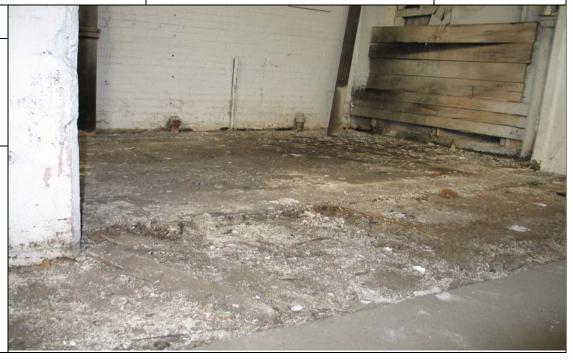
Building B – Rotting wood flooring of drum storage site south wall of building.

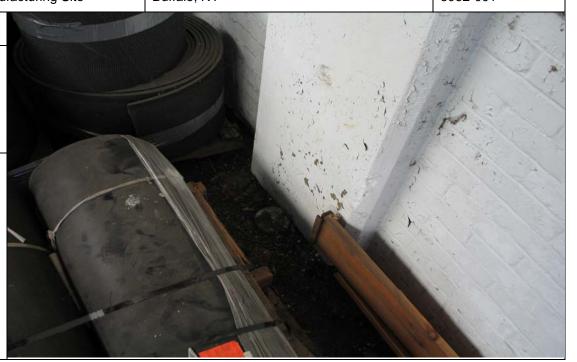
Building B – Suspect pipe on floor at west wall.

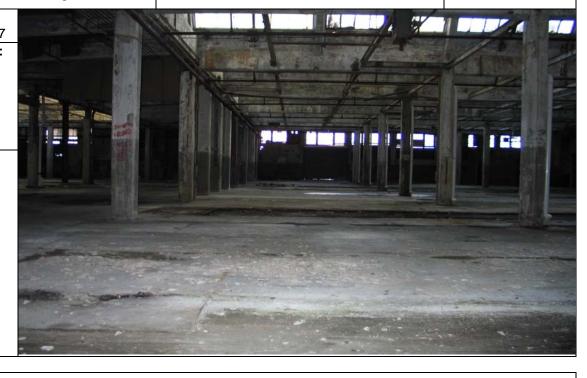
Photo No. 5

Building A - Mineral spirits storage area.

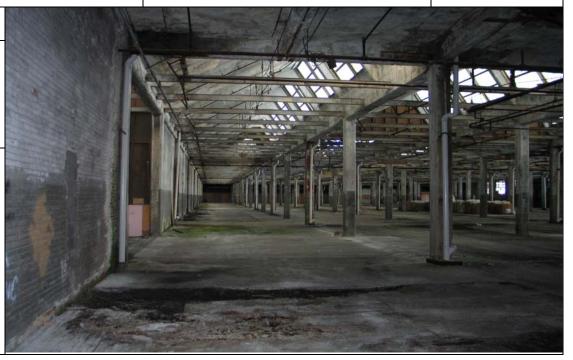
Building A – South side walls inside building.

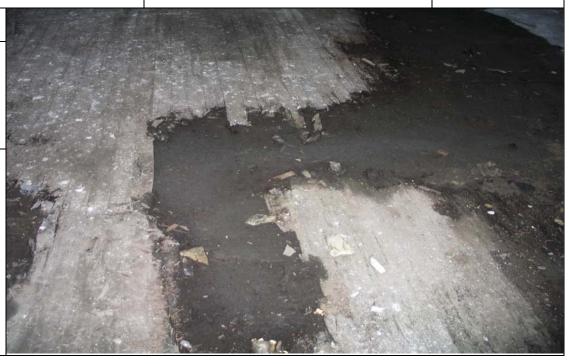
Building A – Rotting wood floor at southeast corner of building.

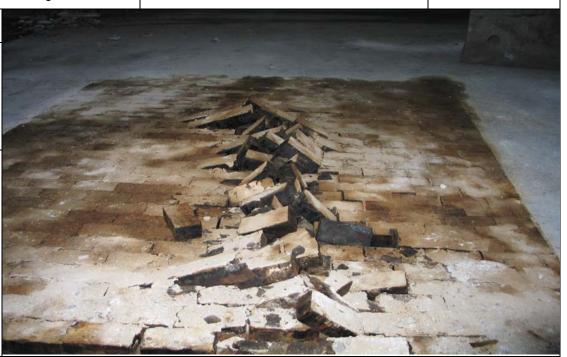
Building A – Rotting, oilsoaked wood block floor at east end of building.

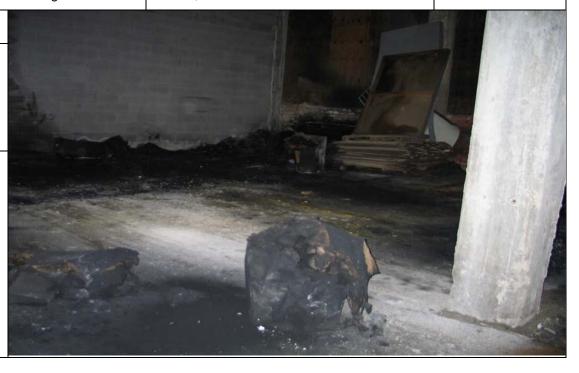
Photo No. 9 **Date:** 9/18/2007

Building A – Open compromised bags containing unknown black substance.

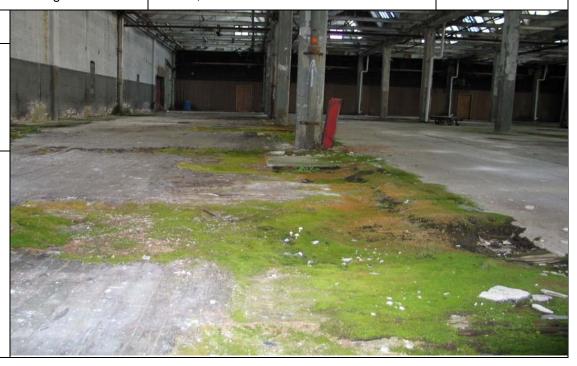
Building A – Southwest floor with green moss.

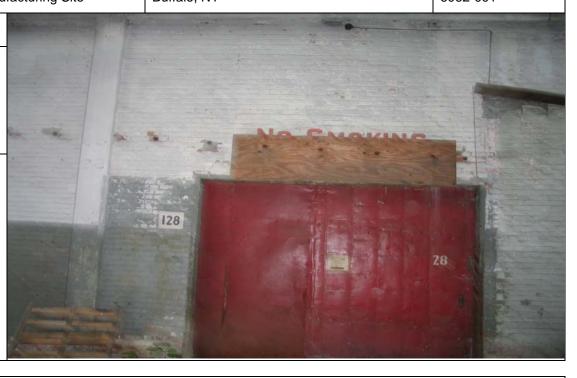
Building A – Red door of former cyanide room.

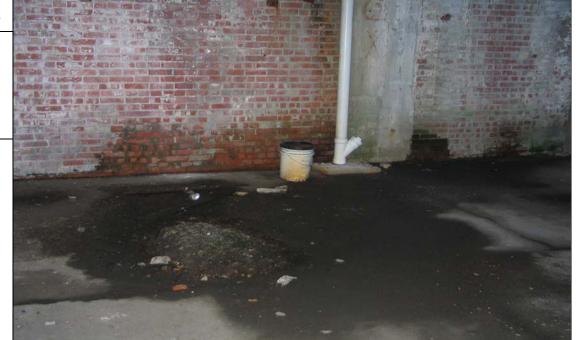
Photo No. 17

Building A – Oily stained floor and 5 gallon bucket of penetrating oil in building.

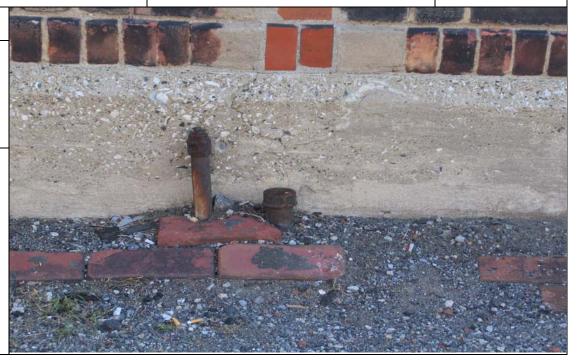
Photo No. 36

Building A – Tank fill pipe - center of west wall.

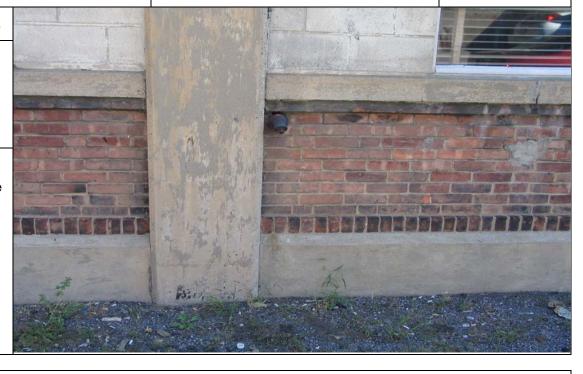
Building A – Tank fill pipe north of center of west wall.

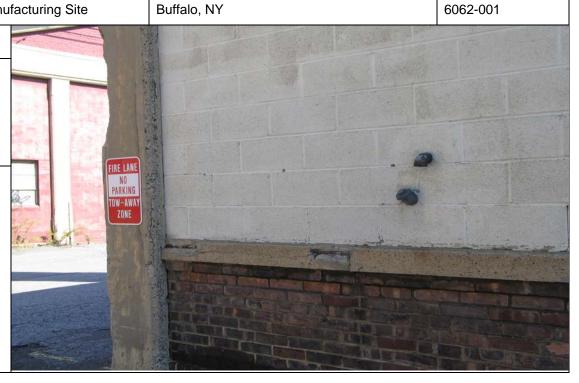
Photo No. 38

Building A - 2 pipes - 1 fuel oil fill pipe northwest corner.

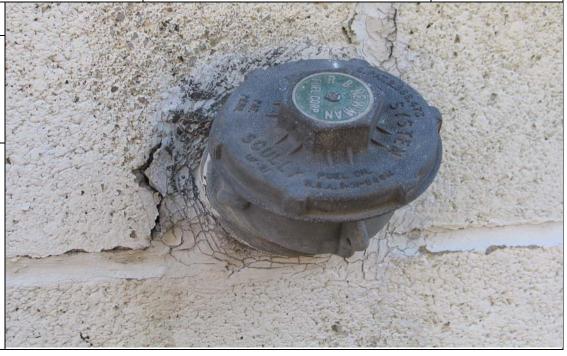
Building A – Close up of northwest fill pipe.

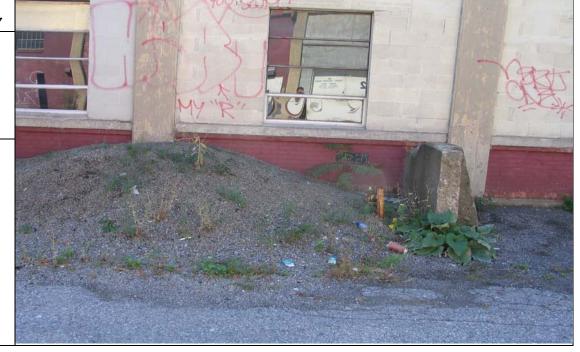
Building A – Fuel fill pipe and possible excavation backfill on north wall of building.

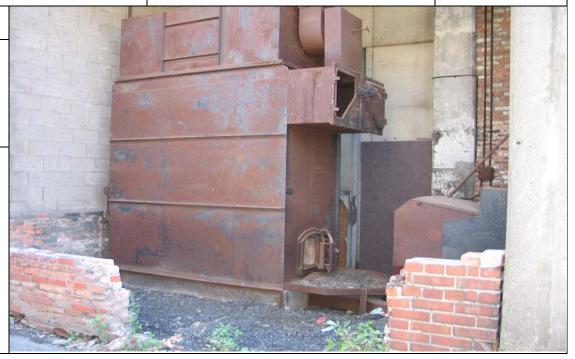
Building A – Old furnace on outside north wall of building.

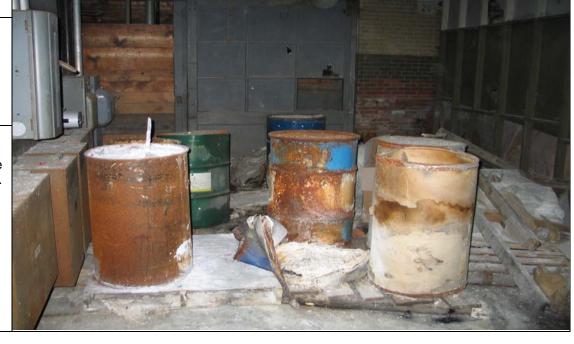
Building C – Compromise waste drum storage area.

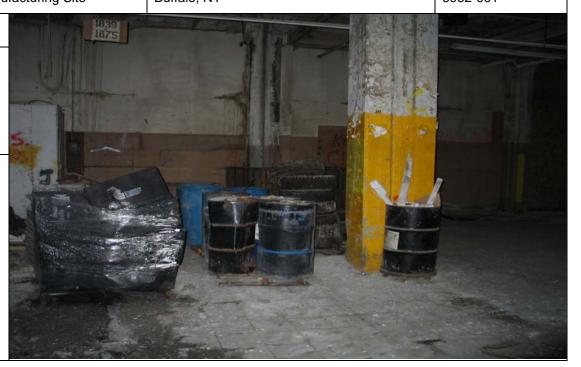
Building C – Compromise waste drum storage area.

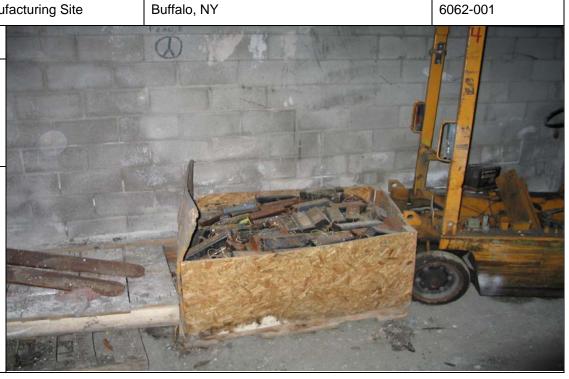
Photo No. 16 **Date:** 9/18/2007

Building C – Crate of fluorescent light ballasts in north area of building.

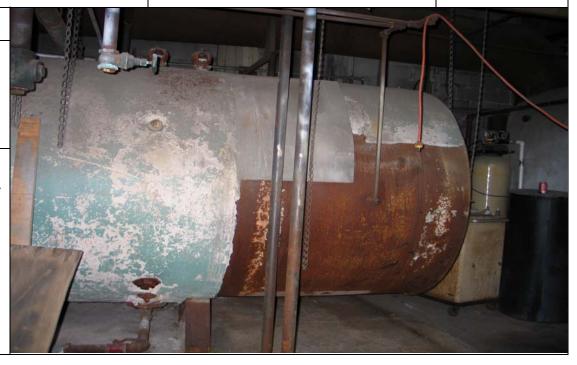
Building C – Boiler room - asbestos coating on boiler.

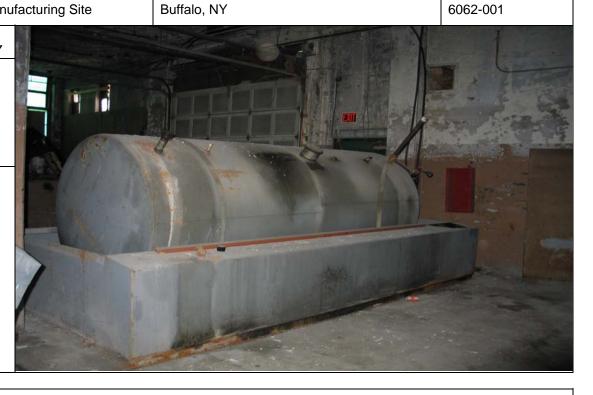
Building C – Empty UST for boiler.

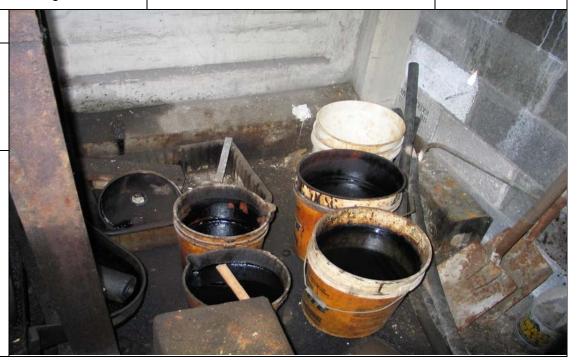
Building C – Fuel pump room – buckets of oil and staining.

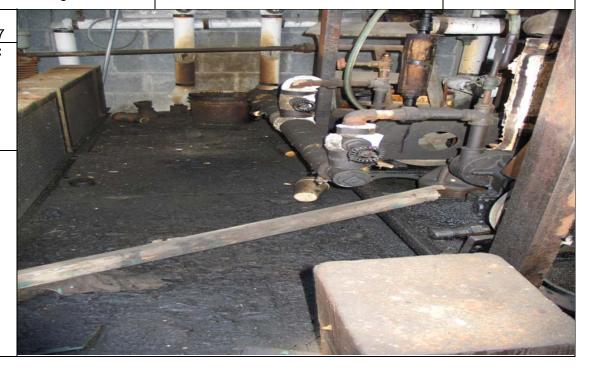
Building C – Fuel pump room – oil soaked floor.

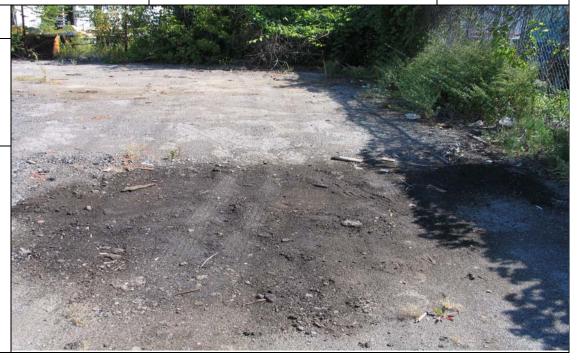
Photo No. 49 **Date:** 9/18/2007

Building D – Oily stained soil at east end of site.

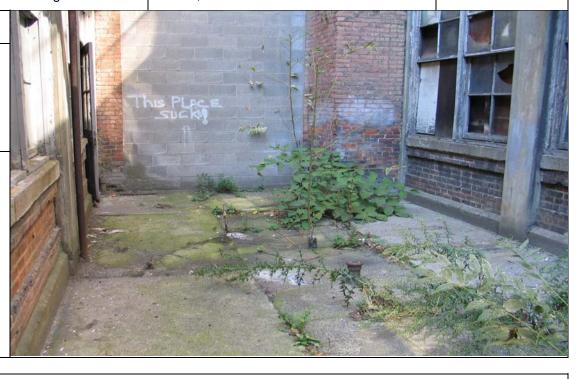
Building G & H – West tank fill-port in courtyard with suspected UST.

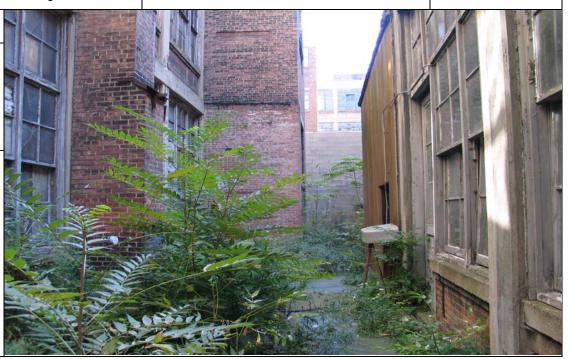
Photo No. 32

Building G & H – Courtyard between building with suspected UST.

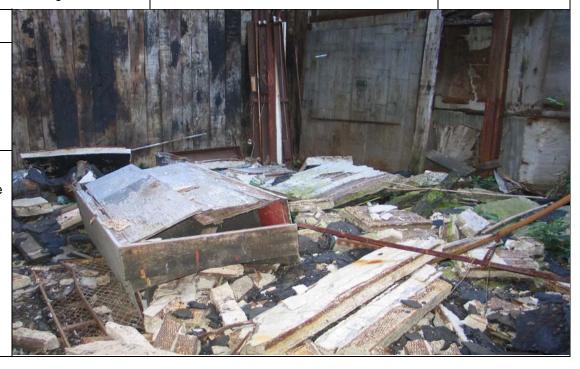
Photo No. 34

Building G & H – Furnace room of building courtyard containing unknown debris.

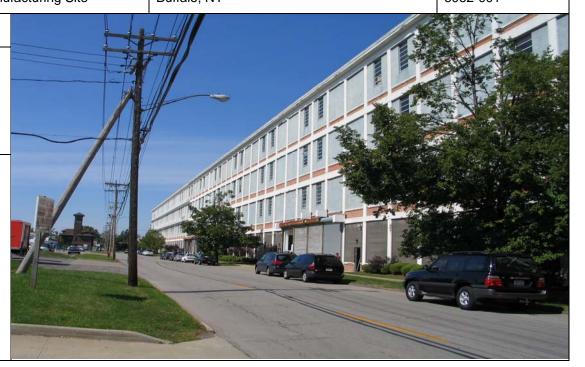
Photo No. 55

Building G & H – Front of building adjacent to historic UST locations.
