Report No.: 172-016	E&E Project	E&E Project File: NV28.03 Da			ate: Monday, February 20, 2006			
NYSDEC	DR 172 - 016		Temperature: (F)	15	(am)	31	(pm)	
Division of Environr	Division of Environmental Remediation			W	(am)	W	(pm)	
Shenago Steel Mold Site, NYSDEC #9-15-172			Weather:	(am) Ov	ercast			
				(pm) Cle	ear			
Contract # D005660		Arrive at site	0650	(am)				
Buffalo, New York			Leave site:	1547	(pm)			
HEALTH & SAFETY:								
Are there any changes to (If yes, list the deviation un		?	Yes ()	1	No (X)			
Are monitoring results at a	acceptable levels?	Soil Waters Air	Yes () n/	a (̀ X)	No () No () No ()			
OTHER ITEMS:		7 tii	If No, provide comments					
Site Sketch Attached:			Yes () N	o(X)				
Photos Taken:			Yes (X) No ()					
DESCRIPTION OF DAILY	Y WORK PERFORMED:							
excavator, and using it to point were neither excave Hydraulic Oil Spill Area in Horizon loaded out (7 tru	•	ween the track rizon continued pegan demolition as soil from the	s of both excavator lexcavating and lo on of he vault with Hydraulic Oil Spill	rs. The traded ad out soil the Deere Area to P	cks were f from the l 200LC ex ariso Truc	rozen to LNAPL cavator. king for

Report No.: 172-016 E&E Project Fi

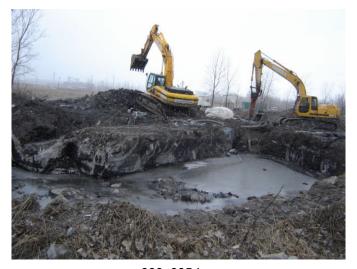
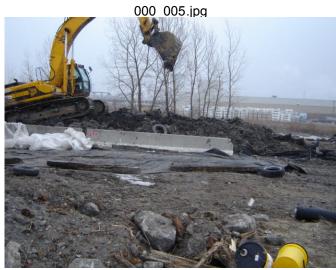
000_007.jpg 000_008.jpg

Horizon would like to use a Vacuum Truck to remove water from the open excavation in the LNAPL area. Site Representative unable to view the floor conditions of the LNAPL area excavation due to approximately 4-feet of standing water.

Date	Photo ID	Description	Direction
2/20/06	000_005.jpg	Horizon attempting to break up concrete foundation in LNAPL Area.	N
2/20/06	000 006.jpg	Upper 4-feet of excavated side wall in Hydraulic Oil Spill Area.	NW
2/20/06	000_007.jpg	Existing stockpile of LNAPL Area.	S
2/20/06	000 008.jpg	Concrete foundation appears to be 6-feet in depth.	N

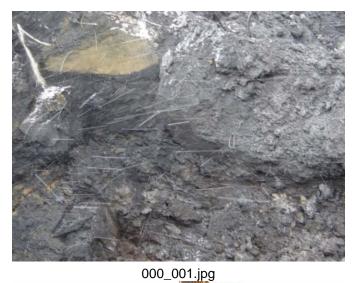
Date	Photo ID	Description	Direction
2/21/06	000_001.jpg	Excavation to native clay appoximatley 11' below ground surface	SE
2/21/06	000_002.jpg	Oil sheen on water in Hydraulic Oil Spill Area (LNAPL) excavation.	SE
2/21/06	000_003.jpg	Excavating on the north side of the Hydraulic Oil Spill Area (LNAPL).	W
2/21/06	000_004.jpg	Loading out excavated soil from the Hydraulic Oil Spill Area (LNAPL).	W

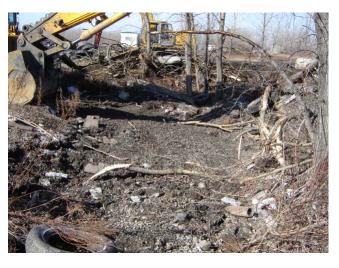
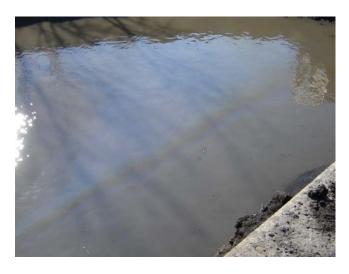
000 0038.jpg 000 039.jpg

The task of demolition of the concrete foundation in the Hydraulic Oil Spill Area may extend past the submitted project schedule for completion of excavation.

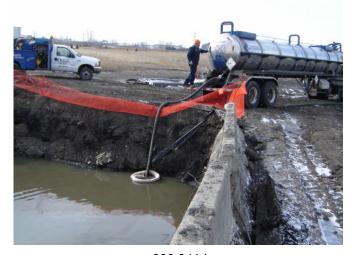
000_040.jpg 000_041.jpg

Date	Photo ID	Description	Direction
2/23/06	000 040.jpg	LNAPL Area additional 5' excavation on west end of excavation.	NW
2/23/06	000 041.jpg	LNAPL Area excavation dewatering process.	W
2/23/06	000 042.jpg	Discharging water from LNAPL to infiltration basin	S

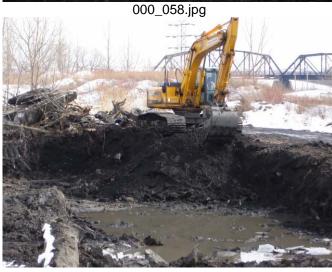
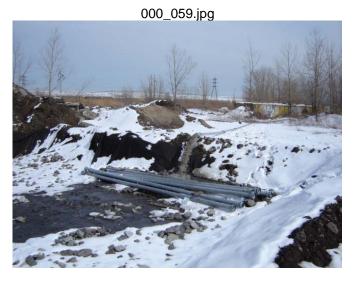
000_060.jpg 000_061.jpg

Date	Photo ID	Description			
3/06/06	000 058.jpg	View of concrete removal from southwest corner of LNAPL excavation.	SW		
3/06/06	000 059.jpg	View of clay on the floor of LNAPL southwest corner of excavation.	SW		
3/06/06	000 060.jpg	View of remaining soil to be excavated from LNAPL area.	W		
3/03/06	000 061.jpg	View LNAPL Area dewatering discharge to the infiltration basin.	SW		
3/06/06	000 062.jpg	View of excavated west wall of LNAPL area.	N		
3/06/06	000 063.jpg	View of east and north wall of excavated LNAPL area.	N		
3/06/06	000 064.jpg	View of discharged water in infiltration basin.	S

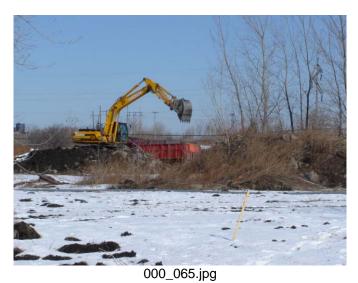
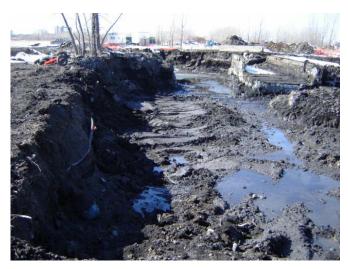
000_067.jpg 000_068.jpg

Date	Photo ID	Description	Direction
3/07/06	000 065.jpg	View of non-hazardous soil load out in the TGA.	N
3/07/06	000 066.jpg	View of slag material 4-feet BGS in the Test Pit # 2 area of the TGA.	SW
3/07/06	000 067.jpg	View of LNAPL Area. Post excavation 100%.	N
3/07/06	000 068.jpg	View of LNAPL Area Post excavation 100%.	SW
3/07/06	000 069.jpg	View of concrete foundation in Test Pit # 2 area of the TGA.	S
3/07/06	000 070.jpg	Overall view of the Test Pit # 2 excavation area in the TGA.	SW

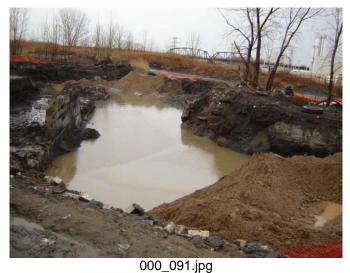
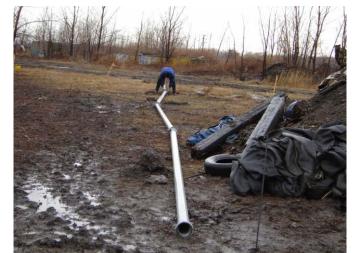
000_093.jpg 000_094.jpg

Date	Photo ID	Description	Direction
3/13/06	000 091.jpg	View of standing water on the west end in the LNAPL area.	N
3/13/06	000 092.jpg	View of standing water on the east and north end of the LNAPL area.	NW
3/13/06	000 093.jpg	View of Horizon personal assembling discharge pipe from the LNAPL area.	S
3/13/06	000 094.jpg	View of standing water in the TGA LNAPL excavation.	SE
3/13/06	000 095.jpg	View of standing water in the north end of TGA LNAPL excavation.	SE
3/13/06	000 096.jpg	View of three foot excavation north end of the TGA.	N
3/13/06	000 097.jpg	View of infiltration basin floor condition.	W

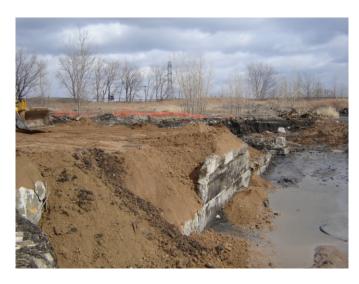
Photo 1 LNAPL Area

Date	Photo ID	Description	Direction
3/15/06	1	View of LNAPL Area showing backfill operations	SE
3/15/06	2	View of LNAPL Area showing fill offloading area	S
3/15/06	3	View of LNAPL Area showing direct fill placement at northeast corner	NE
3/15/06	4	View of TGA LNAPL Area showing excavator and groundwater conditions	N
