November 2022
Buffalo River Area of Concern

Buffalo River Annual Monitoring Report 2022

Honeywell International Inc.
115 Tabor Road
Morris Plains, New Jersey 07950

Anchor QEA Engineering, PLLC
290 Elwood Davis Road
Suite 340
Syracuse, New York 13088

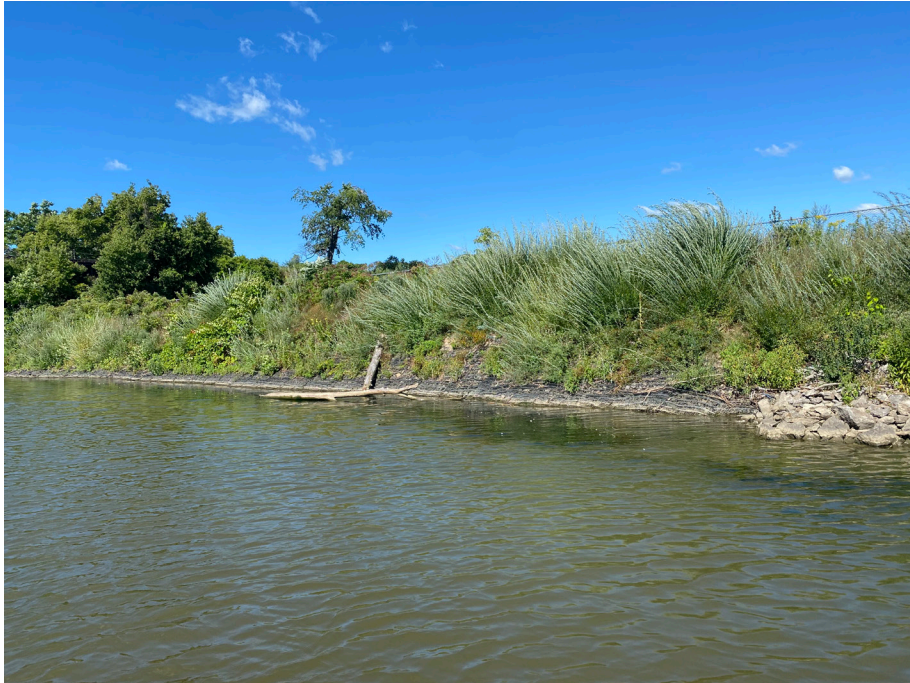
Photograph 3
DMUs 9 and 10 Knee Wall Area

Comments (Erosion along shoreline? Note what/where, photo ID):	Small area of exposed geotextile upstream of knee wall area was observed by accompanying City of Buffalo staff. Was confirmed with property owner not to be a component of remedial measure.
--	--

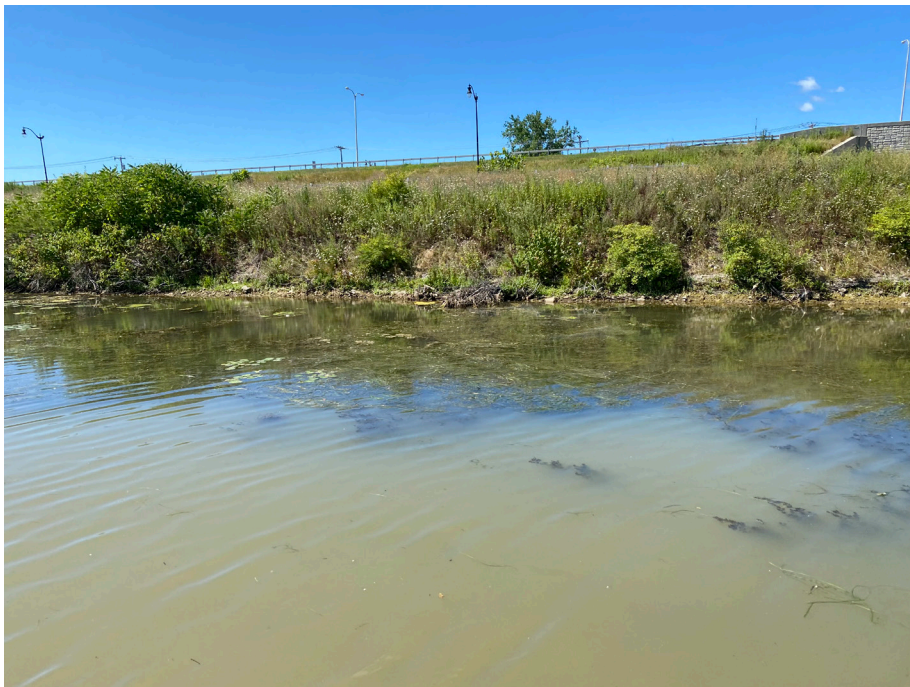
Photograph 6
City Ship Canal Habitat Restoration Area—Turbid Water Area

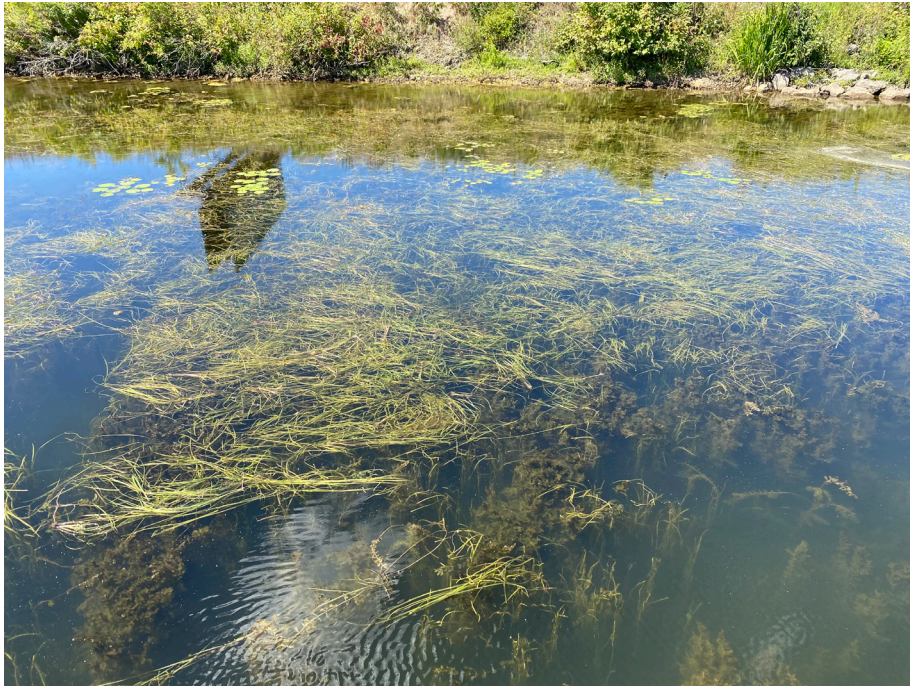
Photograph 7
City Ship Canal Habitat Restoration Area—Clear Water Area

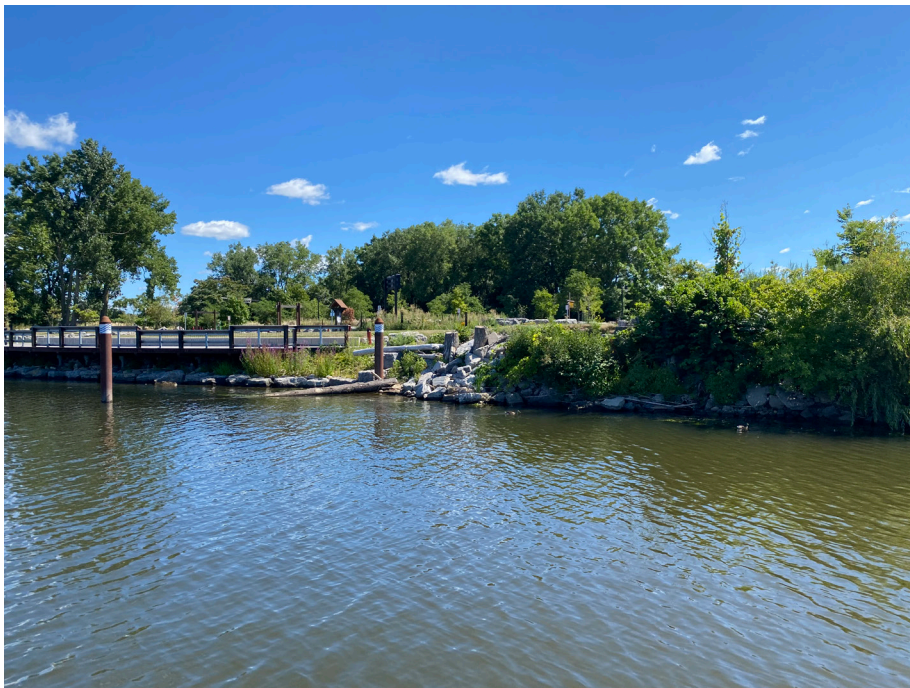
Photograph 8
Ohio Street Shoreline Habitat Restoration Area

Ohio Street Shoreline	No	Adjacent upland and in-water area has undergone park restoration on NYSDEC property (Ohio Street Shoreline Access Project) but has not impacted restoration area. Healthy SAV bed remains, as previously documented in 2020 and Year 5 GLLA Project Monitoring.
	Katherine Street Peninsula	No	Healthy SAV bed remains as previously documented in 2020 and Year 5 GLLA Project Monitoring. Shoreline stand of cattails was observed resulting from 2017 EV planting test performed as part of GLLA Project operation, maintenance, and monitoring efforts.
	Buffalo Color	No	Healthy SAV bed remains as previously documented in 2020 and Year 5 GLLA Project Monitoring. Some invasive SAV coverage observed (Eurasian watermilfoil).

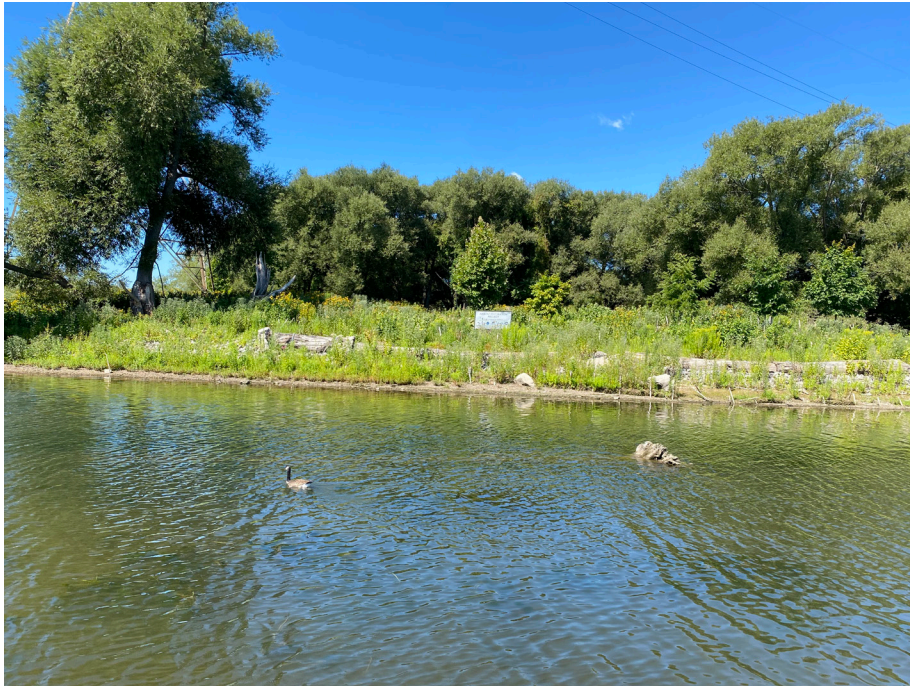
Photograph 9
Katherine Street Peninsula Habitat Restoration Area

Submerged Aquatic Vegetation (SAV) present?	Yes
Comments on presence/absence of vegetation growing beneath water surface:	Vallisneria americana, Potamogeton natans, Potamogeton crispus, Ceratophyllum demersum
Emergent Vegetation (EV) present?	Yes
Comments on presence/absence of vegetation emerging from water surface (e.g., lilies, grasses, fleshy leaved plants):	Nymphaea odorata, small batch of Cattails planted as part of 2017 OM&M effort
Signs of significant erosion?	No
Comments (Erosion along shoreline? Note what/where, photo ID):	N/A
Are large (> 100 square foot) accumulations of floating debris present?	No
Comments (Natural materials, anthropogenic materials, photo ID):	N/A
Was accumulated debris removed?	No
Comments (date removed; if not removed, reason not removed):	N/A
Installation of shoreline or nearshore structures?	No
Comments on Installation of shoreline or nearshore structures (e.g., piling, piers, armoring, fill placement, sheeting, mooring, boat ramp, etc.):	N/A

Presence of petroleum sheen on water surface?	No
Comments on color and size (square feet) of sheen area. Contact USCG if source is identifiable.	N/A
Presence of invasive species?	No
Comments (estimate % of area dominated by invasives, invasive species present)	N/A
Photographs from set points?	Yes
Photo IDs (file names) and locations. If set points for reference photos have not been identified, identify them and provide coordinates for future monitoring	See photograph log and photograph database
Other Photographs?	Yes
Photo IDs (file names), locations, and notes	See photograph log and photograph database
Other Comments:	No indications of significant disturbance

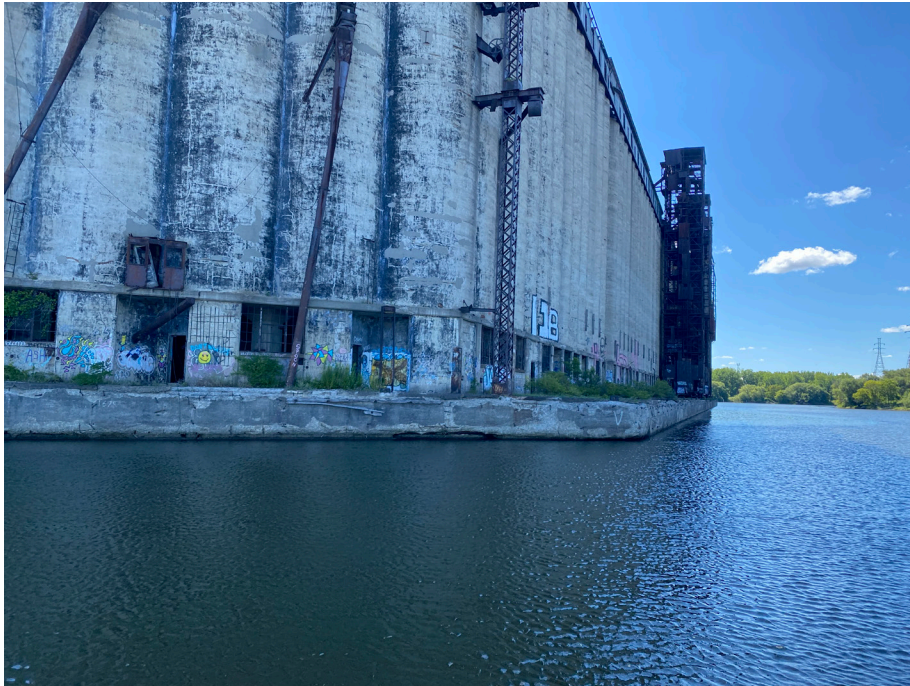
Photograph 13
Concrete Central Critical Structure Area (DMU 37a Vicinity)

Signs of significant erosion? No
Comments (Erosion along shoreline? Note what/where, photo ID): N/A
Has Navigational Dredging occurred in or near the Critical Structure? No
Comments on confirmation of recent dredging activities with USACE personnel (See References and Supporting Information Sheet) No recent dredging - confirmed via USACE website
Significant modifications to upland conditions along the shoreline or change in site use? No
Comments on presence of new buildings, excavation, modification to site use, redevelopment, etc.): N/A
Installation of shoreline or nearshore structures? No
Comments on Installation of shoreline or nearshore structures (e.g., piling, piers, armoring, fill placement, sheeting, mooring, boat ramp, etc.): N/A
Presence of petroleum sheen on water surface? No
Comments on color and size (square feet) of sheen area. Contact USCG if source is identifiable. N/A
Photographs from set points? Yes
