# **Niagara Transformer Corporation**

ERIE, NEW YORK

# **Periodic Review Report**

**NYSDEC Site Number: C915234**

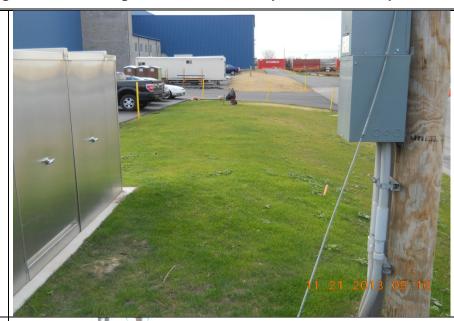
#### **PHOTO 1**

Looking South: West Property line vegetation adjacent to 1747 Dale Rd parcel

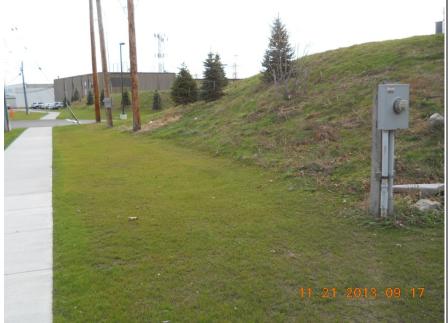
#### **PHOTO 2**

Looking East: North Side of West Soil Berm

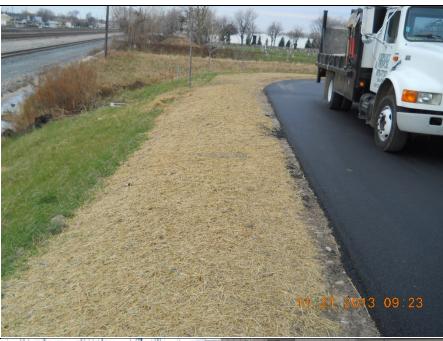
#### **PHOTO 3**

Looking West: Newly paved Access Road on South side of BCP property and topsoil/seeding restoration

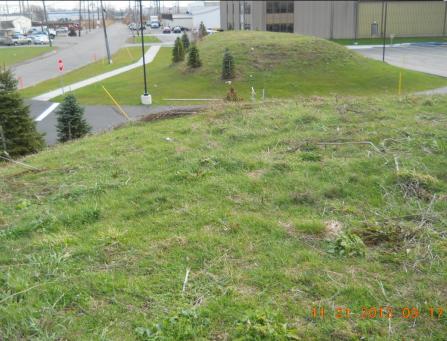
#### **PHOTO 4**

Looking East: Vegetation on top of West Berm and East Berm adjacent to entrance road

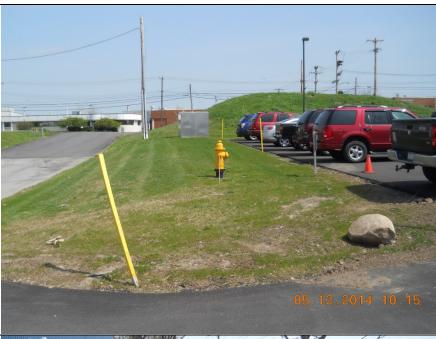
#### **PHOTO 5**

Looking North: Vegatation along west property line and south side of West Berm

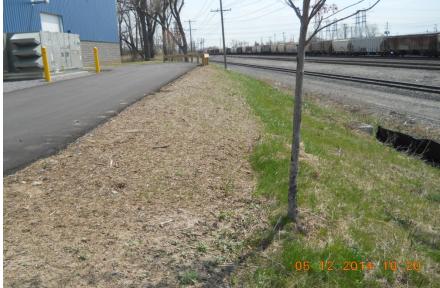
#### **PHOTO 6**

Looking East: South property line area and slope adjacent to rail corridor
