## Periodic Review Report

Former American Linen Supply Company  
Facility  
NYSDEC BCP #C915241  
822 Seneca Street  
Buffalo, New York

June 2026  
(May 24, 2025 to May 24, 2026 Reporting Period)

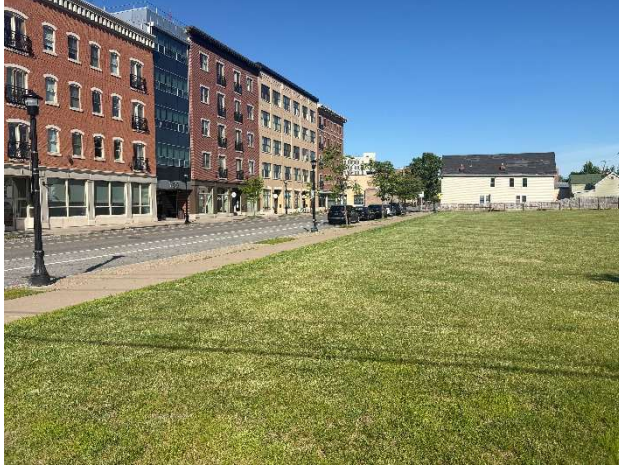
**Photo 1:** Southeast corner of site looking west – topsoil cover system.

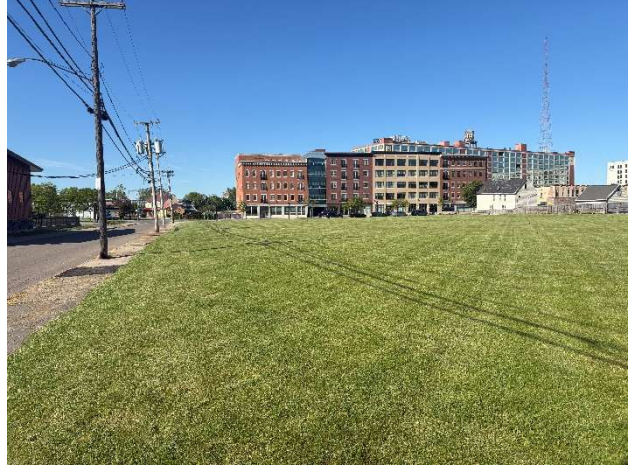
**Photo 2:** Northeast corner of site looking southwest – topsoil cover system.

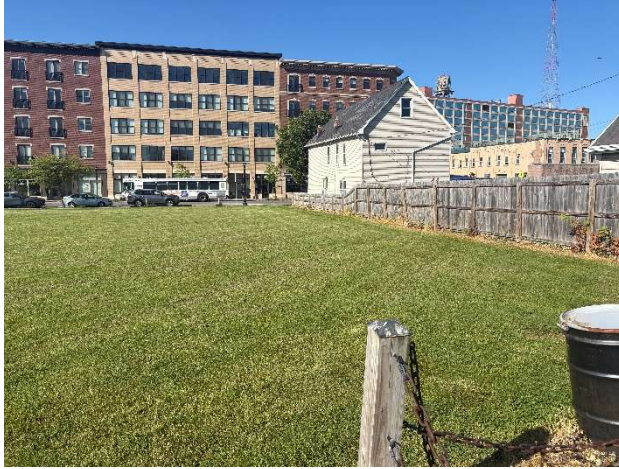
**Photo 5:**

**Photo 5.** Standing on asphalt looking south – topsoil cover system

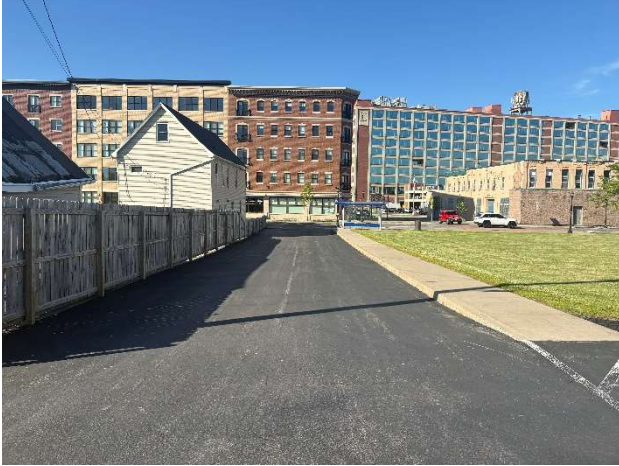
**Photo 9:** Asphalt cover system, looking towards Seneca Street.
