# PERIODIC REVIEW REPORT

**300 OHIO STREET SITE  
BCP SITE NO. C915257**

**BUFFALO, NEW YORK**

May 2023

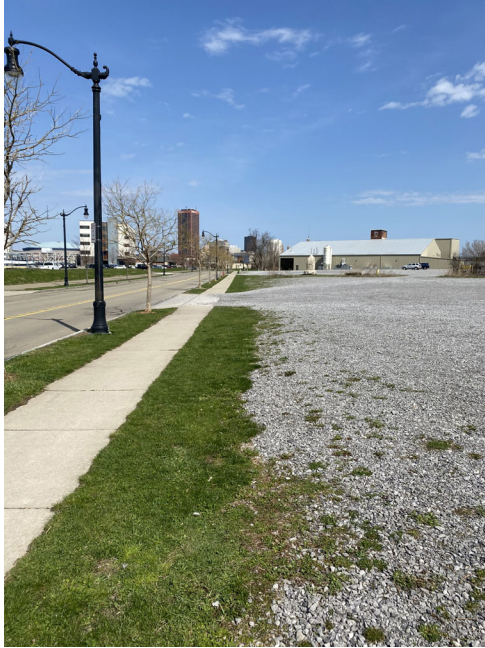
- Photo 1: Site Inspection – Cover system – western boundary along Ohio Street (looking northwest).  
Photo 2: Site Inspection – Cover system – corner of Ohio and Chicago Streets (looking northwest).  
Photo 3: Site Inspection – Cover system – south side of building (looking west).  
Photo 4: Site Inspection – Cover system – east side of building (looking north).

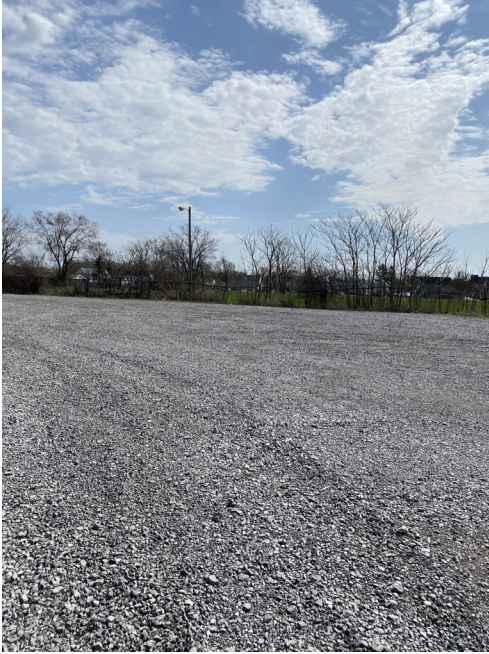
- Photo 5: Site Inspection – Cover system southern stone cover (looking east).  
Photo 6: Site Inspection – Cover system eastern boundary along park (looking north).  
Photo 7: Site Inspection – Cover System – RRSCO to CSCO transition (looking south).  
Photo 8: Site Inspection – Asphalt and concrete cover east side (looking south).

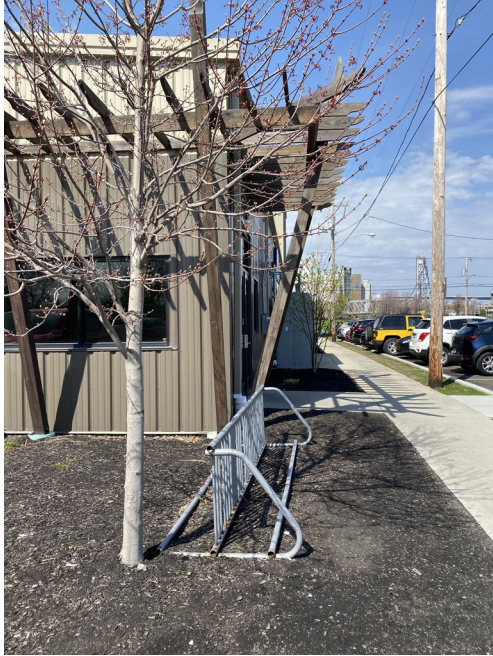
- Photo 9: Site Inspection – Mackinaw Street boundary (looking west)  
Photo 10: Site Inspection – Mackinaw Street boundary (looking east)  
Photo 11: Site Inspection – Chicago Street boundary (looking west)  
Photo 12: Site Inspection – Chicago Street boundary (looking northeast)
