PERIODIC REVIEW REPORT
for the
132 DINGENS ST. SITE
(SITE NO. C915263)

132-136 DINGENS STREET
BUFFALO, NEW YORK

May 2019

PERIODIC REVIEW REPORT

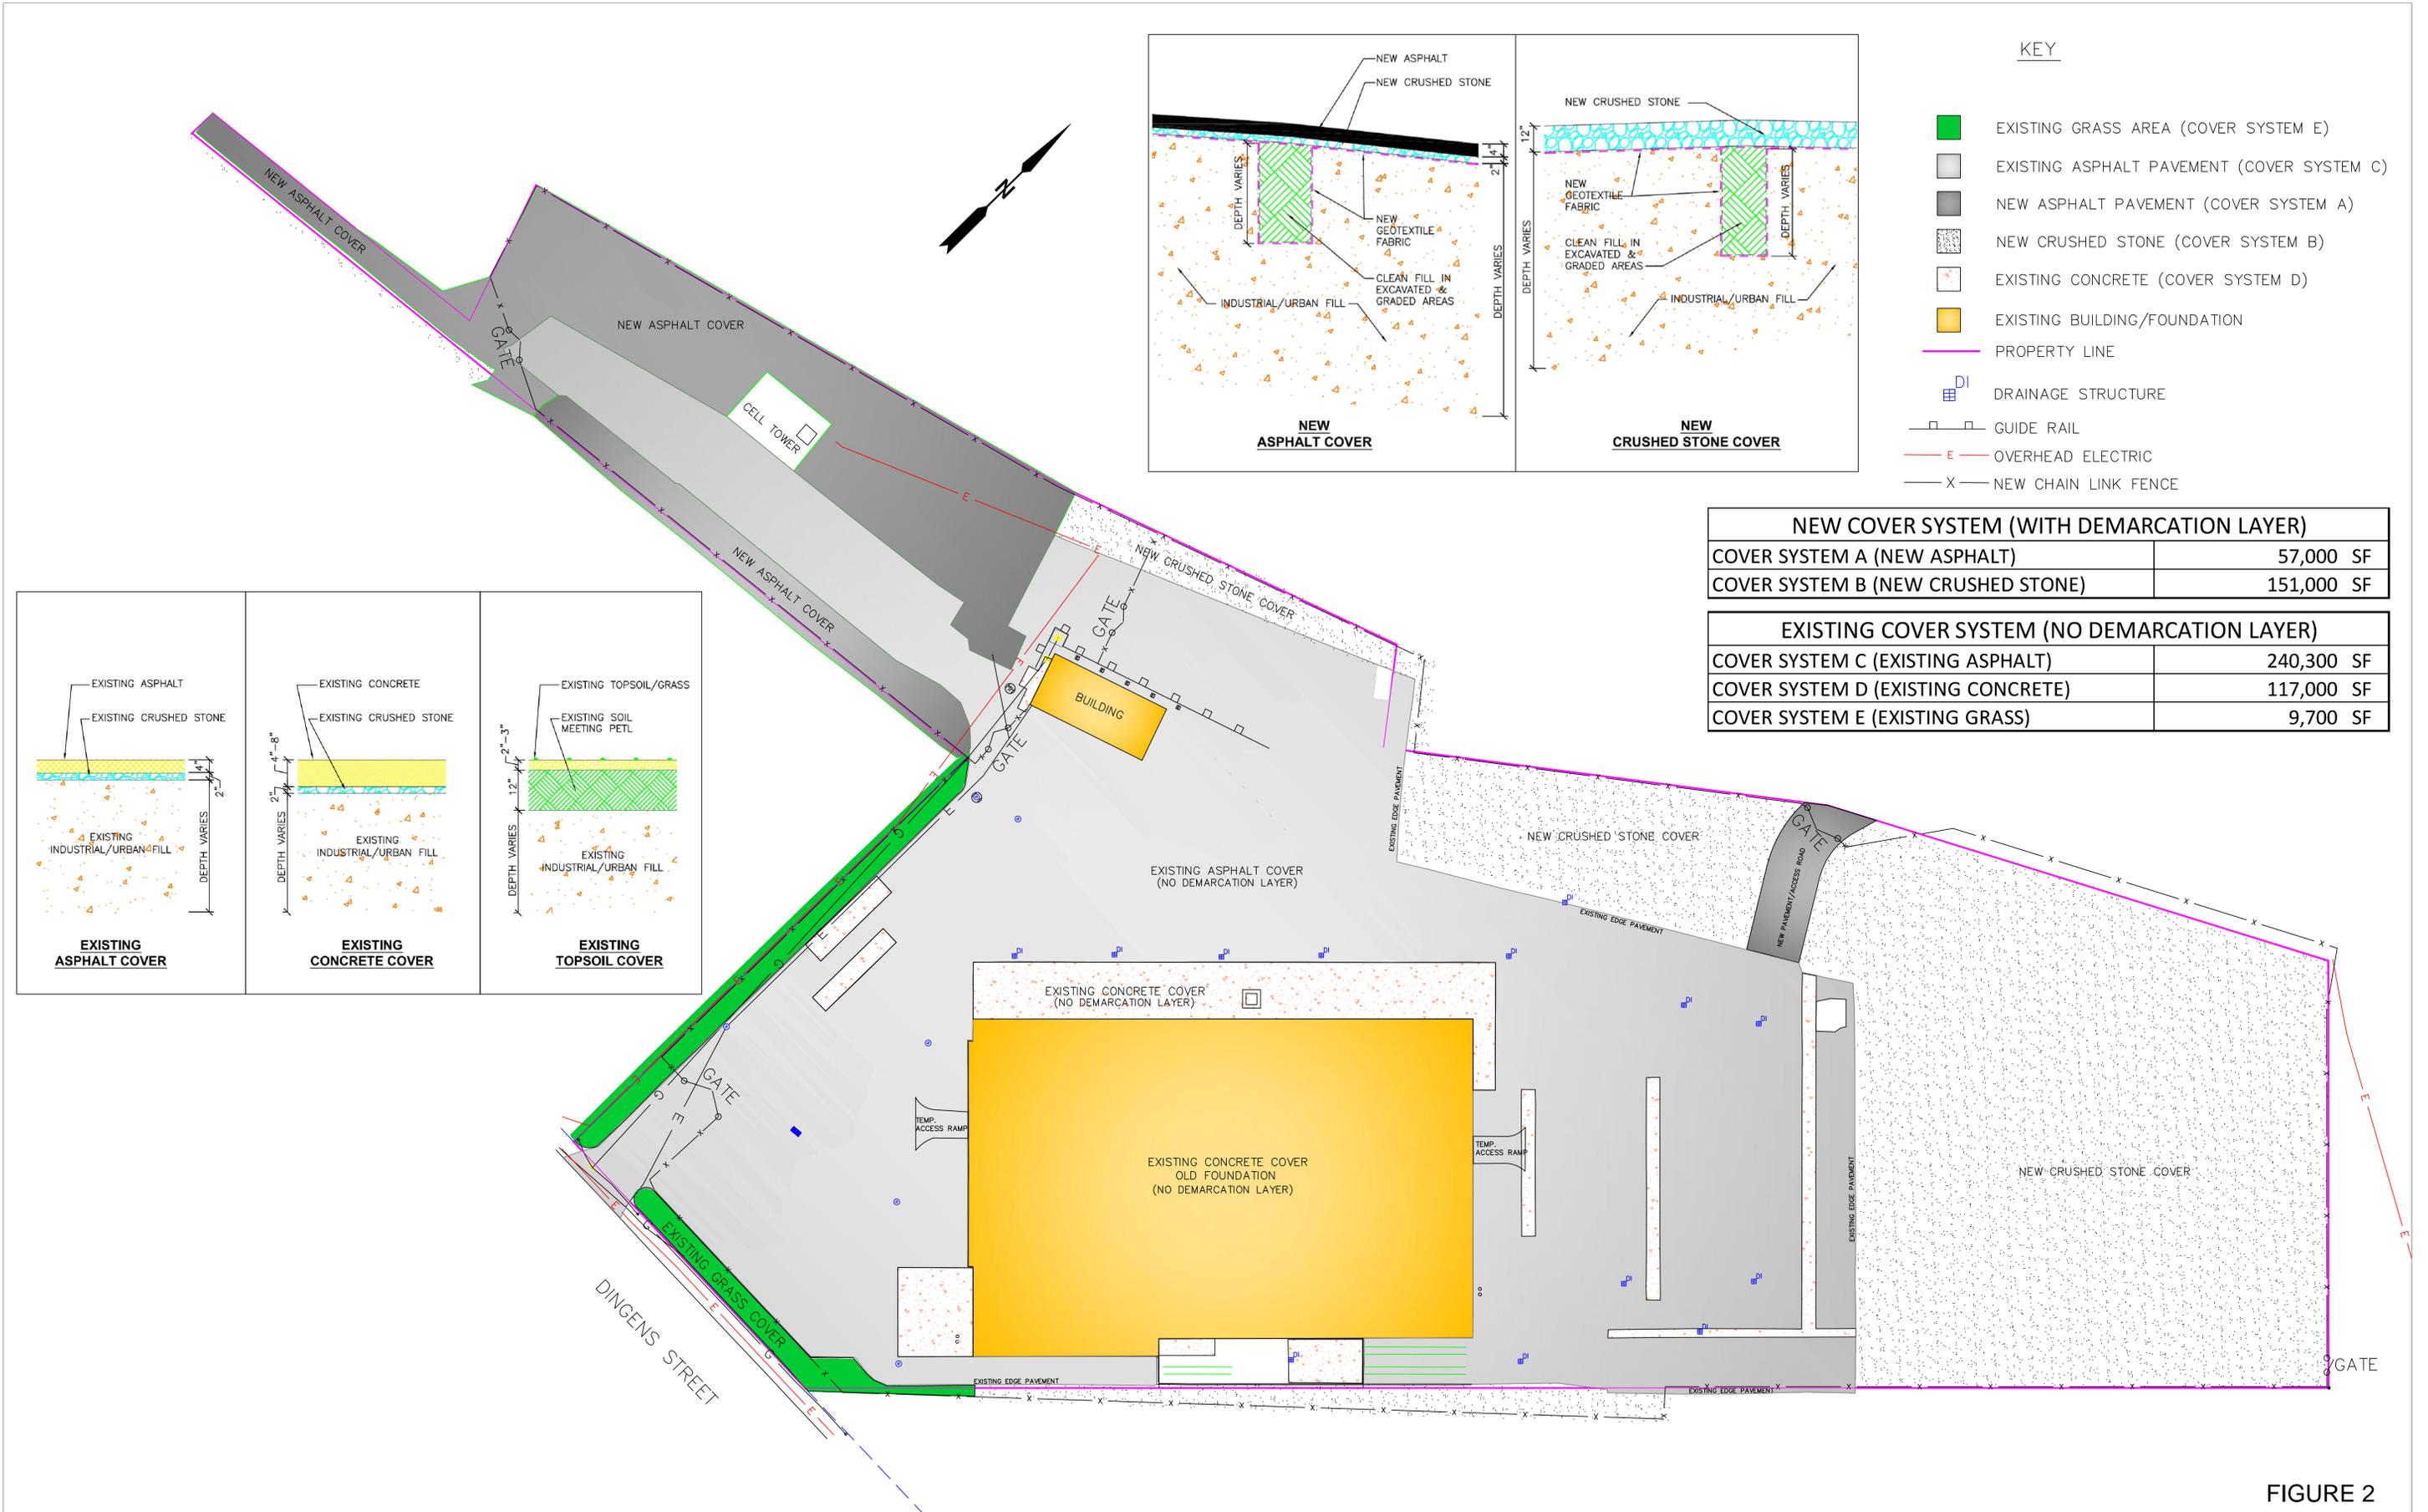
FIGURE 2

commercial use as set forth in 6NYCRR Part 375-6.7(d). Figure 2 shows the cover system across the Site. All groundwater monitoring wells were decommissioned during remedial activities.

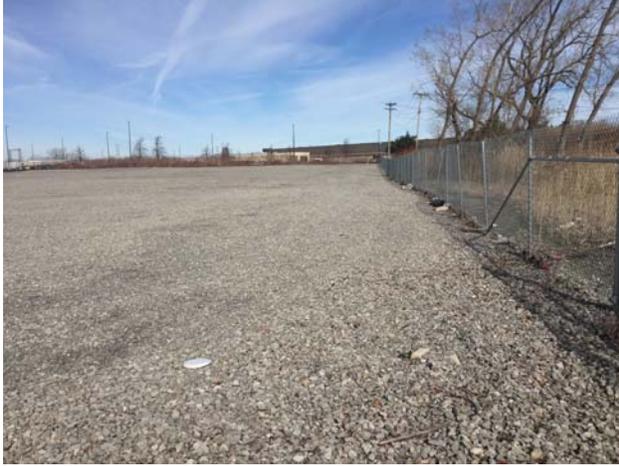
Photo 1: Crushed stone cover and fence along eastern property boundary (looking northwest)

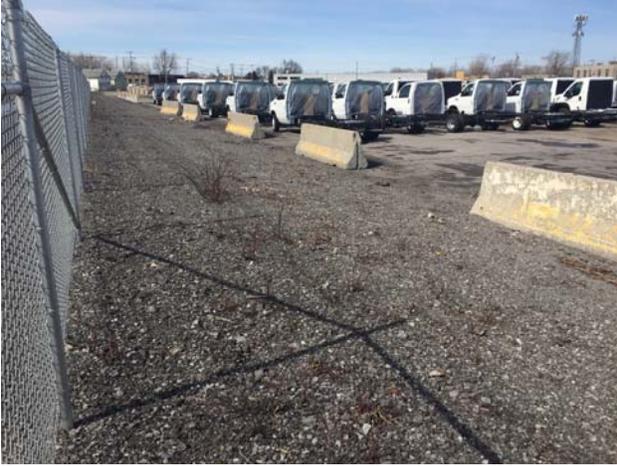
Photo 5: New crushed stone cover and fence along southern property boundary (looking southwest)

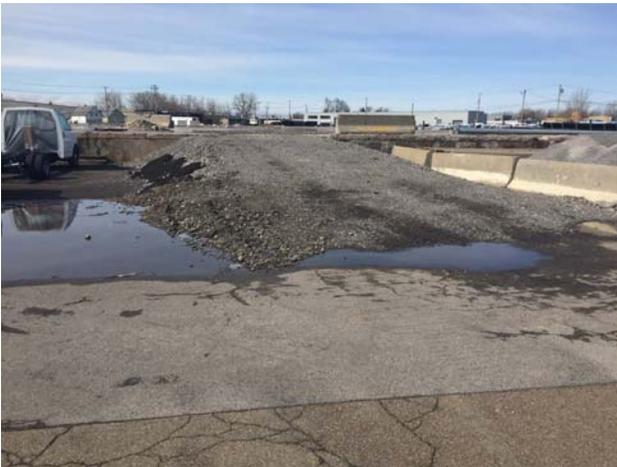
Photo 7: Existing concrete and asphalt cover and temporary access ramp to old foundation (looking southwest)

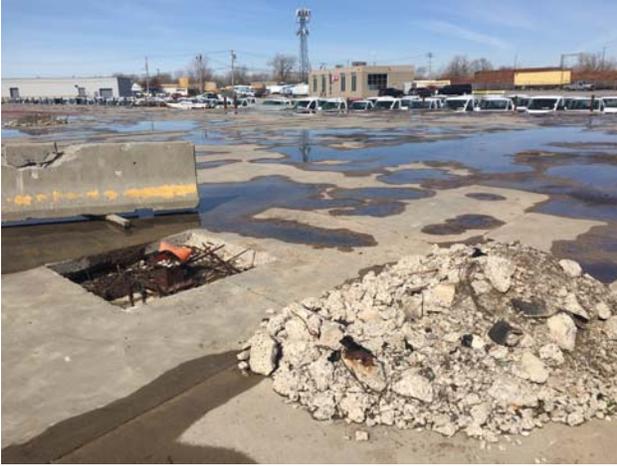
Photo 9: Old concrete foundation; test hole to confirm structural integrity for future use (looking west)

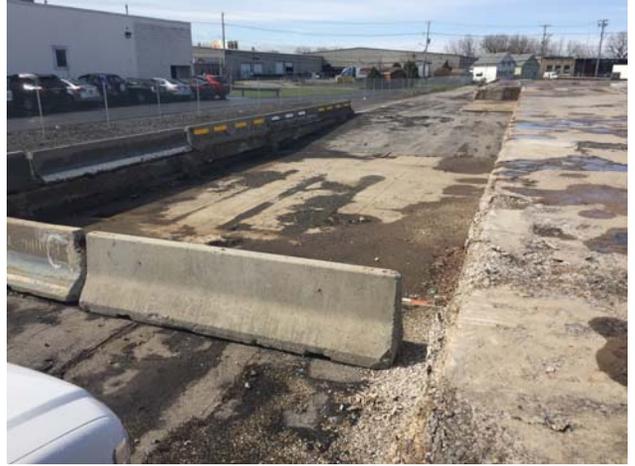
Photo 10: Existing concrete & asphalt cover along southern property boundary (looking south from foundation)

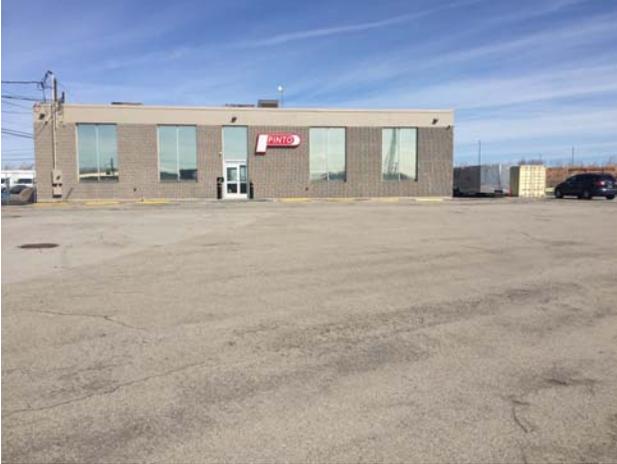
Photo 13: Renovated office building and existing asphalt cover (looking north)

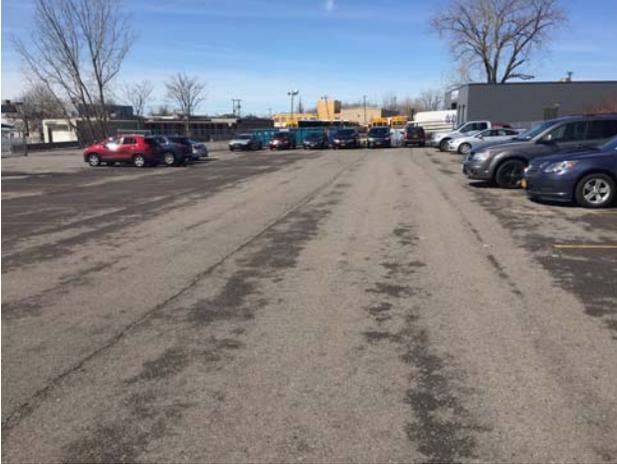
Photo 17: New asphalt cover along northwestern property boundary (looking west)
