Periodic Review Report

*132 Dingens St. Site
BCP Site No. C915263
Buffalo, New York*

May 2020

PERIODIC REVIEW REPORT
for the
132 DINGENS ST. SITE
(SITE NO. C915263)

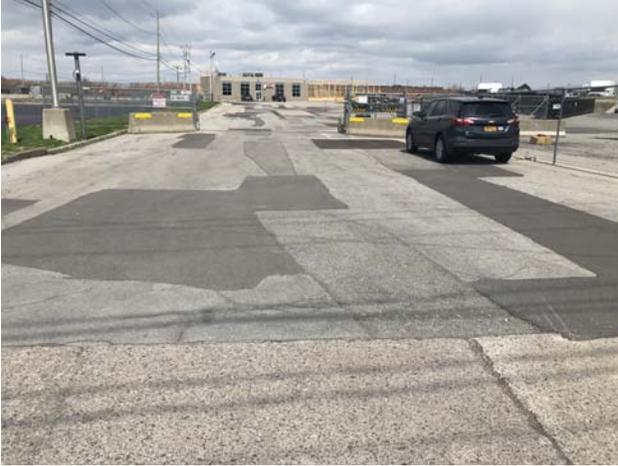
Photo 1: Asphalt cover repairs and access road at gate (looking north)

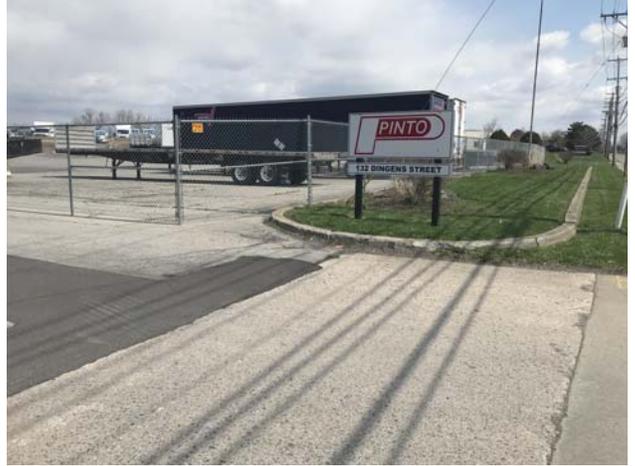
Photo 2: Asphalt cover repairs and access road at gate (looking east along southern property boundary)

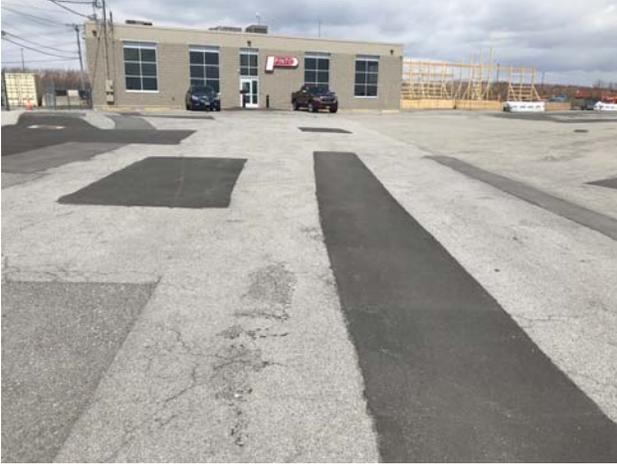
Photo 5: Office building, asphalt cover, and asphalt cover repairs (looking north)

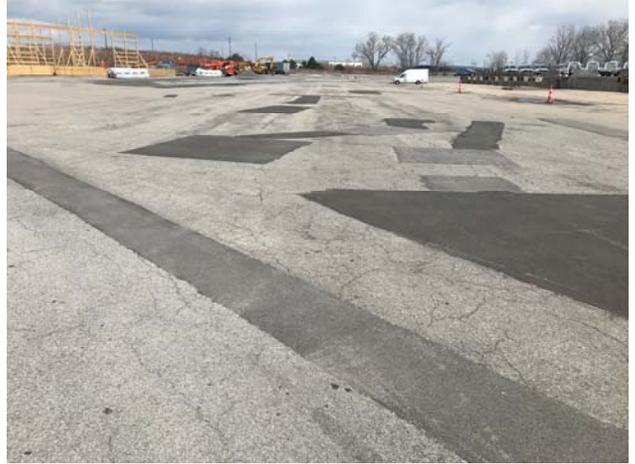
Photo 6: Asphalt cover and asphalt cover repairs (looking east)

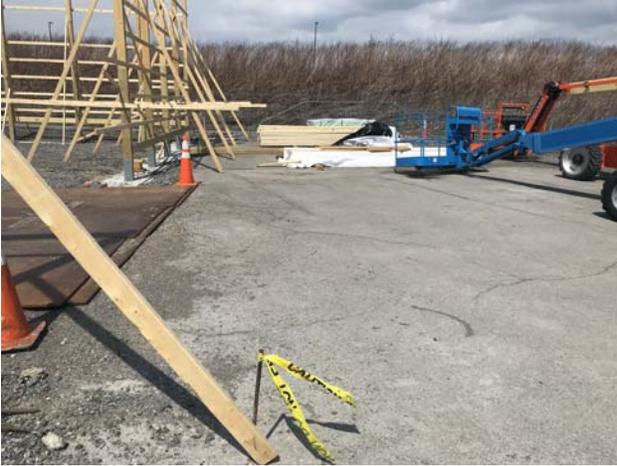
Photo 9: New building construction and existing asphalt cover (looking north)

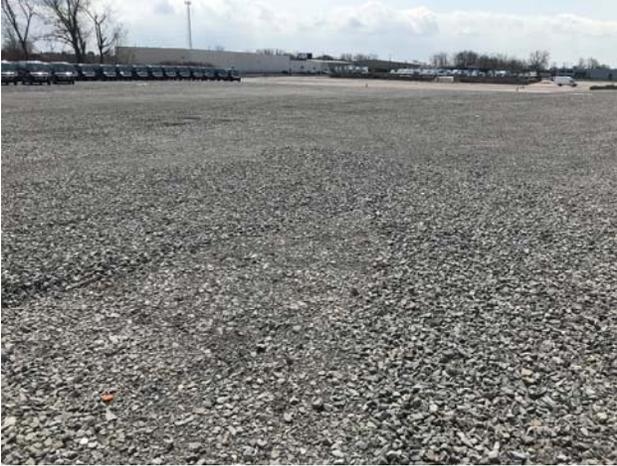
Photo 13: Crushed stone cover (looking west)

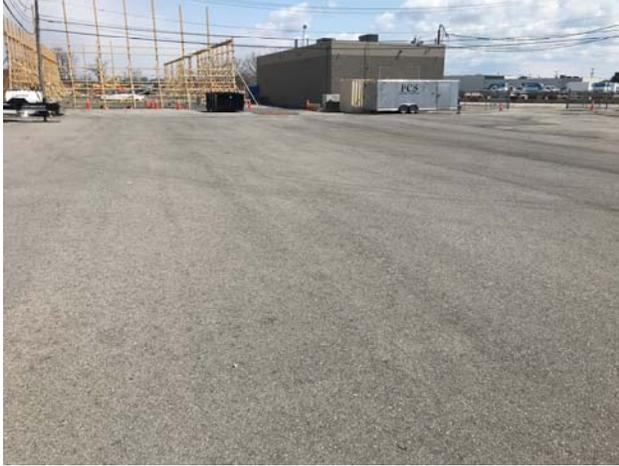
Photo 17: Asphalt cover, office building, and new building construction (looking southeast)

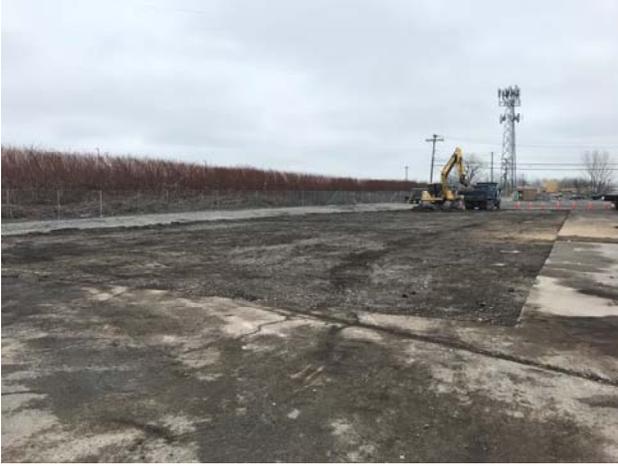
Photo 21: Asphalt removal from new building footprint (looking west)

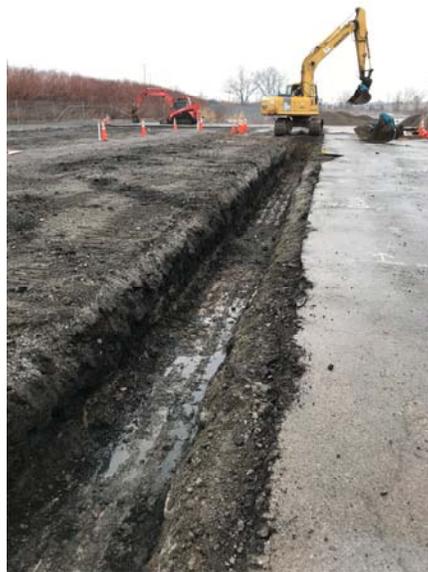
Photo 24: New building foundation excavation (looking east)

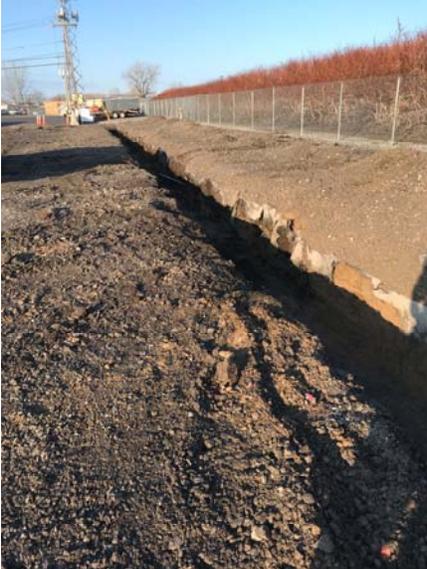
Photo 25: New building foundation excavation and clean stone above existing demarcation fabric (looking west)

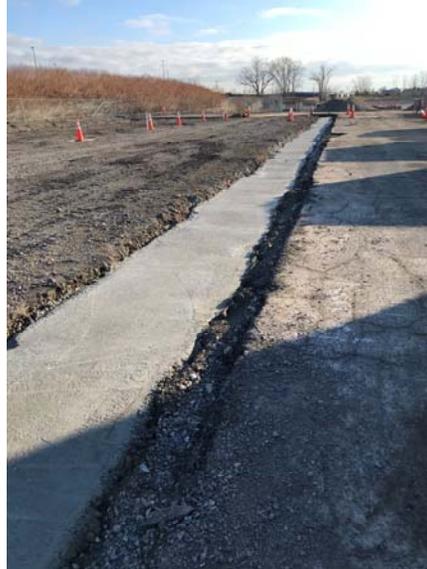
Photo 26: Poured concrete building perimeter foundation (looking east)

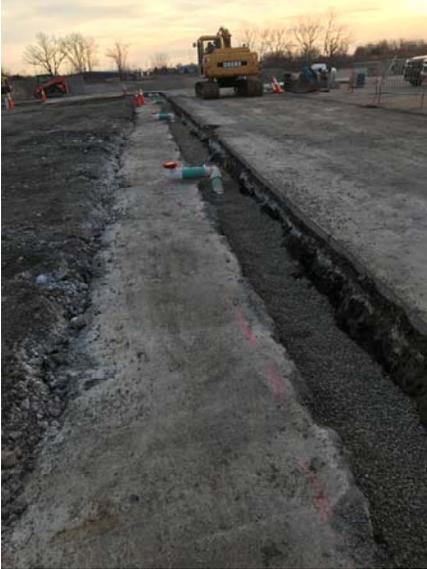
Photo 29: New building foundation excavation and clean stone above existing demarcation fabric (looking west)

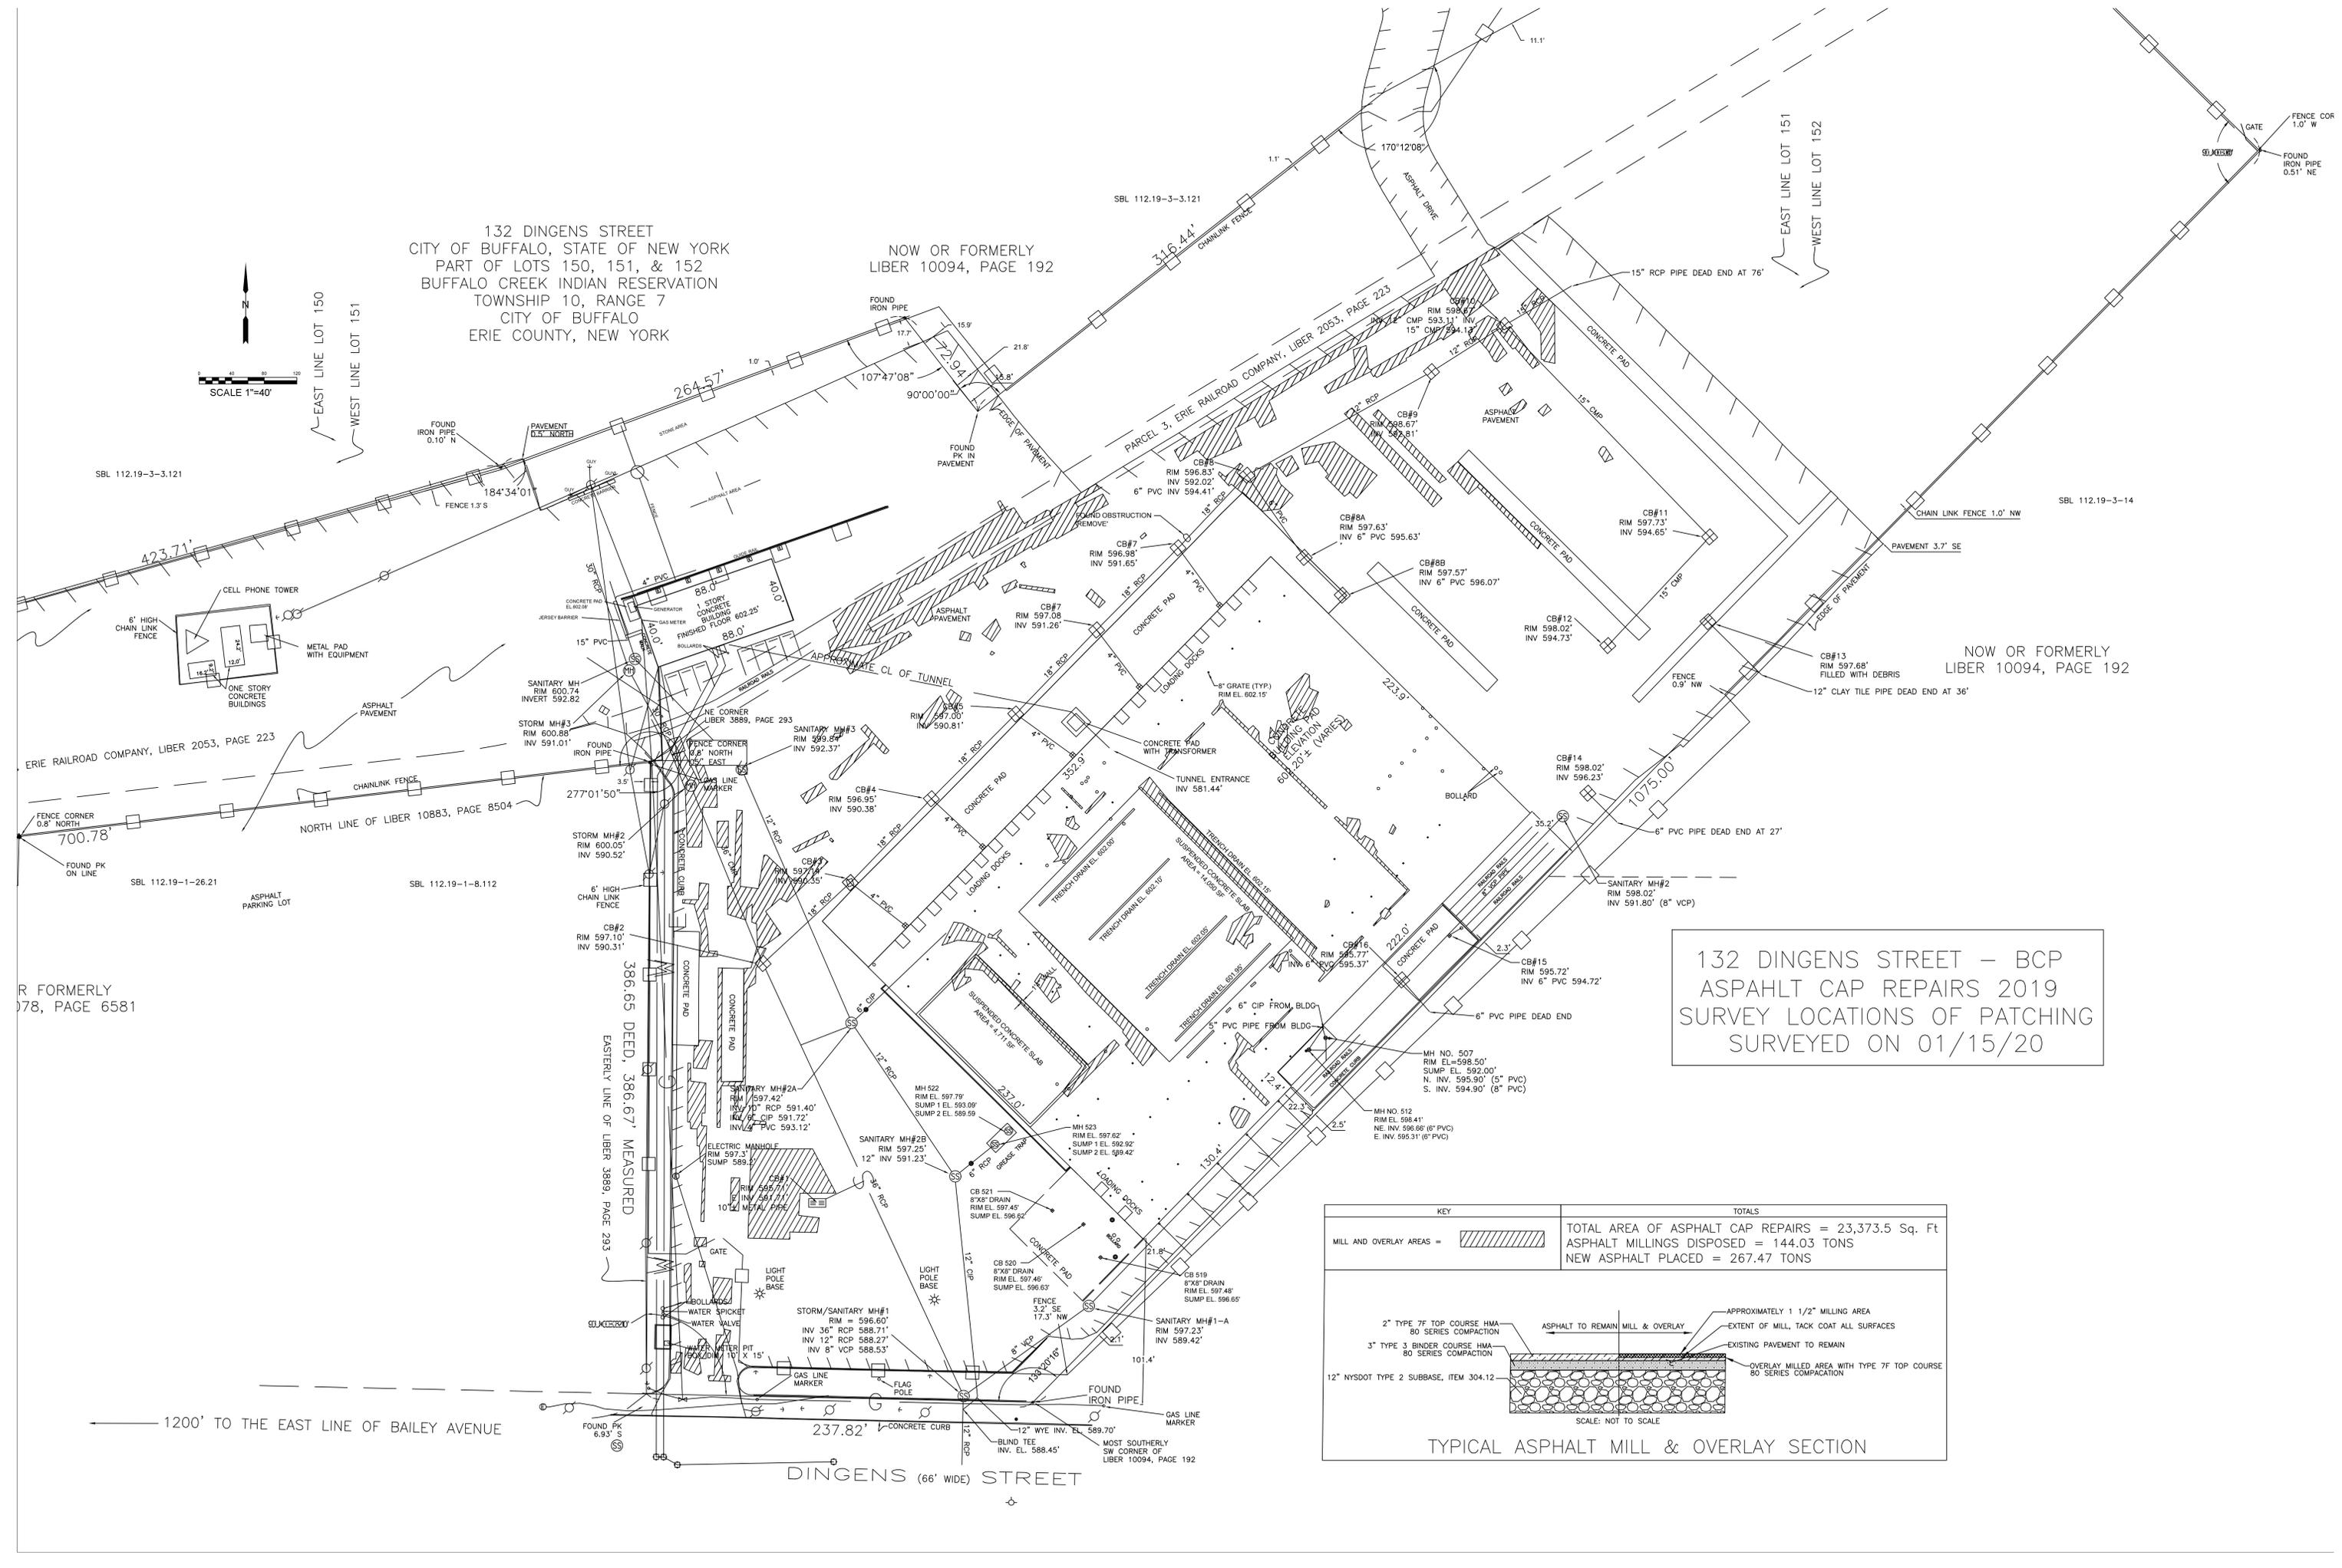
TYPICAL ASPHALT MILL & OVERLAY SECTION

TOTAL AREA OF ASPHALT CAP REPAIRS = 23,373.5 Sq. Ft
	ASPHALT MILLINGS DISPOSED = 144.03 TONS
	NEW ASPHALT PLACED = 267.47 TONS
