Re: 154 South Ogden Street Site (C915268)  
Buffalo, New York  
Periodic Review Report (December 9, 2014 to January 2, 2016)

# Periodic Review Report

*154 South Ogden Street Site*

*BCP Site No. C915268  
154 South Ogden Street  
Buffalo, New York*

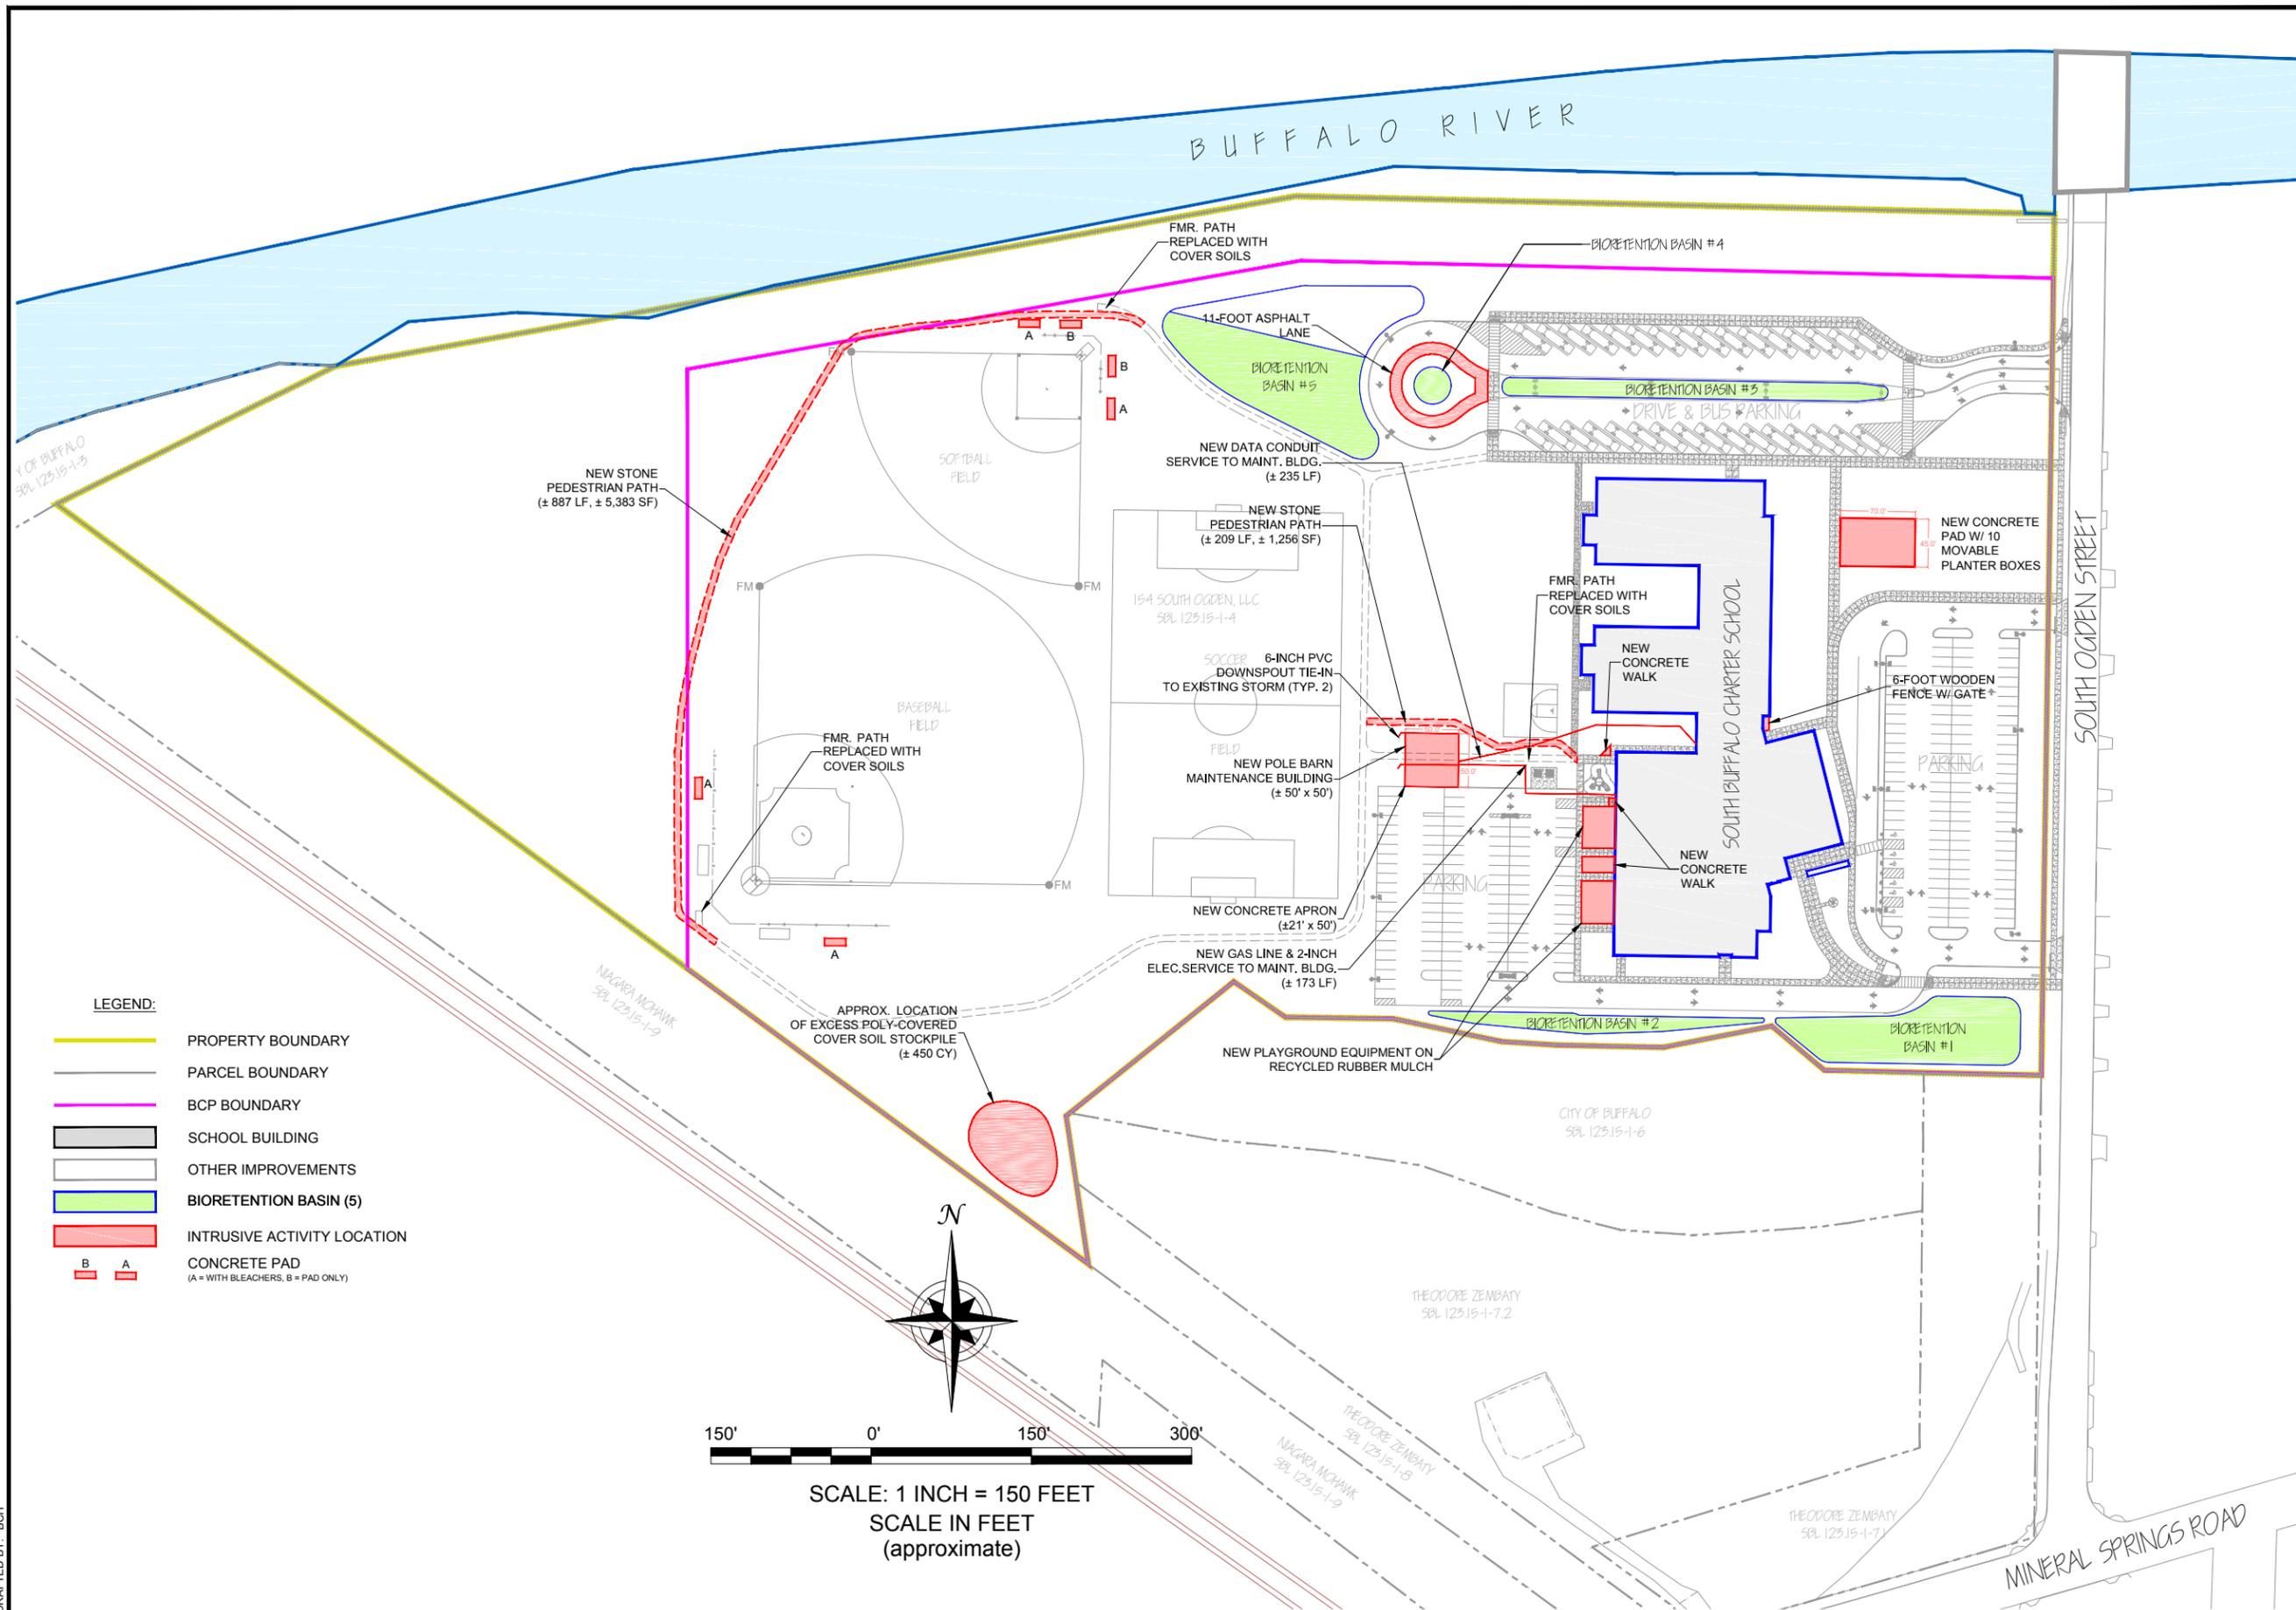
**INTRUSIVE ACTIVITY LOCATION MAP**  
PERIODIC REVIEW REPORT  
154 SOUTH OGDEN STREET SITE  
BUFFALO, NEW YORK  
PREPARED FOR  
154 SOUTH OGDEN, LLC

Intrusive activities were observed by Benchmark/Zoladz/R&P personnel to verify conformance with the SMP. Approximately 450 cubic yards (CYs) of stockpiled cover soils (topsoil and clay) were stockpiled in the southwest corner of the Site and covered with polyethylene tarp to prevent erosion runoff. Approximately 70 tons of generated spoils from beneath the final cover were transported to the Chautauqua County Landfill (CCLF) in accordance with the SMP for disposal. Scale receipts from the CCLF along with a certification statement of proper disposal by Zoladz construction are provided in Appendix B. Quantities and sources of imported material used during construction activities are provided in the next section. New construction elements and modified surfaces described above are presented on Figure 3.

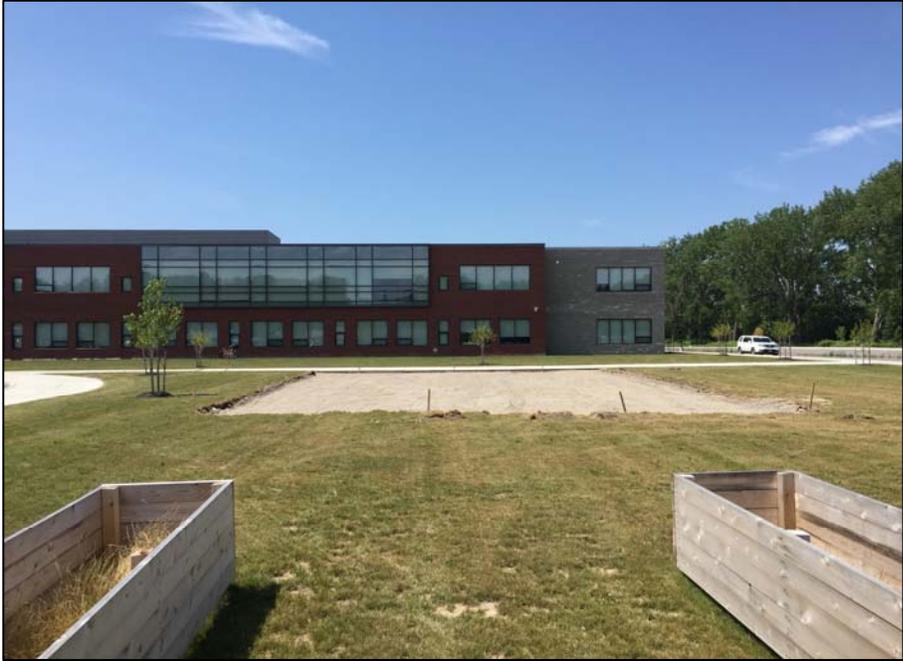
<b>Client Name:</b> South Buffalo Charter School		<b>Site Location:</b> 154 South Ogden Street Site (C915268)	<b>Project No.:</b> B0249-015-014
<b>Photo No.</b> 1	<b>Date</b> 07/29/15

<b>Direction Photo Taken:</b> west			
<b>Description:</b> New 45 ft. by 70 ft. concrete pad area to accommodate placement of above grade garden boxes. Two inch run of crush subbase shown with garden boxes in foreground.

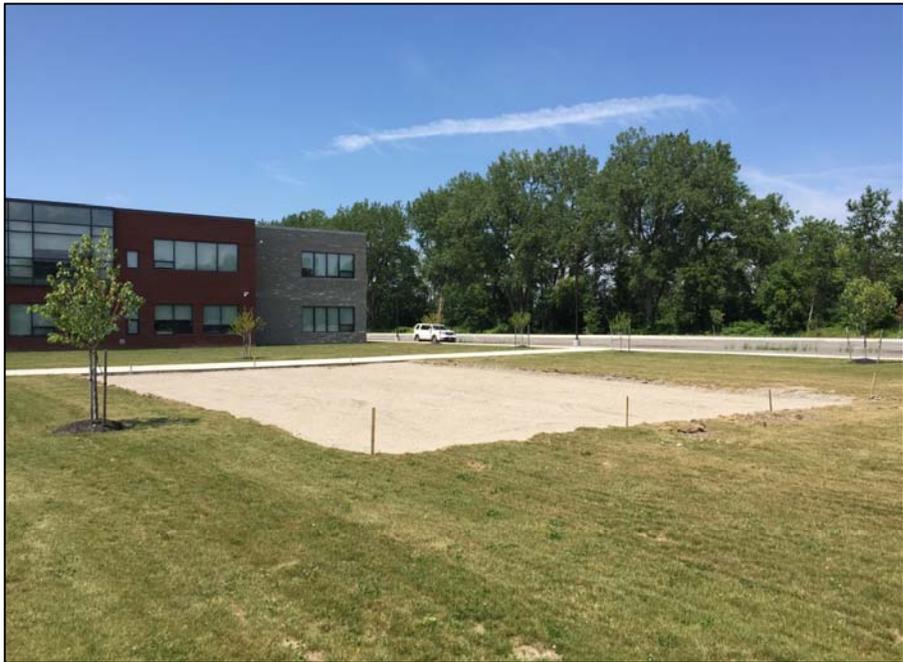
<b>Photo No.</b> 2	<b>Date</b> 07/29/15

<b>Direction Photo Taken:</b> northwest		
<b>Description:</b> New 45 ft. by 70 ft. concrete pad area to accommodate placement of above grade garden boxes. Two inch run of crush subbase shown.

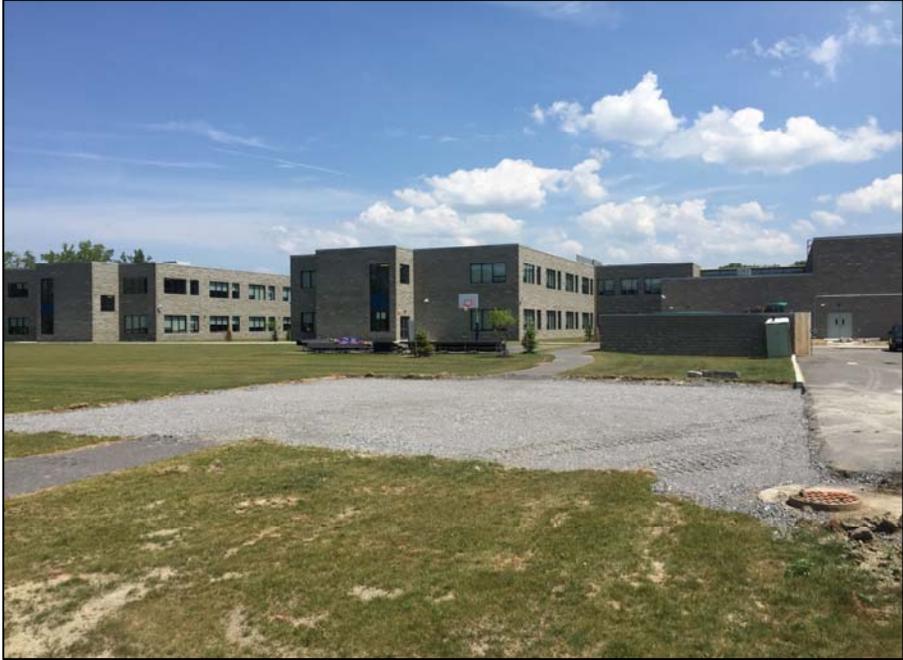
<b>Client Name:</b> South Buffalo Charter School		<b>Site Location:</b> 154 South Ogden Street Site (C915268)	<b>Project No.:</b> B0249-015-014
<b>Photo No.</b> 3	<b>Date</b> 07/29/15

<b>Direction Photo Taken:</b> east			
<b>Description:</b> New approximately 50 ft. by 50 ft. concrete pad to accommodate a new 30 ft. by 50 ft. pole barn used to house school lawn maintenance equipment and provide additional storage. Two inch run of crush subbase shown.

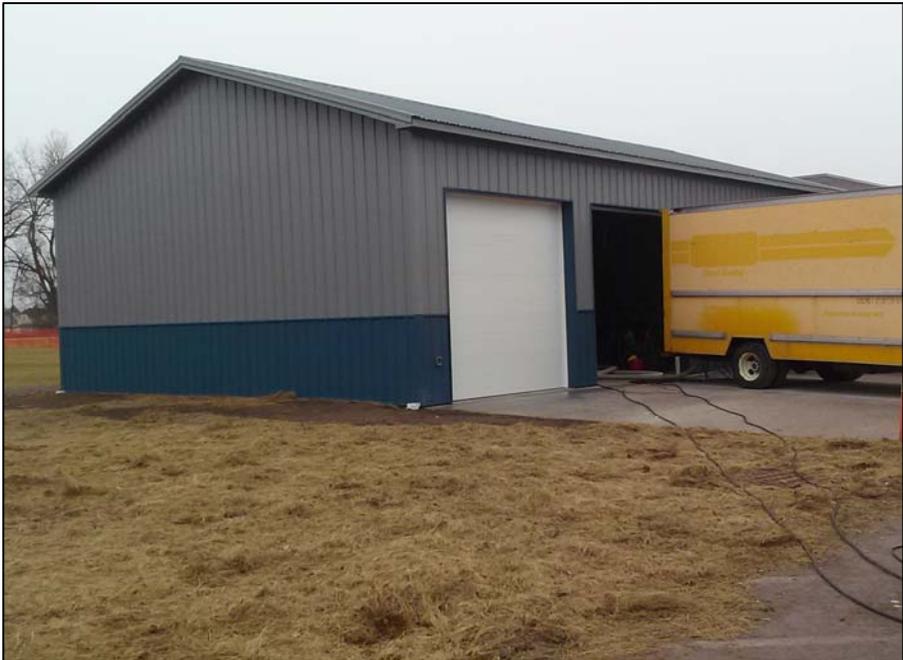
<b>Photo No.</b> 4	<b>Date</b> 12/21/15

<b>Direction Photo Taken:</b> northeast		
<b>Description:</b> Completed new pole barn.

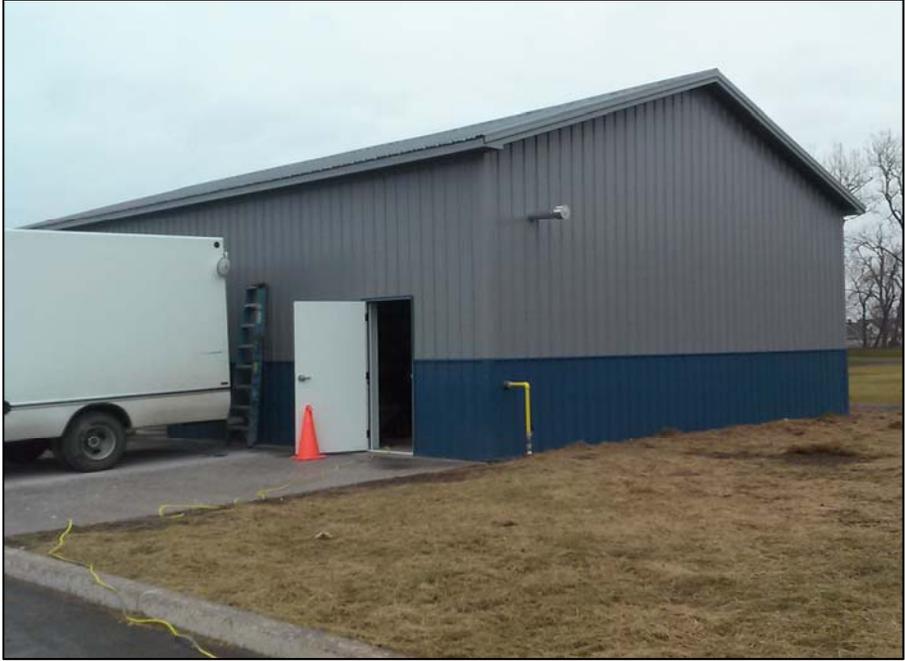
<b>Client Name:</b> South Buffalo Charter School		<b>Site Location:</b> 154 South Ogden Street Site (C915268)	<b>Project No.:</b> B0249-015-014
<b>Photo No.</b> 5	<b>Date</b> 12/21/15

<b>Direction Photo Taken:</b> southwest			
<b>Description:</b> Completed new pole barn.

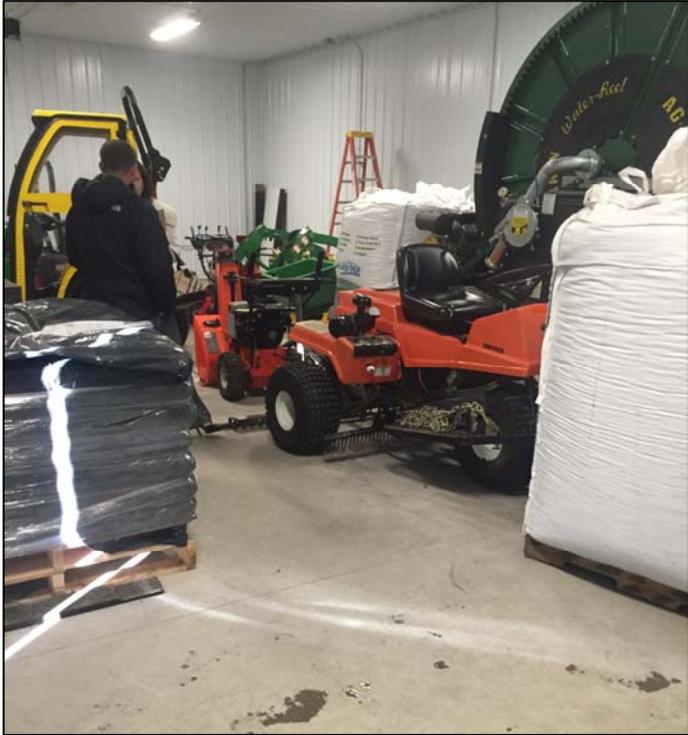
<b>Photo No.</b> 6	<b>Date</b> 01/06/16

<b>Direction Photo Taken:</b> northwest		
<b>Description:</b> Interior of new pole barn showing items stored.

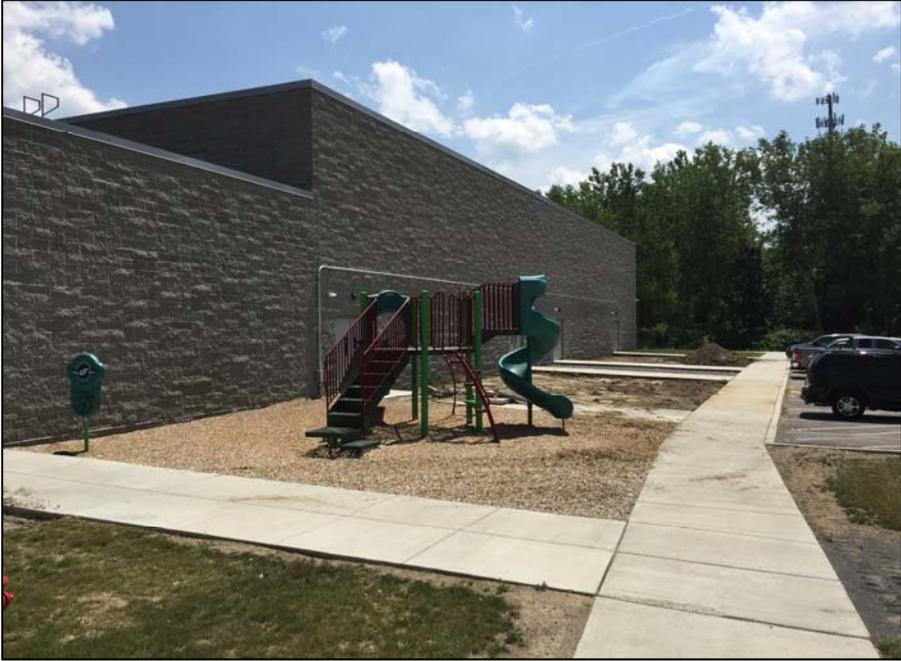
<b>Client Name:</b> South Buffalo Charter School		<b>Site Location:</b> 154 South Ogden Street Site (C915268)	<b>Project No.:</b> B0249-015-014
<b>Photo No.</b> 7	<b>Date</b> 07/29/15

<b>Direction Photo Taken:</b> south			
<b>Description:</b> Existing playground in foreground, two new playground areas in background.

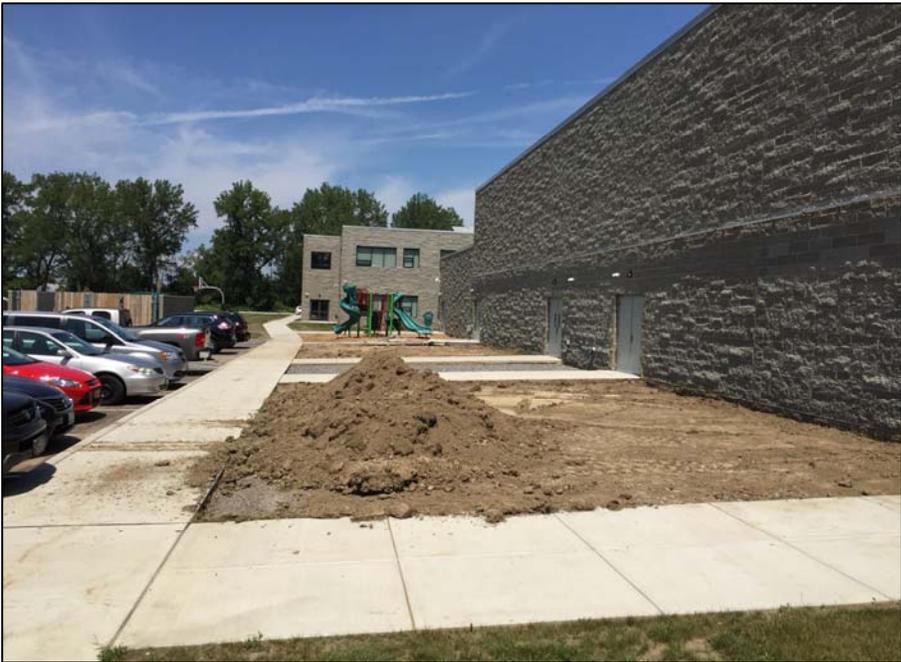
<b>Photo No.</b> 8	<b>Date</b> 07/29/15

<b>Direction Photo Taken:</b> north			
<b>Description:</b> Two new playground areas in foreground, existing playground in background.

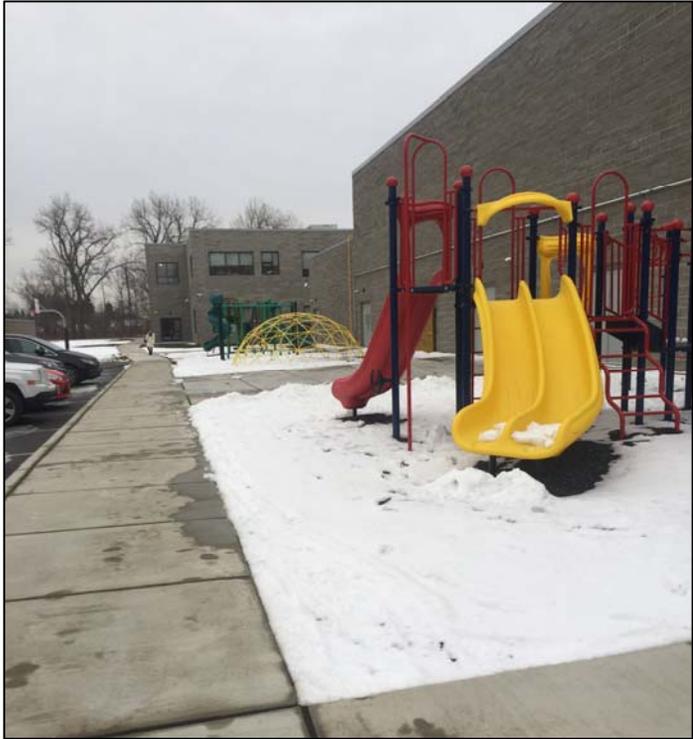
<b>Client Name:</b> South Buffalo Charter School		<b>Site Location:</b> 154 South Ogden Street Site (C915268)	<b>Project No.:</b> B0249-015-014
<b>Photo No.</b> 9	<b>Date</b> 01/06/16

<b>Direction Photo Taken:</b> north			
<b>Description:</b> Completed new playgrounds (yellow slide and climbing bars). New concrete walk between new playground areas.

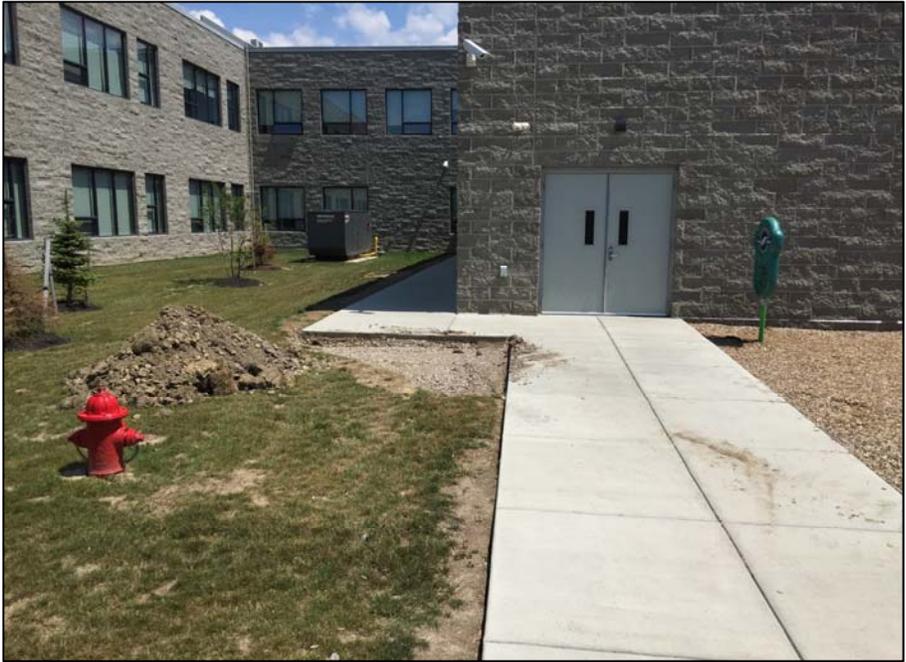
<b>Photo No.</b> 10	<b>Date</b> 07/29/15

<b>Direction Photo Taken:</b> east		
<b>Description:</b> New corner sidewalk section.

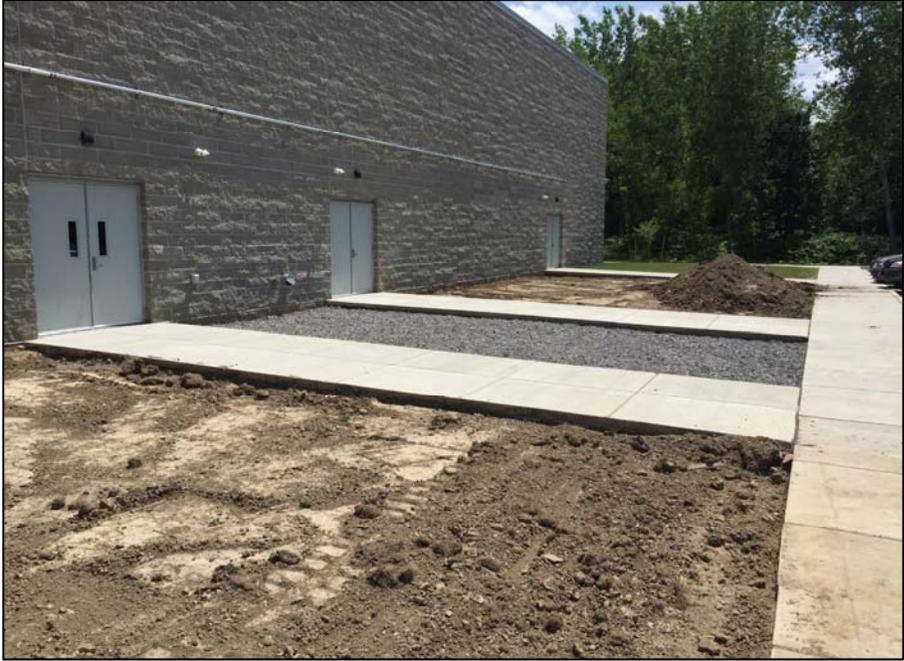
<b>Client Name:</b> South Buffalo Charter School		<b>Site Location:</b> 154 South Ogden Street Site (C915268)	<b>Project No.:</b> B0249-015-014
<b>Photo No.</b> 11	<b>Date</b> 07/29/15

<b>Direction Photo Taken:</b> south			
<b>Description:</b> New concrete sidewalk subbase between two new playground areas.

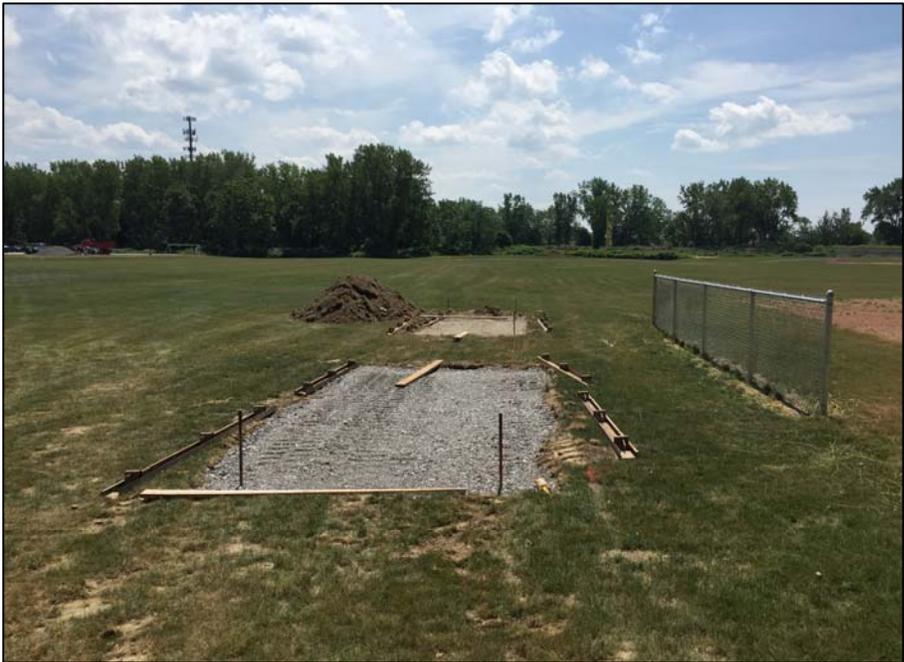
<b>Photo No.</b> 12	<b>Date</b> 07/29/15

<b>Direction Photo Taken:</b> south		
<b>Description:</b> Subbase for concrete bleacher pads (typical of 6; four adjacent to the softball field and two adjacent to the baseball field).

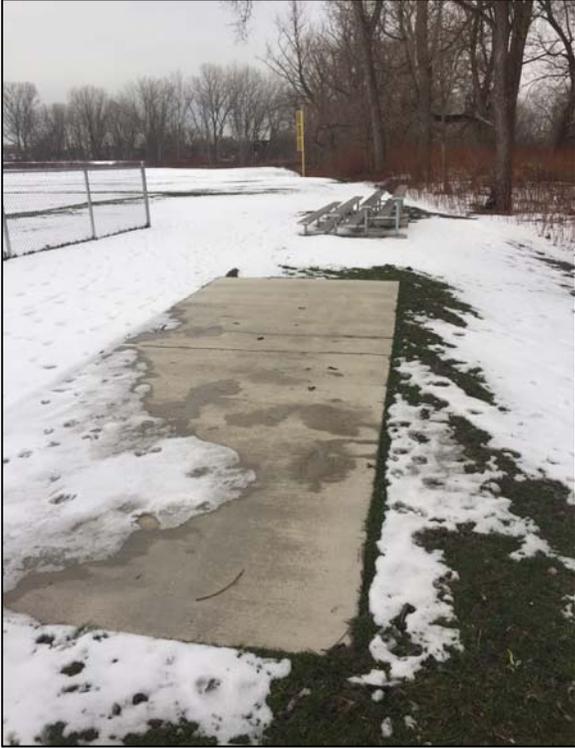
<b>Client Name:</b> South Buffalo Charter School		<b>Site Location:</b> 154 South Ogden Street Site (C915268)	<b>Project No.:</b> B0249-015-014
<b>Photo No.</b> 13	<b>Date</b> 01/06/16

<b>Direction Photo Taken:</b> west			
<b>Description:</b> New concrete bleacher pads adjacent to softball field (typical of 6; four adjacent to the softball field and two adjacent to the baseball field).

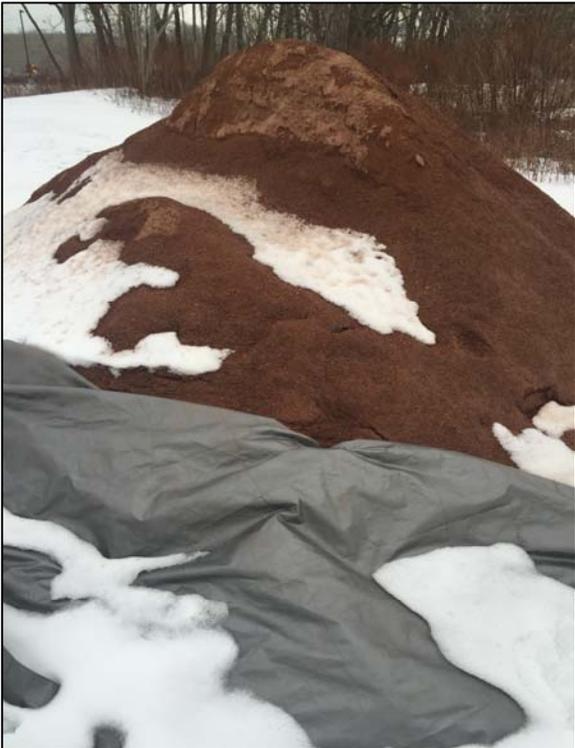
<b>Photo No.</b> 14	<b>Date</b> 01/06/16

<b>Direction Photo Taken:</b> east			
<b>Description:</b> Stockpiled Mar-Co Clay for ballfields. Tarpred stockpile of cover soils in foreground.

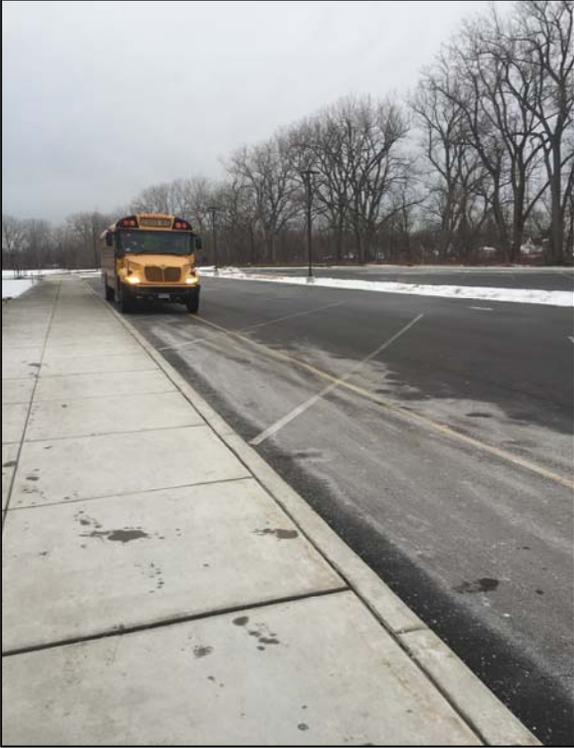
<b>Client Name:</b> South Buffalo Charter School		<b>Site Location:</b> 154 South Ogden Street Site (C915268)	<b>Project No.:</b> B0249-015-014
<b>Photo No.</b> 15	<b>Date</b> 01/06/16

<b>Direction Photo Taken:</b> west			
<b>Description:</b> Bus turnaround driveway.

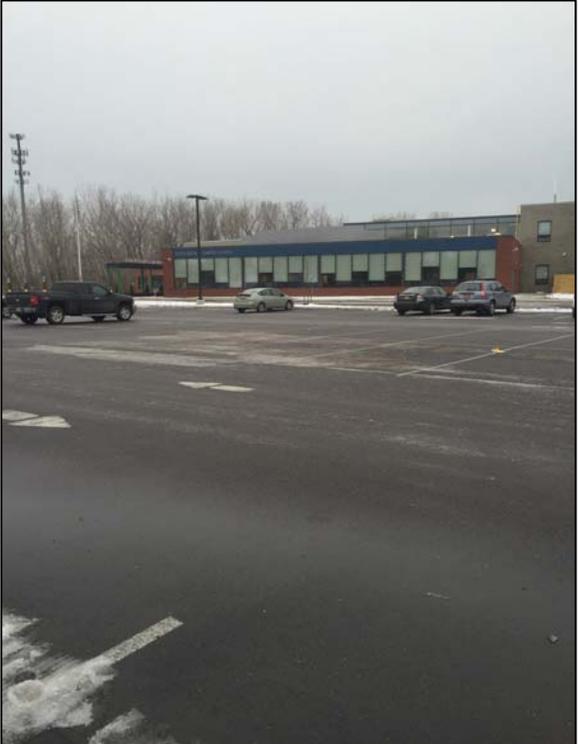
<b>Photo No.</b> 16	<b>Date</b> 01/06/16

<b>Direction Photo Taken:</b> west			
<b>Description:</b> Front asphalt parking lot of school.

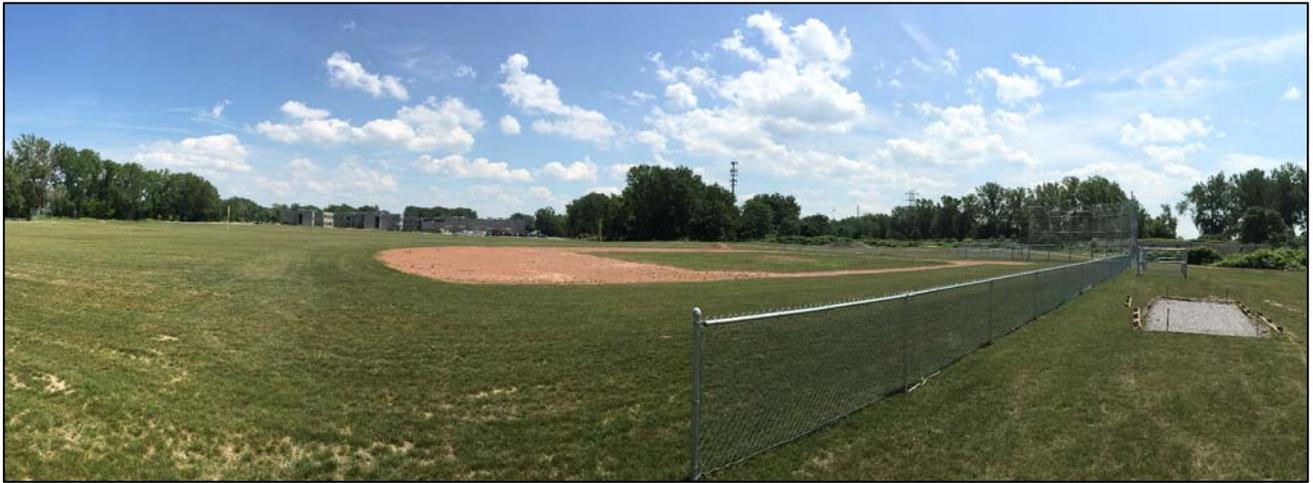
<b>Client Name:</b> South Buffalo Charter School		<b>Site Location:</b> 154 South Ogden Street Site (C915268)	<b>Project No.:</b> B0249-015-014
<b>Photo No.</b> 17	<b>Date</b> 07/29/15	<b>Description:</b> Final cover system showing grass, ballfield Mar-Co Clay, and new bleacher pad (right) covered areas in western portion of Site.	
<b>Direction Photo Taken:</b> east

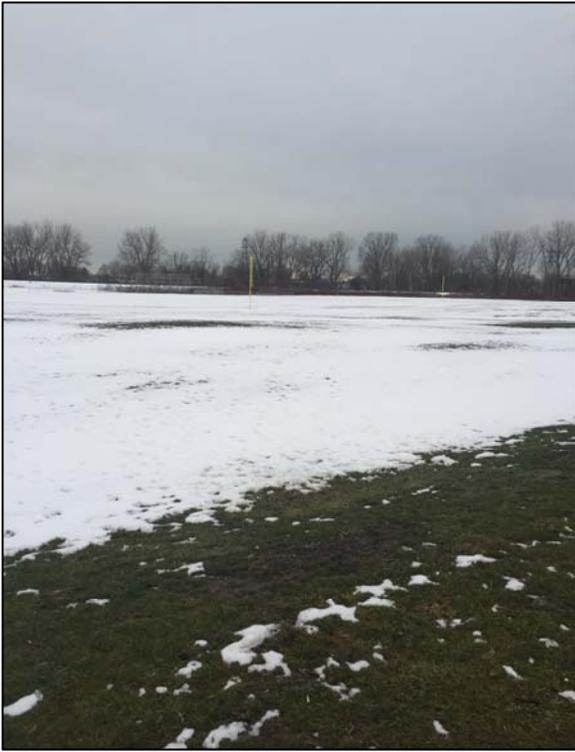
<b>Photo No.</b> 18	<b>Date</b> 01/06/16

<b>Direction Photo Taken:</b> west		
<b>Description:</b> Snow covered ballfields in western portion of Site.
