Periodic Review Report

154 South Ogden Street Site

*BCP Site No. C915268
154 South Ogden Street
Buffalo, New York*

July 2018

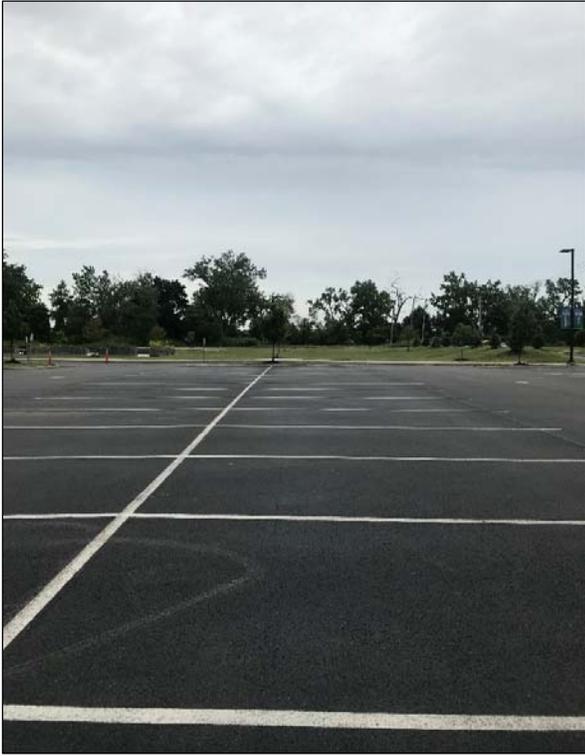
| Photo No. 1 | Date 06/22/18 | | |

| Description: Surface lot in front of school. | | | |

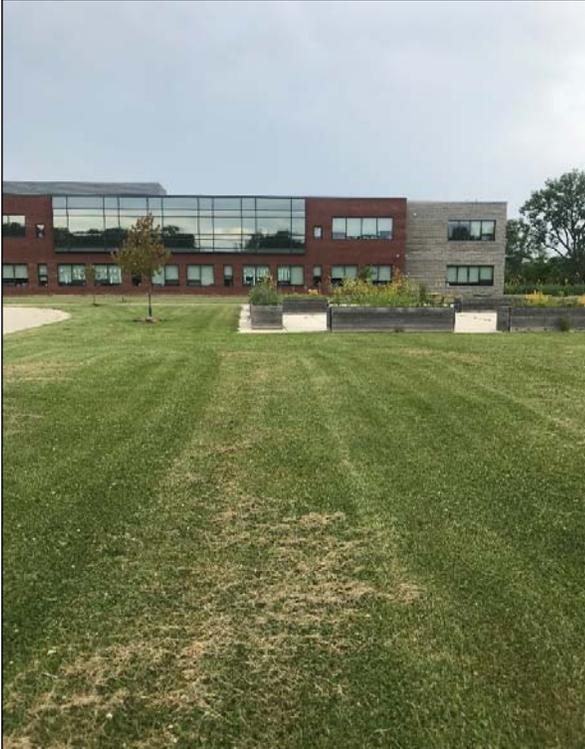
| Photo No. 2 | Date 06/22/18 | | |

| Description: Lawn and above grade planter boxes in front of school. | | | |

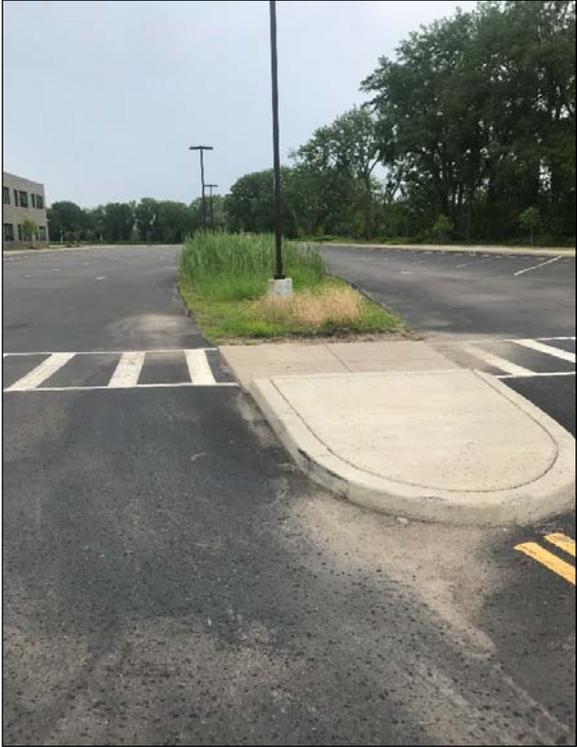
| Photo No. 3 | Date 06/22/18 | | |

| Description: Bus entrance drive/parking area. | | | |

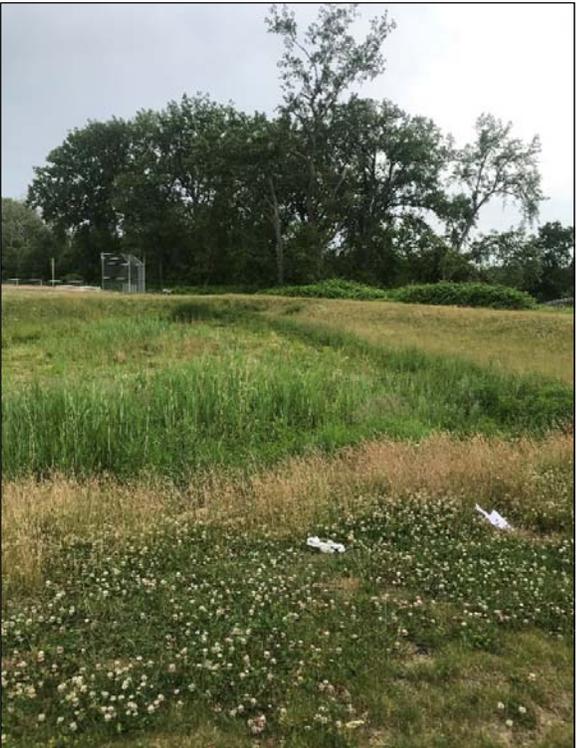
| Photo No. 4 | Date 06/22/18 | | |

| Description: Bioretention pond #5. | | | |

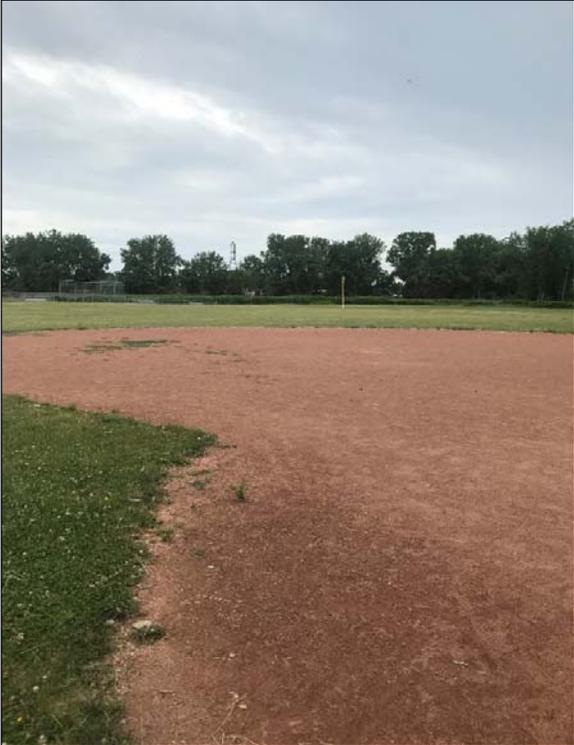
| Photo No. 5 | Date 06/22/18 | | |

| Description: Ball fields showing Marco clay and grass/topsoil cover system components. | | | |

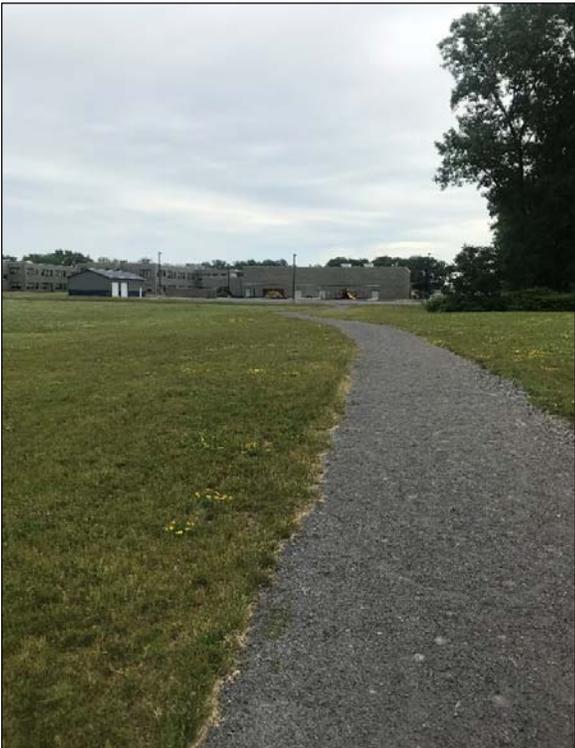
| Photo No. 6 | Date 06/22/18 | |

| Description: Grass/topsoil and stone pedestrian path with school in background. | | |

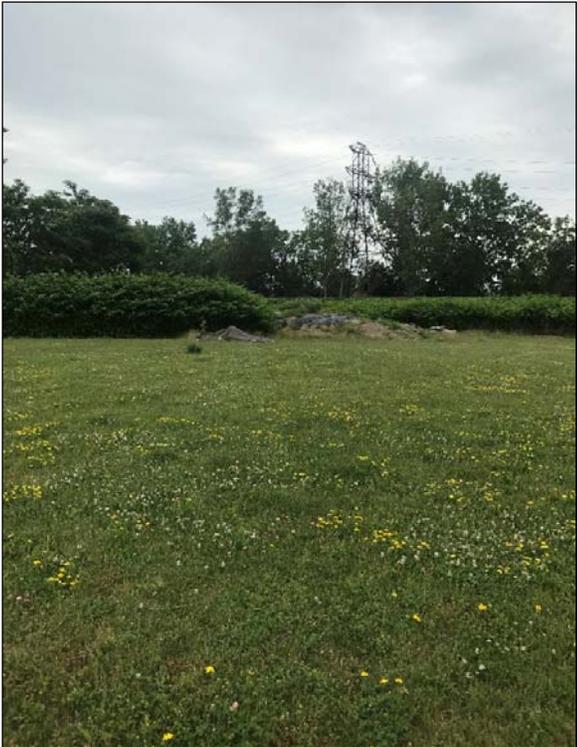
| Photo No. 7 | Date 06/22/18 | | |

| Description: Stockpiled cover soils covered with poly tarp. | | | |

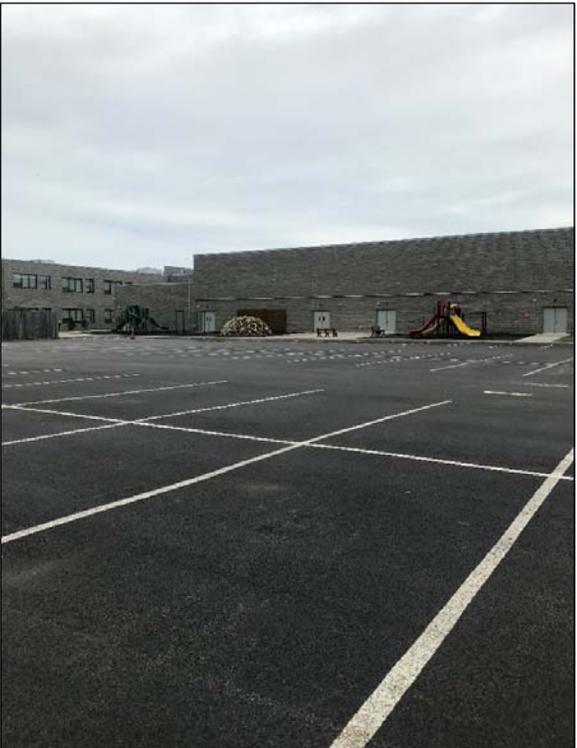
| Photo No. 8 | Date 06/22/18 | | |

| Description: Playground and rear parking area. | | | |

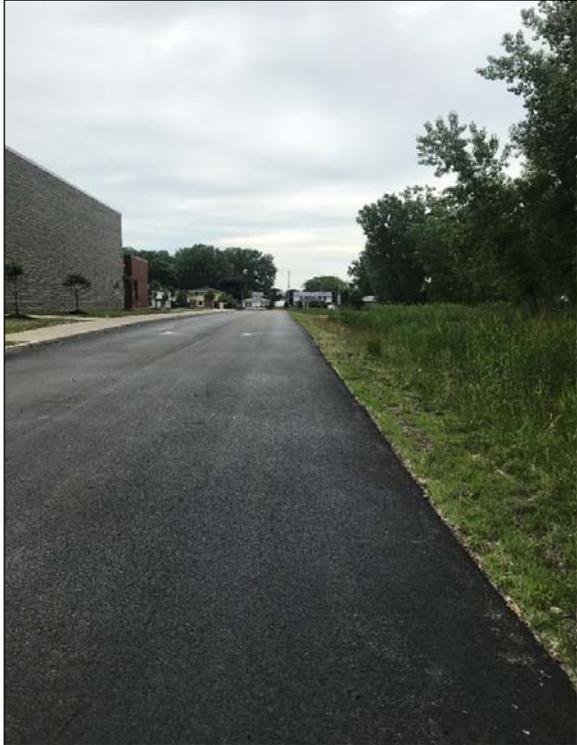
| Photo No. 9 | Date 06/22/18 | | |

| Description: Access drive on south side of school building. Bioretention basins #1 and #2 at right. | | | |

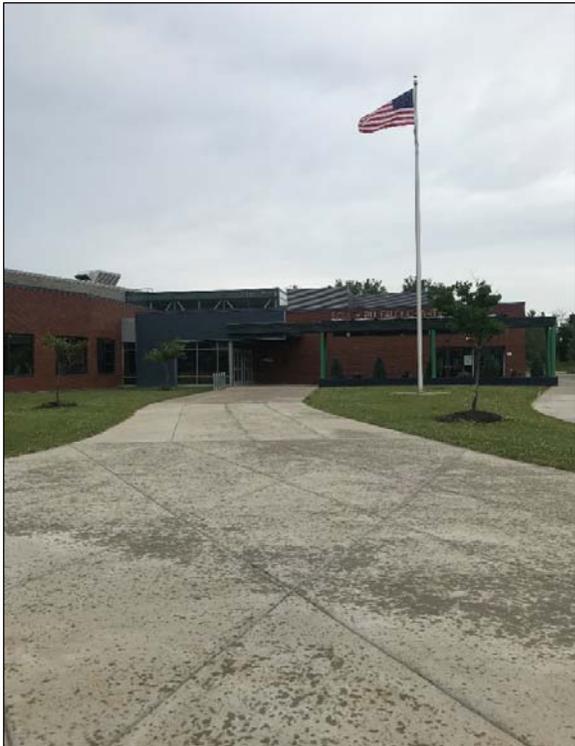
| Photo No. 10 | Date 06/22/18 | | |

| Description: School entrance. | | | |
