Re: AAI Phase I Environmental Site Assessment  
Industrial Property, 100 Ridge Road, Lackawanna, NY  
Project No. e1037

# **PHASE I ENVIRONMENTAL SITE ASSESSMENT**

**Industrial Property  
100 Ridge Road  
Lackawanna, New York**

May 2011

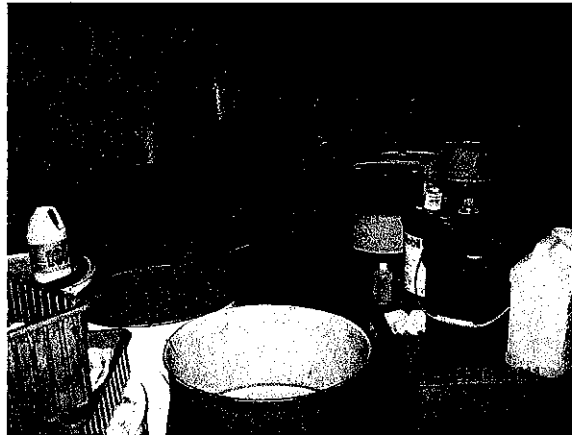
**Photo 2:**

Photo 2: Former chemical storage room.

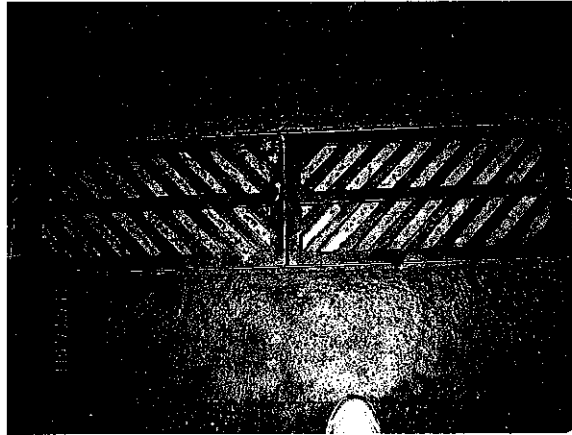
**Photo 6:**

Photo 6: Spill containment sump located in former chemical storage room.

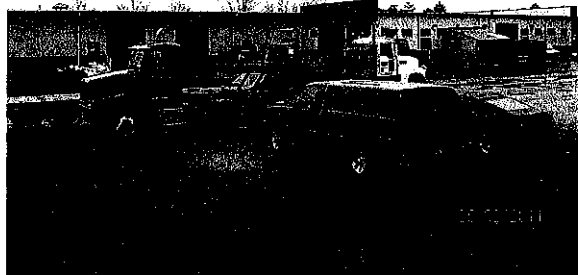
**Photo 9:**

Photo 9: Subject site looking southwest from northeast corner of property.

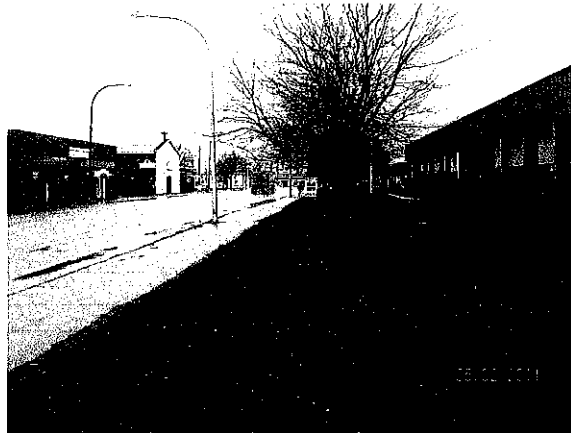
**Photo 10:**

Photo 10: Subject site looking west down southern property boundary (Ridge Rd).
