**Re: Post Remediation Hazardous Materials Inspection
Former BMHA Housing Towers – Kensington Heights**

**Post Remediation Hazardous Materials Inspection
of**

**Kensington Heights
1827 North Fillmore Avenue
Buffalo, NY 14214**

Conditions as of January 29, 2010

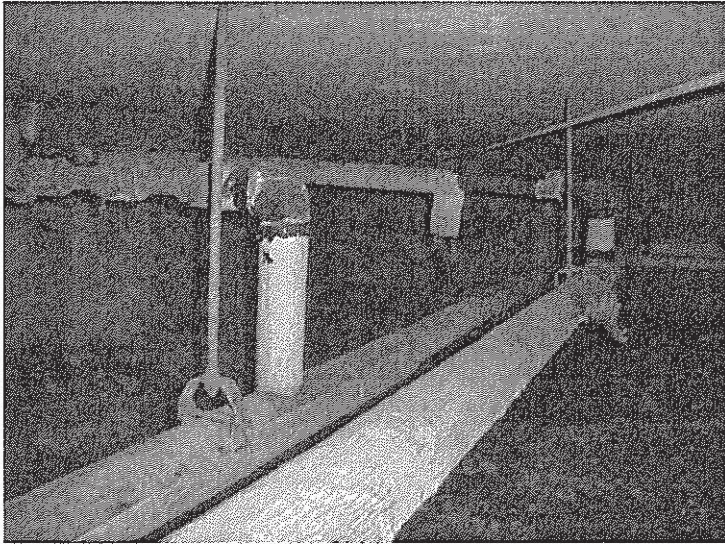
ACM Pipe Fittings Still in Place in Crawlspace

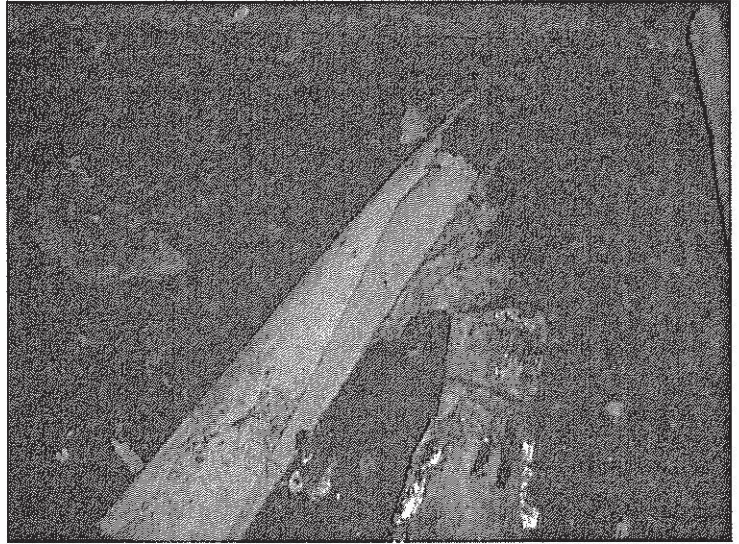
Crawlspace Soil Contaminated with ACM Pipe Insulation

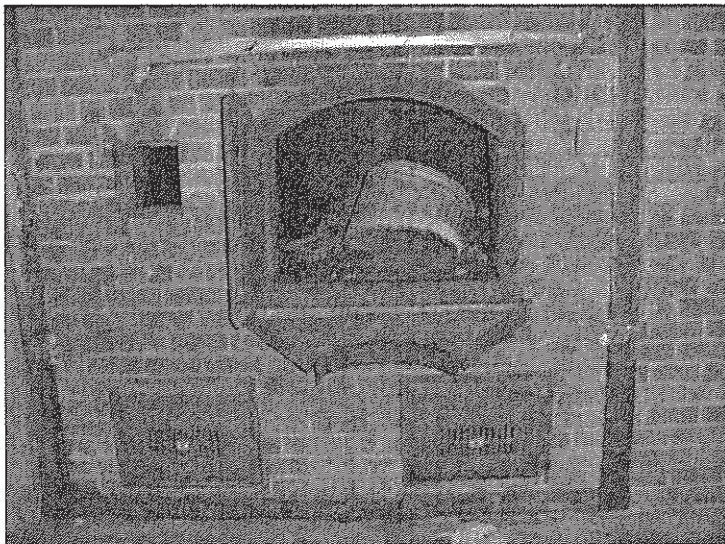
Incinerator with Suspect ACM Located Inside

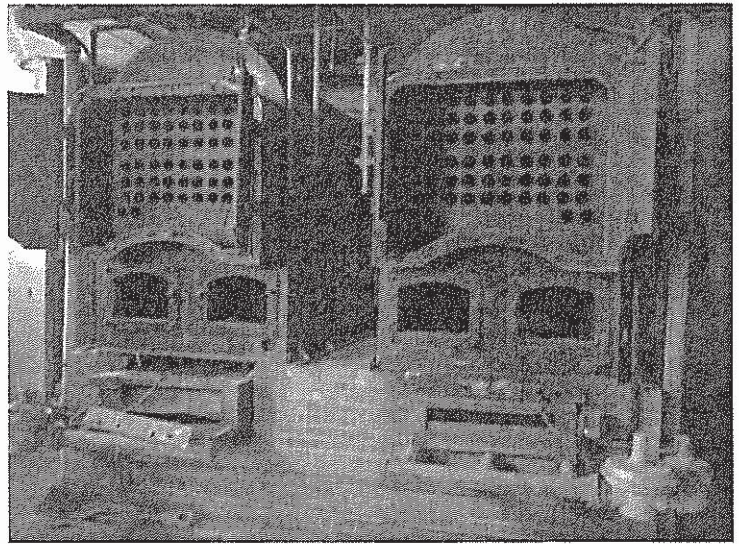
Boiler with Suspect ACM Located Inside, ACM Boiler Insulation at Seam of Boiler and ACM Boiler Gasket on the Doors

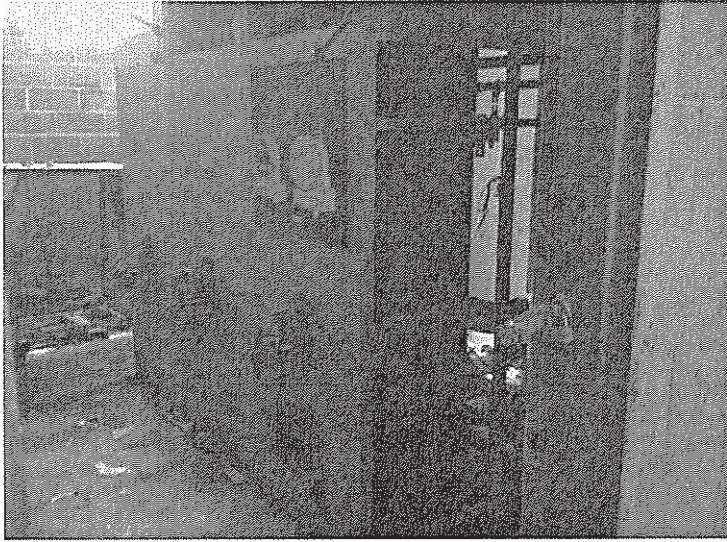
Switchgear Box in the Transformer Room with Bake-Lite Panels in it

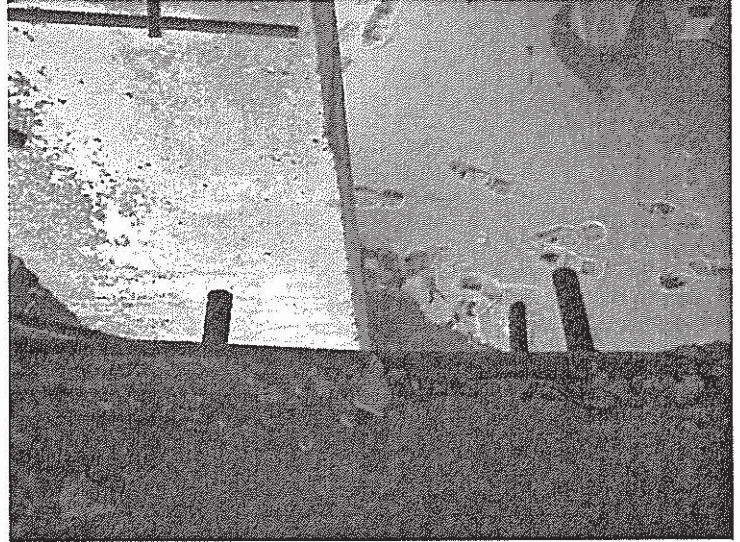
ACM Floor Tile Debris Located at Chute

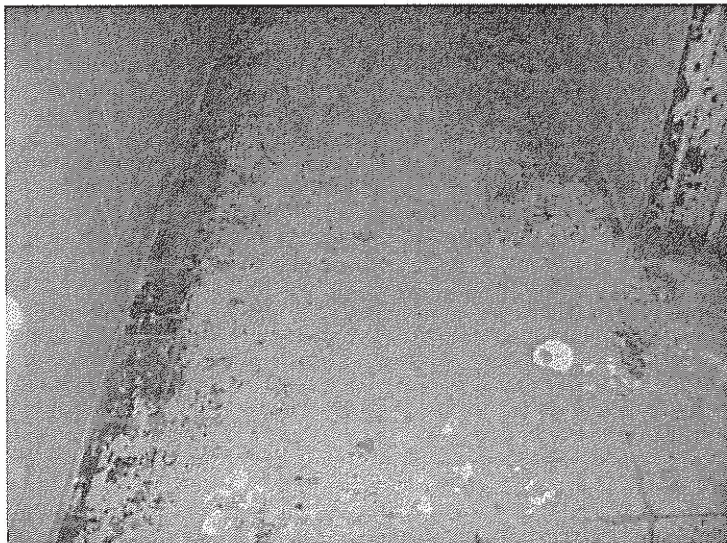
ACM Floor Tile Debris and Mastic Inside Building

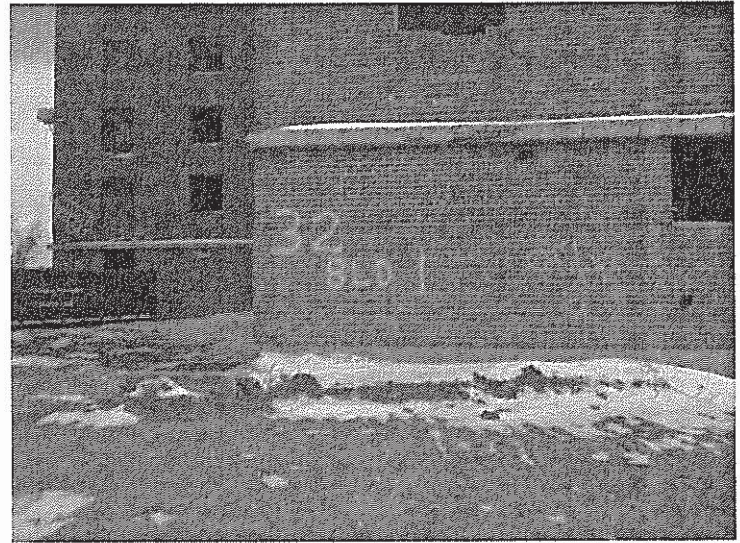
Exterior of Building with Soil Contaminated with ACM Caulk and Floor Tile Debris

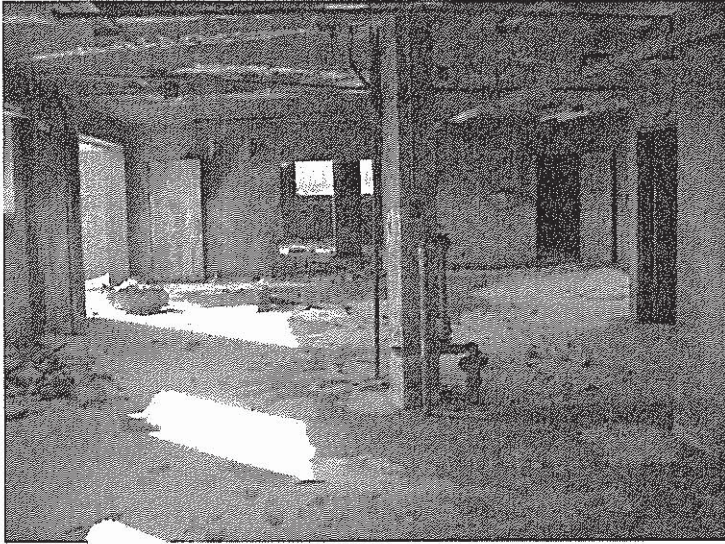
Interior of Building Contaminated with ACM Debris

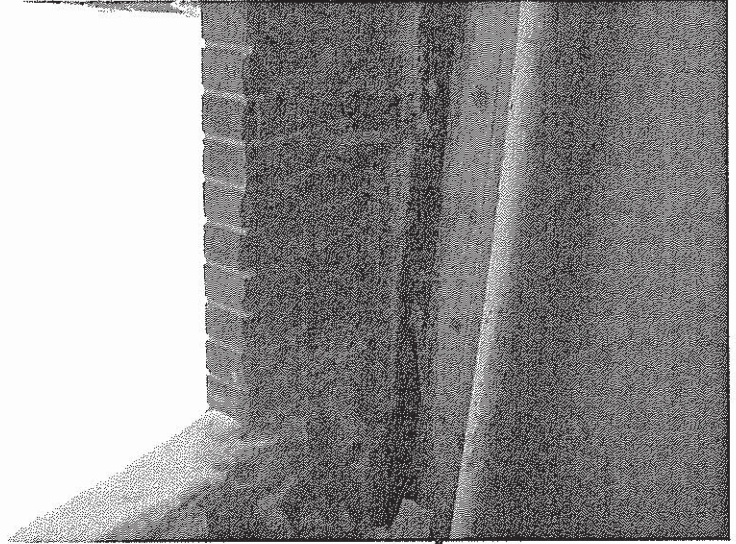
ACM Tar Counterflashing at Interior Support Piers

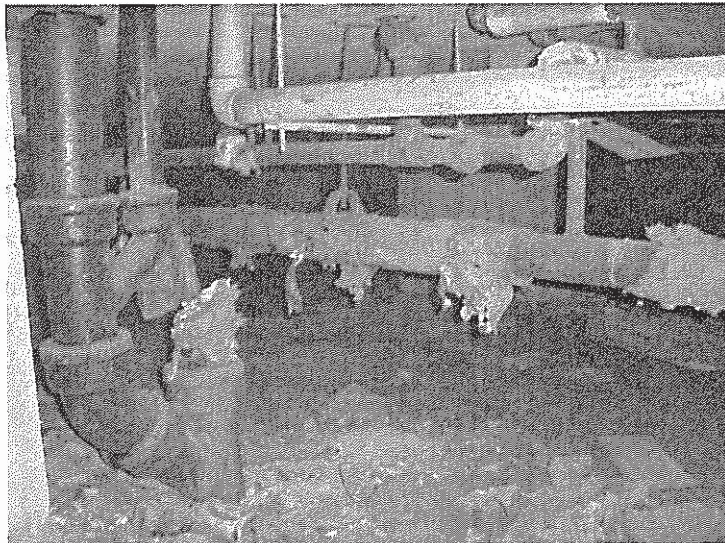
Some ACM Pipe Fitting Still in Place in Crawlspace. Soil Contaminated with ACM Debris

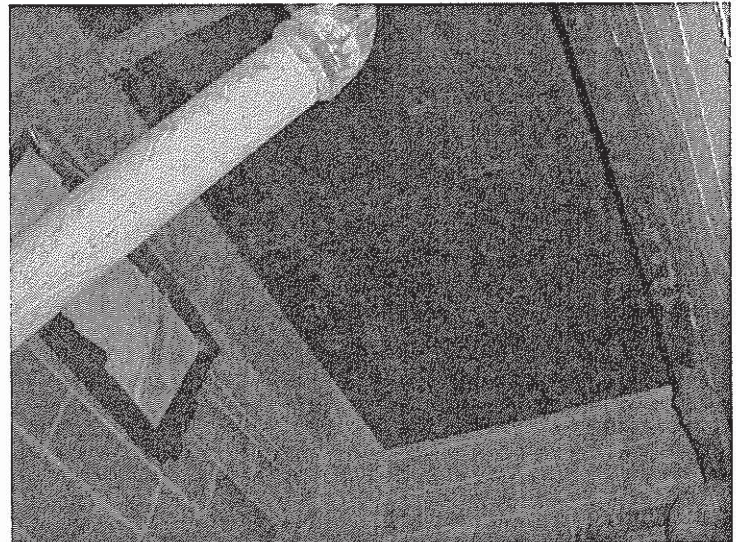
Ceiling Insulation in Place in Gas Meter Room with ACM Glue Holding the Pins to the Ceiling.

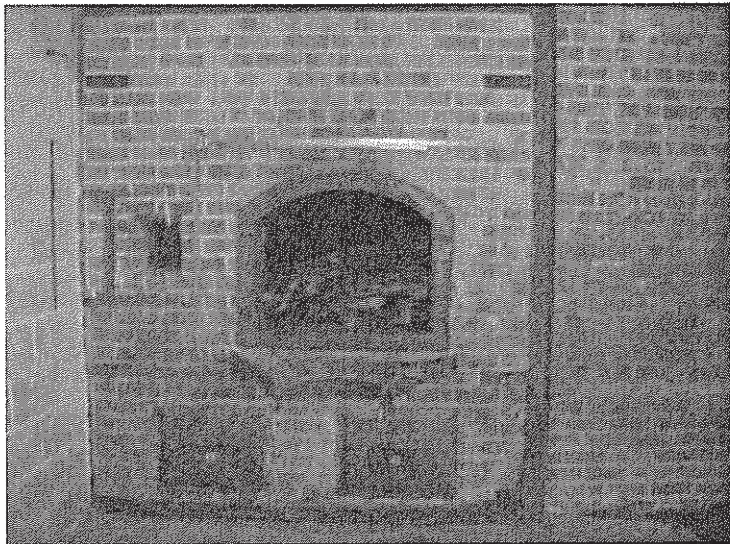
Incinerator with Suspect ACM Located Inside

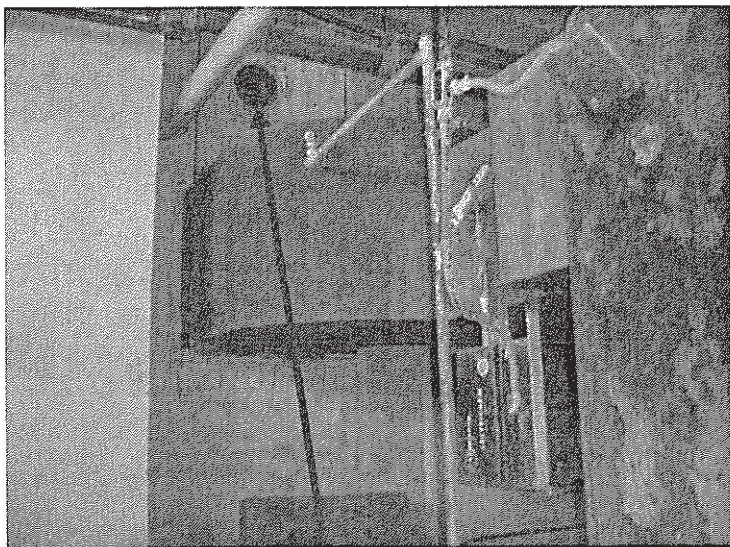
ACM Transite Pipe in Wall

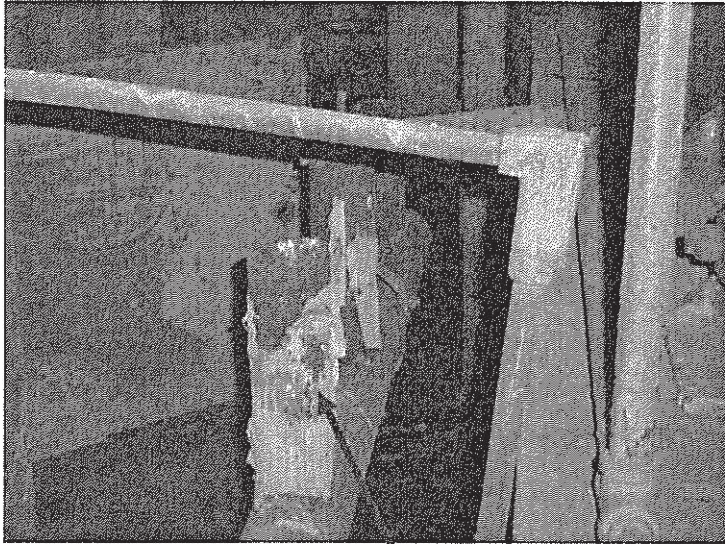
ACM Pipe Insulation Still in Place on Pipes Behind Boiler

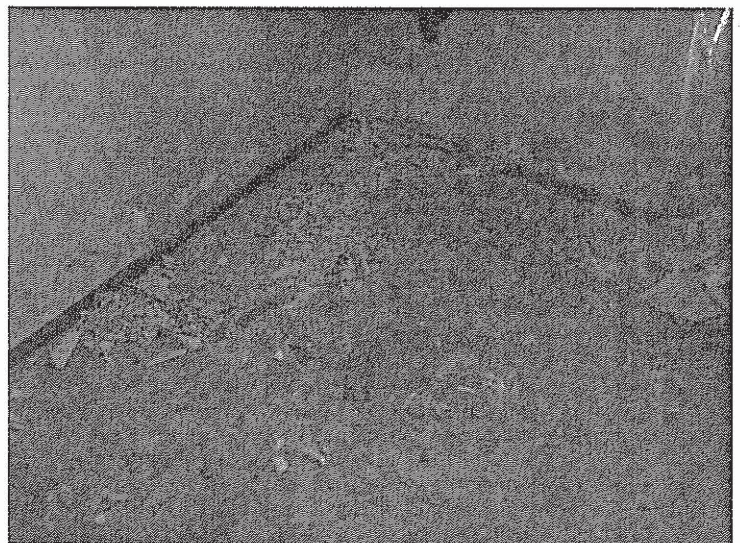
Interior of Building Contaminated with ACM Floor Tile Debris and Mastic Still on Floor.

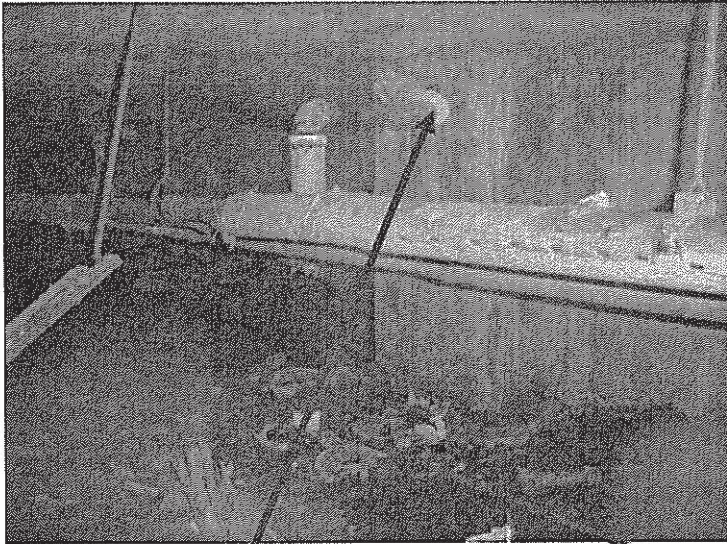
Some ACM Pipe Fitting Still in Place in Crawlspace. Soil Contaminated with ACM Debris

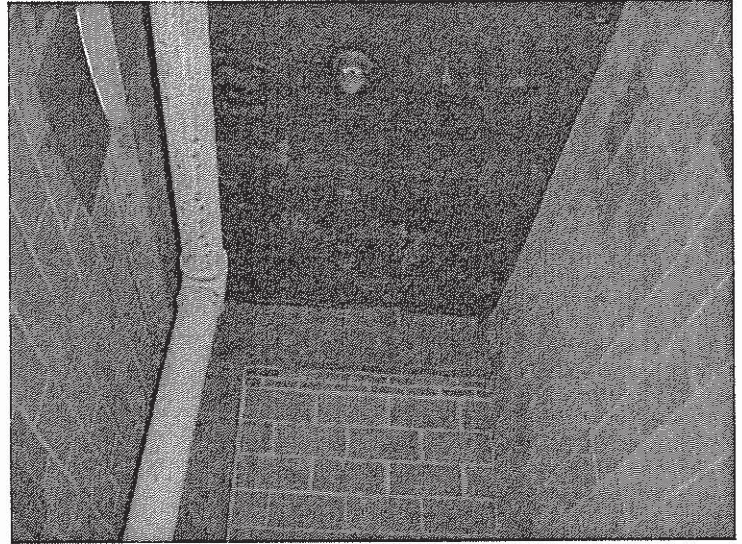
Ceiling Insulation in Place in Gas Meter Room with ACM Glue Holding the Pins to the Ceiling.

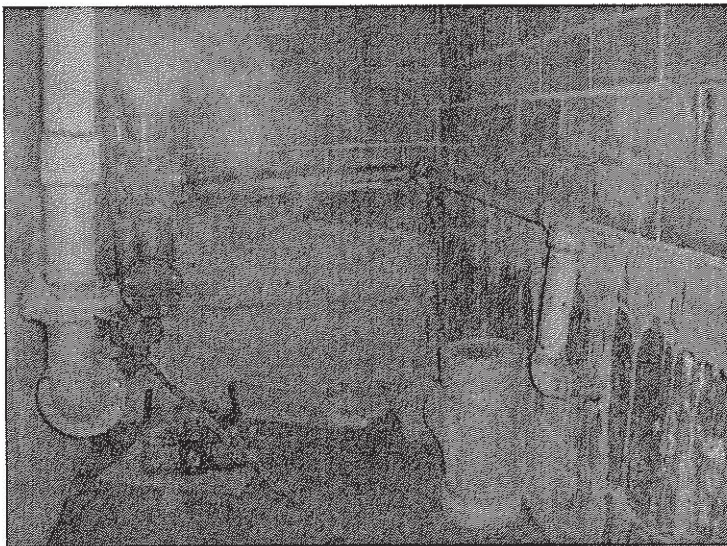
ACM Flange Gaskets in Gas Meter Room

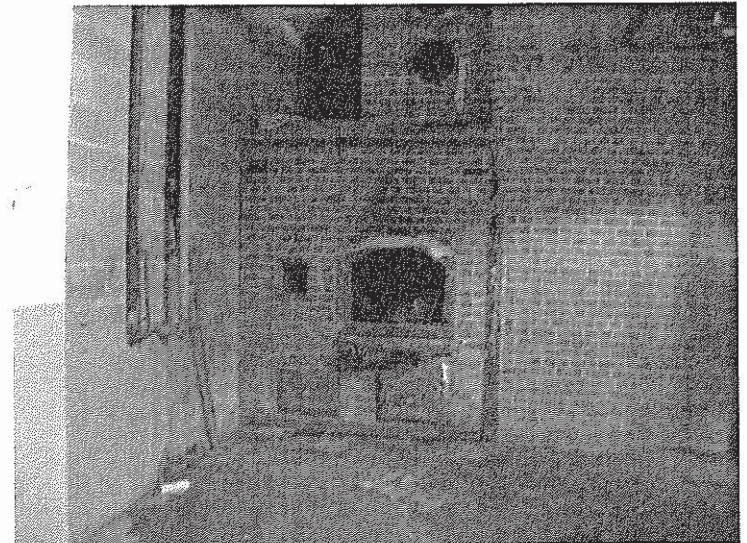
Incinerator with Suspect ACM Located Inside

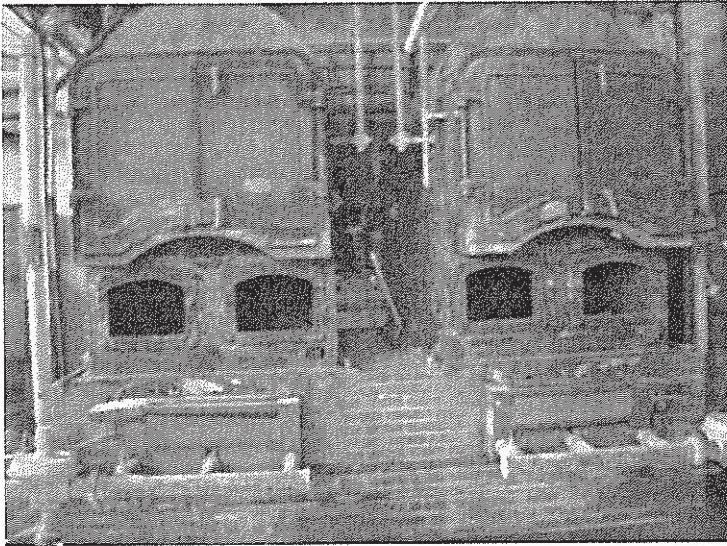
Boiler with Suspect ACM Located Inside, ACM Boiler Insulation at Seam of Boiler and ACM Boiler Gasket on the Doors

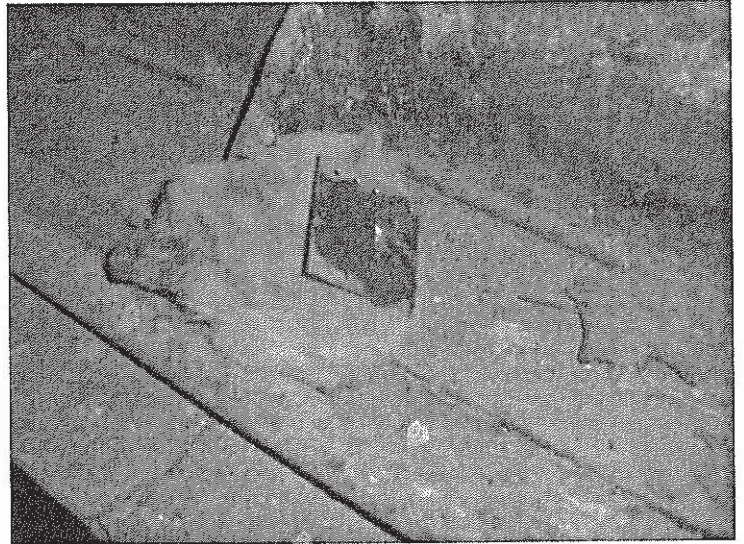
ACM Glue Debris Scattered Throughout Boiler Room

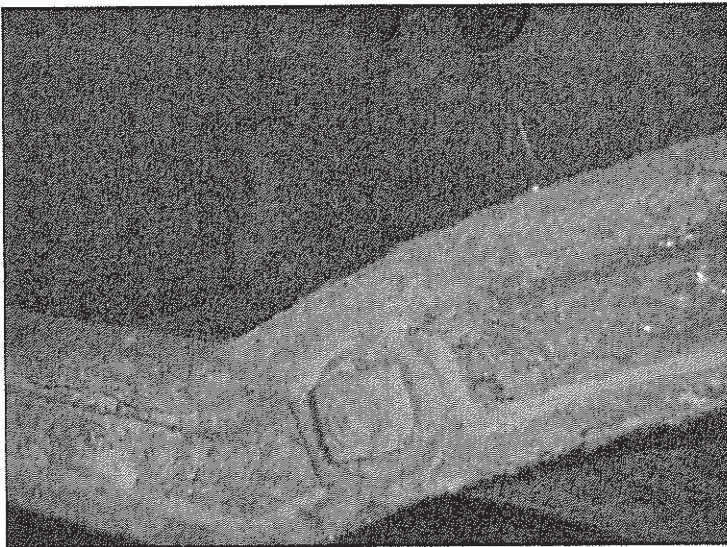
ACM Boiler Gasket

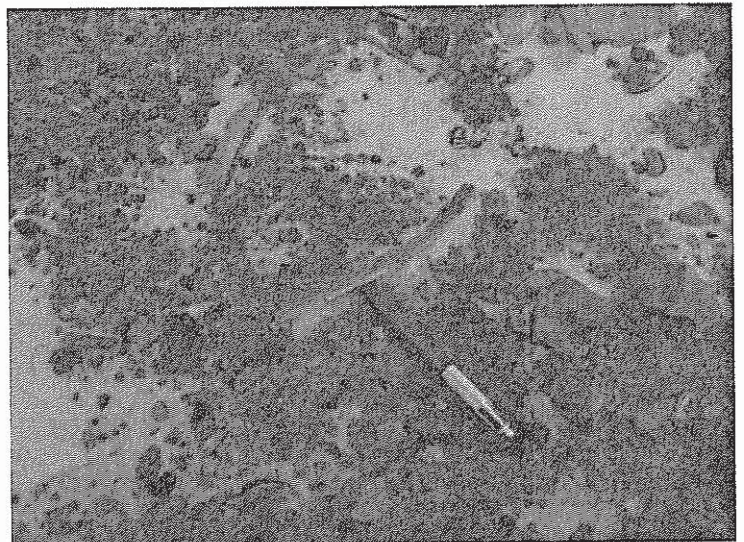
Exterior Soil Contaminated with ACM Caulk Debris

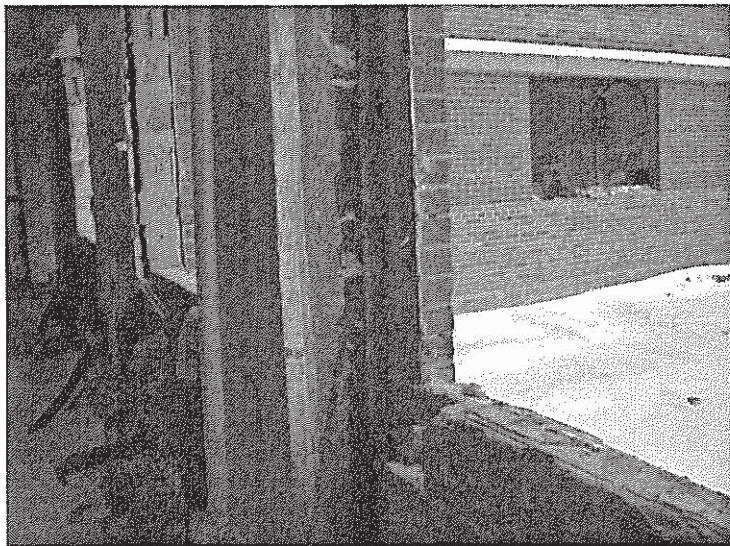
ACM Tar Counterflashing at Interior Support Piers and
ACM Window Caulk Still in Place

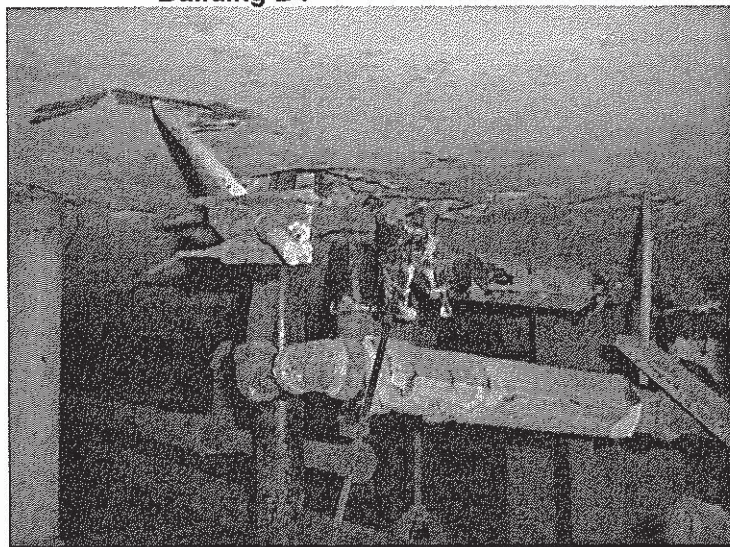
Some ACM Pipe Fitting Still in Place in Crawlspace.

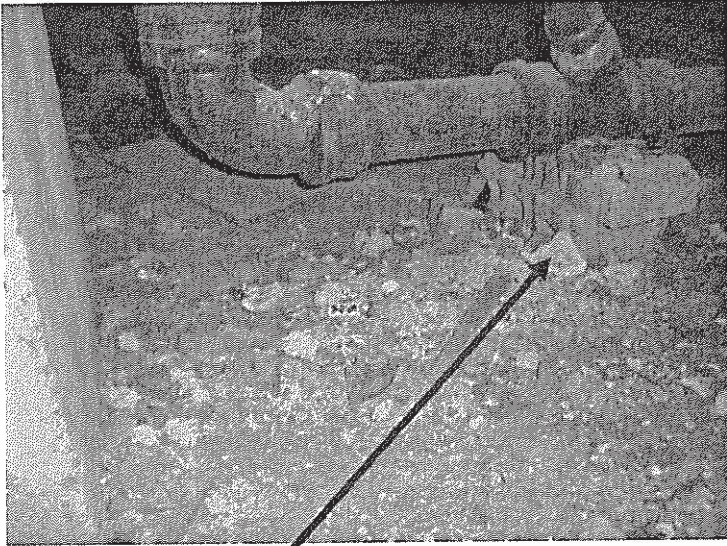
Crawlspace Soil Heavily Contaminated with ACM Pipe Fitting Debris

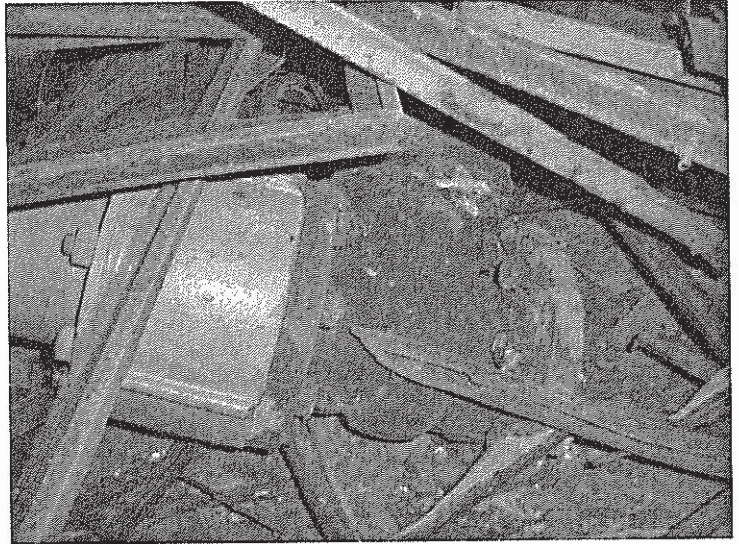
ACM Contaminated Construction Debris at Entrance to Crawlspace.

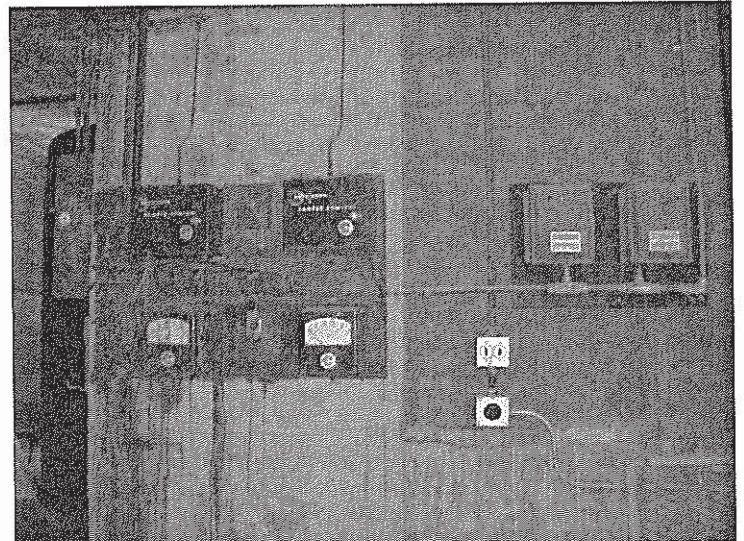
Sealed Control Boxes and Meters Potentially Containing Hazardous Materials.

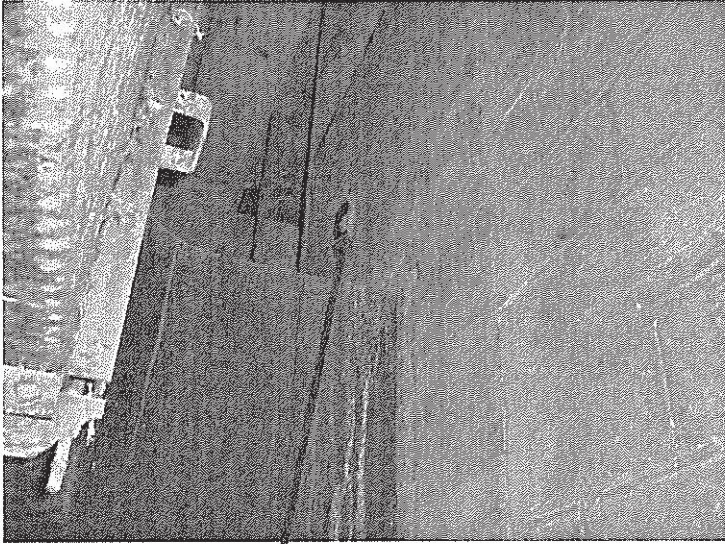
ACM Transite Pipe Still in Place in Wall

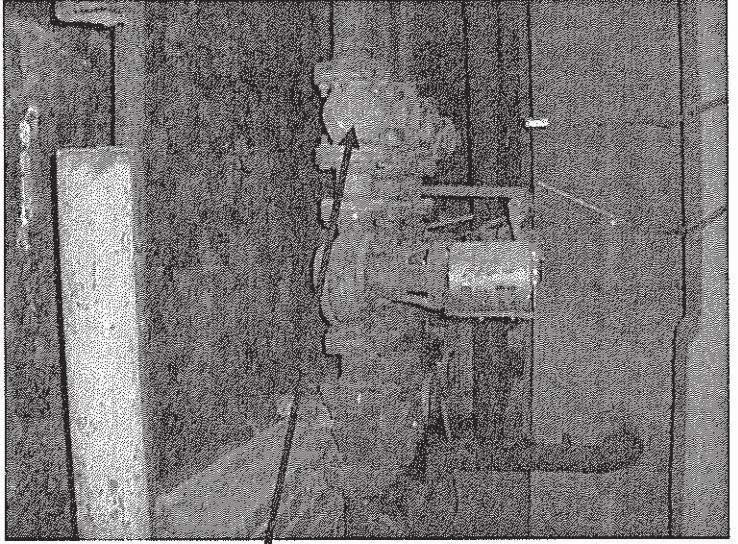
ACM Pipe Fittings Still in Place Behind Boiler

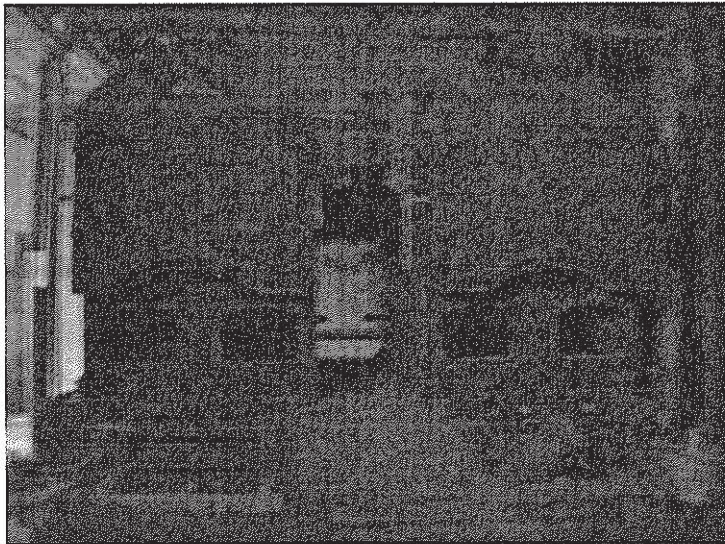
Boiler with Suspect ACM Located Inside, ACM Boiler Insulation at Seam of Boiler and ACM Boiler Gasket on the Doors

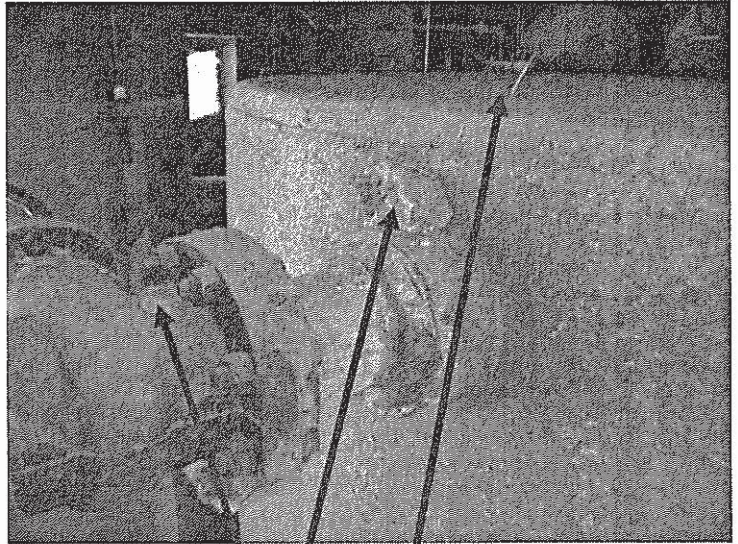
ACM Debris on Top of Large Tank. ACM Pipe Debris on Top of Large Tank

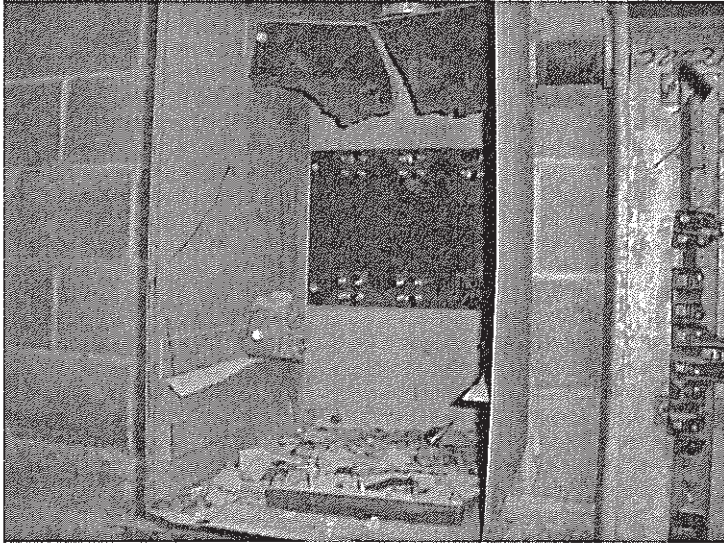
ACM Transite and Bake-Lite Debris in Cabinet in
Transformer Room

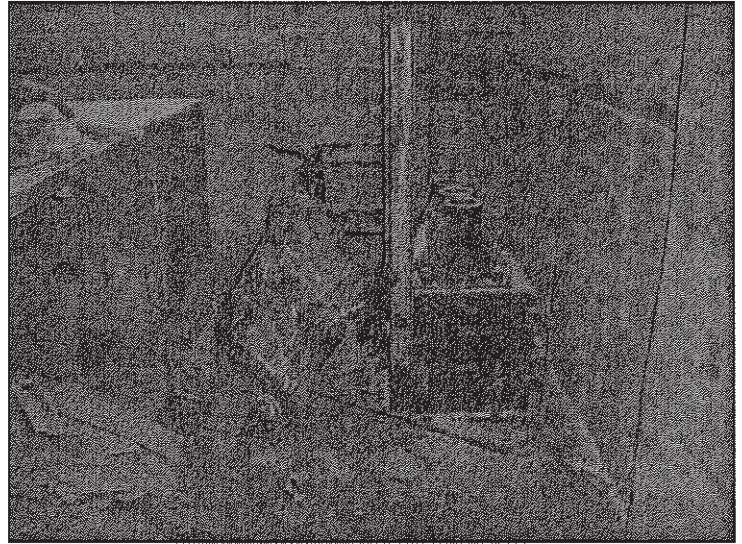
Asbestos Waste Bag with Contaminated Debris Inside.
Transformer Carcas Possibly Contaminated with PCBs

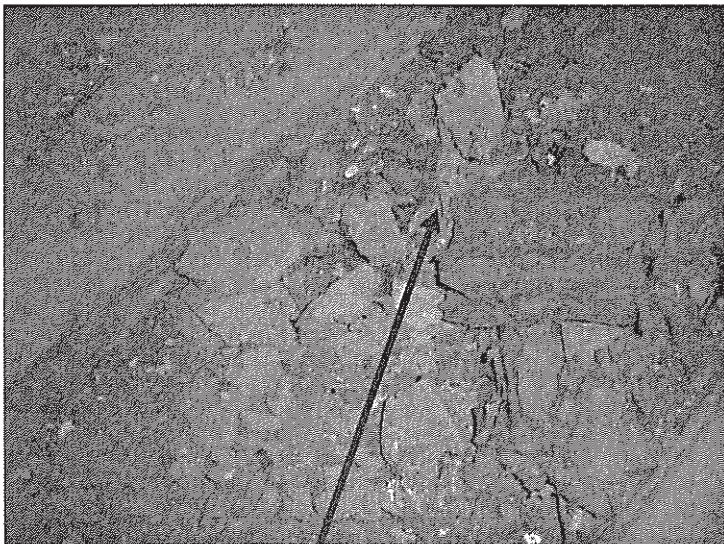
ACM Debris on Laundry Room Floor Inside Building

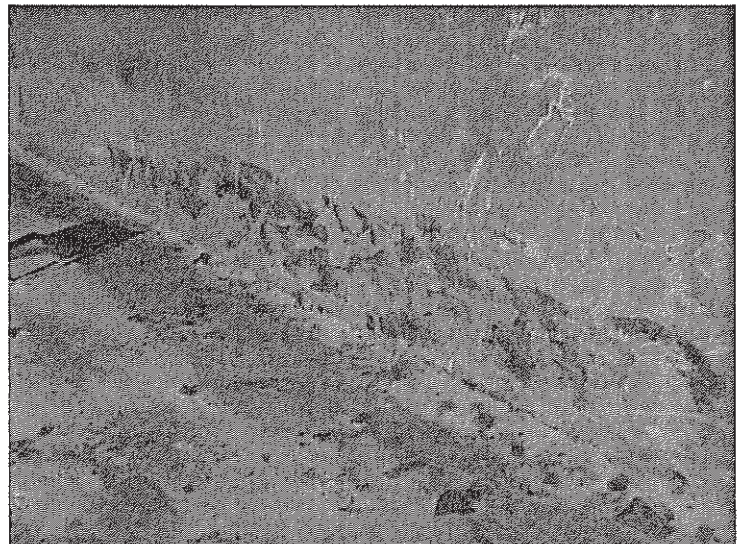
Skidsteer Tire Marks on Wall with ACM Floor Tile Debris on
Floor. (Loading Area)

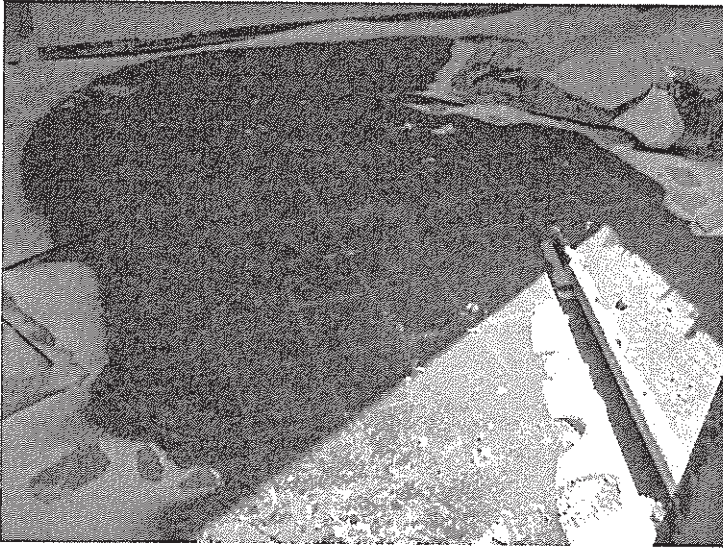
ACM Mastic On Floor in Interior of Building

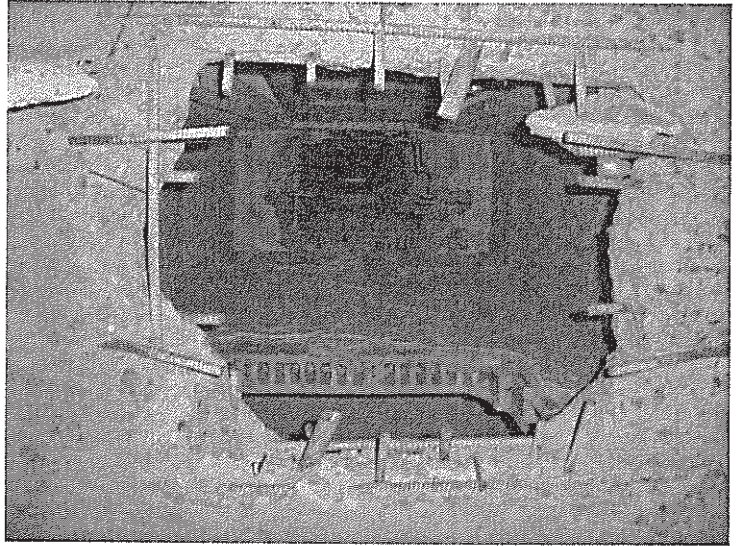
Chute Made by Contractor

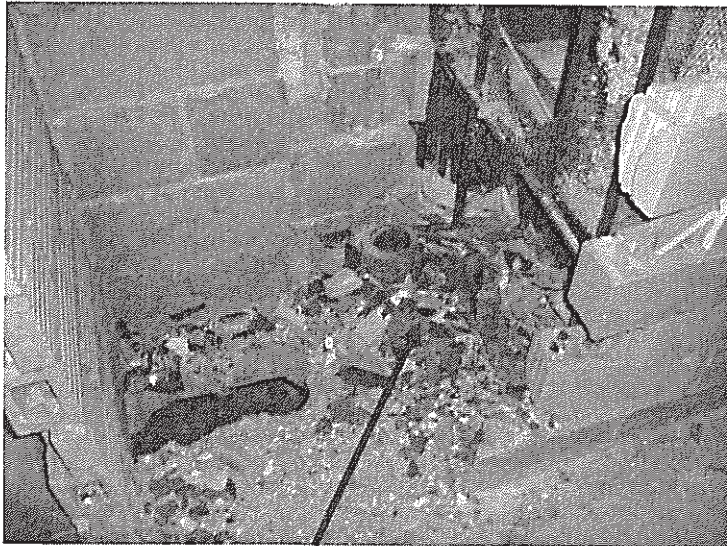
ACM Floor Tile Debris Around Hole to Crawlspace

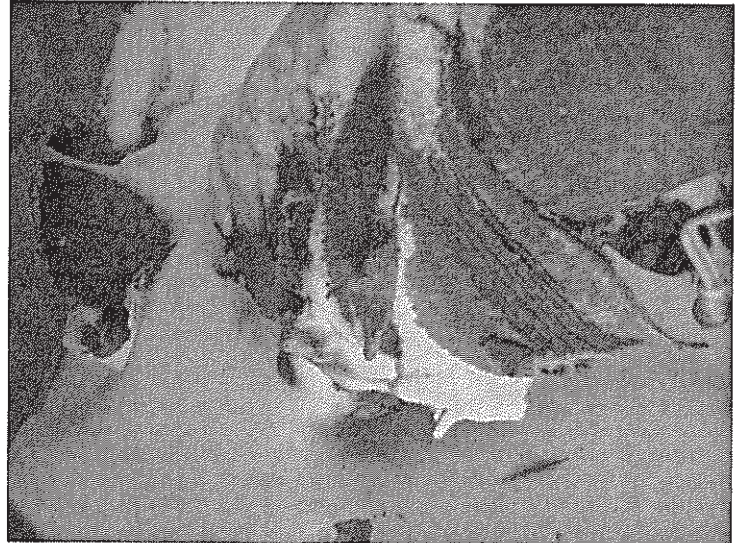
ACM Duplex Pipe Insulation Jacket on Roof

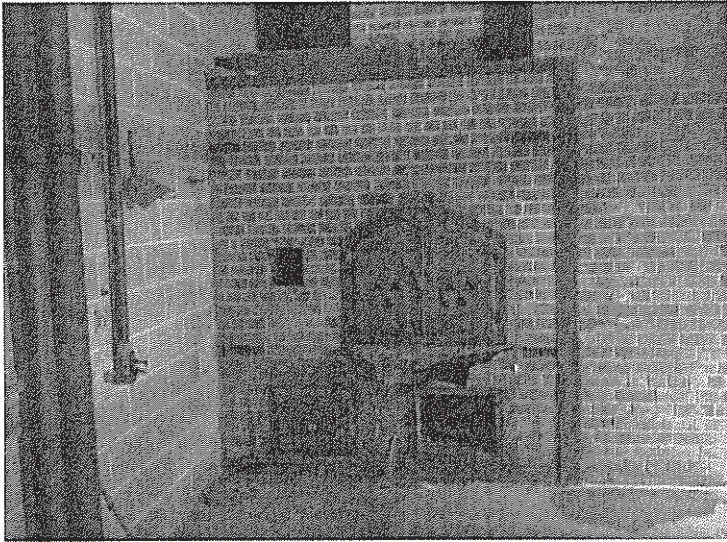
Incinerator with Suspect ACM Located Inside

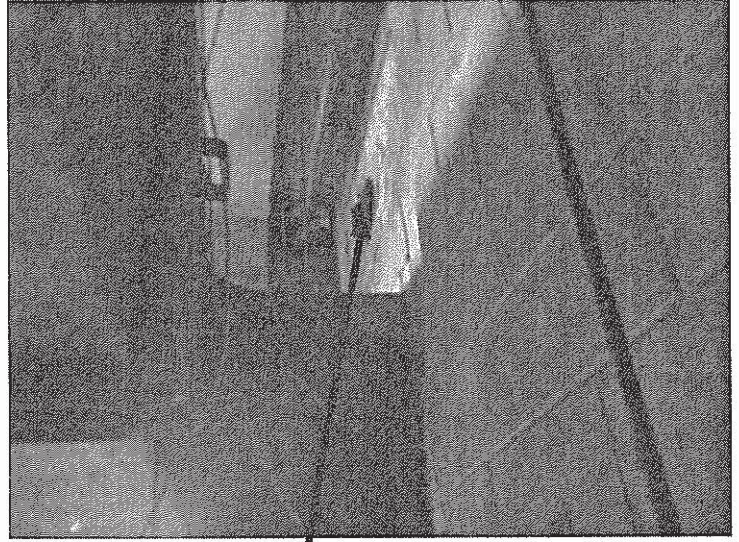
ACM Transite Pipe Still in Wall

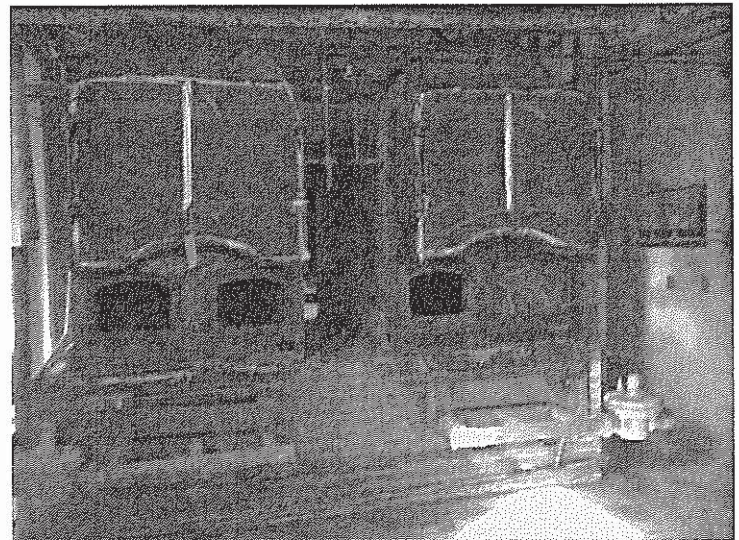
Boiler with Suspect ACM Located Inside, ACM Boiler Insulation at Seam of Boiler and ACM Boiler Gasket on the Doors

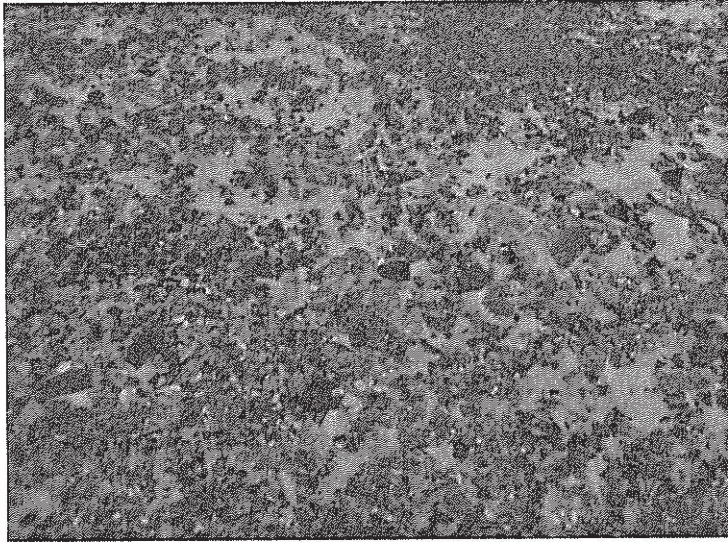
Exterior of Building with Soil Heavily Contaminated with
ACM Floor Tile Debris

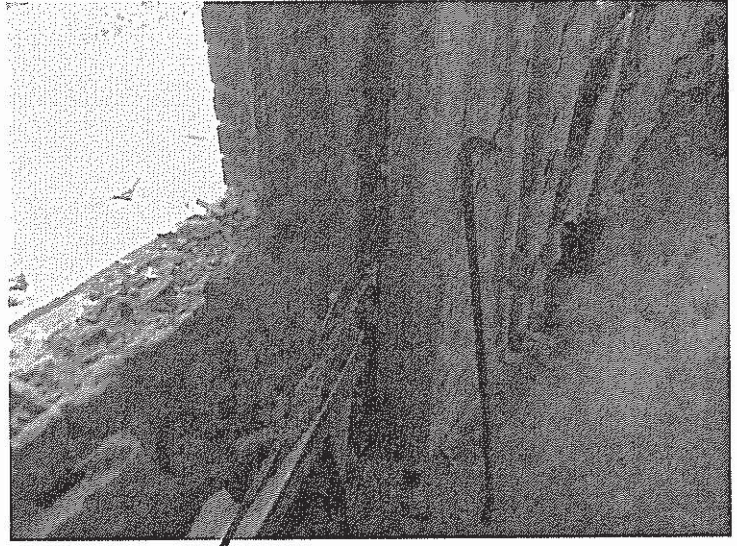
ACM Tar Counterflashing at Interior Support Piers and ACM
Floor Tile Debris on Floor

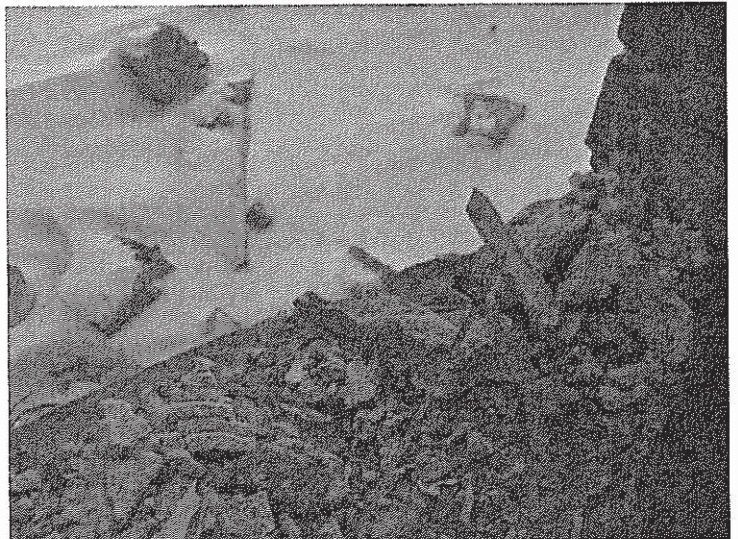
ACM Window Caulk Debris Inside Window Openings.

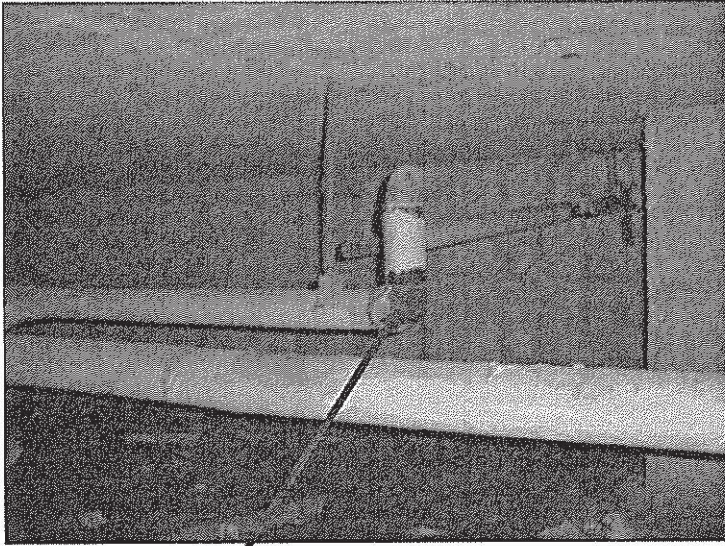
ACM Pipe Fittings Still in Place in Crawlspace. Soil Contaminated with ACM Debris

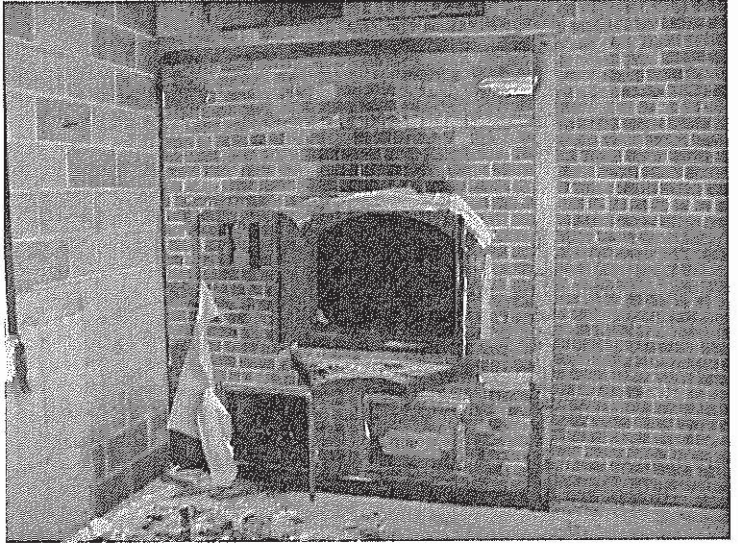
Incinerator with Interior Suspect ACM Located Inside

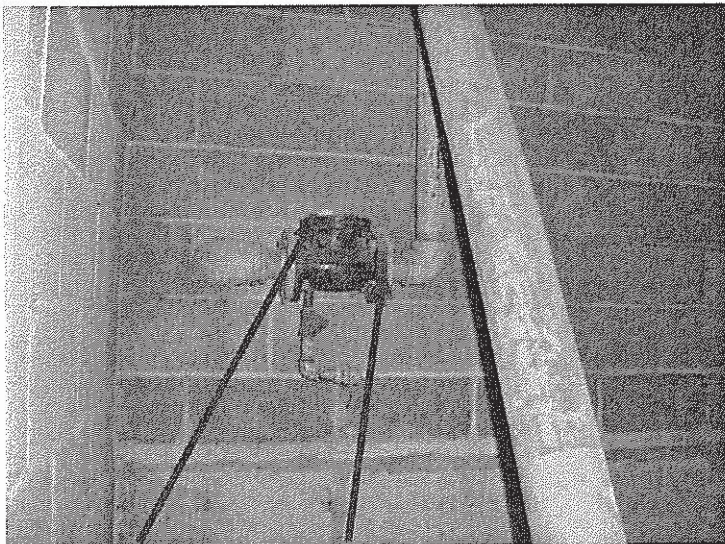
Gas Meter Room Contaminated with ACM Pipe Fitting Debris. ACM Flange Gasket in Room.

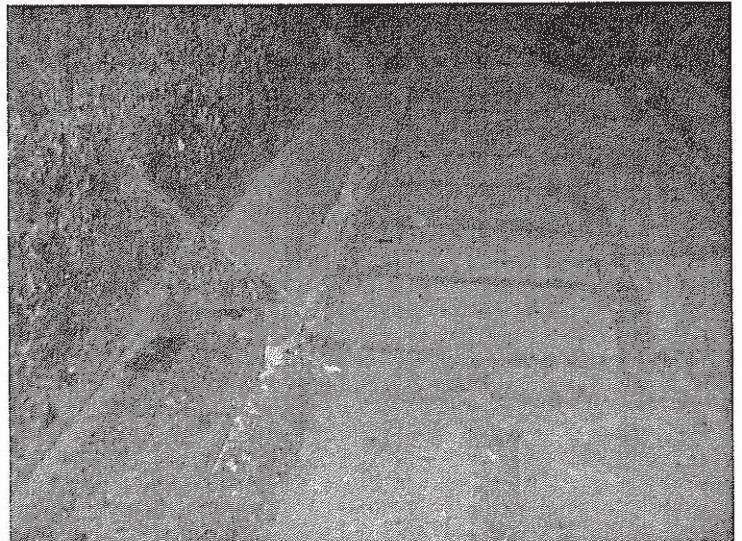
ACM Boiler Insulation at Seam of Boiler

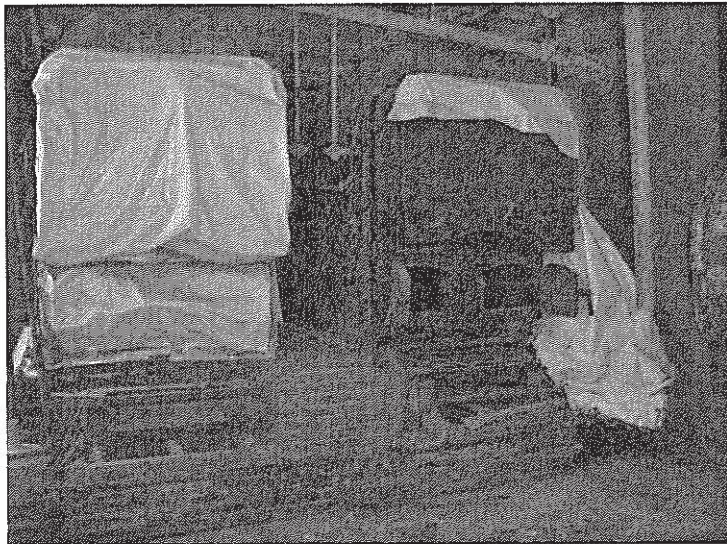
Boiler with Suspect ACM Located Inside, ACM Boiler Insulation at Seam of Boiler and ACM Boiler Gasket on the Doors

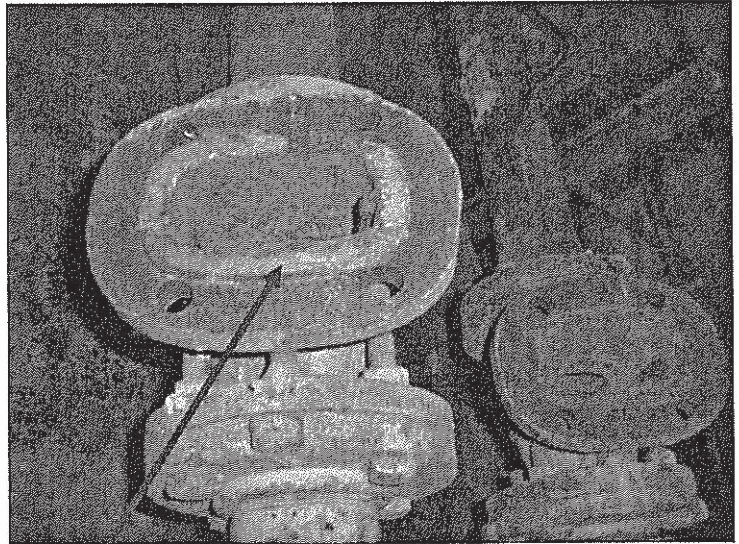
ACM Flange Gaskets Behind Boiler With ACM Pipe Insulation Still in Place on Pipe

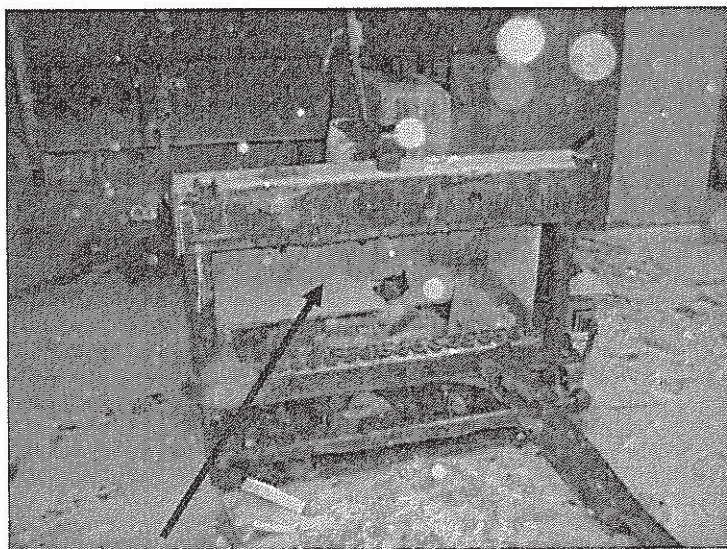
- The summer boiler remains in the boiler room. The interior insulation material was tested by Stohl Environmental and found to be an asbestos containing material.

Summer Boiler With ACM Insulation Inside it

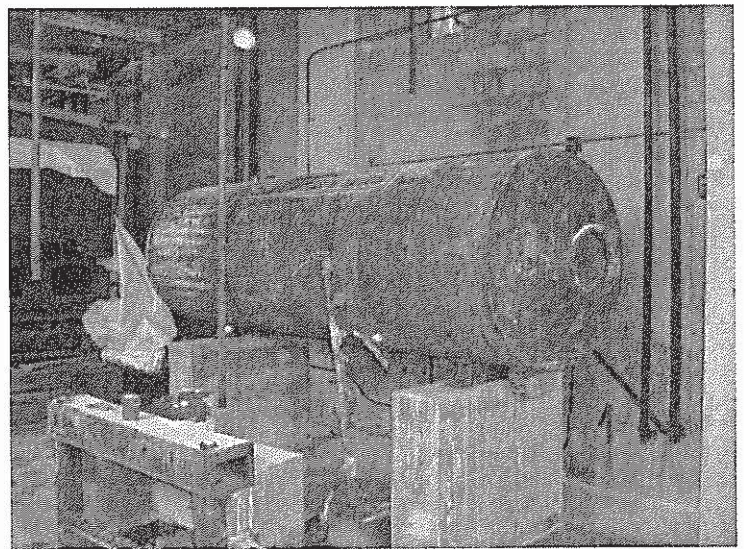
- The hot water tank remains and has an interior concrete lining. This material was tested by Stohl Environmental and found to be an asbestos containing material.

Hot Water Tank with ACM Concrete Lining Inside it
