**Re: Post Remediation Hazardous Materials Inspection
Former BMHA Housing Towers – Kensington Heights**

**Post Remediation Hazardous Materials Inspection
of**

**Kensington Heights
1827 North Fillmore Avenue
Buffalo, NY 14214**

Conditions as of January 29, 2010

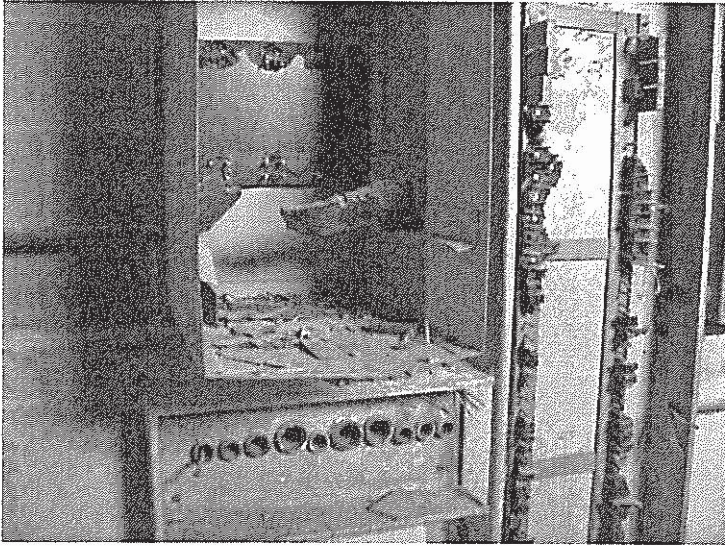
- Transformer Room
 - PCB Residue as Identified in 56 Services Inspection Report remains on the floor.
 - Transite and Bake-Lite debris were found in the cabinet along the left wall. These materials were tested by Stohl Environmental and found to be asbestos containing materials.

ACM Transite and Bake-Lite Debris in Cabinet in
Transformer Room

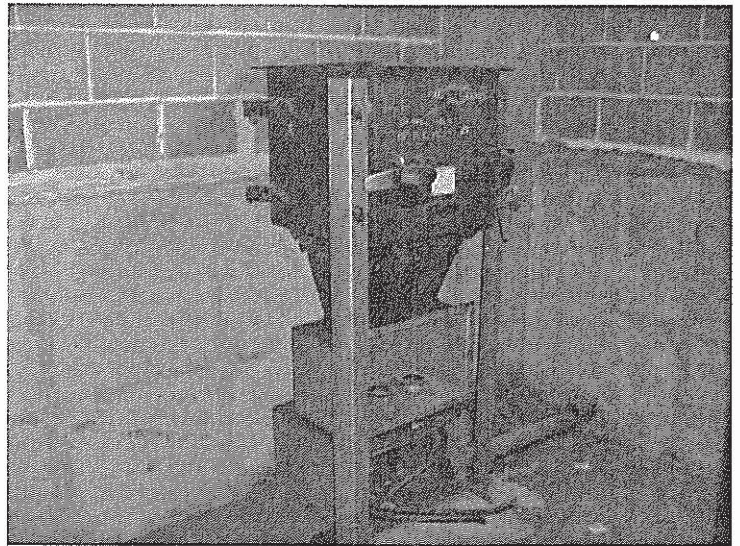
- Asbestos electrical paper was also found in the cabinet along the left wall.
 - The transformer carcass remains in place with debris located inside of it. Transformer carcass may contain PCB residue and should be properly closed or tested.

Transformer with PCB Residue Inside

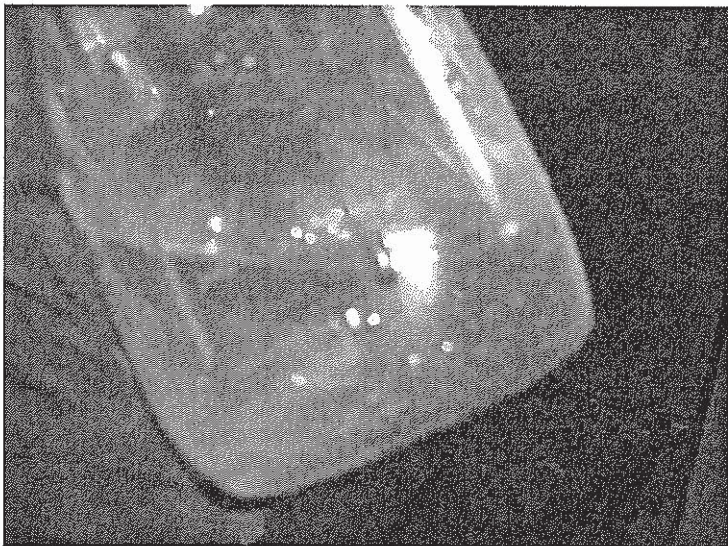
Mason Jar of Oil Located Behind Transformer

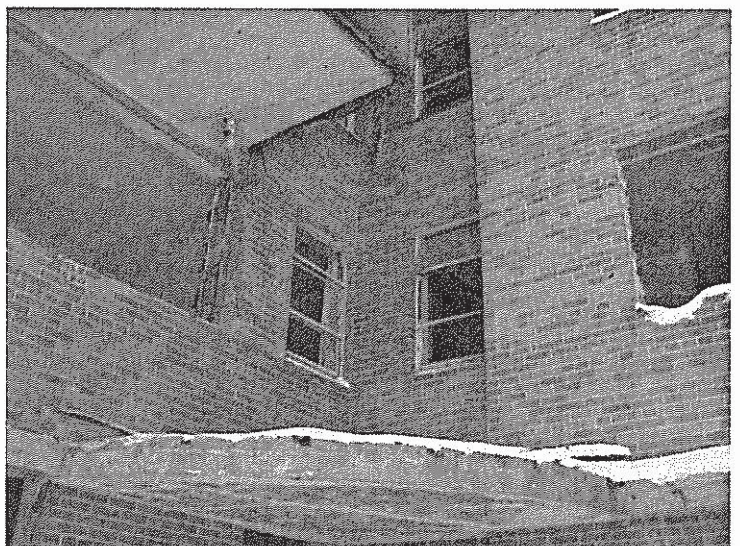
- Some windows with asbestos containing caulk around the perimeter remain in place on the building.
 - Asbestos containing window and door caulk debris is located on the soil surrounding the perimeter of the building. Asbestos in a debris condition requires a variance as per Industrial Code Rule (ICR) 56 Guidance Document.

Exterior Windows Still in Place with ACM Caulk around
Them. ACM Caulk Still in Place on Window Openings.

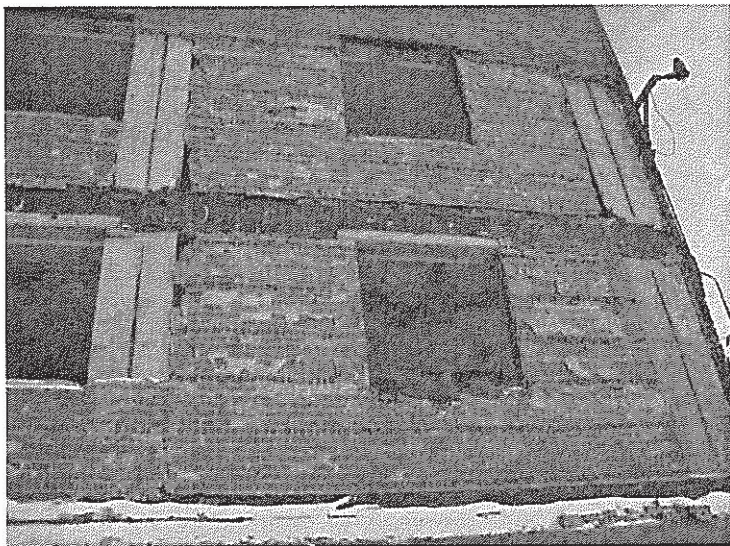
ACM Counterflashing Tar Still in Place on Support Piers

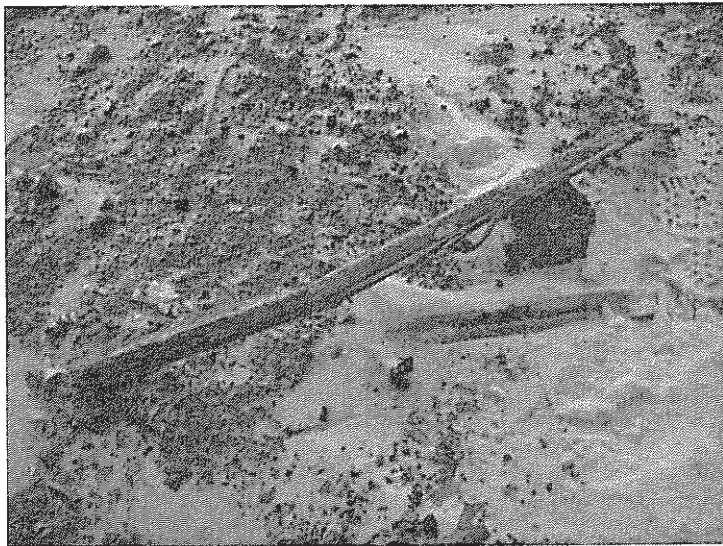
Exterior Window Frame with ACM Caulk Still on it Located
Away From Building

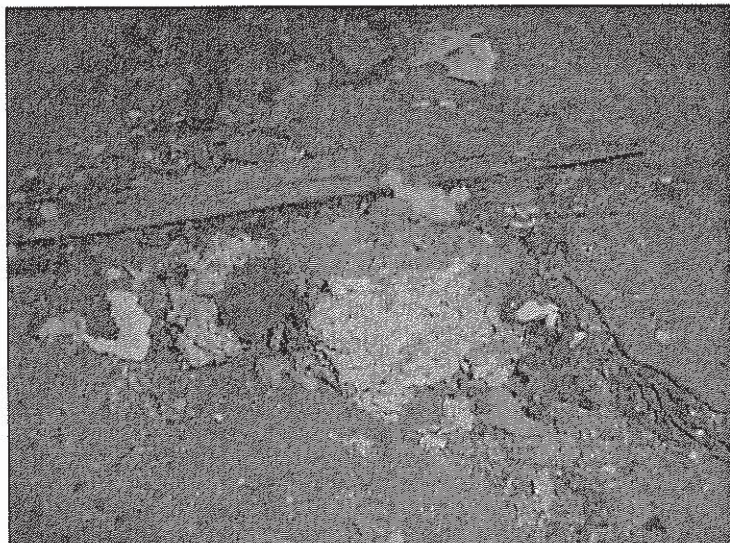
ACM Pipe Fitting Debris Located in Laundry Room

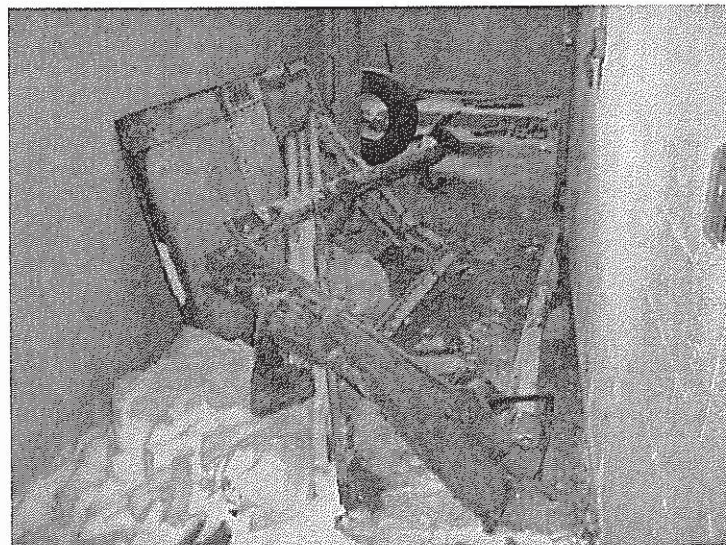
Door Frame Located Inside Building

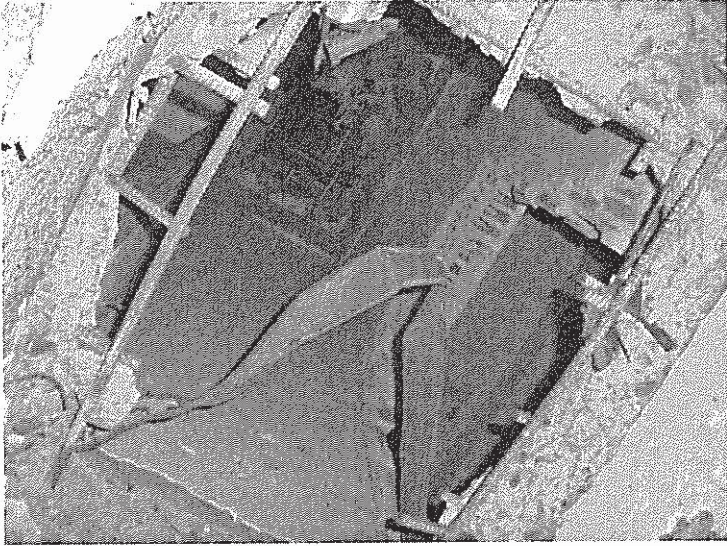
Chute Made by Contractor with ACM Counterflashing Paper
Hanging From Rebar

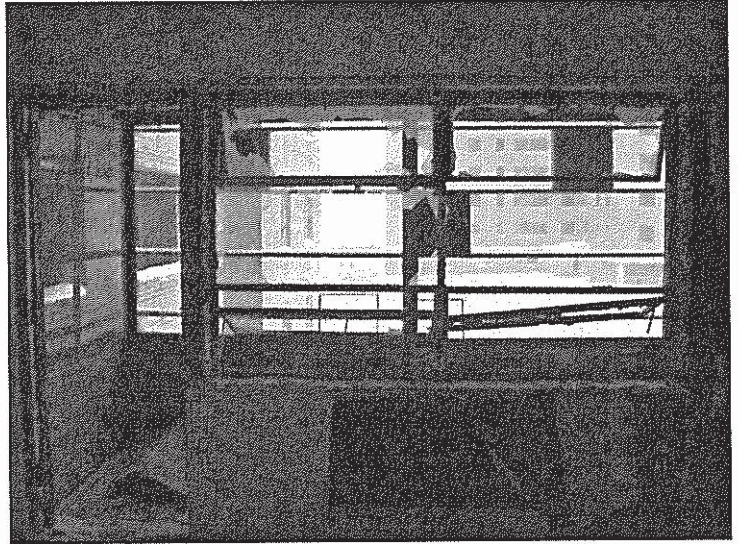
- Exterior porches – Windows with asbestos caulk around the perimeter remain. Exterior porches are insulated with honeycomb insulation. This material was tested by Stohl Environmental and found to be negative for asbestos in building B6. Sampling of each building should be performed to confirm the honeycomb insulation in the exterior porches of each building is negative. Until sampling of this material is performed it should be assumed to contain asbestos.

Porches with Windows Still in Place

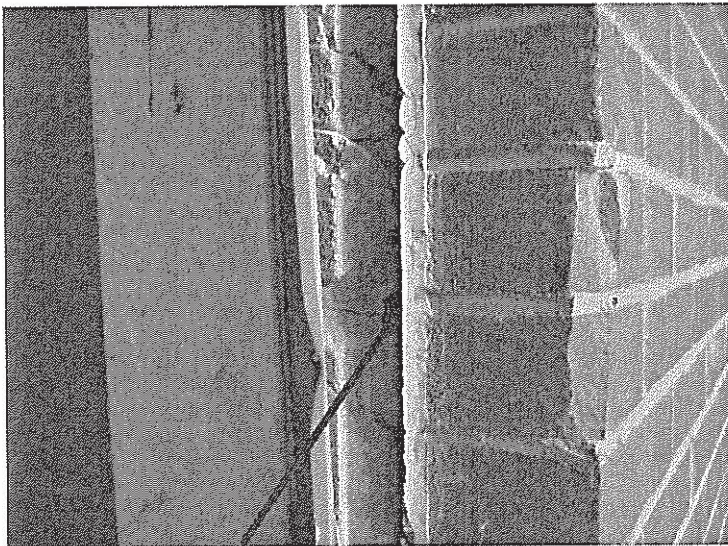
ACM Window Caulk Still in Place Around Perimeter of
Window Openings
