STOHL ENVIRONMENTAL, LLC

Re: Visual Survey and Bulk Sampling of Suspect Materials/Debris
Kensington Heights Complex

Buffalo Municipal Housing Authority
Limited Asbestos Inspection - Client Defined Areas/Materials
Kensington Heights
Buffalo, New York
Conditions as of September 13, 2011

Buffalo Municipal Housing Authority
Visual Asbestos Inspection for Debris
Kensington Heights
Buffalo, New York
Conditions as of October 5, 2011

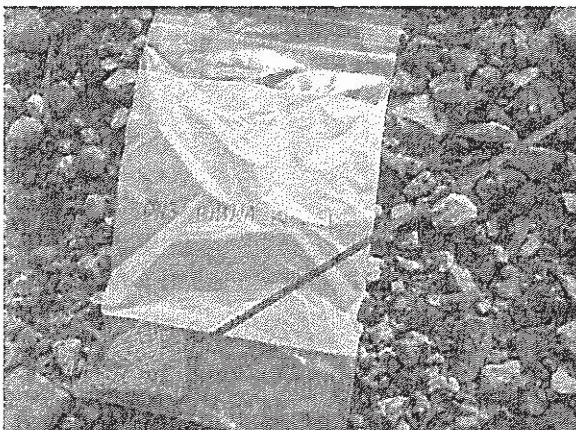
Sample 1 Transite Debris

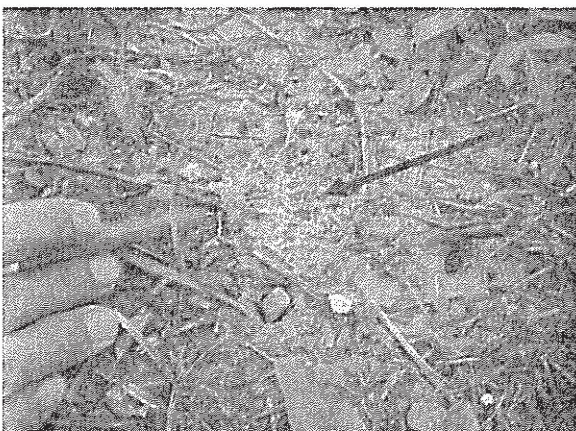
Sample 2 Friable Debris

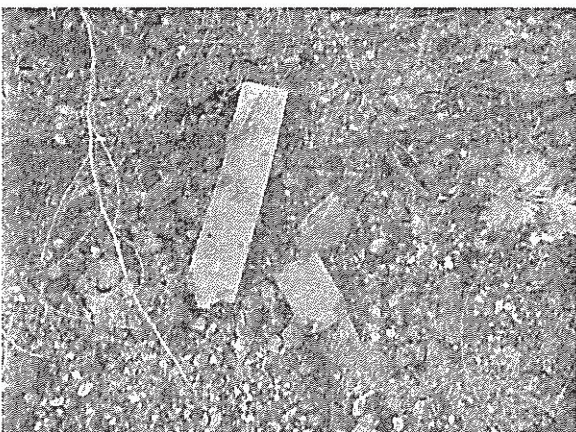
Sample 3 Debris of Brake Shoe

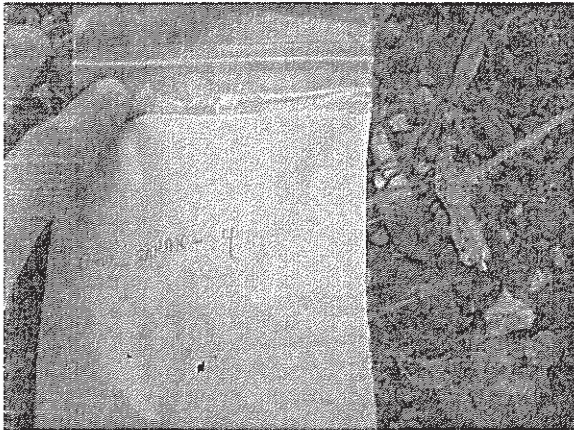
Sample 4 Window Caulk Debris

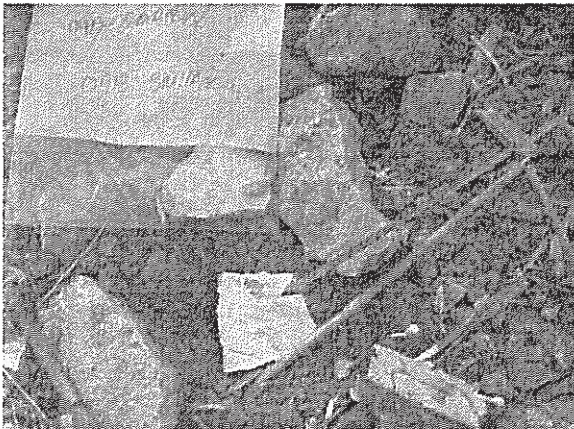
Sample 5 Transite Debris

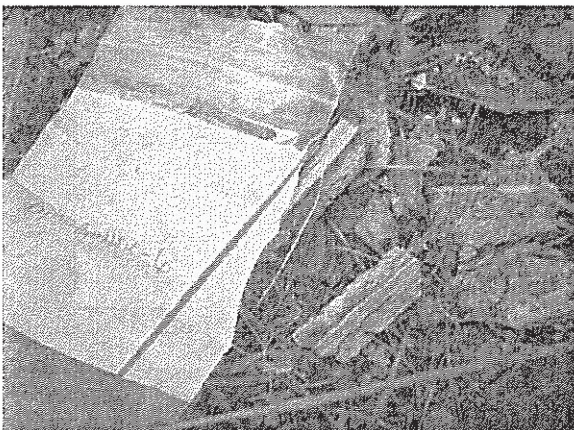
Sample 6 Caulk Debris

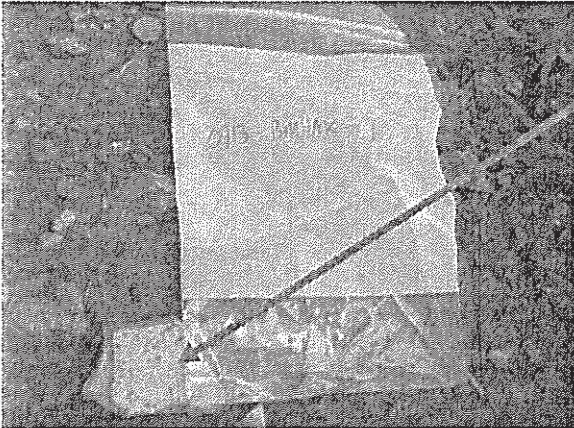
Sample 7 Transite Debris

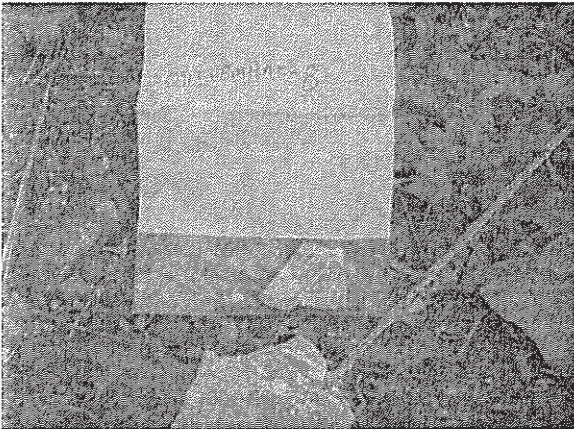
Sample 8 Transite Debris

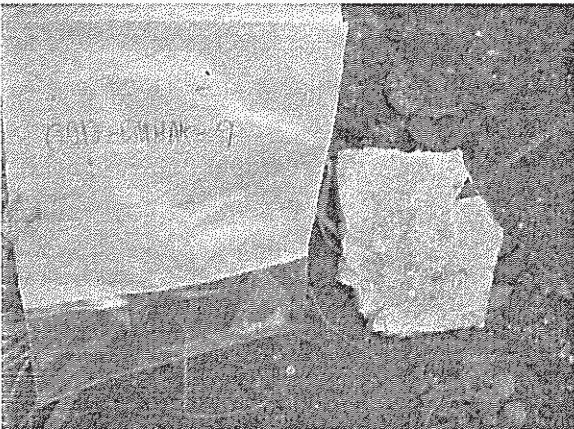
Sample 9 Transite Debris

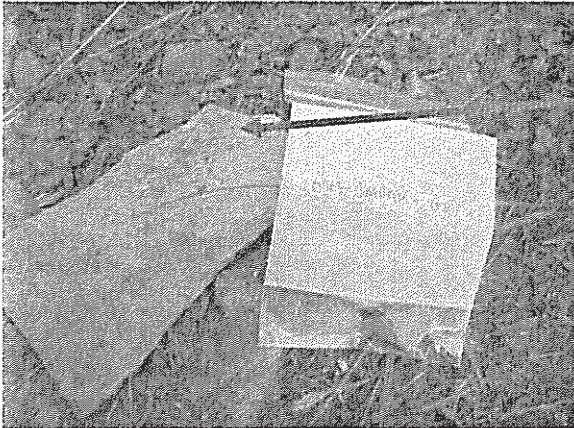
Sample 10 Transite Debris

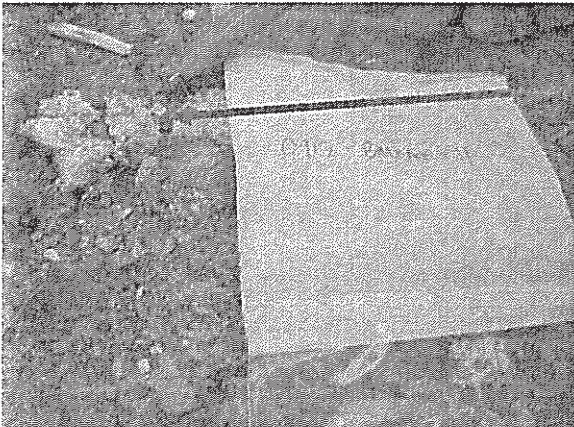
Sample 11 Friable Debris

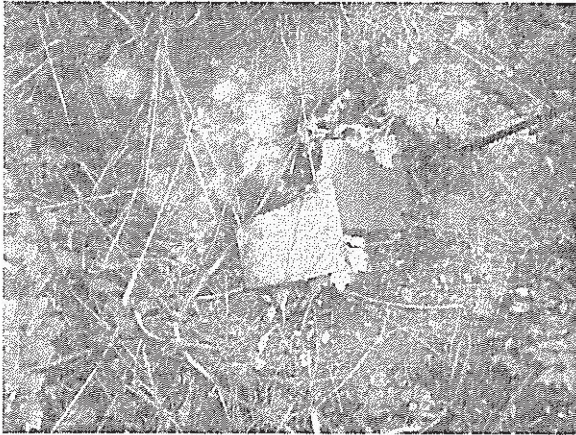
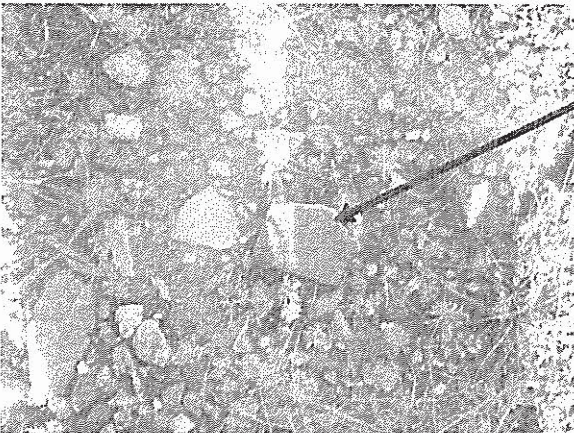
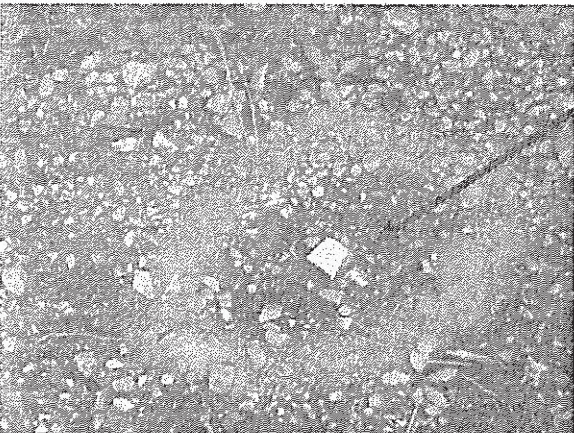
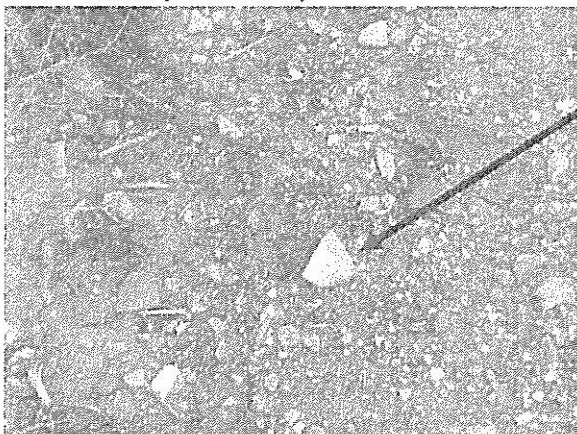
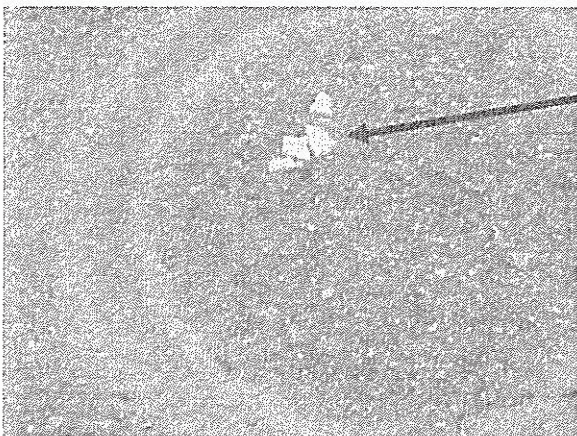
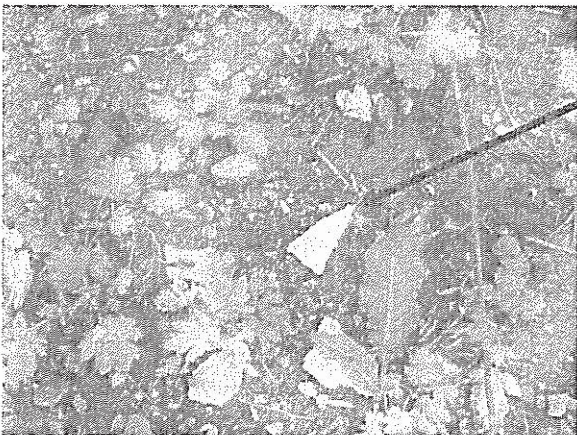
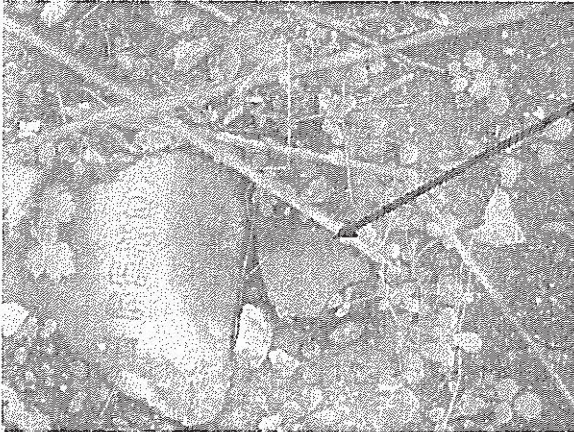
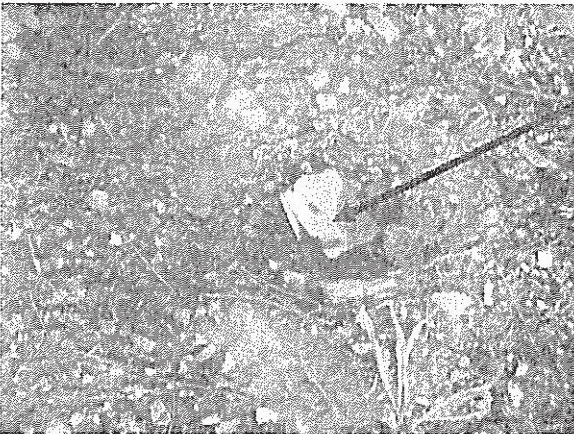
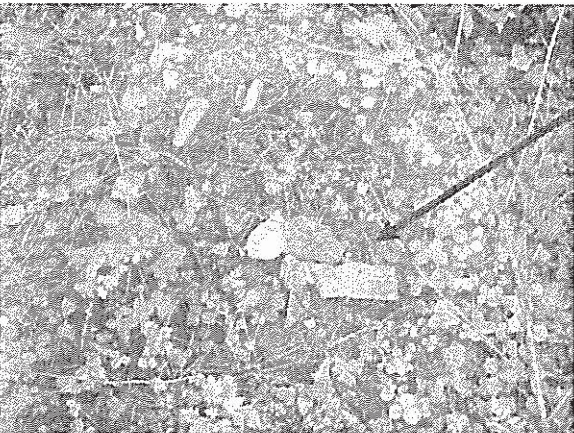
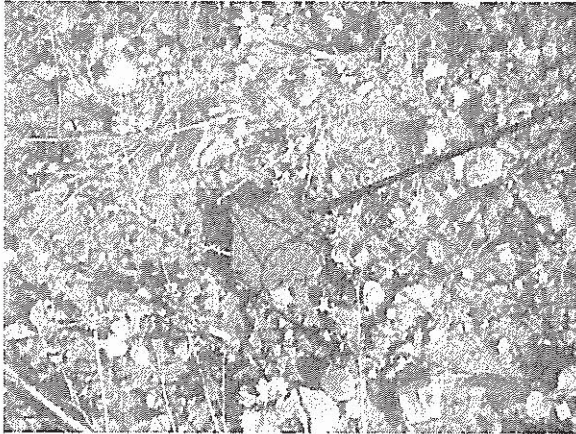
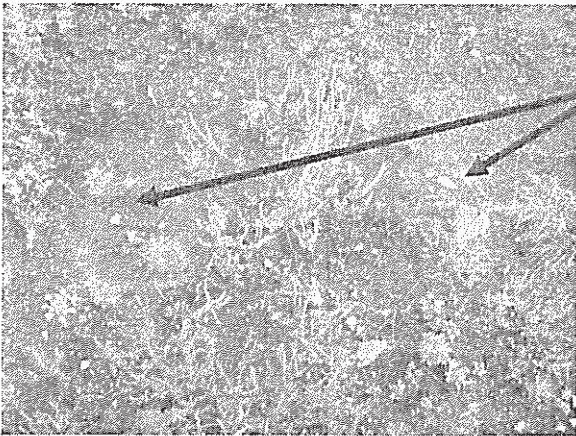
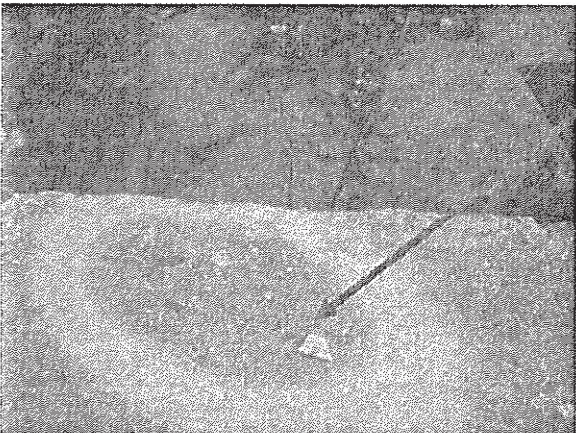
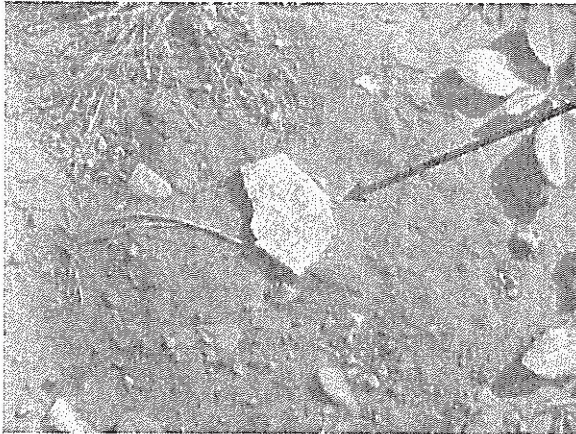
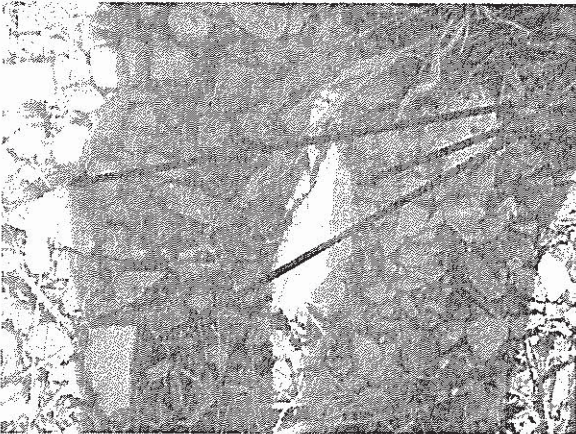
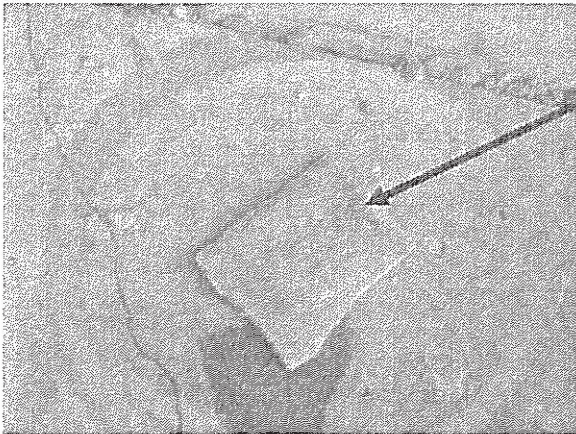
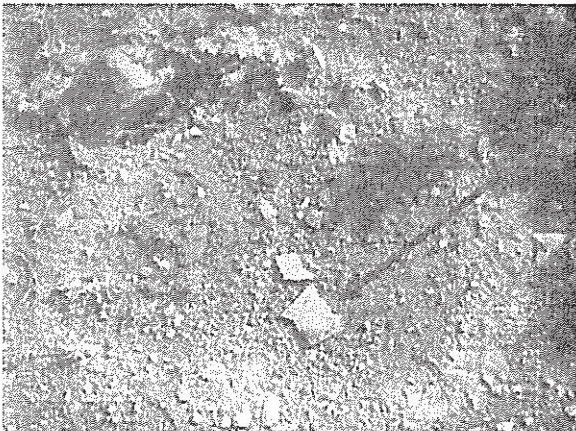
Debris of Transite Cement Board

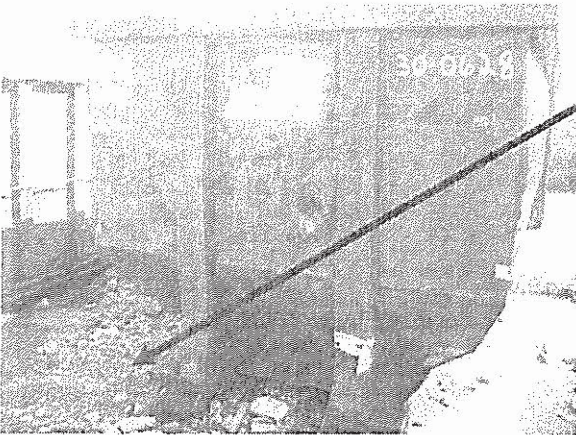
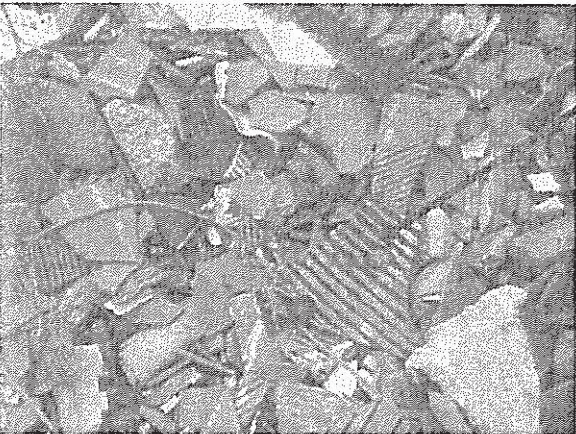
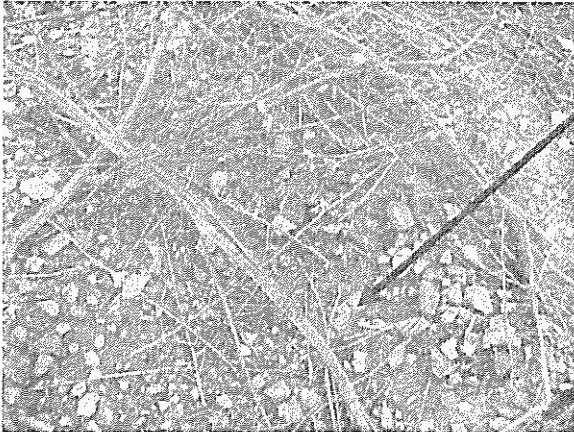
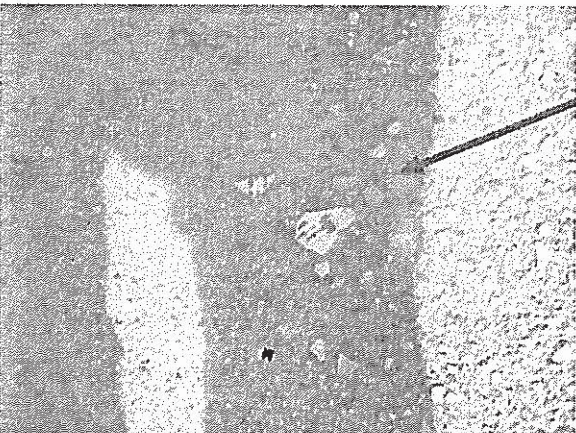
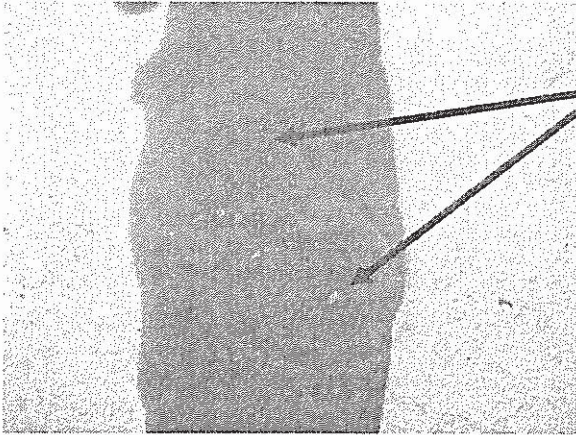
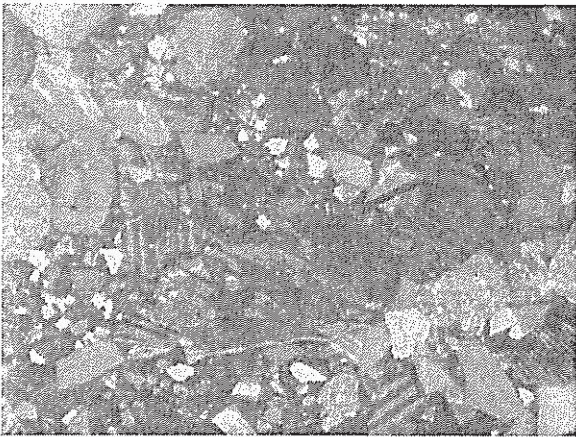
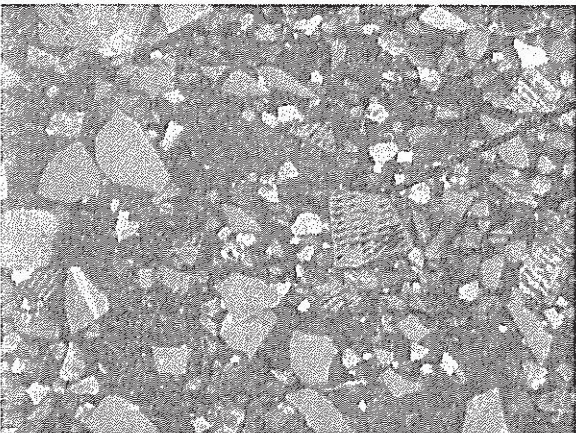
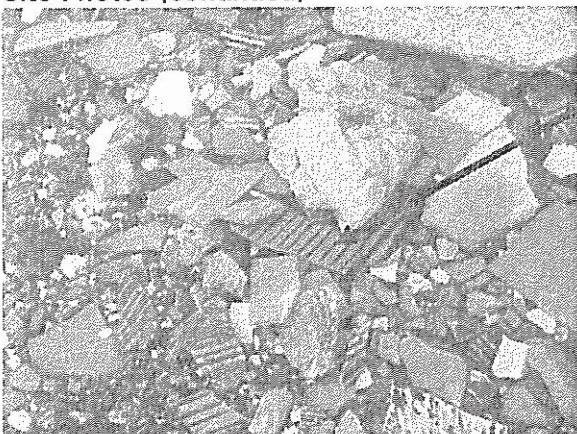
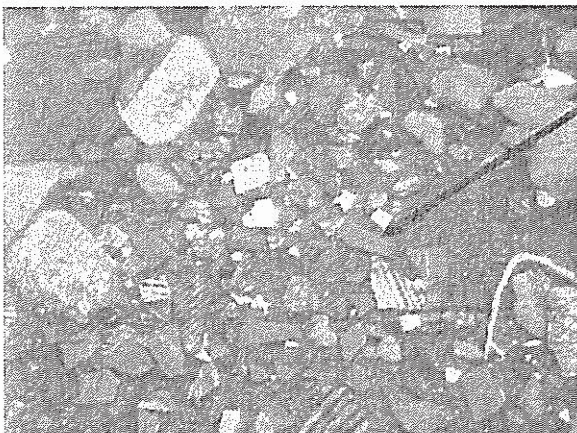
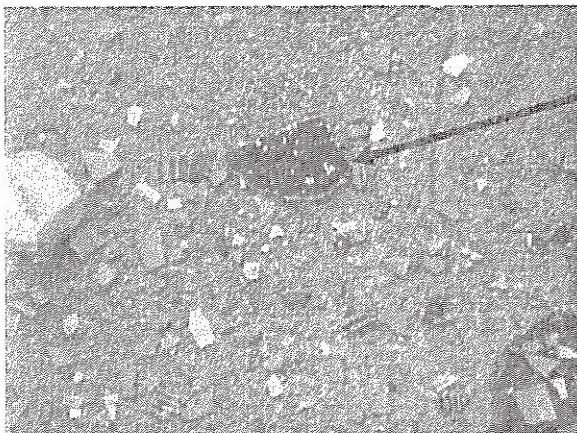
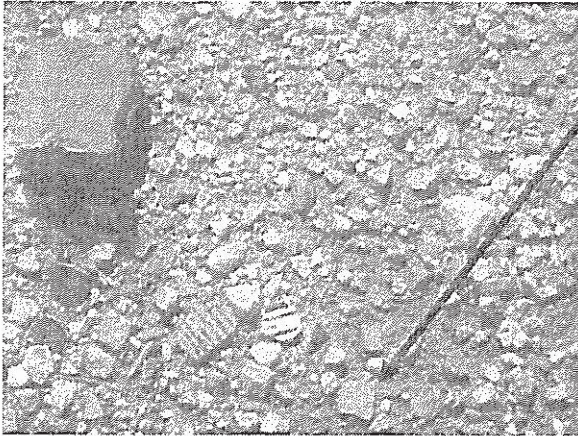
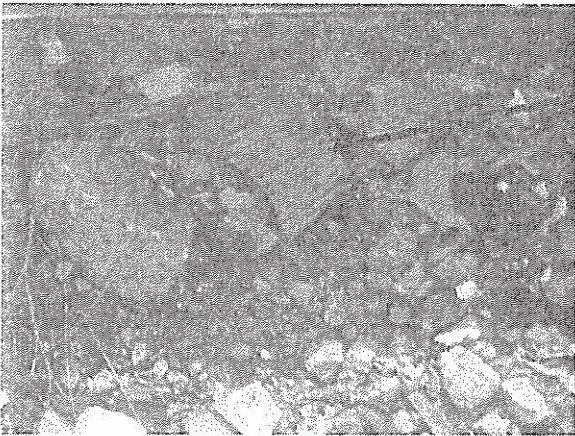
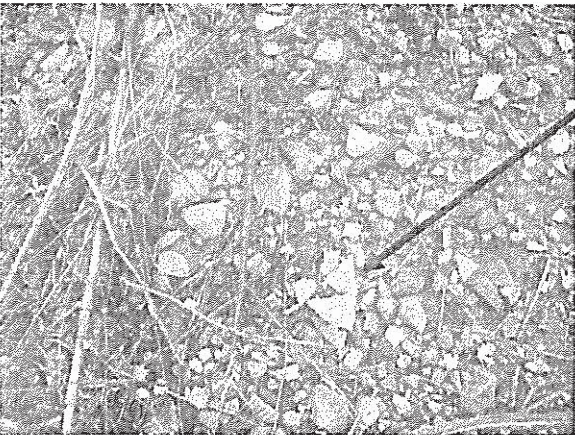
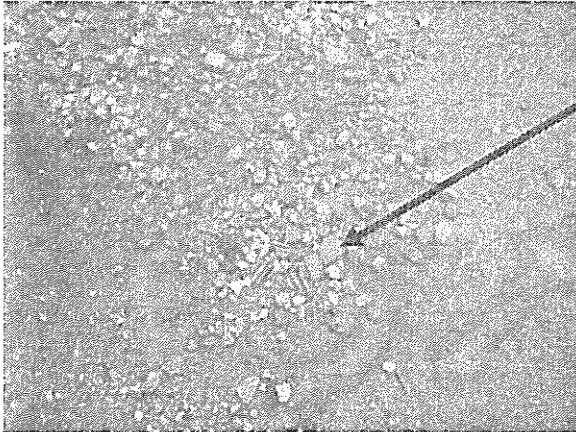
Debris of Floor Tile and Mastic

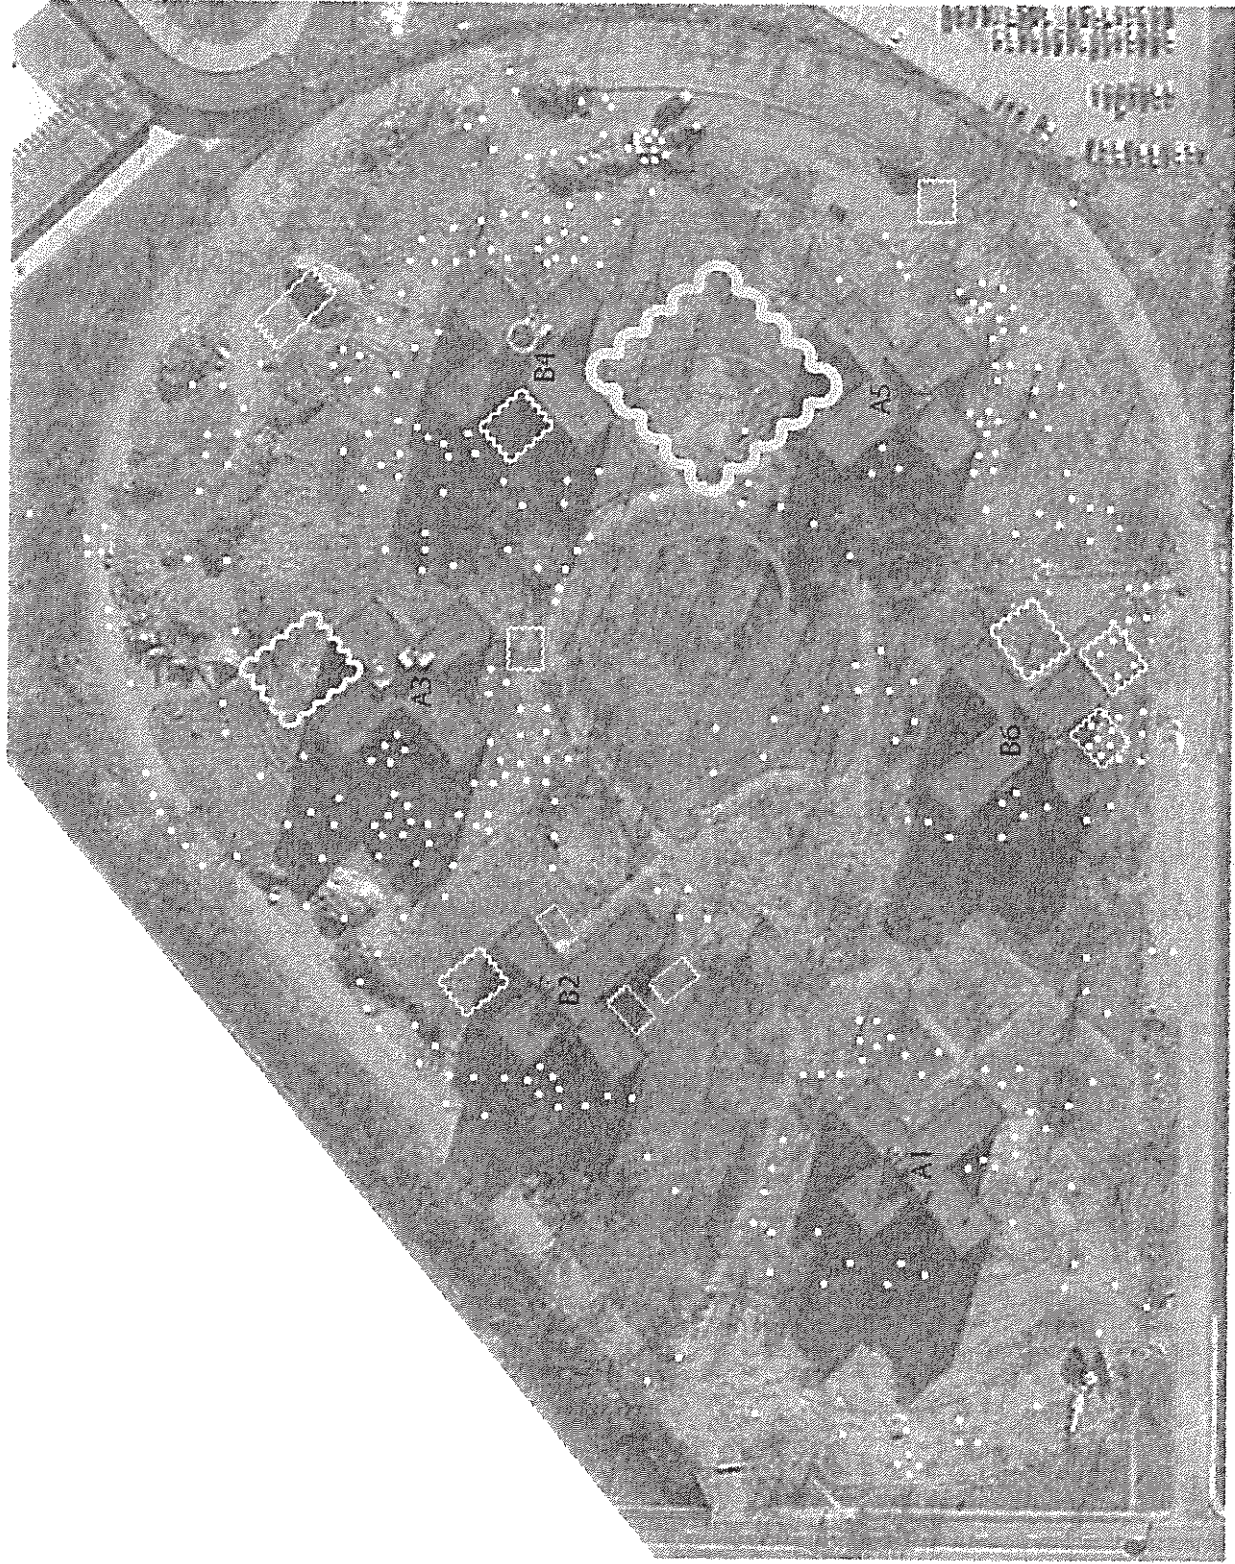
Represents a single piece of debris or smaller debris pile consisting of Window Caulks, Transit Asbestos Cement Board, or Floor Tile.

Note: At the time of inspection areas of dense vegetation prevented certain areas from being seen with clarity. Therefore it should be noted that debris may exist outside of the yellow dots and demarcated green boxes especially in these thick areas of vegetation.

It was noted during the inspection that a large pile of staged fill soil type material is located in the middle of the site, presumably brought in by the previous demolition contractor, to be used as backfill after demolition. It is recommended that the staged soil be thoroughly inspected before being used to confirm that it does not contain asbestos contaminants from other sites.

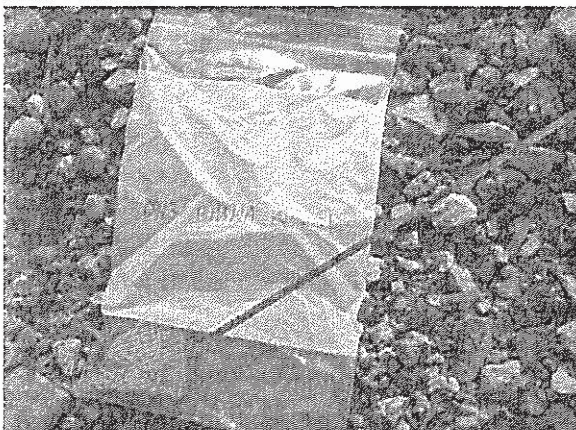
Sample 1 Transite Debris

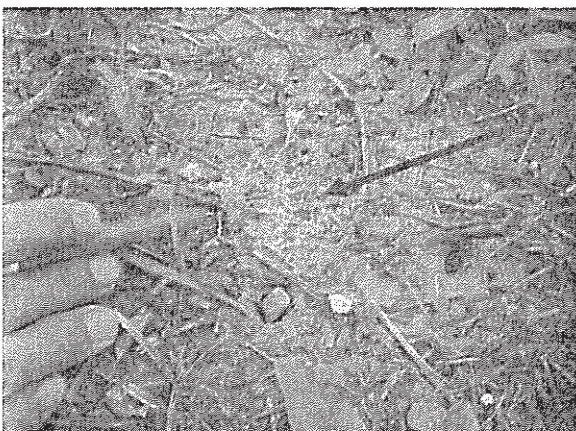
Sample 2 Friable Debris

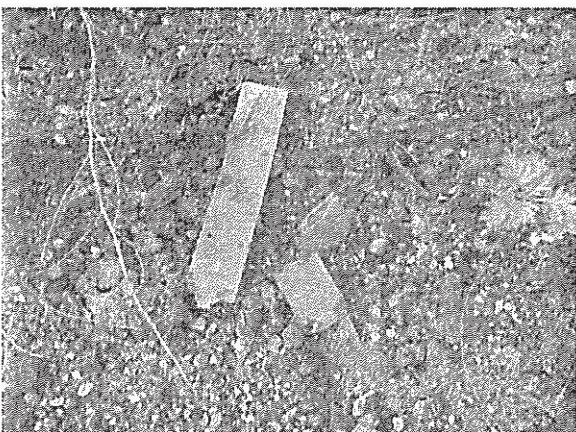
Sample 3 Debris of Brake Shoe

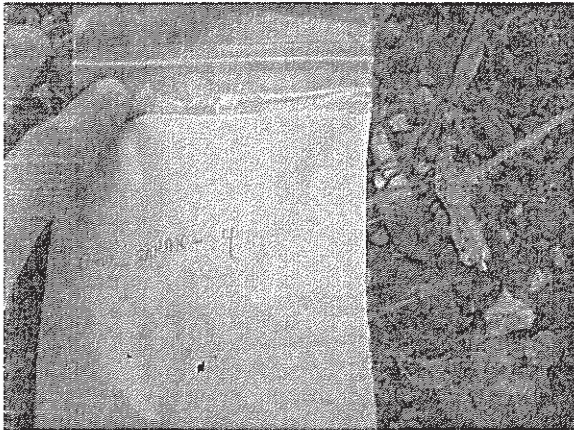
Sample 4 Window Caulk Debris

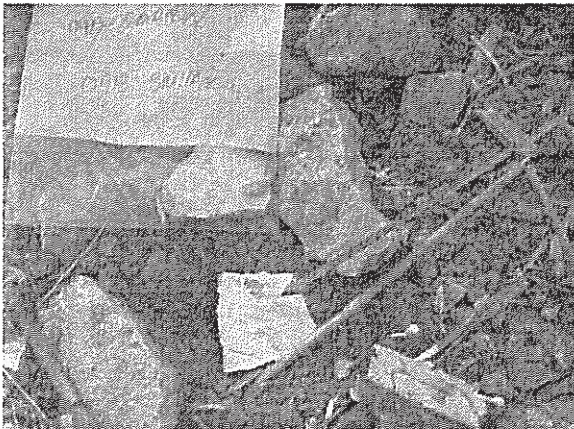
Sample 5 Transite Debris

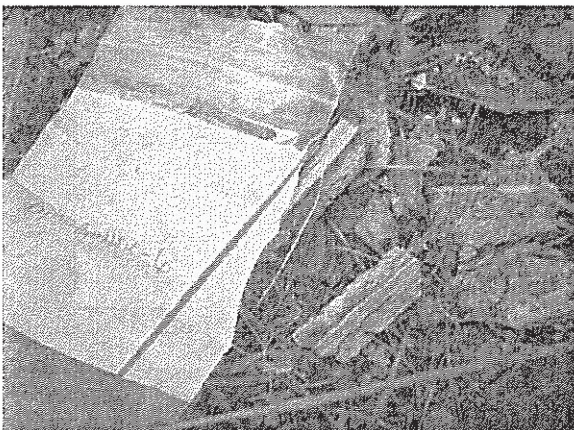
Sample 6 Caulk Debris

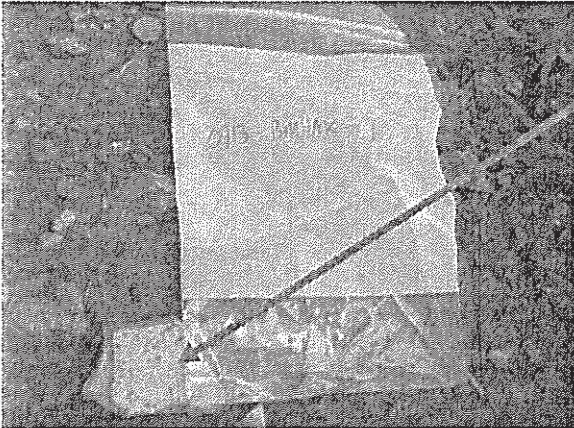
Sample 7 Transite Debris

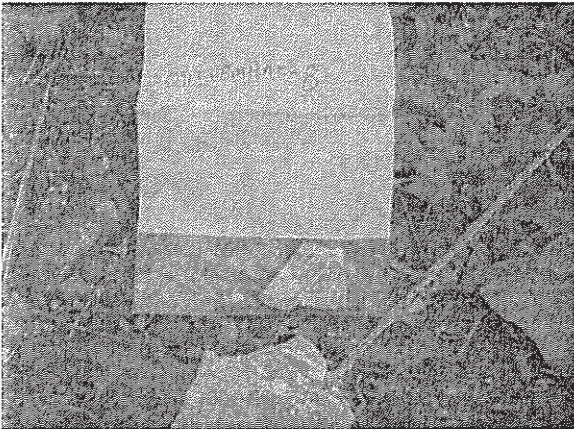
Sample 8 Transite Debris

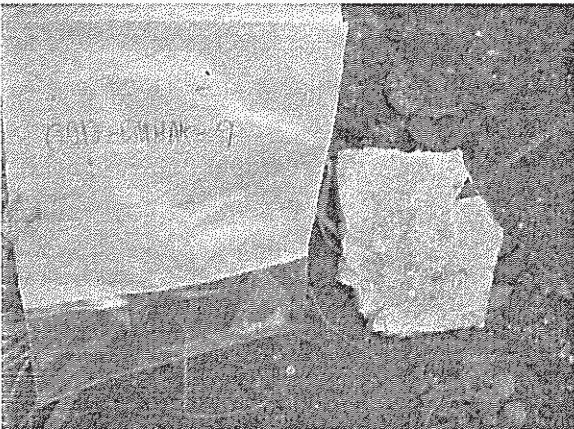
Sample 9 Transite Debris

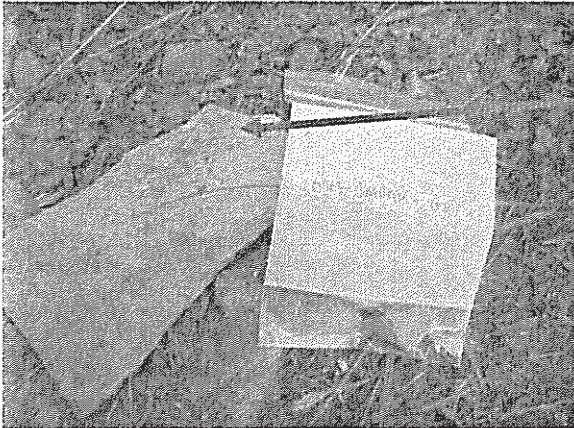
Sample 10 Transite Debris

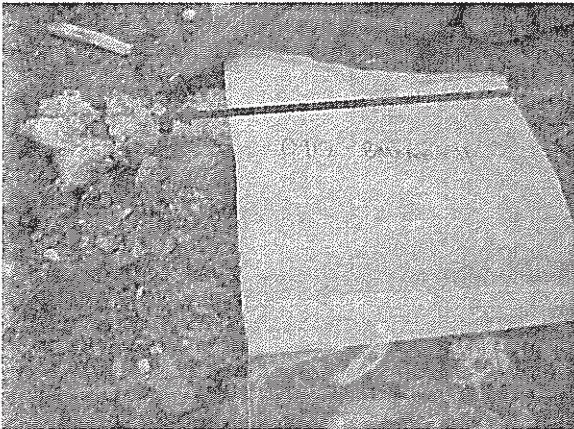
Sample 11 Friable Debris
