Periodic Review Report 2021-2022

1827 Fillmore Avenue Site
BCP Site No. C915279
Buffalo, New York

April 2022

PERIODIC REVIEW REPORT
REPORTING PERIOD MARCH 22, 2021 TO MARCH 22, 2022

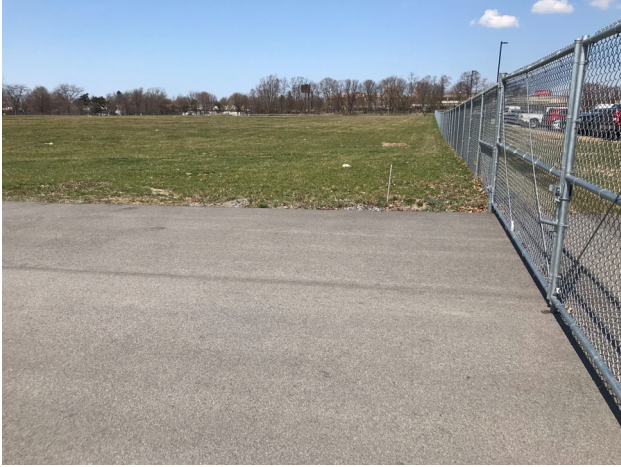
Photo 1: Asphalt and vegetated soil cover (looking north).

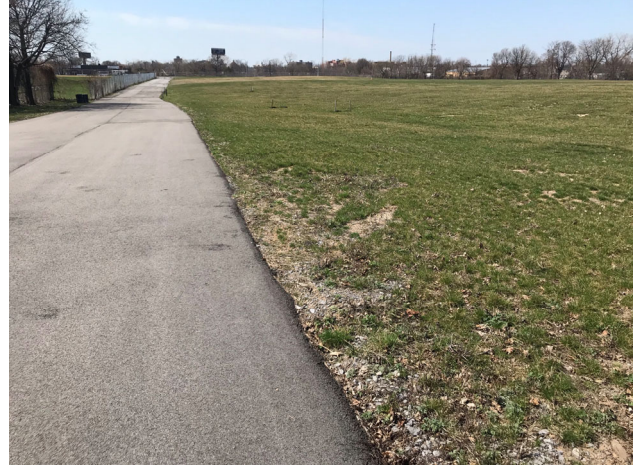
Photo 2: Asphalt and vegetated soil cover (looking west).

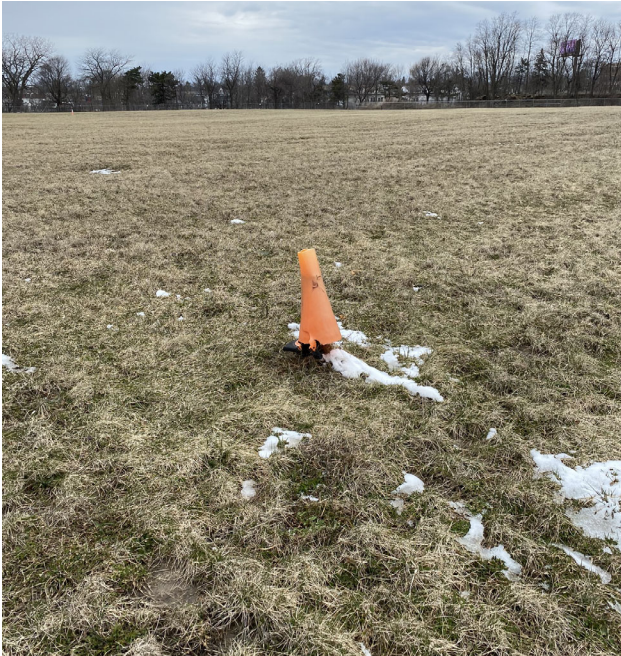
Photo 3: View of cover and monitoring well MW-7 (looking northwest).

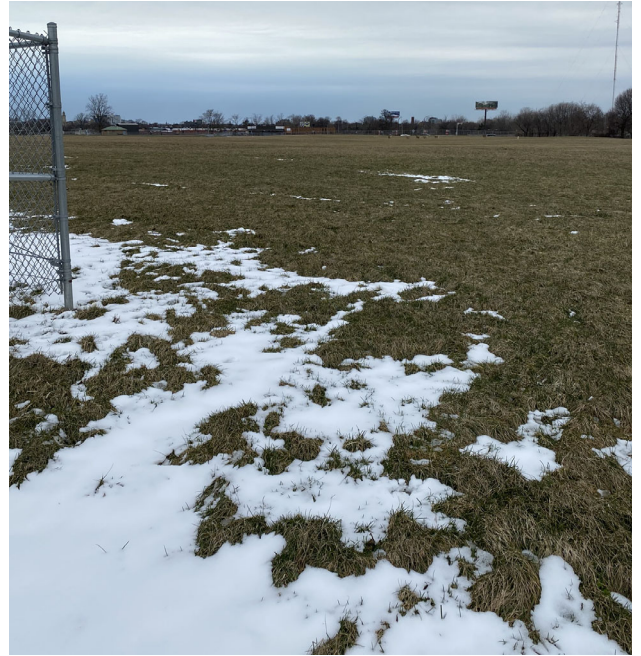
Photo 4: Vegetated soil cover (looking southwest).

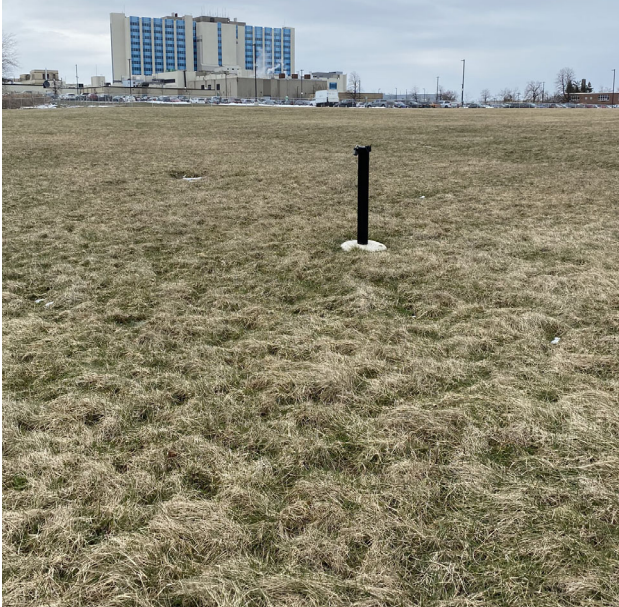
Photo 5: View of cover and monitoring well MW-10 (looking southeast).

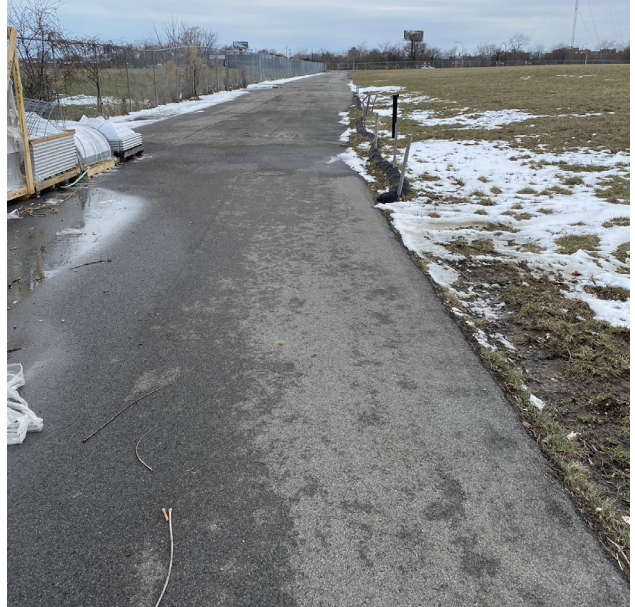
Photo 6: Asphalt cover along the southern property boundary (looking west)

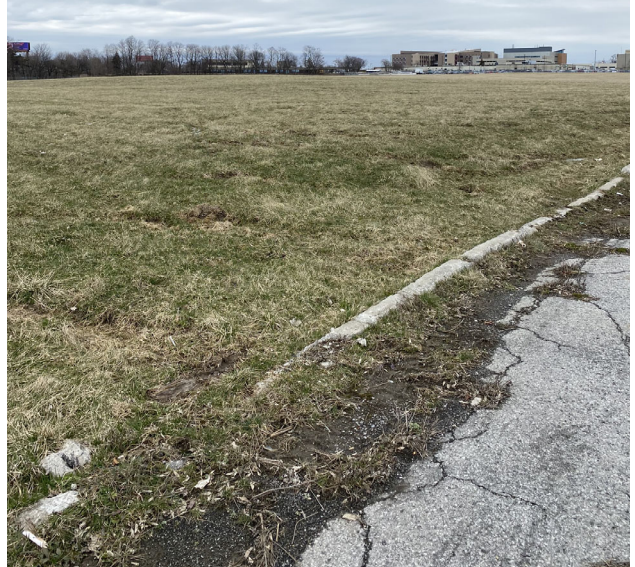
Photo 8: Asphalt and vegetated soil cover (looking northeast).

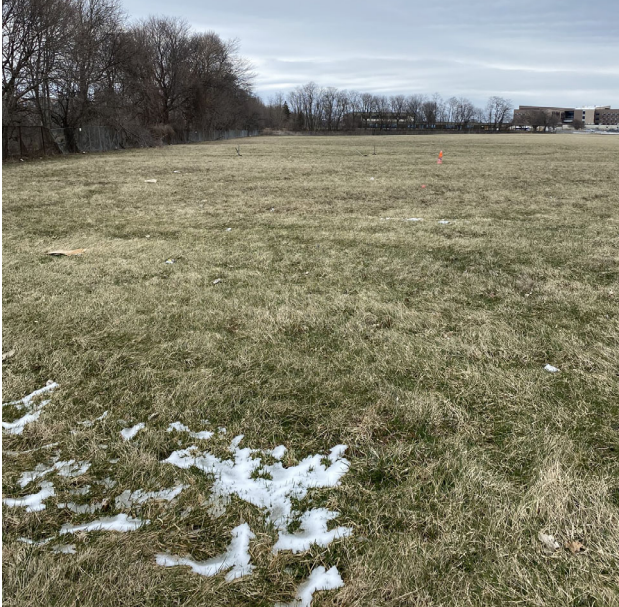
Photo 9: Vegetated soil cover along the northern property boundary (looking northeast).

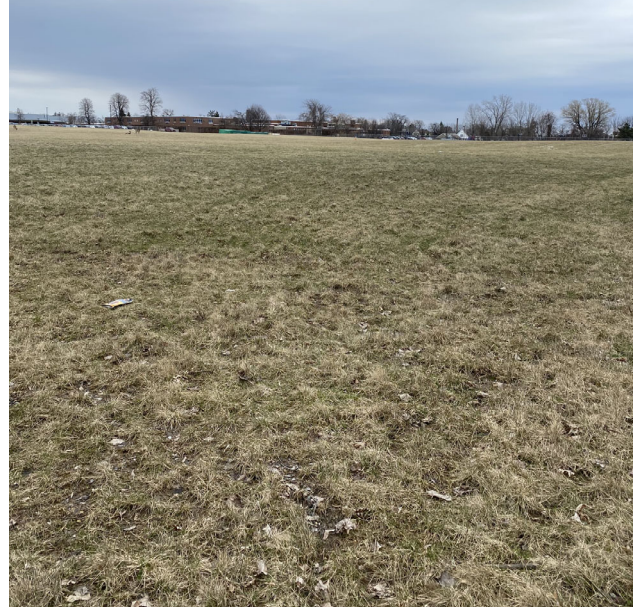
Photo 10: Vegetated soil cover (looking southeast).
