PERIODIC REVIEW REPORT
REPORTING PERIOD MARCH 22, 2022 TO MARCH 22, 2023

1827 FILLMORE AVENUE SITE
BCP SITE NO. C915279
BUFFALO, NEW YORK

April 2023

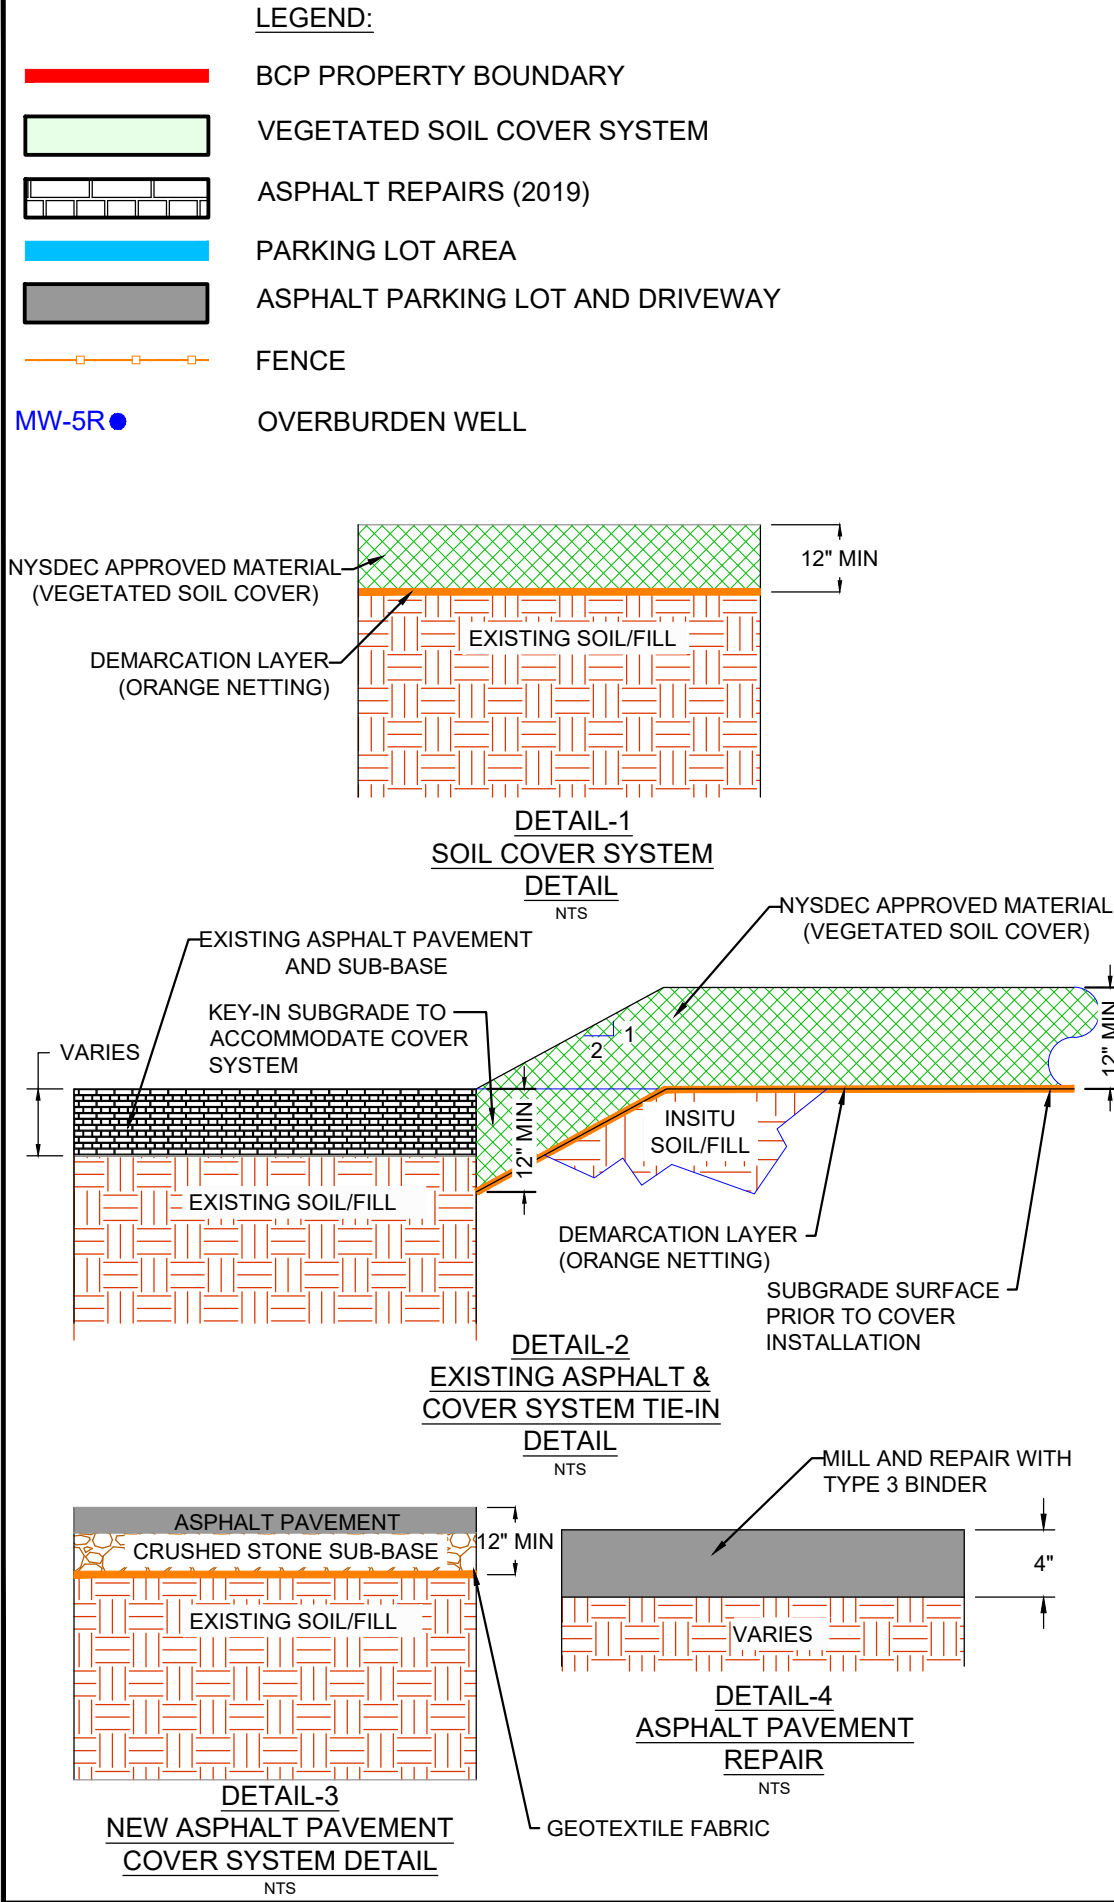
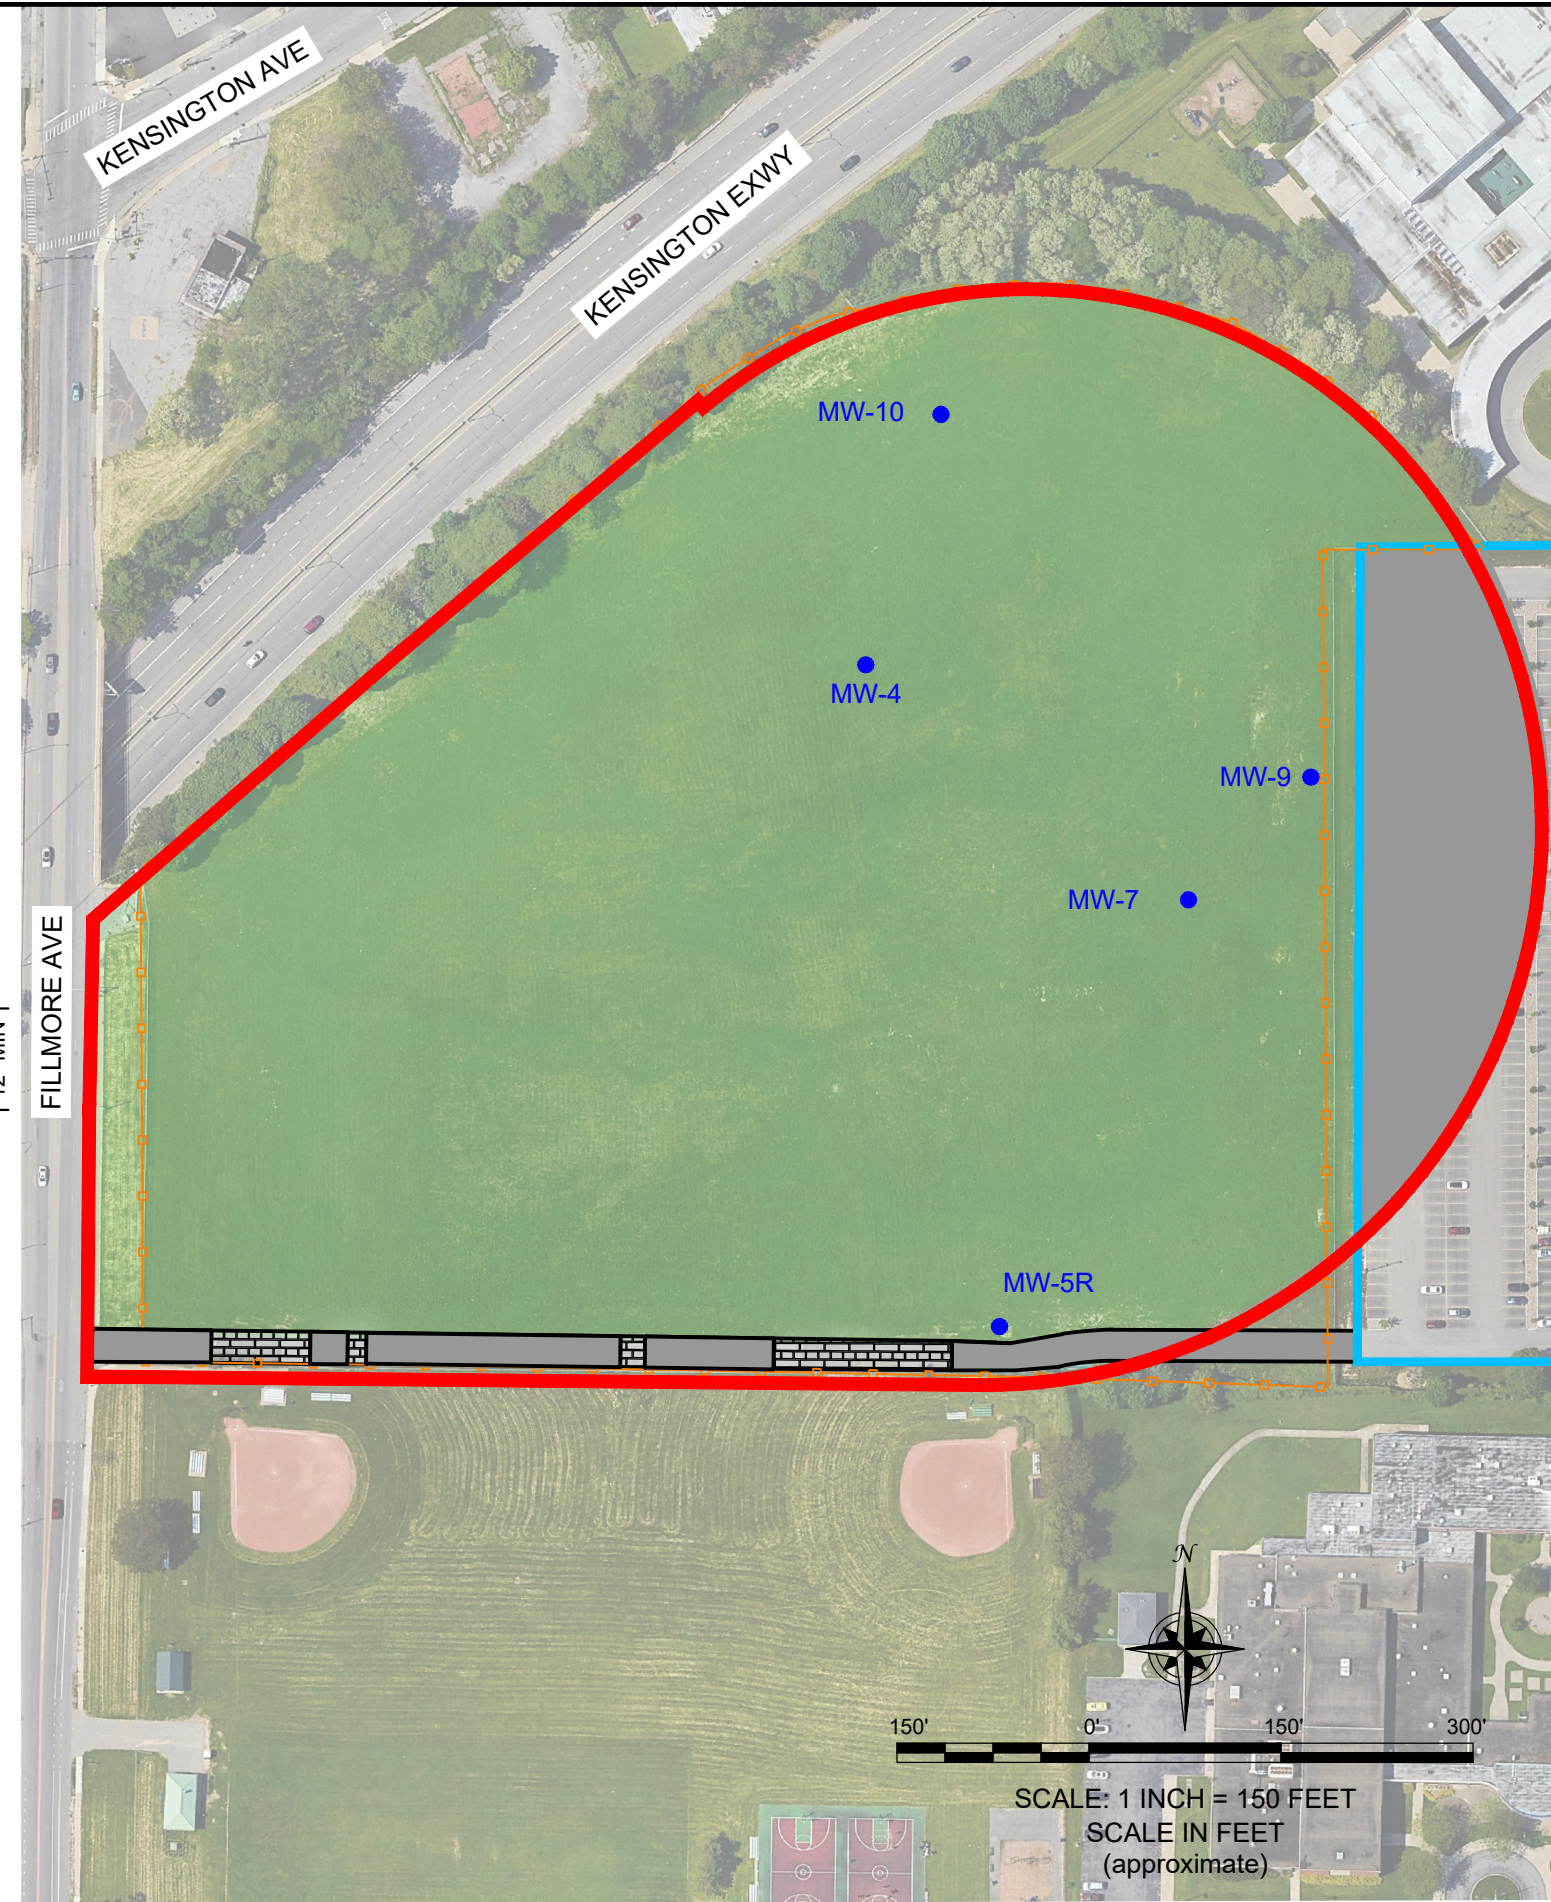
COVER SYSTEM LAYOUT & DETAIL

A cover system has been installed at the Site to prevent exposure to remaining soil/fill contamination above CSCOs. The cover system is comprised of the following (see Figure 3):

- Vegetated Soil Cover – most of the Site is covered by a vegetated soil cover system. The vegetated soil cover consists of a minimum of 12 inches of DER-10 compliant soil placed over a demarcation layer, with the upper six inches of soil of sufficient quality to maintain a vegetative layer to prevent human exposure to contaminated soil/fill remaining at the Site.
- Asphalt Paved Road – the existing and repaired asphalt roadway along the southern property boundary.
- Asphalt Parking Lot – the area associated with the ECMC asphalt parking lot on the eastern portion of the Site. The cover system in this area consists of asphalt pavement and sub-base underlain by geotextile fabric.

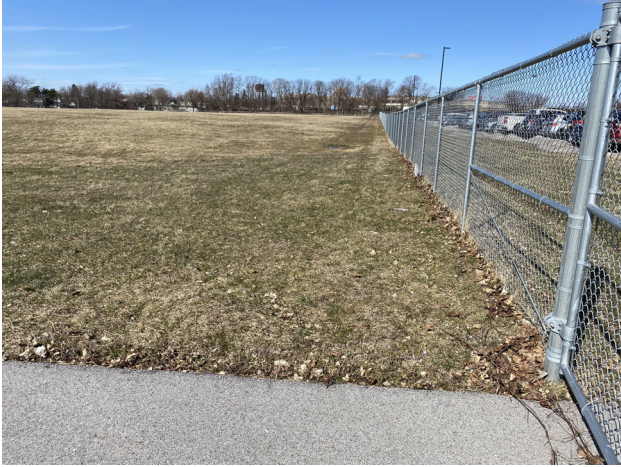
Photo 1: Vegetated soil cover and eastern fence line (looking north).

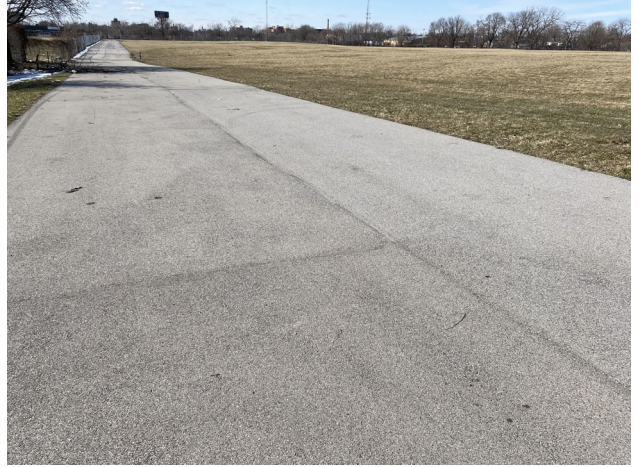
Photo 2: Paved access road and vegetated soil cover (looking west)

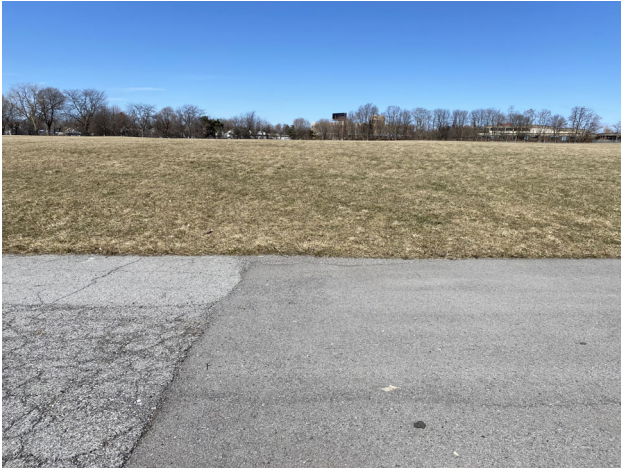
Photo 3: Paved access road and vegetated soil cover (looking north)

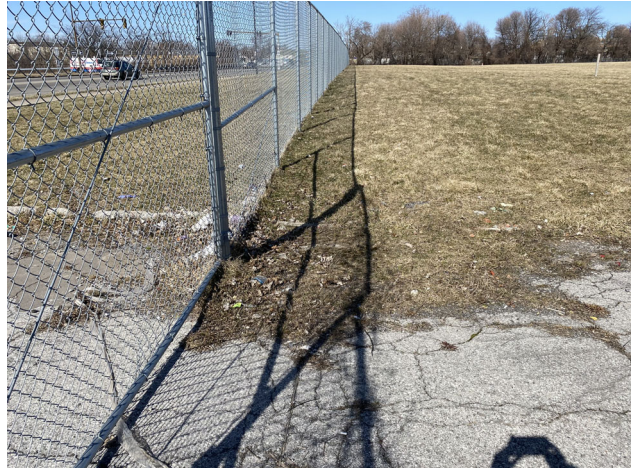
Photo 4: Paved access road, vegetated soil cover, and fence along Fillmore Ave. (looking north)

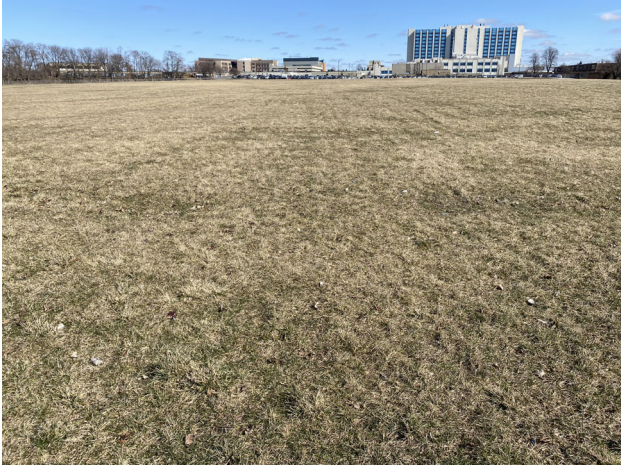
Photo 5: Vegetated soil cover (looking west)

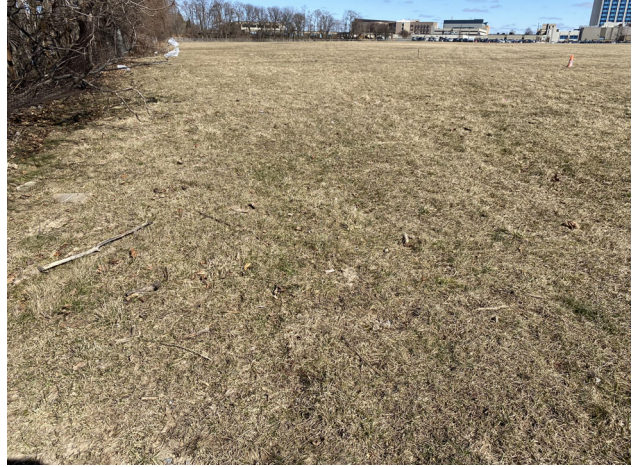
Photo 6: Vegetated cover along northwest boundary (looking northeast)

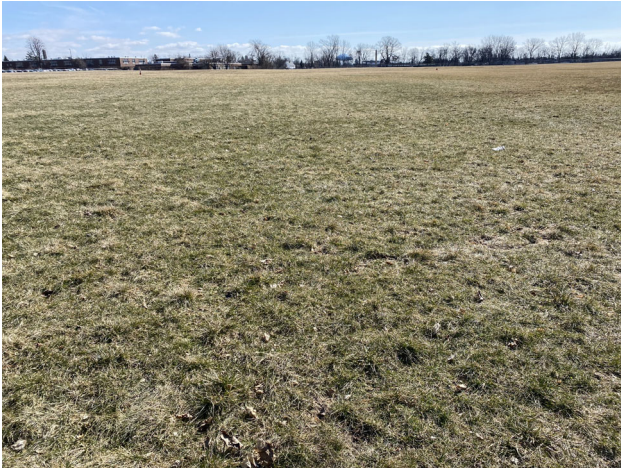
Photo 7: Vegetated soil cover (looking south)

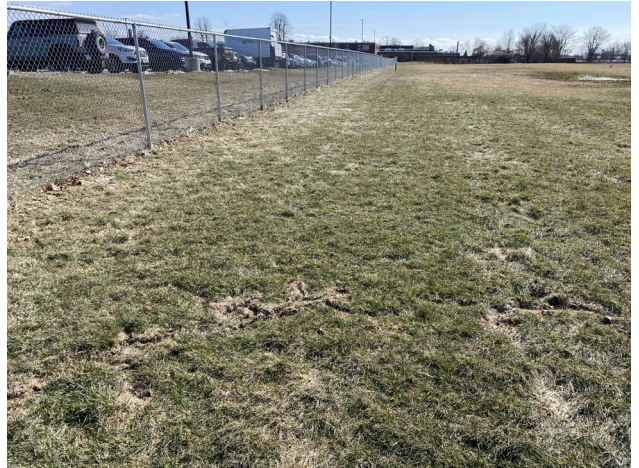
Photo 8: Vegetated soil cover and eastern fence line (looking south)

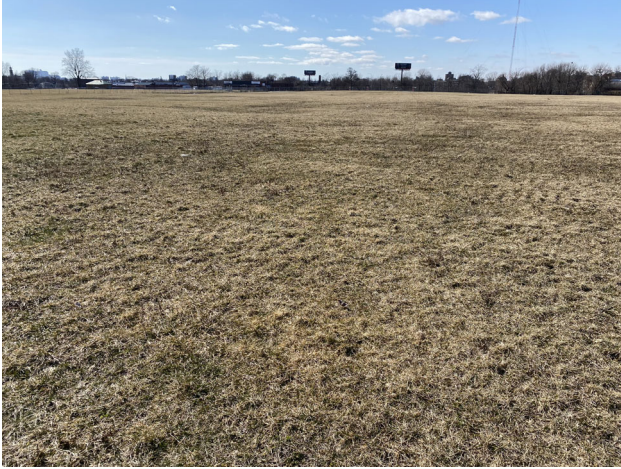
Photo 9: Vegetated soil cover (looking east)

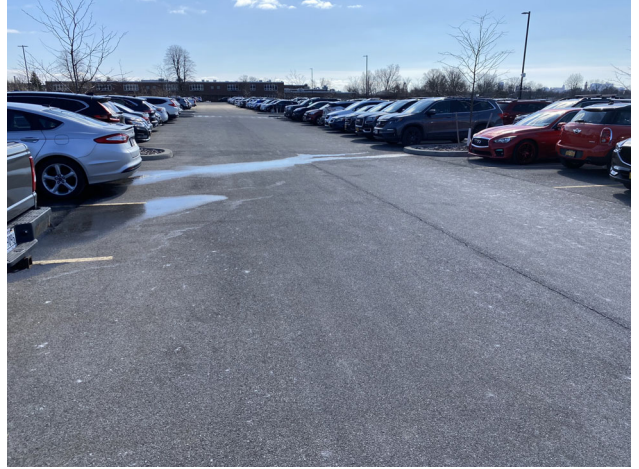
Photo 10: Paved parking lot (looking south)

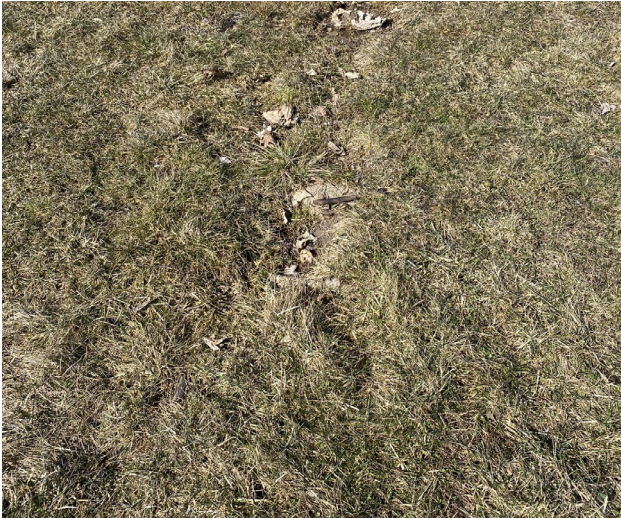
At the time of the annual Site inspection (March 9, 2023), the Site was fully compliant with the NYSDEC-approved SMP (Ref. 2). Minor disturbance of the vegetated cover, likely by animal creating pathways under the snow cover, was observed; however, these areas will fill in as the growing season progresses. Additionally, the vegetated cover system along the edge of the parking lot area was scraped away, likely during snow removal activities. These areas will be reseeded once the growing season begins. No excavation work was observed during the Site inspection for this PRR reporting period.

Photo 11: Minor erosion of vegetated cover

- Reseeding the area proximate the parking lot once the growing season begins.

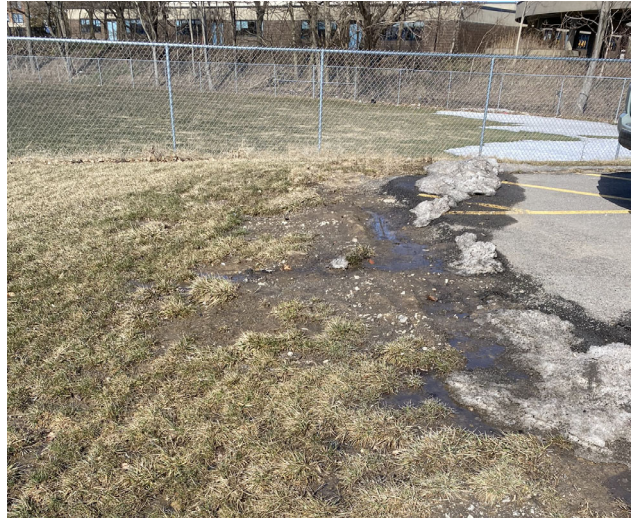
Photo 12: Erosion of cover along paved parking lot likely due to snow plow activities
