STOHL ENVIRONMENTAL, LLC

Re: Visual Survey and Bulk Sampling of Suspect Materials/Debris
Kensington Heights Complex

Buffalo Municipal Housing Authority
Limited Asbestos Inspection - Client Defined Areas/Materials
Kensington Heights
Buffalo, New York
Conditions as of September 13, 2011

Buffalo Municipal Housing Authority
Visual Asbestos Inspection for Debris
Kensington Heights
Buffalo, New York
Conditions as of October 5, 2011

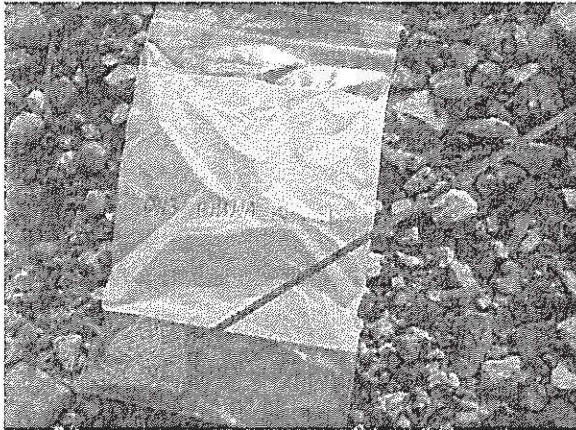
Sample 1 Transite Debris

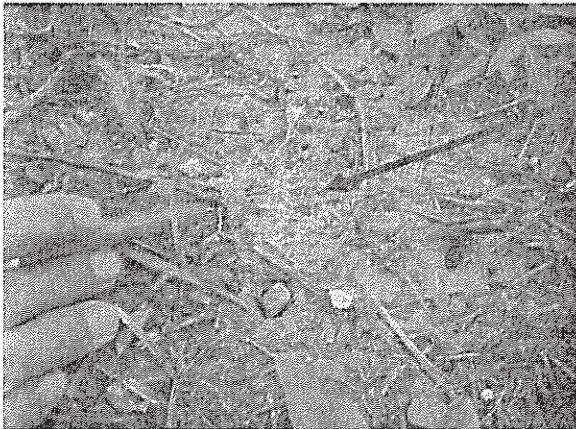
Sample 2 Friable Debris

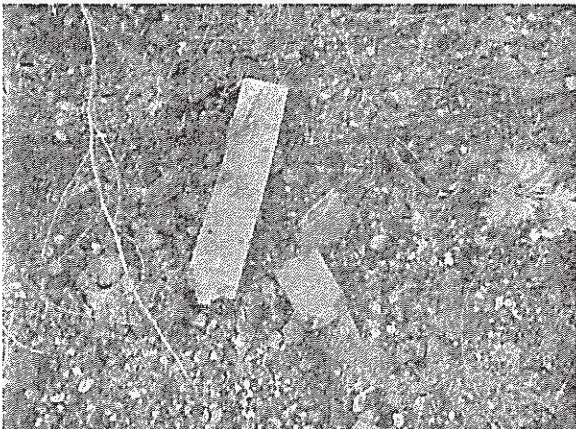
Sample 3 Debris of Brake Shoe

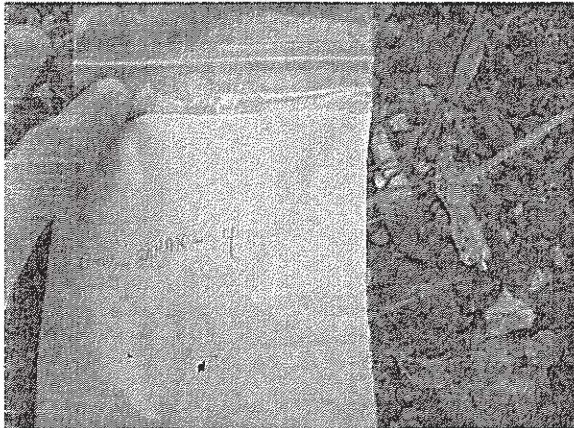
Sample 4 Window Caulk Debris

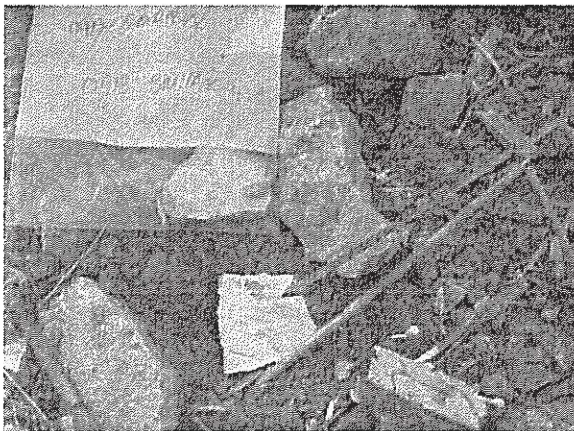
Sample 5 Transite Debris

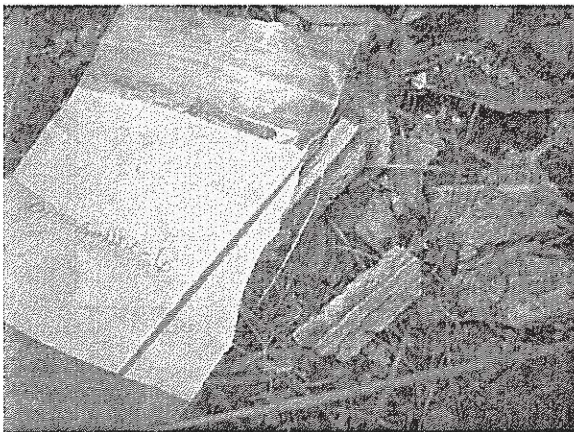
Sample 6 Caulk Debris

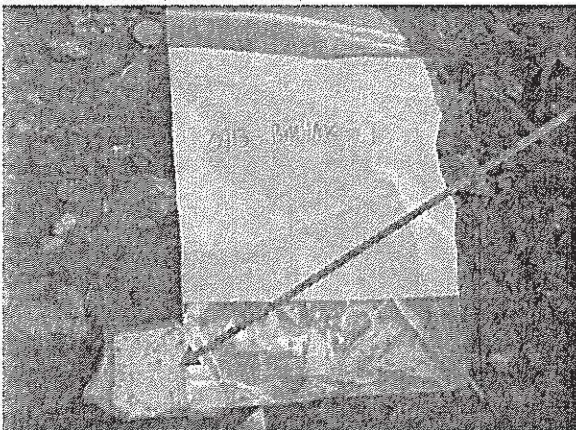
Sample 7 Transite Debris

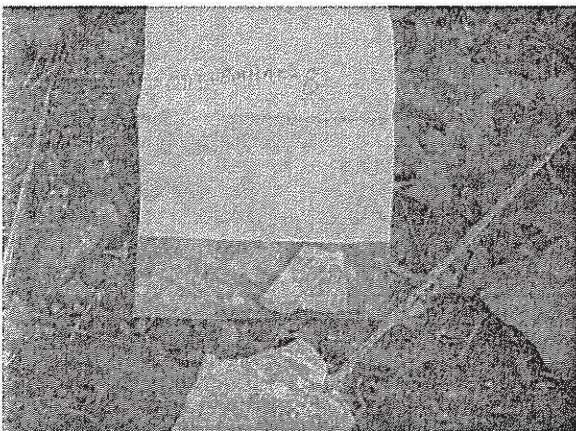
Sample 8 Transite Debris

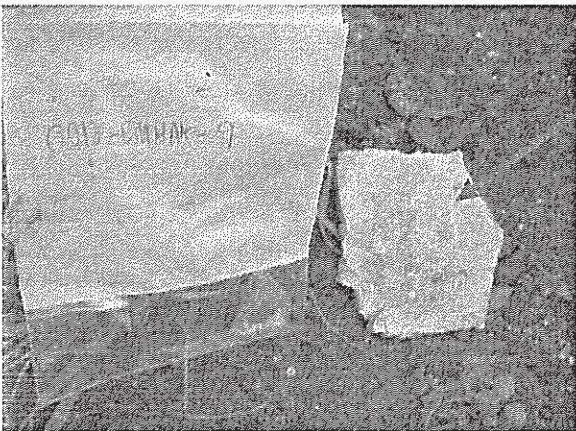
Sample 9 Transite Debris

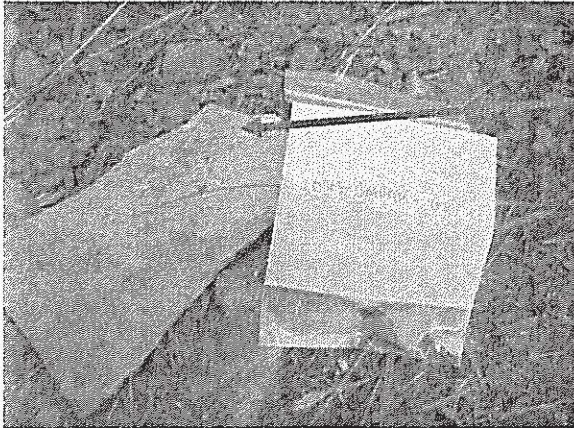
Sample 10 Transite Debris

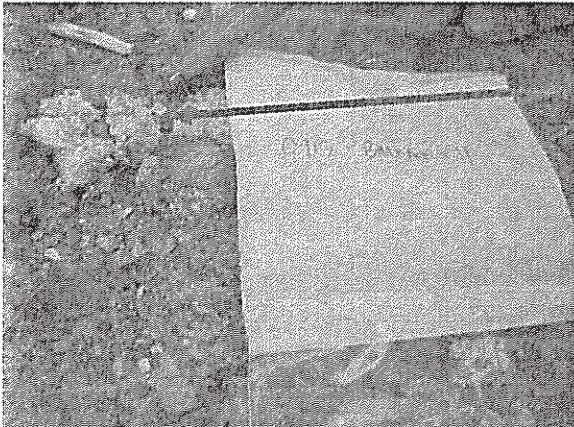
Sample 11 Friable Debris

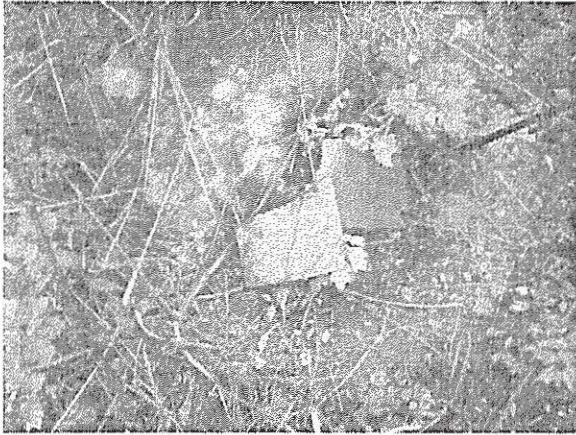
Debris of Transite Cement Board

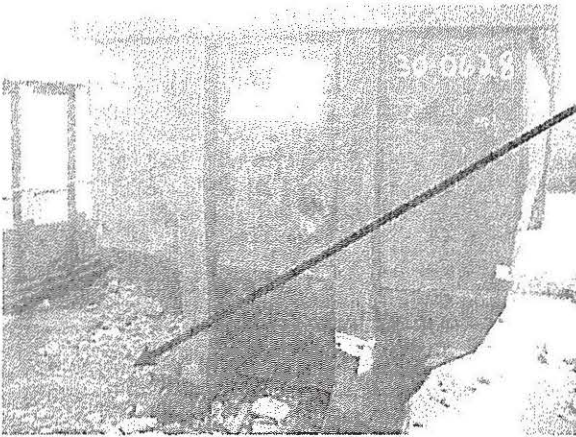
Debris of Floor Tile and Mastic

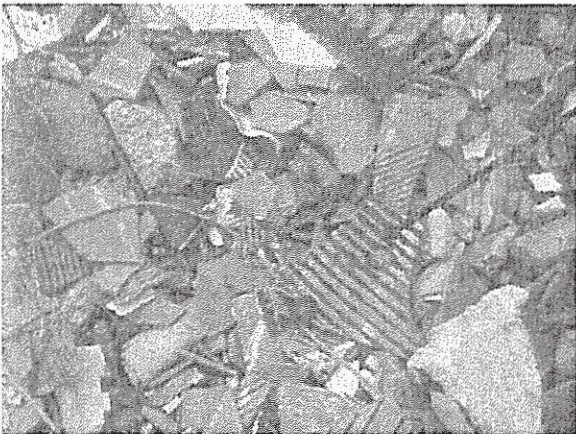
Debris of Floor Tile and Mastic

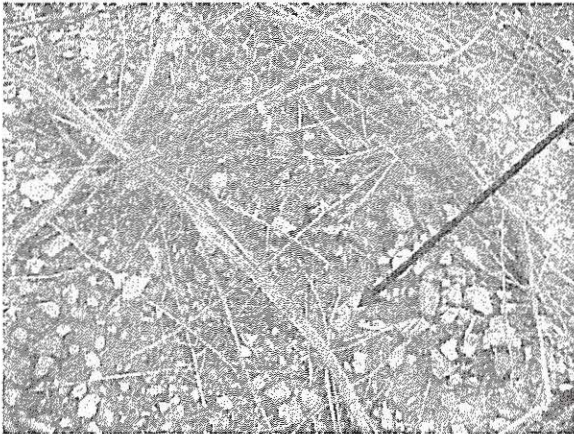
Debris of Floor Tile and Mastic

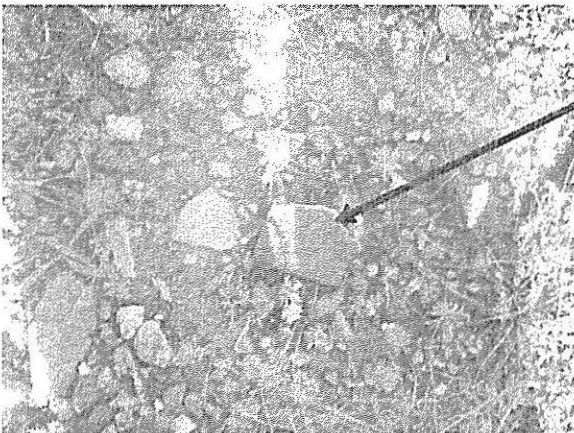
Debris of Transite Cement Board

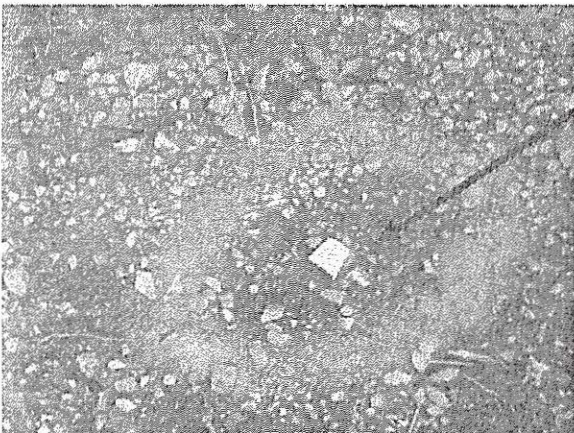
Debris of Transite Cement Board

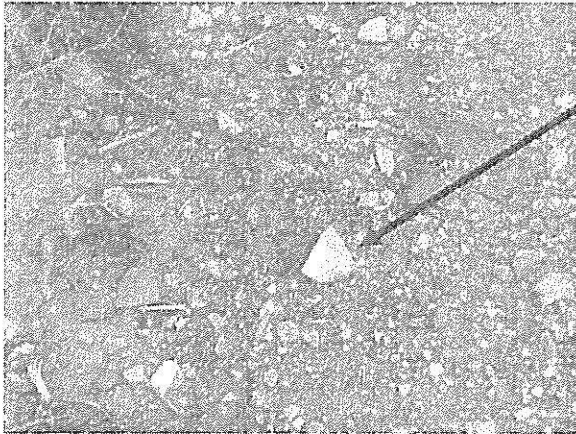
Debris of Transite Cement Board

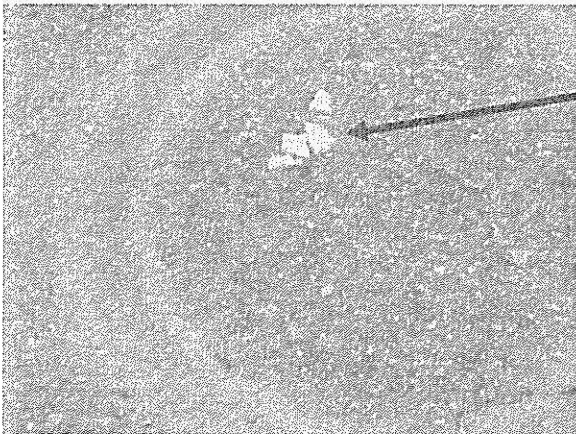
Debris of Transite Cement Board

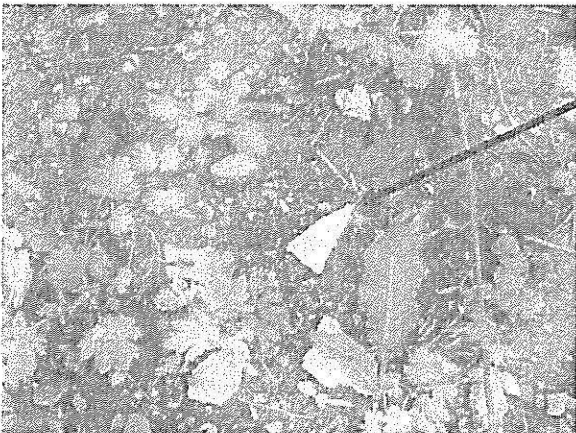
Debris of Transite Cement Board

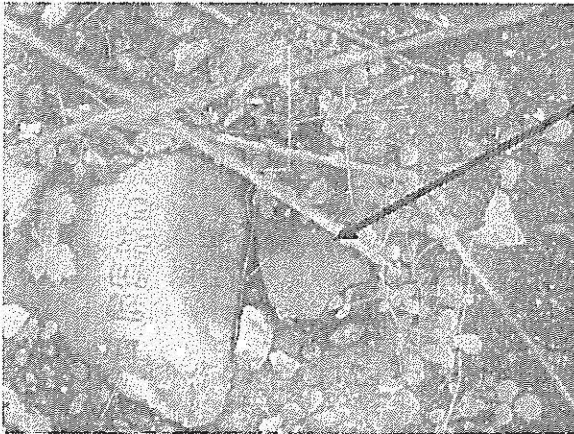
Debris of Transite Cement Board

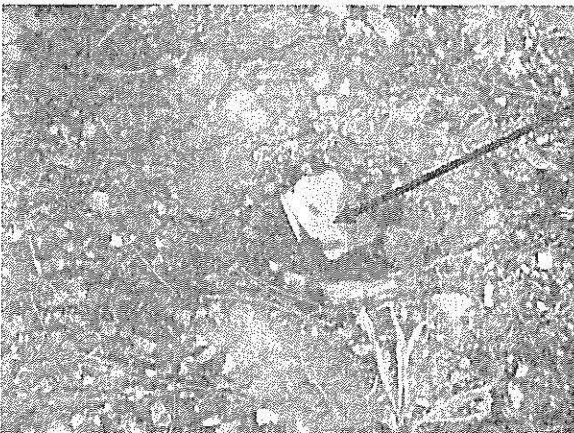
Debris of Transite Cement Board

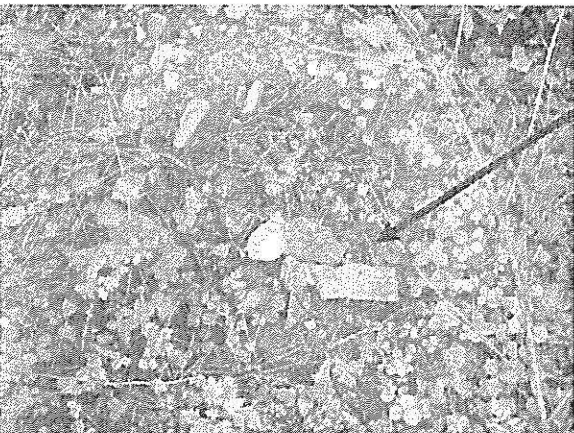
Debris of Transite Cement Board

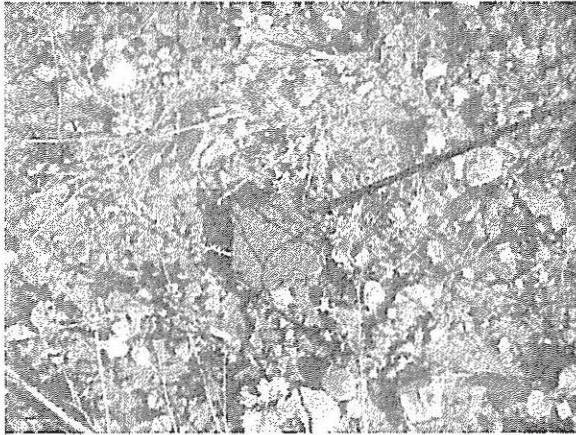
Debris of Transite Cement Board

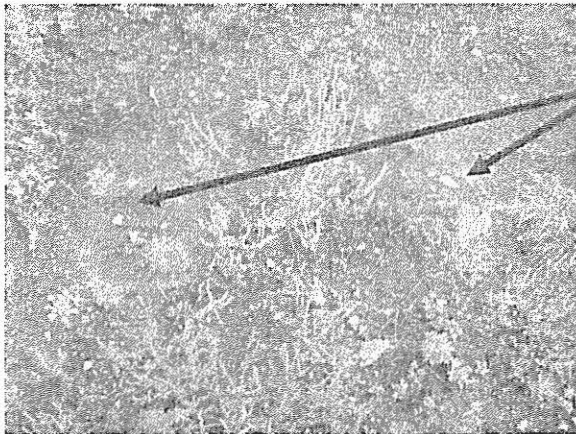
Debris of Transite Cement Board

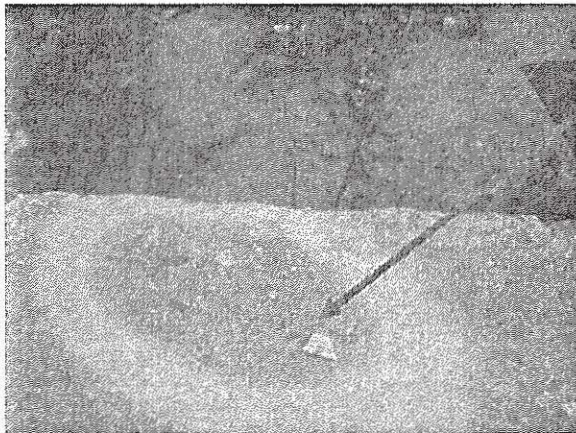
Debris of Transite Cement Board

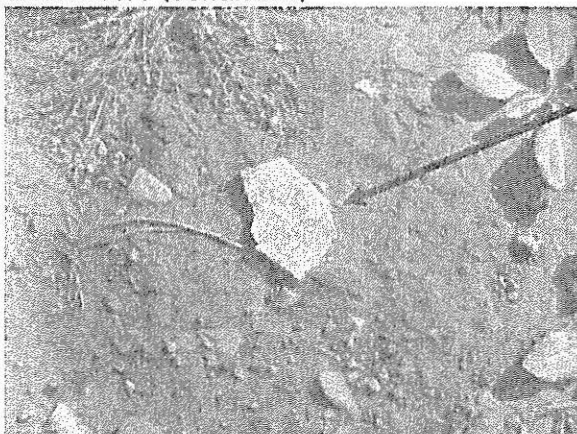
Debris of Transite Cement Board

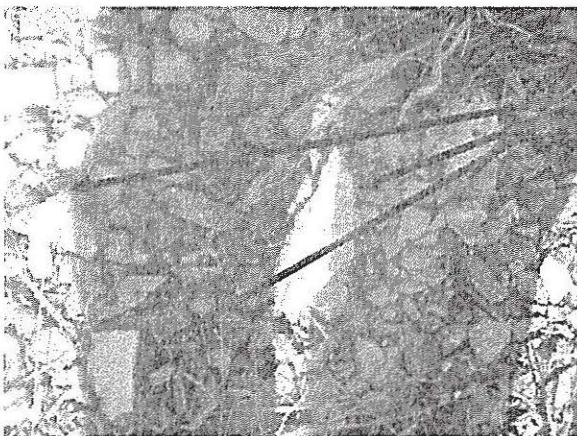
Debris of Transite Cement Board

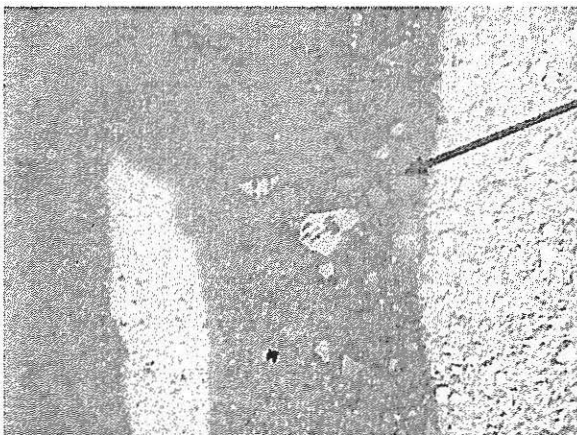
Debris of Floor Tile and Mastic

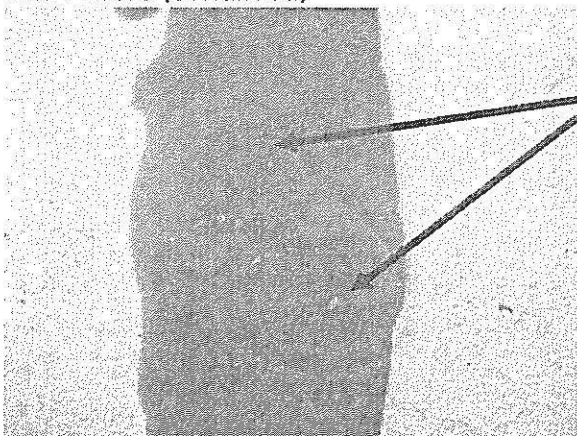
Debris of Floor Tile and Mastic

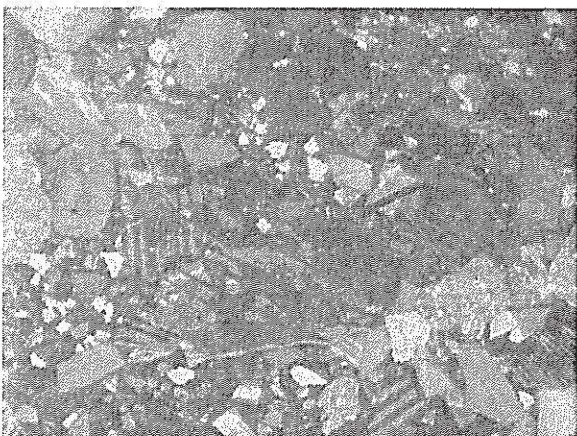
Debris of Floor Tile and Mastic

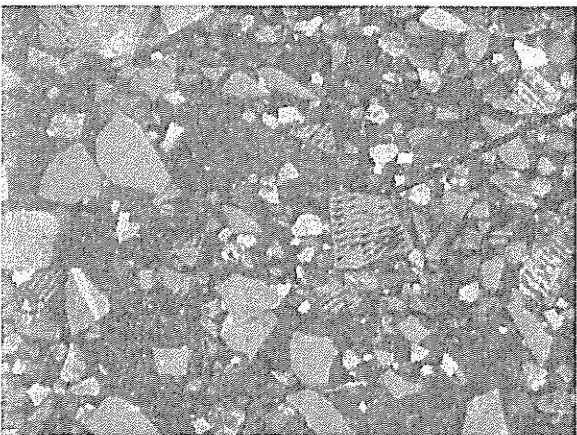
Debris of Floor Tile and Mastic

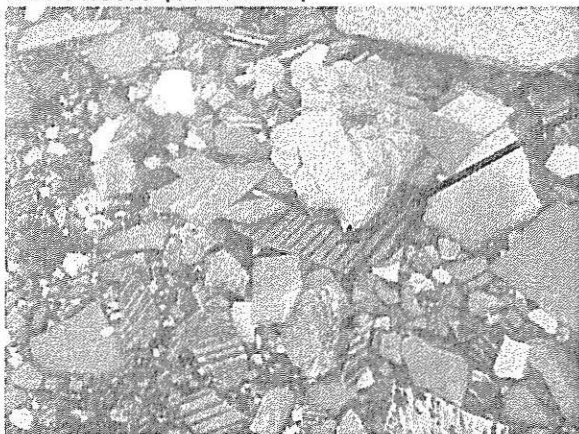
Debris of Floor Tile and Mastic

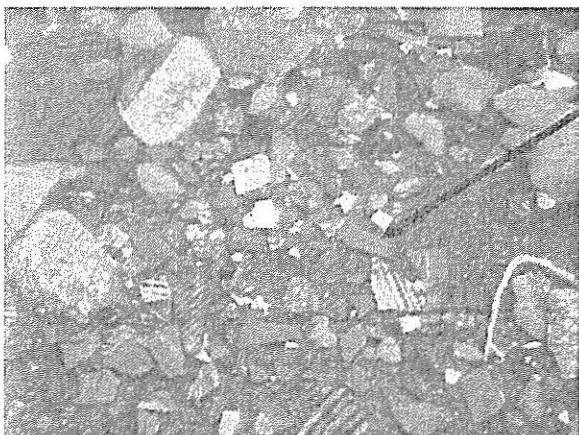
Debris of Floor Tile and Mastic

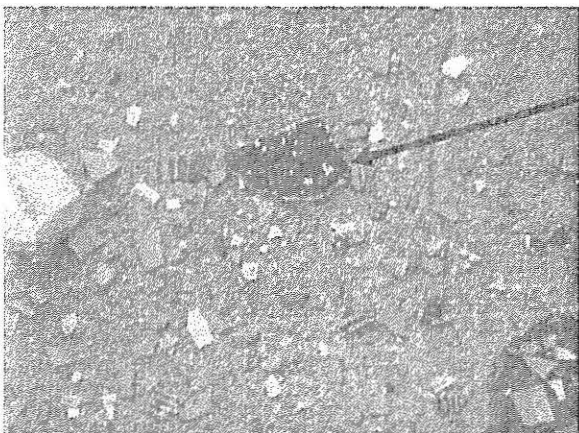
Debris of Floor Tile and Mastic

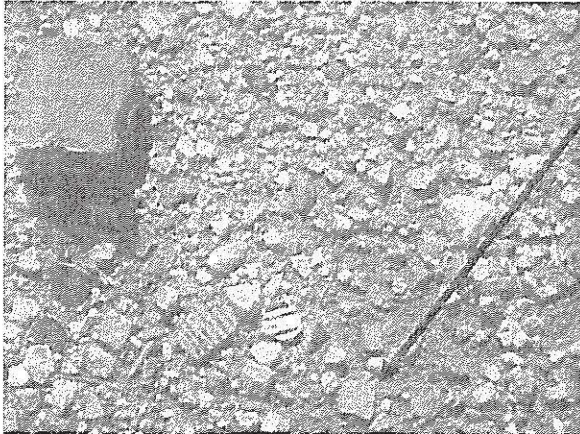
Debris of Floor Tile and Mastic

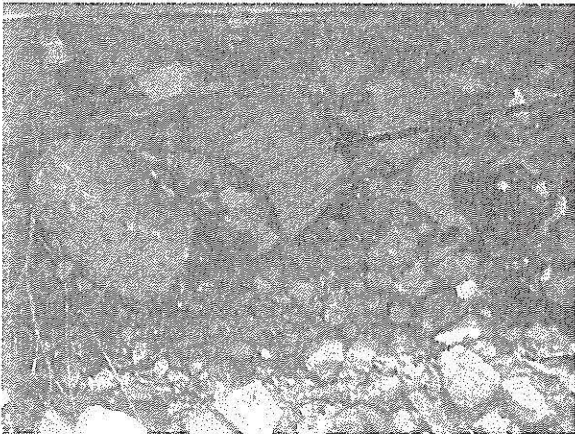
Debris of Floor Tile and Mastic

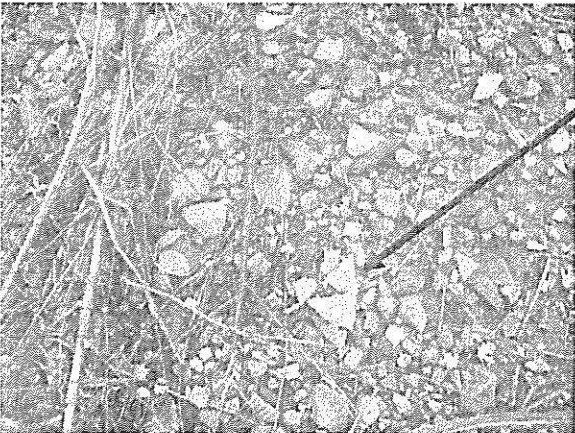
Debris of Floor Tile and Mastic

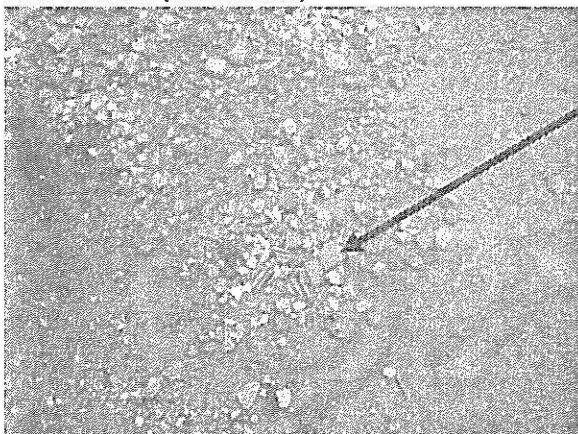
Debris of Floor Tile and Mastic

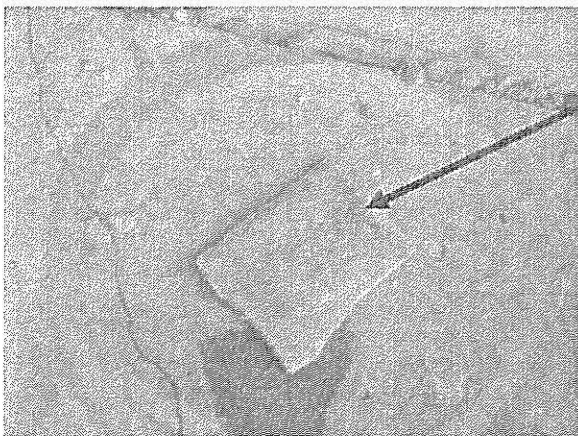
Debris of Transite Cement Board

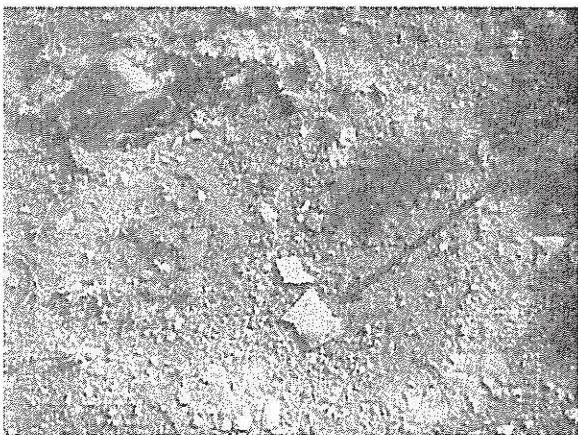
Debris of Transite Cement Board

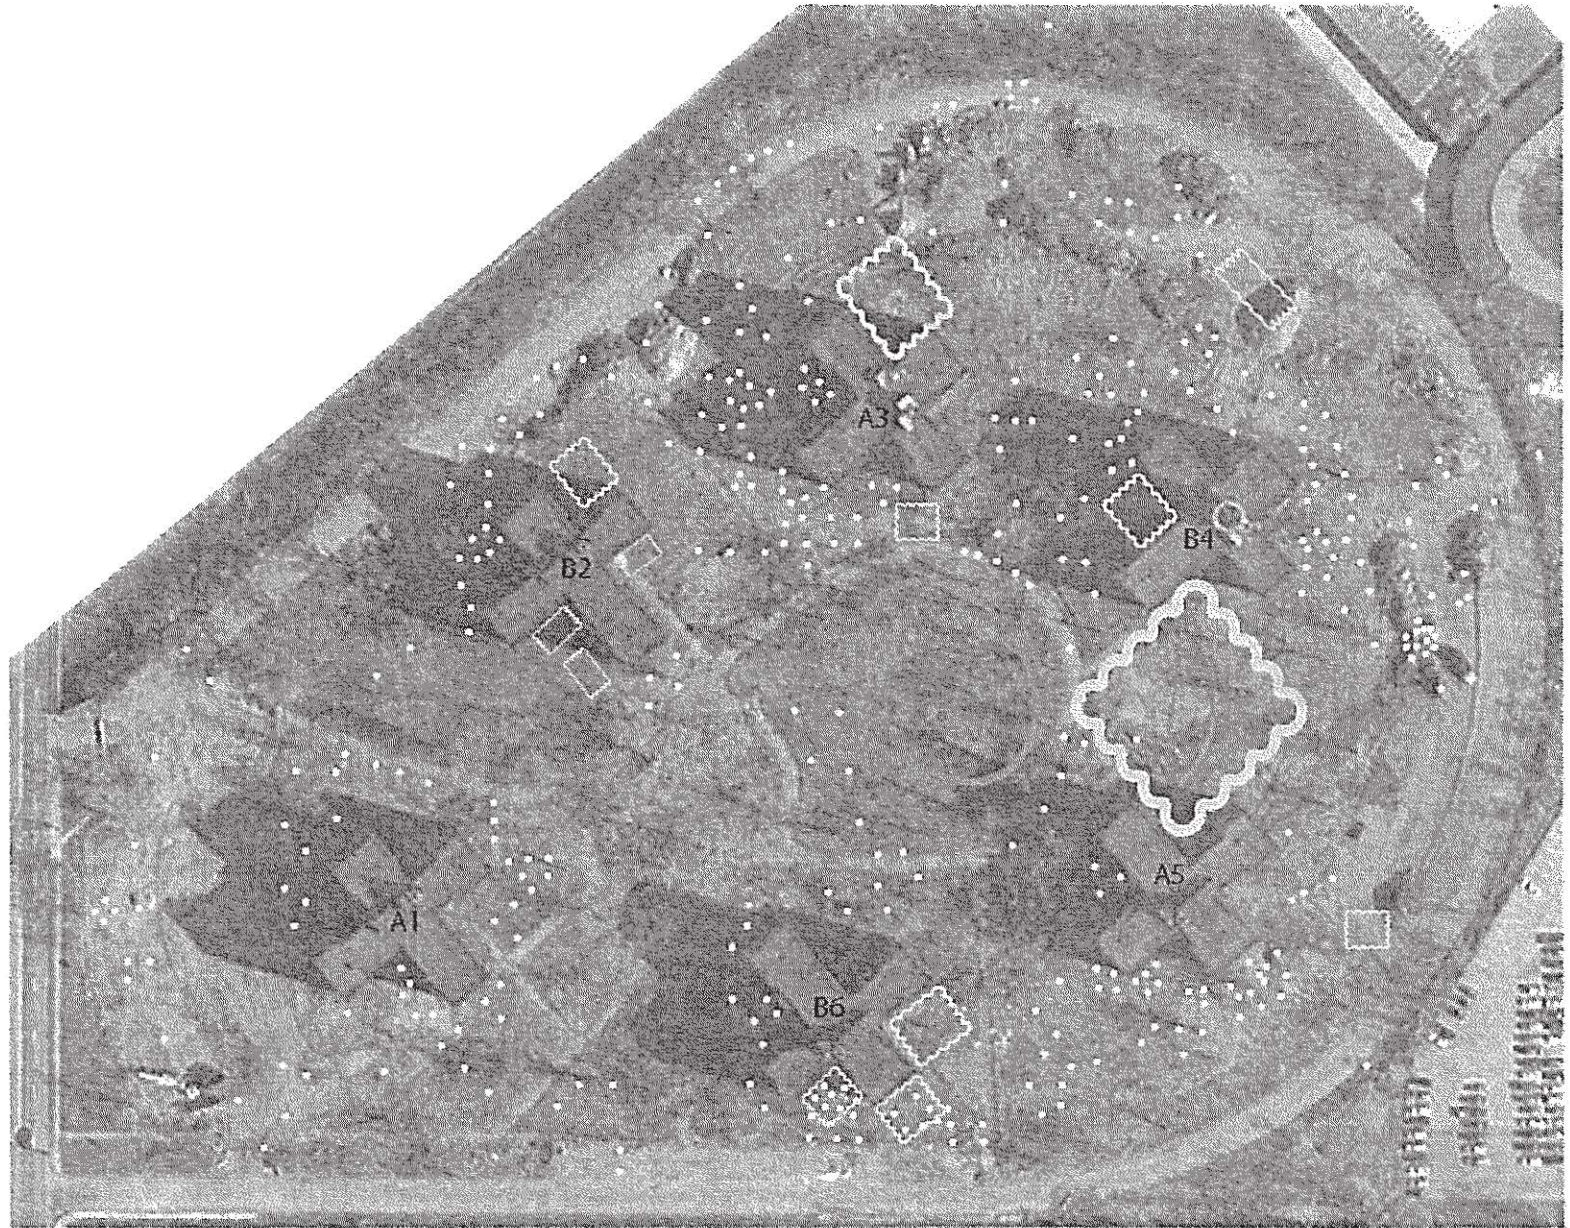
□ Represents a larger, wide spread debris pile consisting of Window Caulks, Transite Asbestos Cement Board, or Floor Tile.

Note: At the time of inspection areas of dense vegetation prevented certain areas from being seen with clarity. Therefore it should be noted that debris may exist outside of the yellow dots and demarkated green boxes especially in these thick areas of vegetation.

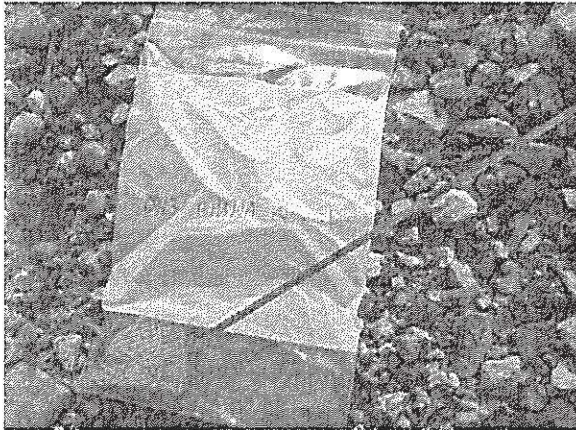
Sample 1 Transite Debris

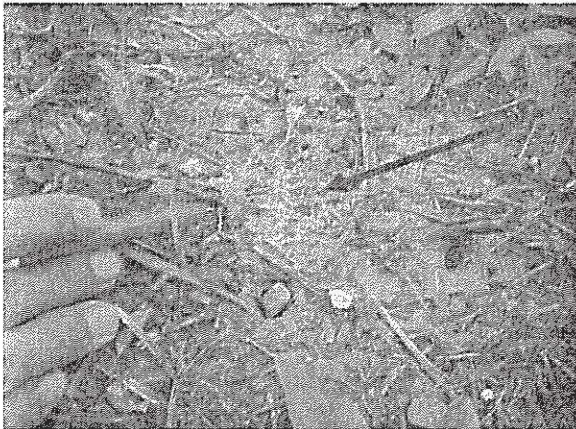
Sample 2 Friable Debris

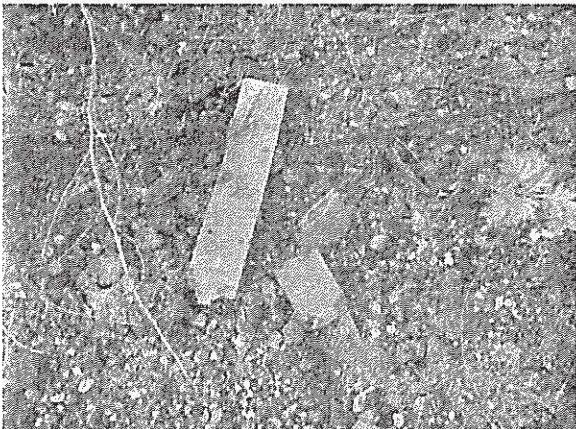
Sample 3 Debris of Brake Shoe

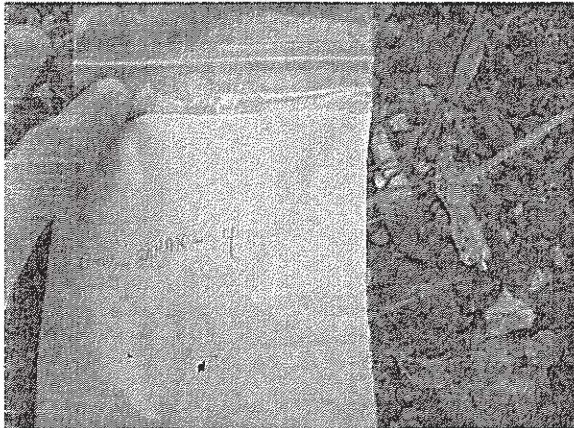
Sample 4 Window Caulk Debris

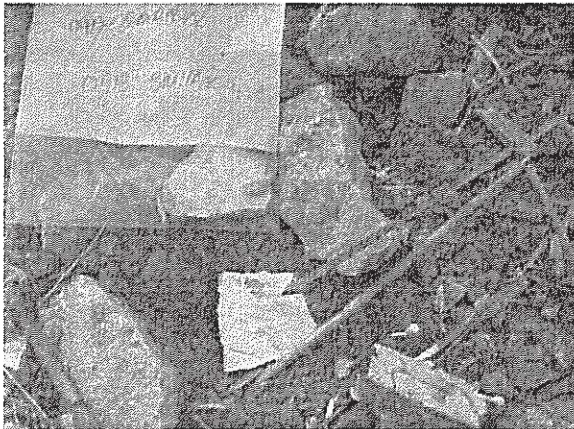
Sample 5 Transite Debris

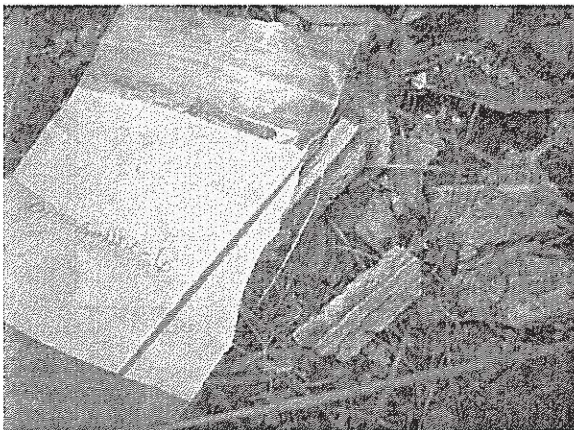
Sample 6 Caulk Debris

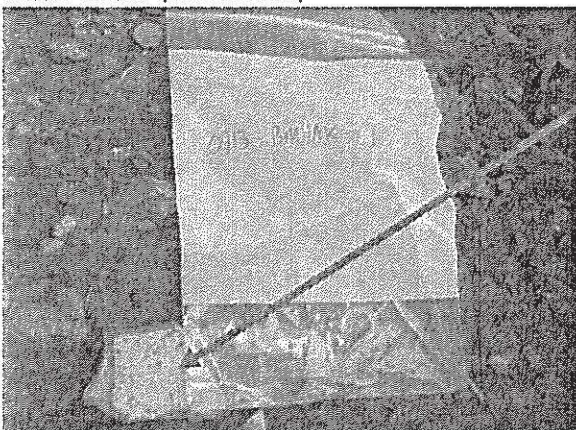
Sample 7 Transite Debris

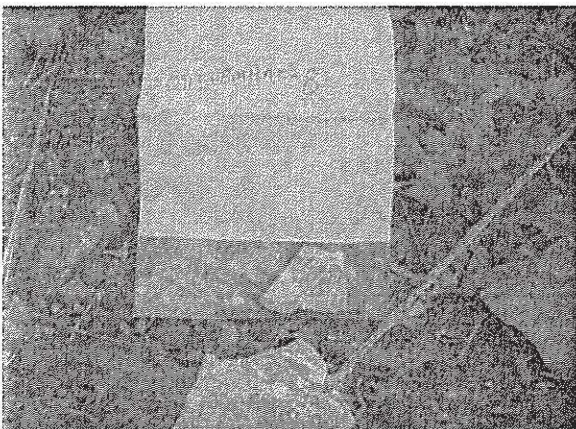
Sample 8 Transite Debris

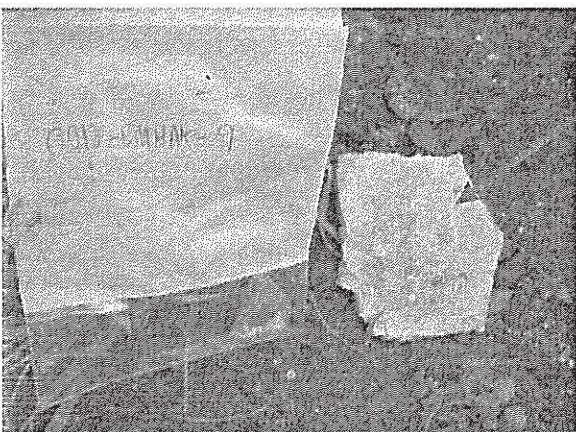
Sample 9 Transite Debris

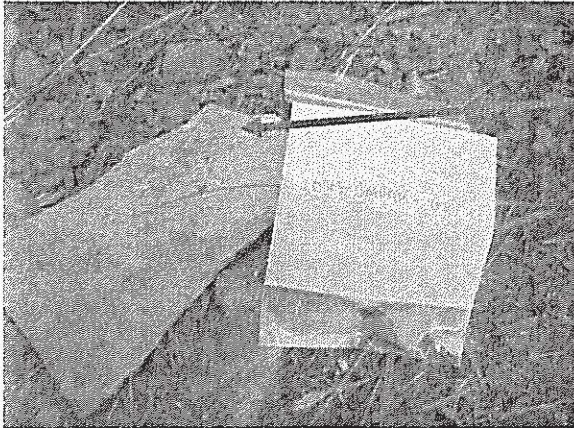
Sample 10 Transite Debris

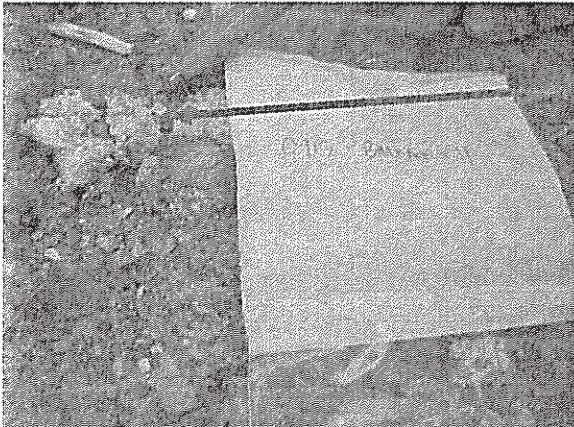
Sample 11 Friable Debris
