# Periodic Review Report

73-79 West Huron Street Site  
Buffalo, New York  
BCP Site No. C915282

May 2021, Revised July 2021

0441-020-001

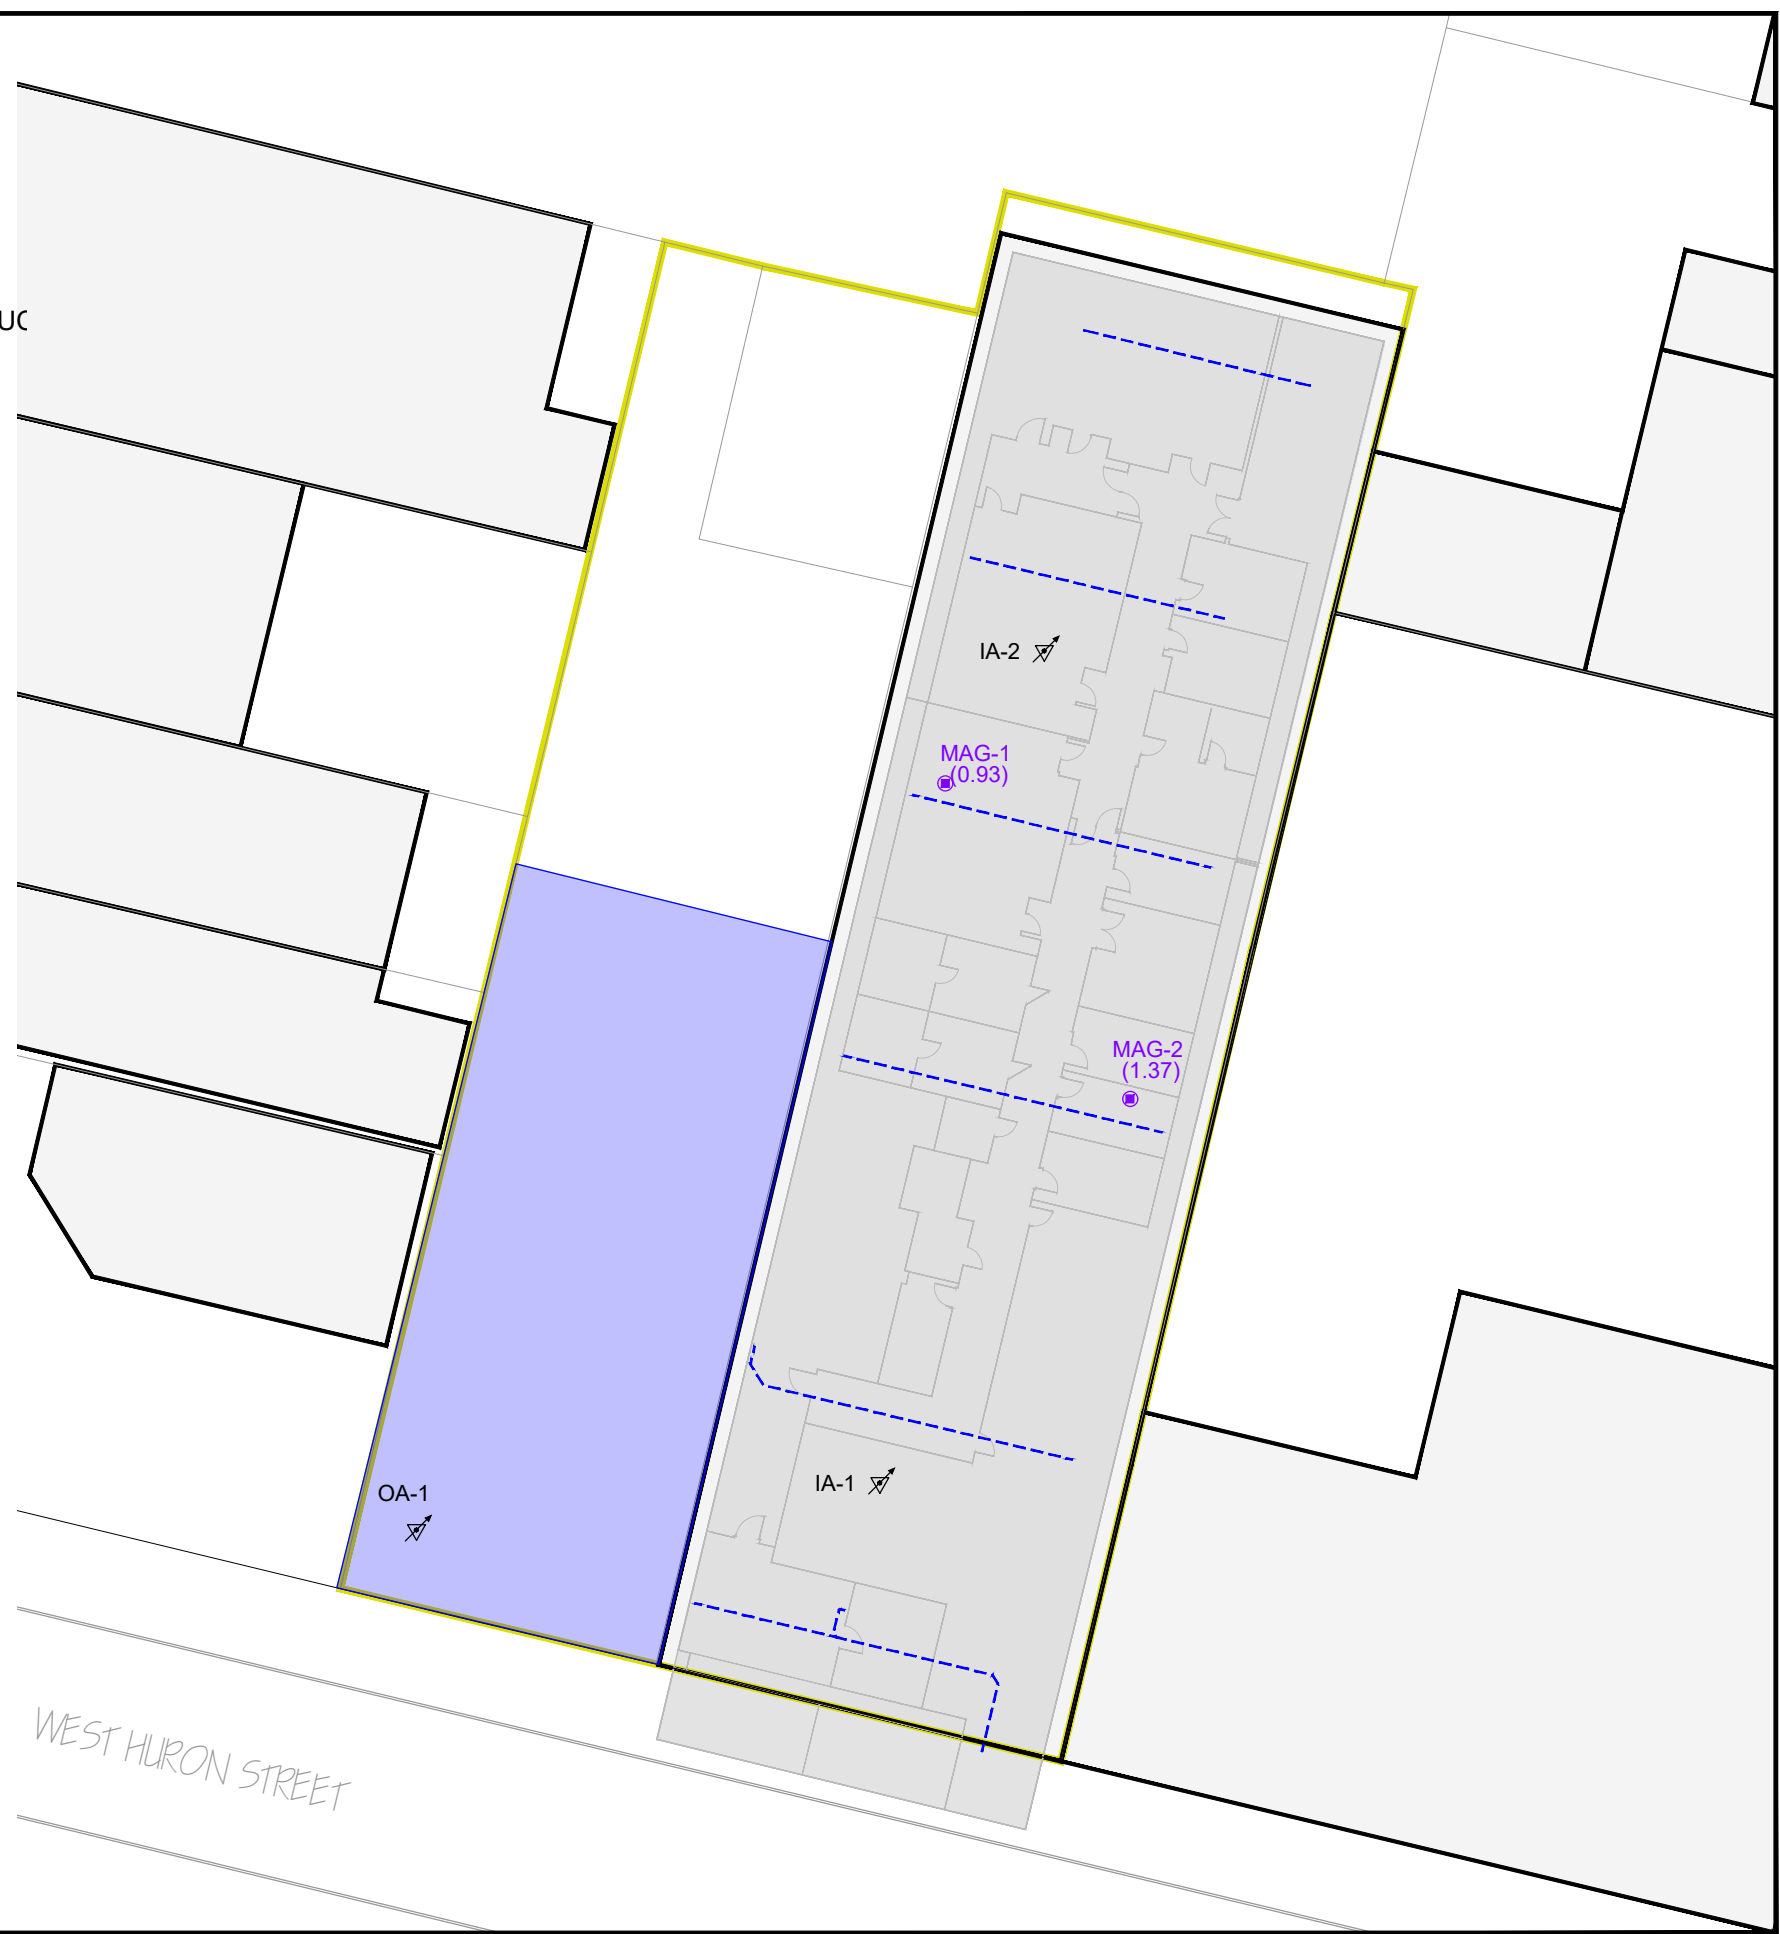
FIGURE 3

Figure 3 illustrates magnehelic gauge locations and readings collected February 3, 2021. Appendix B provides photos of the February 3, 2021 annual magnehelic gauge pressure readings.

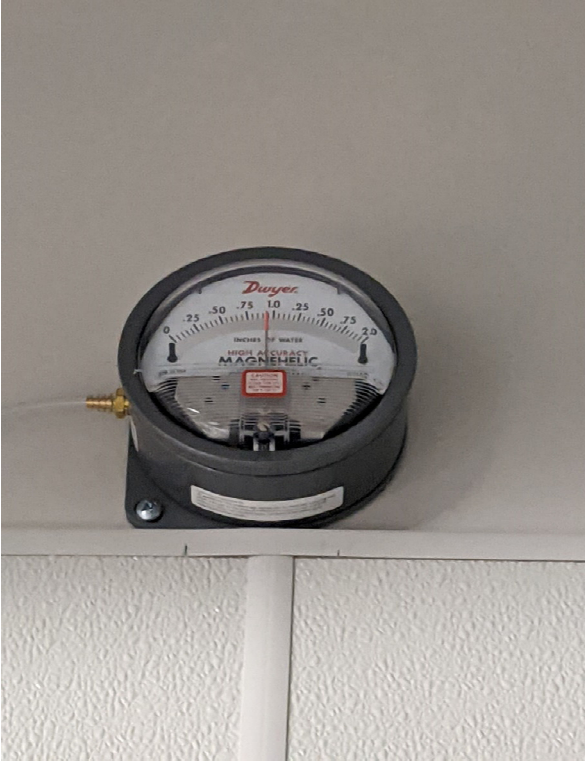
| <b>Photo No.</b><br>1 | <b>Date</b><br>02/03/21 | | |

| <b>Description:</b><br><b>Vapor Assessment ASD</b><br><b>System Monitoring:</b><br>Magnehelic Guage Pressure<br>Reading MAG-1 (0.93 inches of water) | | | |

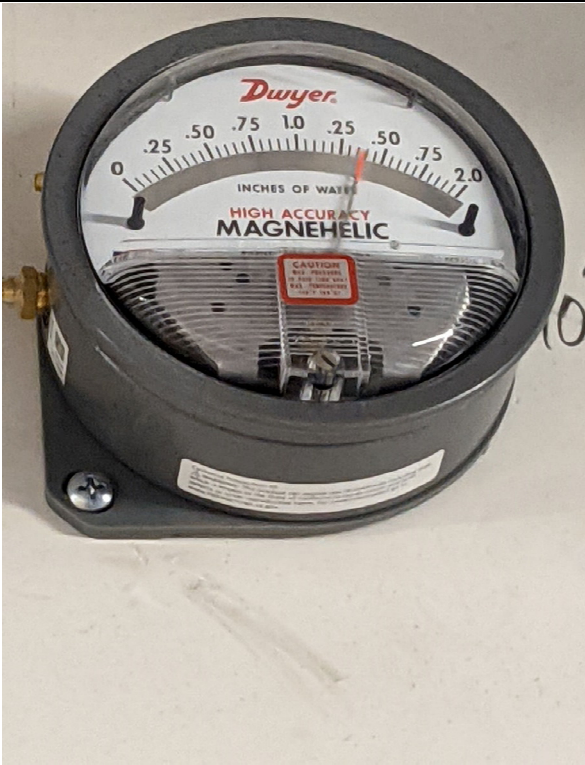
| <b>Photo No.</b><br>2 | <b>Date</b><br>02/03/21 | |

| <b>Description:</b><br><b>Vapor Assessment ASD</b><br><b>System Monitoring:</b><br>Magnehelic Guage Pressure<br>Reading MAG-2 (1.37 inches of water) | | |

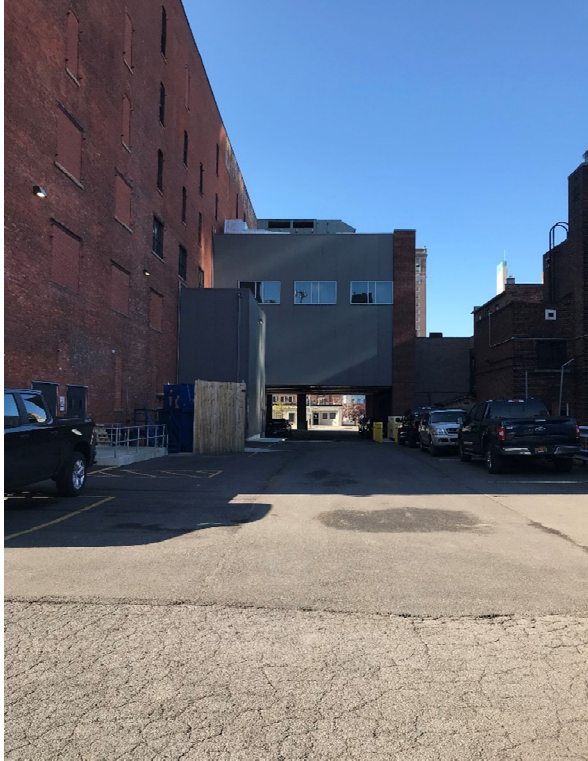
| <b>Photo No.</b><br>3 | <b>Date</b><br>04/23/21 | | |

| <b>Description:</b><br><b>Annual Site Inspection:</b><br>Exterior Elevated Gymnasium Addition. | | | |

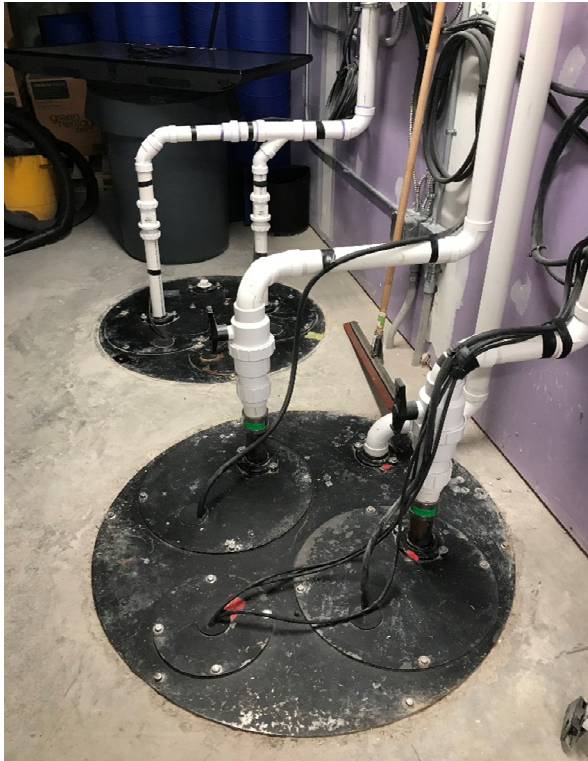
| <b>Photo No.</b><br>4 | <b>Date</b><br>04/23/21 | |

| <b>Description:</b><br><b>Annual Site Inspection:</b><br>Sealed sumps in south side of basement. | | |

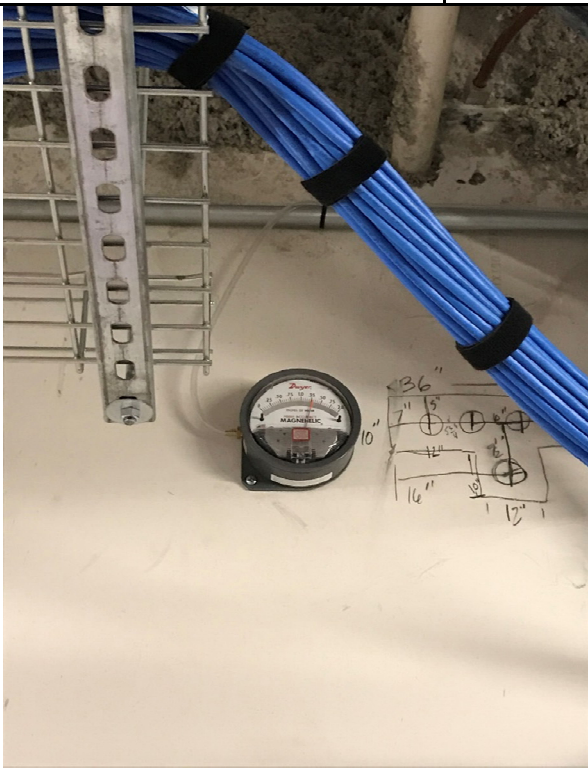
| <b>Photo No.</b><br>5 | <b>Date</b><br>04/23/21 | | |

| <b>Description:</b><br><b>Annual Site Inspection:</b><br>Magnehelic Gauge Pressure Reading (MAG-2; 1.27 inches of water) | | | |

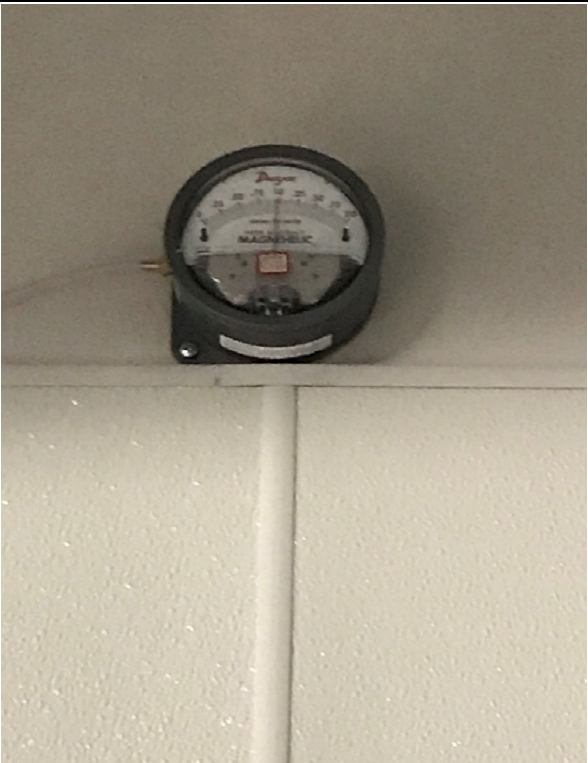
| <b>Photo No.</b><br>6 | <b>Date</b><br>04/23/21 | |

| <b>Description:</b><br><b>Annual Site Inspection:</b><br>Magnehelic Gauge Pressure Reading (MAG-1; 1.0 inches of water) | | |

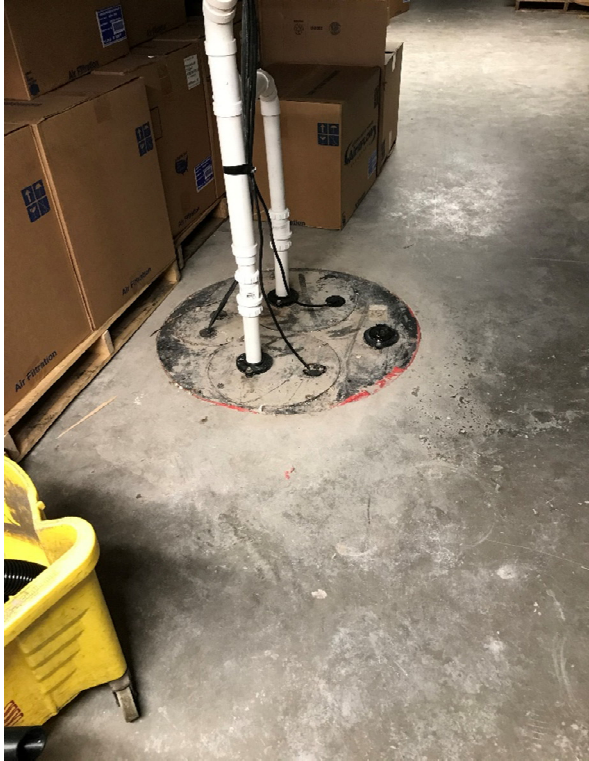
| <b>Photo No.</b><br>7 | <b>Date</b><br>04/23/21 | | |

| <b>Description:</b><br><b>Annual Site Inspection:</b><br>Sealed sumps on northwest side of basement. | | | |

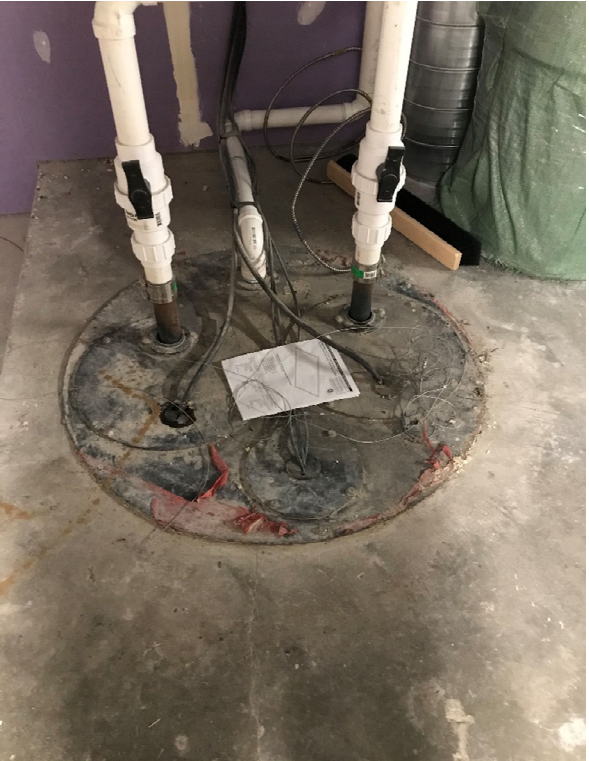
| <b>Photo No.</b><br>8 | <b>Date</b><br>04/23/21 | |

| <b>Description:</b><br><b>Annual Site Inspection:</b><br>Sealed sumps on northeast side of basement. | | |

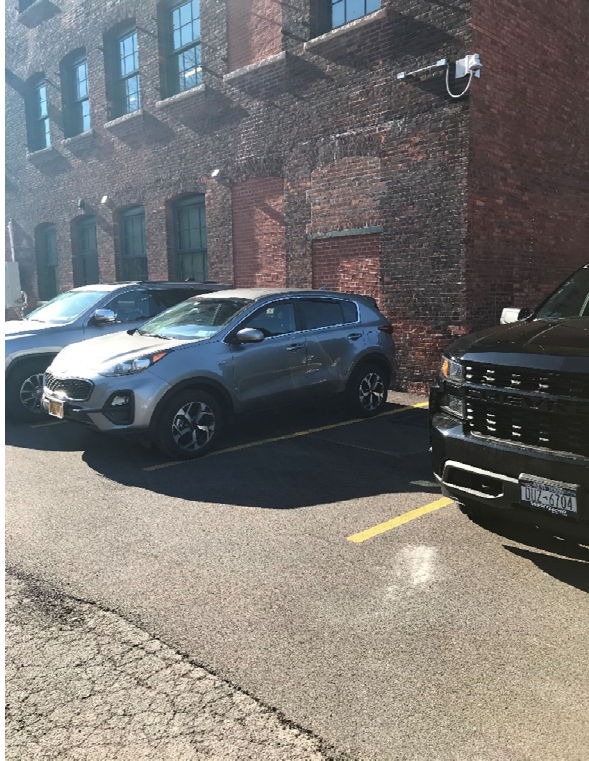
| <b>Photo No.</b><br>9 | <b>Date</b><br>04/23/21 | | |

| <b>Description:</b><br><b>Annual Site Inspection:</b><br>South side of existing building exterior. | | | |

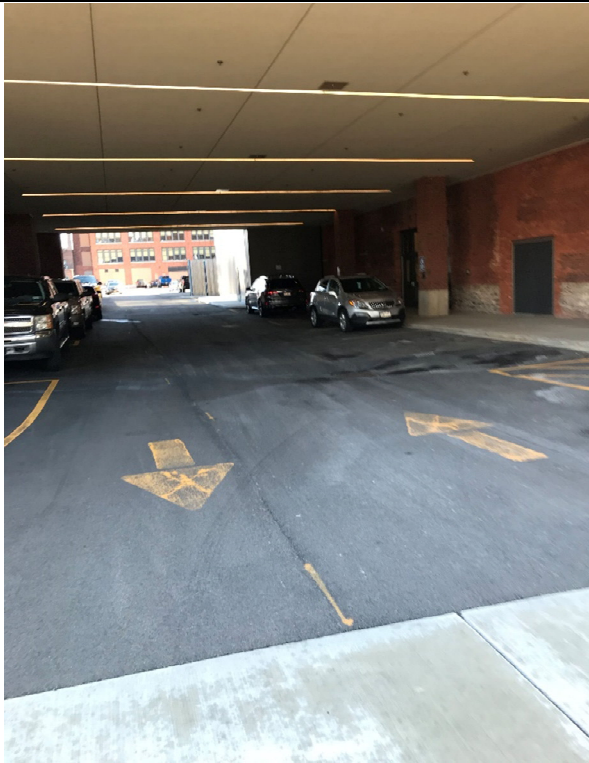
| <b>Photo No.</b><br>10 | <b>Date</b><br>04/23/21 | |

| <b>Description:</b><br><b>Annual Site Inspection:</b><br>Exterior elevated gymnasium addition. | | |

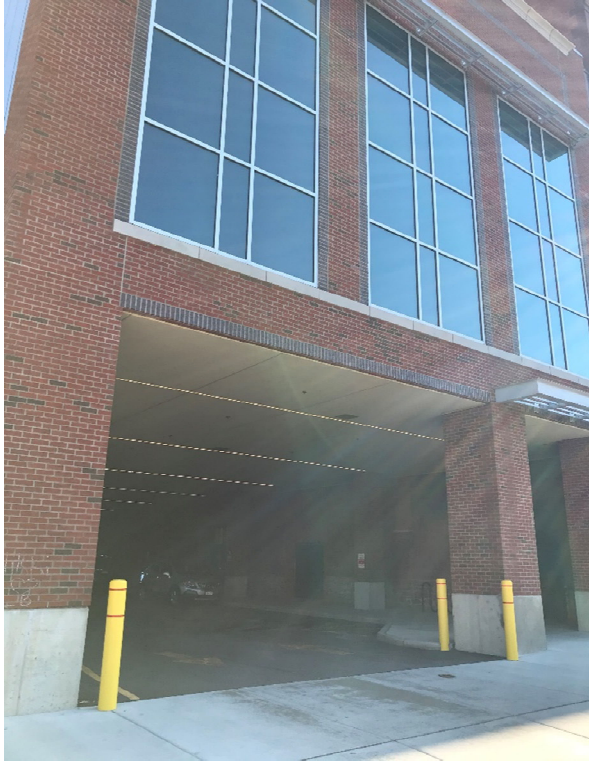
| <b>Photo No.</b><br>11 | <b>Date</b><br>04/23/21 | | |

| <b>Description:</b><br><b>Annual Site Inspection:</b><br>Exterior elevated gymnasium addition façade on West Huron Street. | | | |

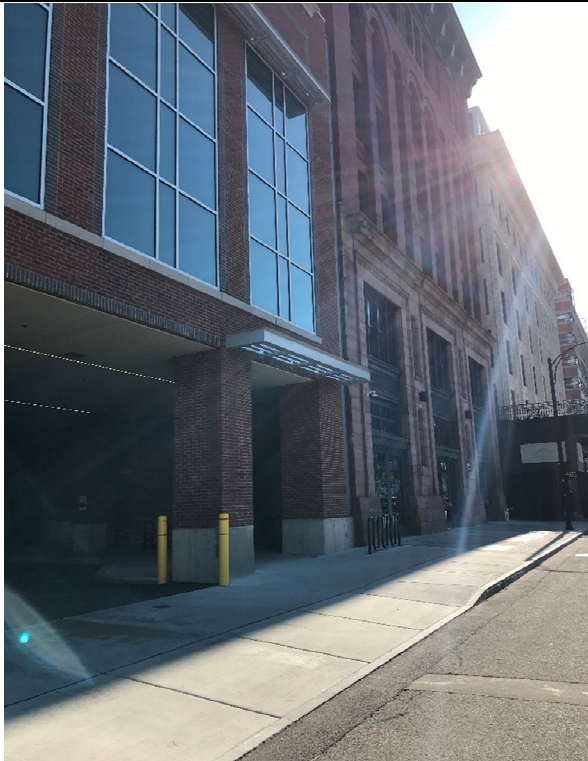
| <b>Photo No.</b><br>12 | <b>Date</b><br>04/23/21 | |

| <b>Description:</b><br><b>Annual Site Inspection:</b><br>Sidewalk along West Huron Street. | | |
