PERIODIC REVIEW REPORT

**399 OHIO STREET SITE
(BCP SITE NO. C915287)**

BUFFALO, NEW YORK

June 2018

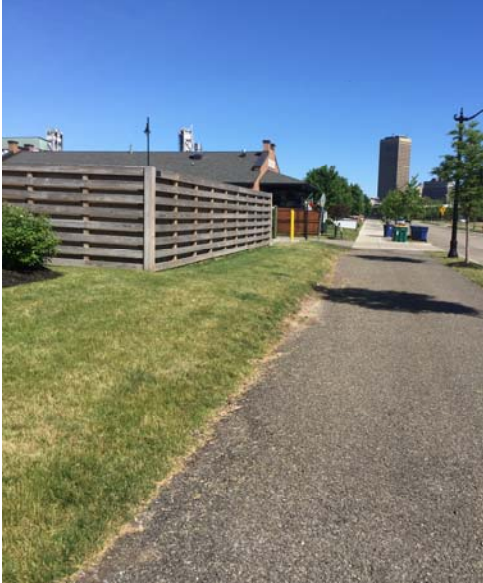
Photo 1: Site Inspection – Vegetative cover along northeast portion of the Site (looking north).

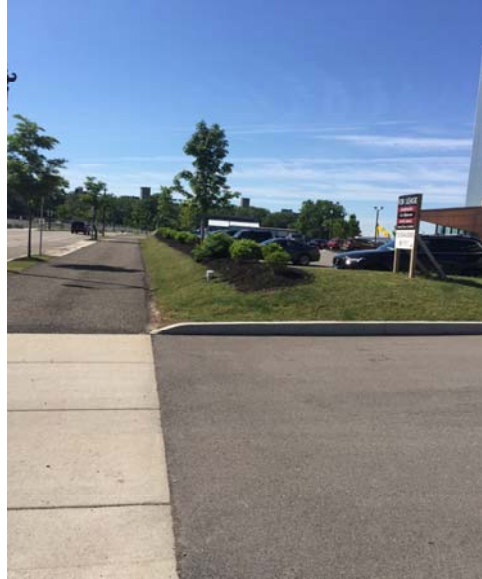
Photo 2: Site Inspection – Cover along eastern property boundary of the Site (looking south).

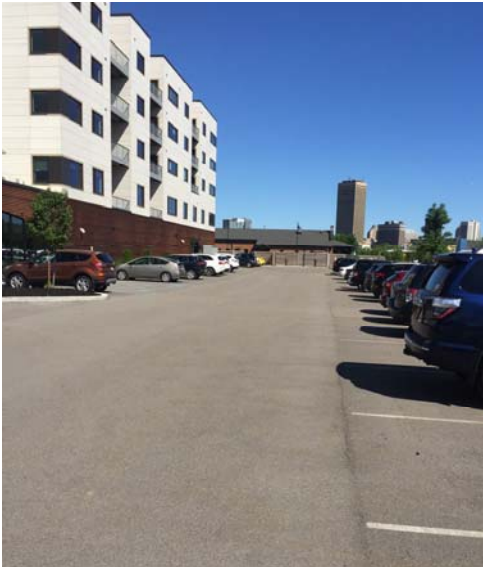
Photo 3: Site Inspection – Parking lot area (looking north).

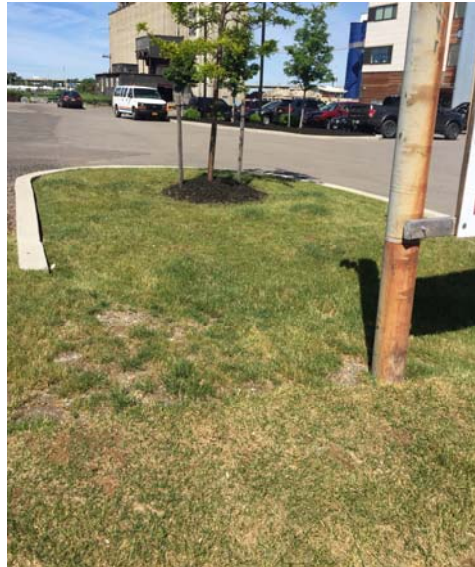
Photo 4: Site Inspection – Vegetative and asphalt cover (looking west).

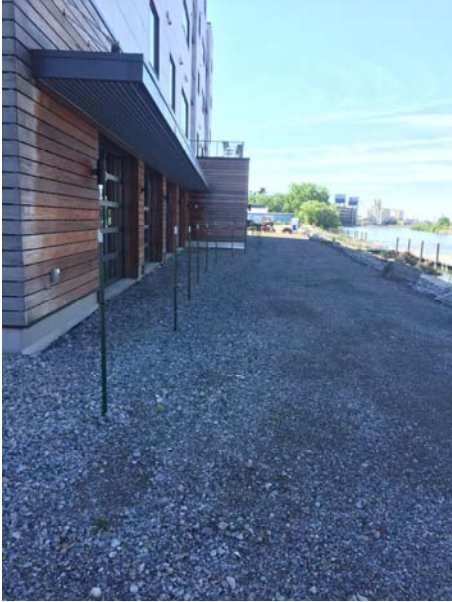
Photo 5: Site Inspection – Stone cover along the western property boundary (looking south).

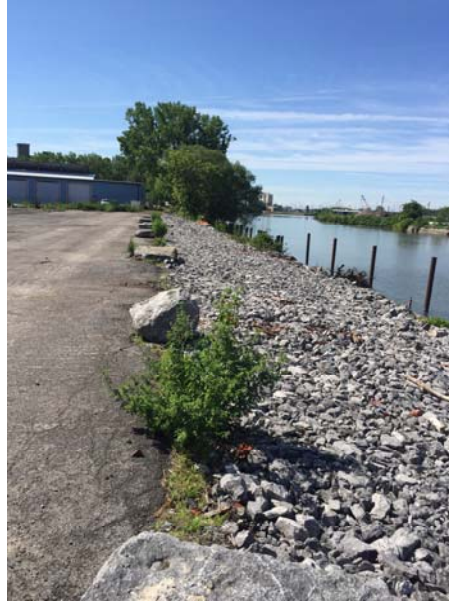
Photo 6: Site Inspection – rip rap stone cover along the Buffalo River (looking south).

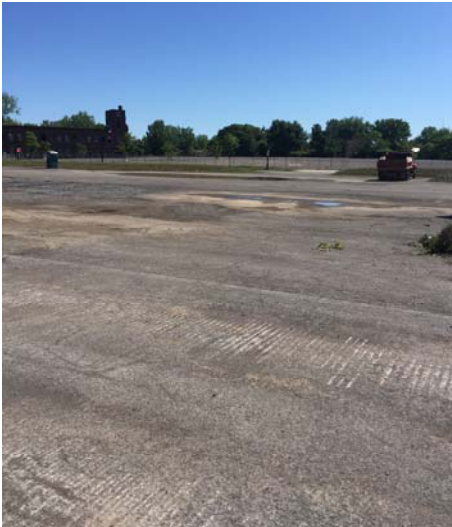
Photo 7: Site Inspection – Asphalt cover (looking east).

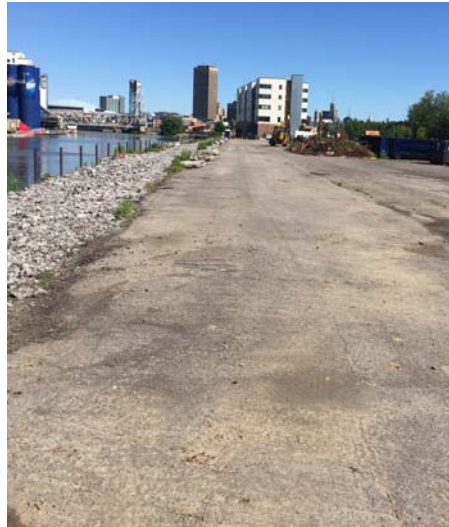
Photo 8: Site Inspection – Asphalt and stone cover along the Buffalo River (looking north).

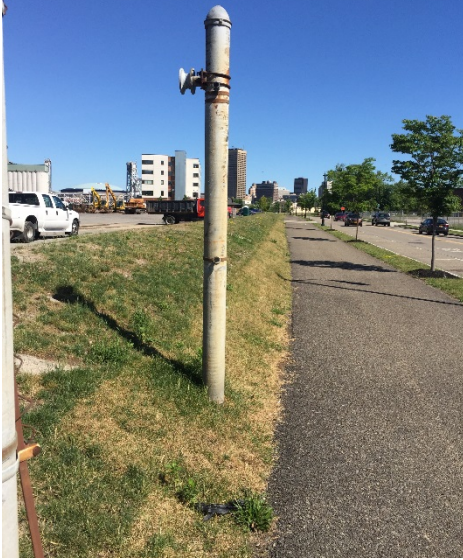
Photo 9: Site Inspection – Bermed vegetative cover along the eastern boundary (looking north).

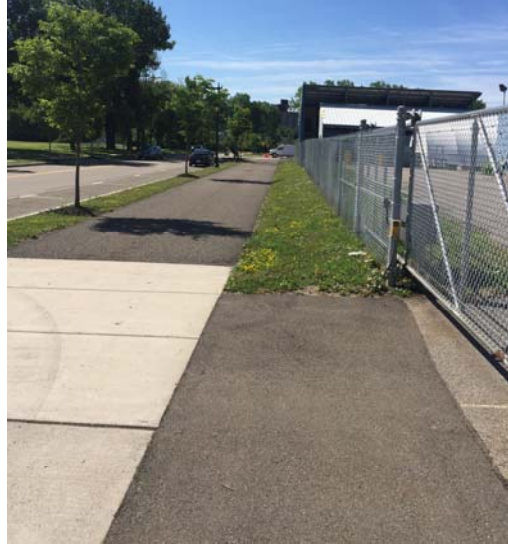
Photo 10: Site Inspection – Vegetative cover along the southeastern property boundary (looking south).

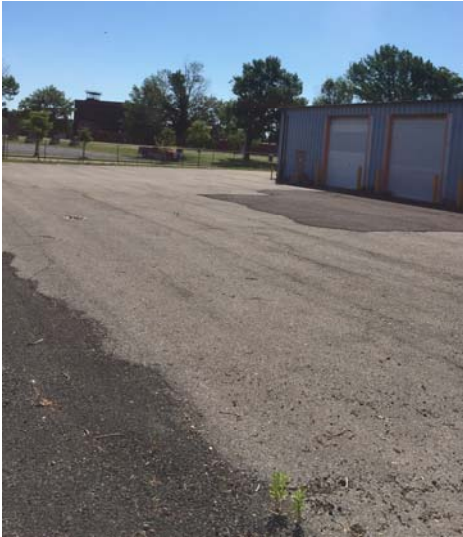
Photo 11: Site Inspection – Asphalt cover north of the utility garage on the southern portion of the site.

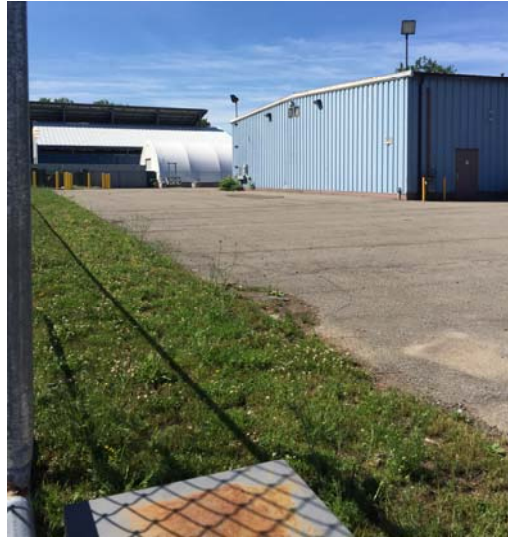
Photo 12: Site Inspection – Vegetative and asphalt cover near utility garage (looking south).
