PERIODIC REVIEW REPORT

**399 OHIO STREET SITE
(BCP SITE NO. C915287)**

BUFFALO, NEW YORK

June 2021

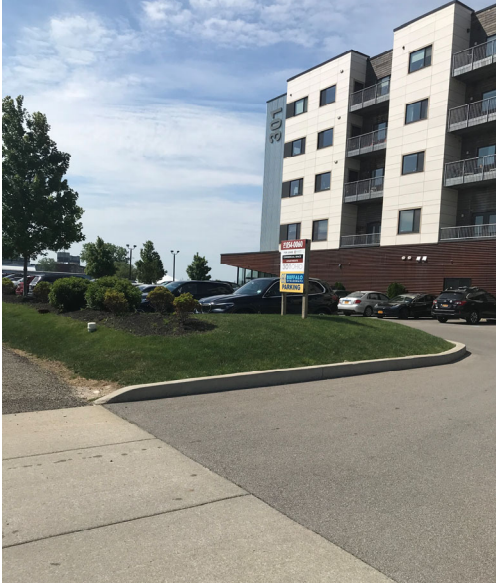
- Photo 1: Site Inspection – Mixed cover system and building 301 Ohio area (looking southwest).
Photo 2: Site Inspection – Mixed cover along eastern side of Building (looking north)
Photo 3: Site Inspection – Parking lot 301 Ohio area (looking south).
Photo 4: Site Inspection – Cover along eastern property boundary of the Site (looking north)

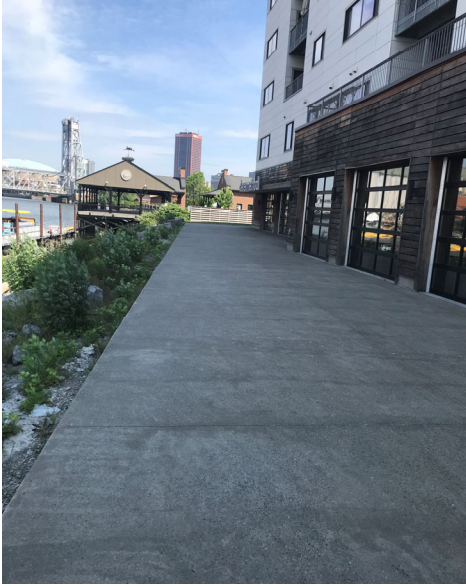
Photo 5: Site Inspection – Concrete patio along the western property boundary (looking north).

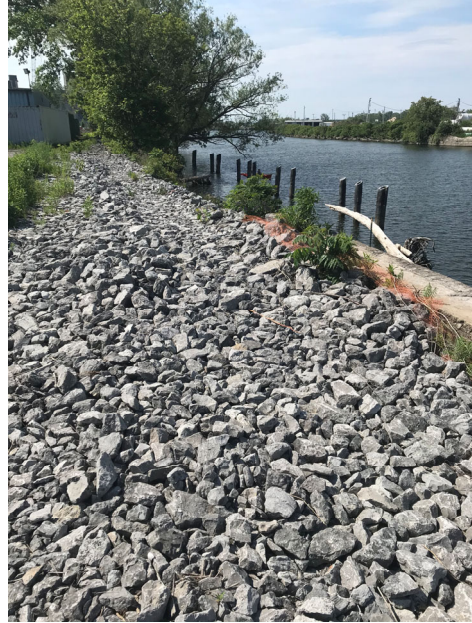
Photo 6: Site Inspection – Rip rap stone cover along the Buffalo River (looking south).

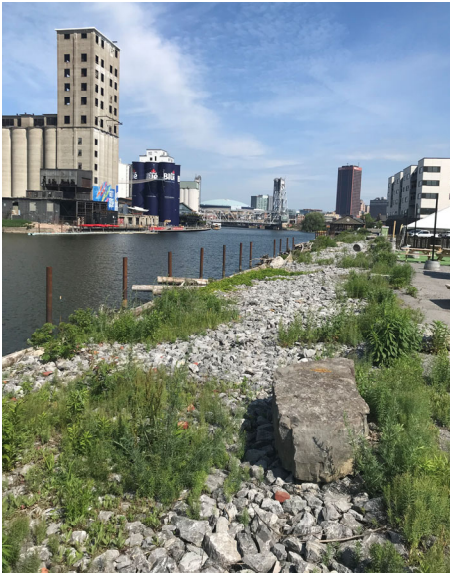
Photo 7: Site Inspection – Rip rap stone cover along Buffalo River (looking north)

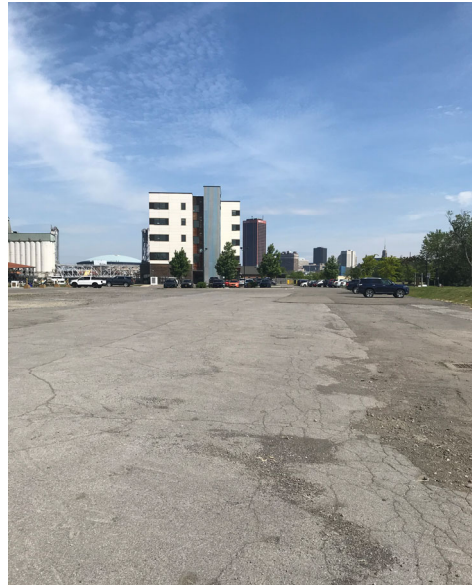
Photo 8: Site Inspection – 399 Ohio portion asphalt cover (looking north).

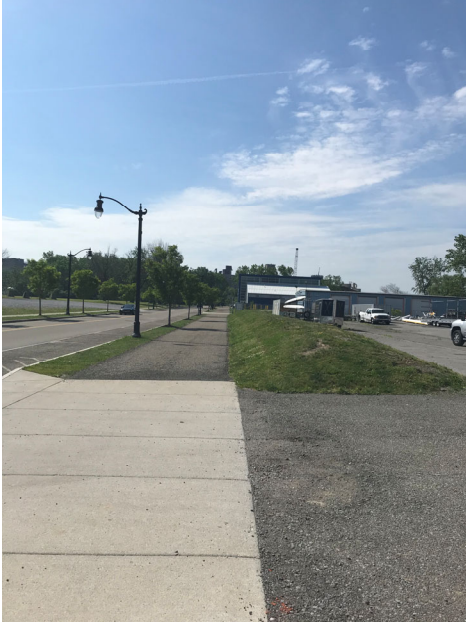
- Photo 9: Site Inspection – Site Inspection - Cover along the eastern boundary (looking south).
Photo 10: Site Inspection – Site Inspection - Cover and fence line at Blue Bldg area (looking south).
Photo 11: Site Inspection – Site Inspection - Asphalt cover around Blue Bldg. (looking west).
Photo 12: Site Inspection – Site Inspection – Cover along eastern boundary (looking north)
