PERIODIC REVIEW REPORT

**399 OHIO STREET SITE
(BCP SITE NO. C915287)**

BUFFALO, NEW YORK

July 2024

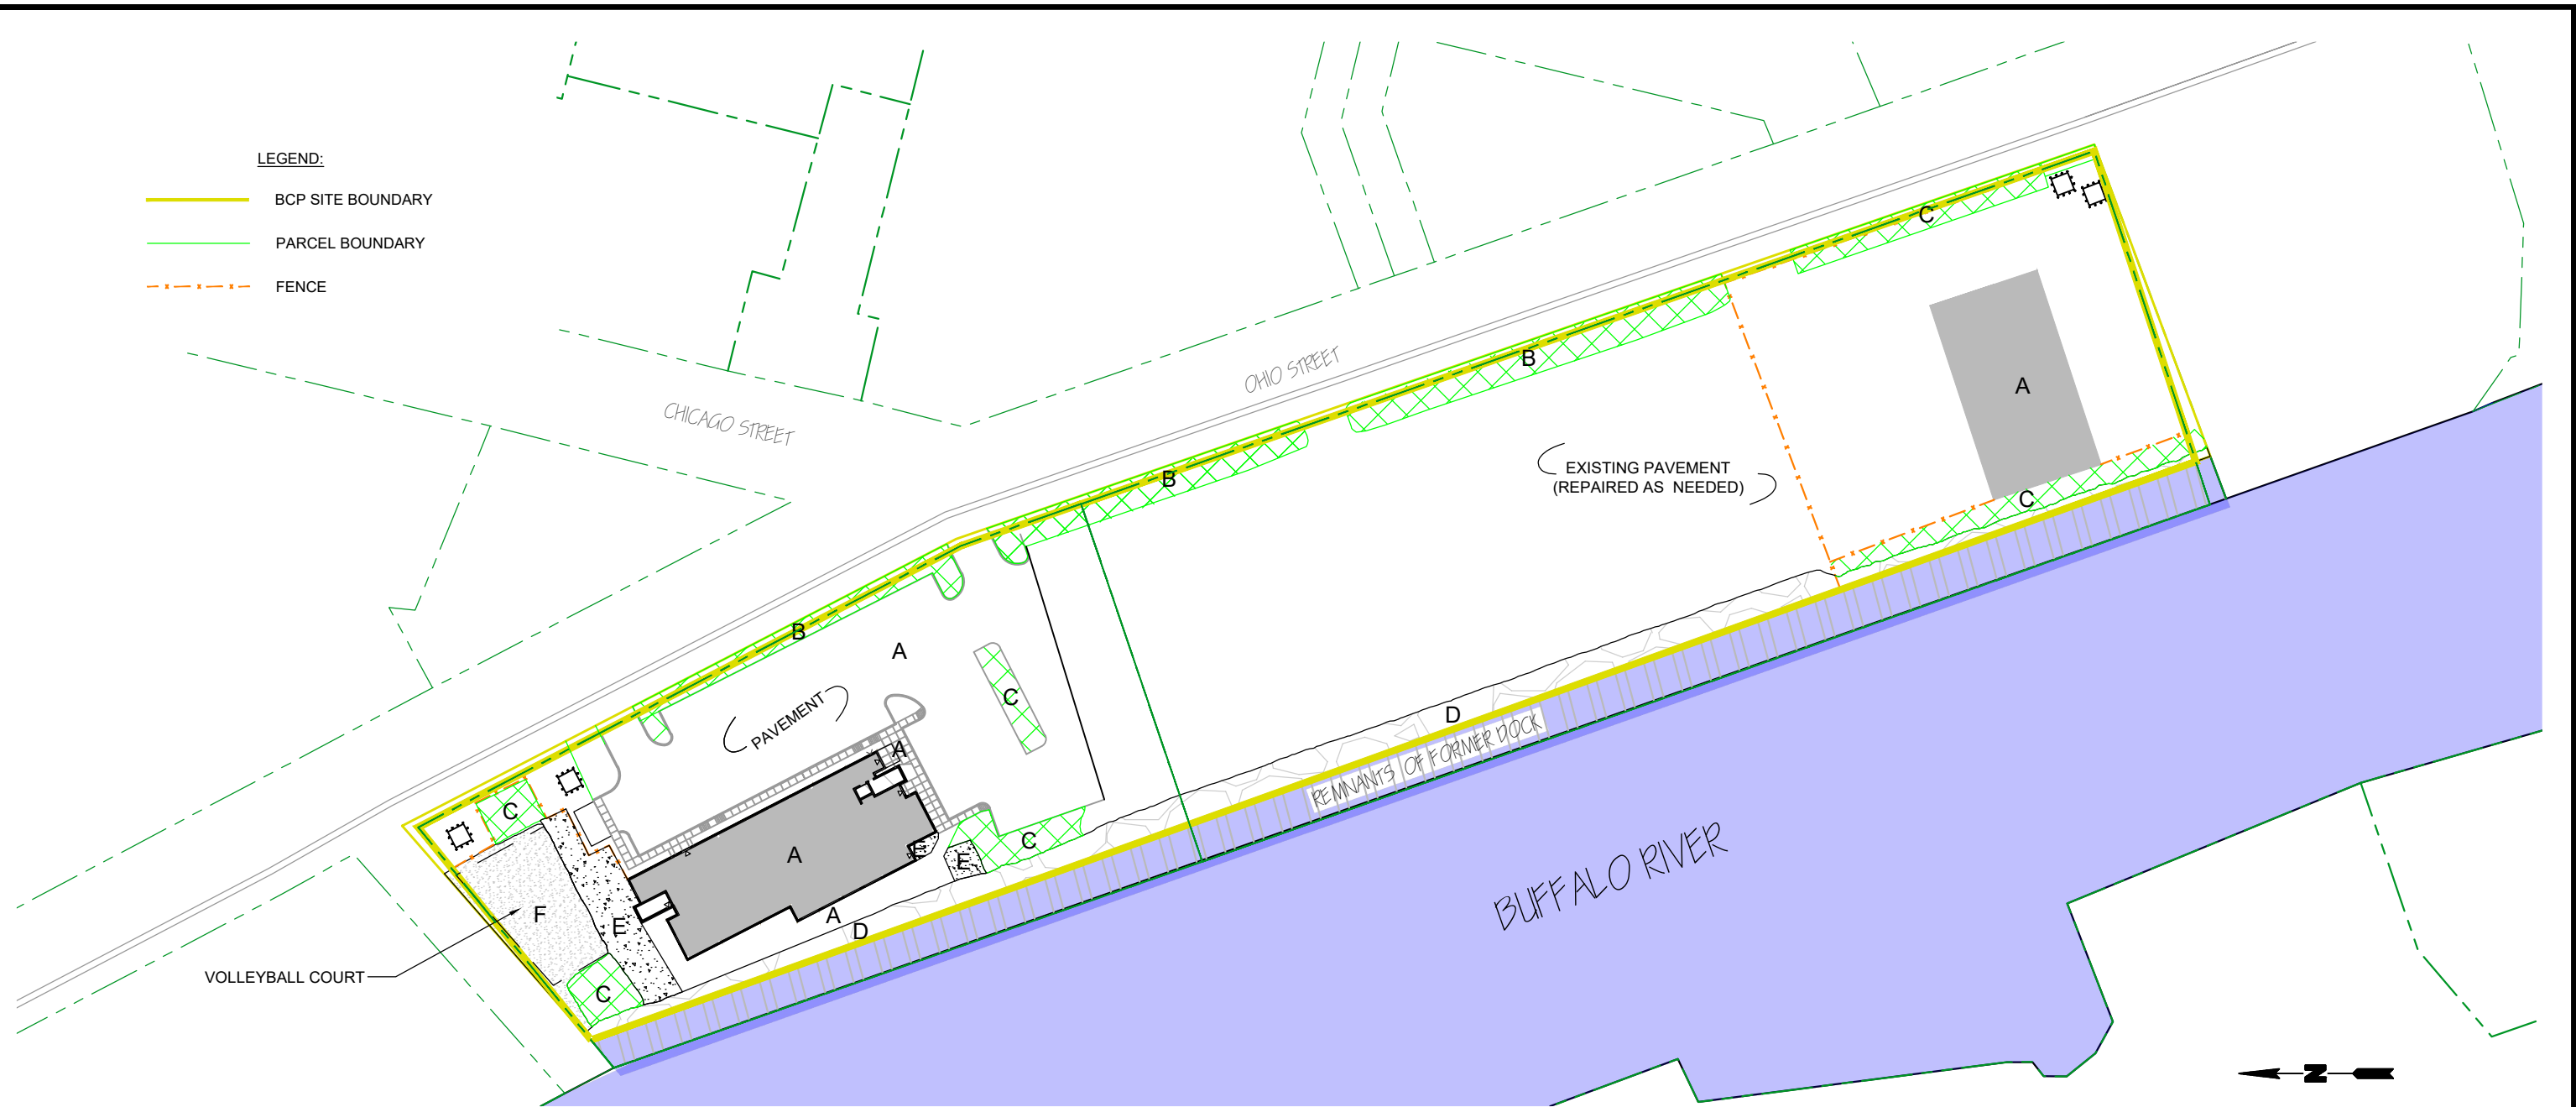
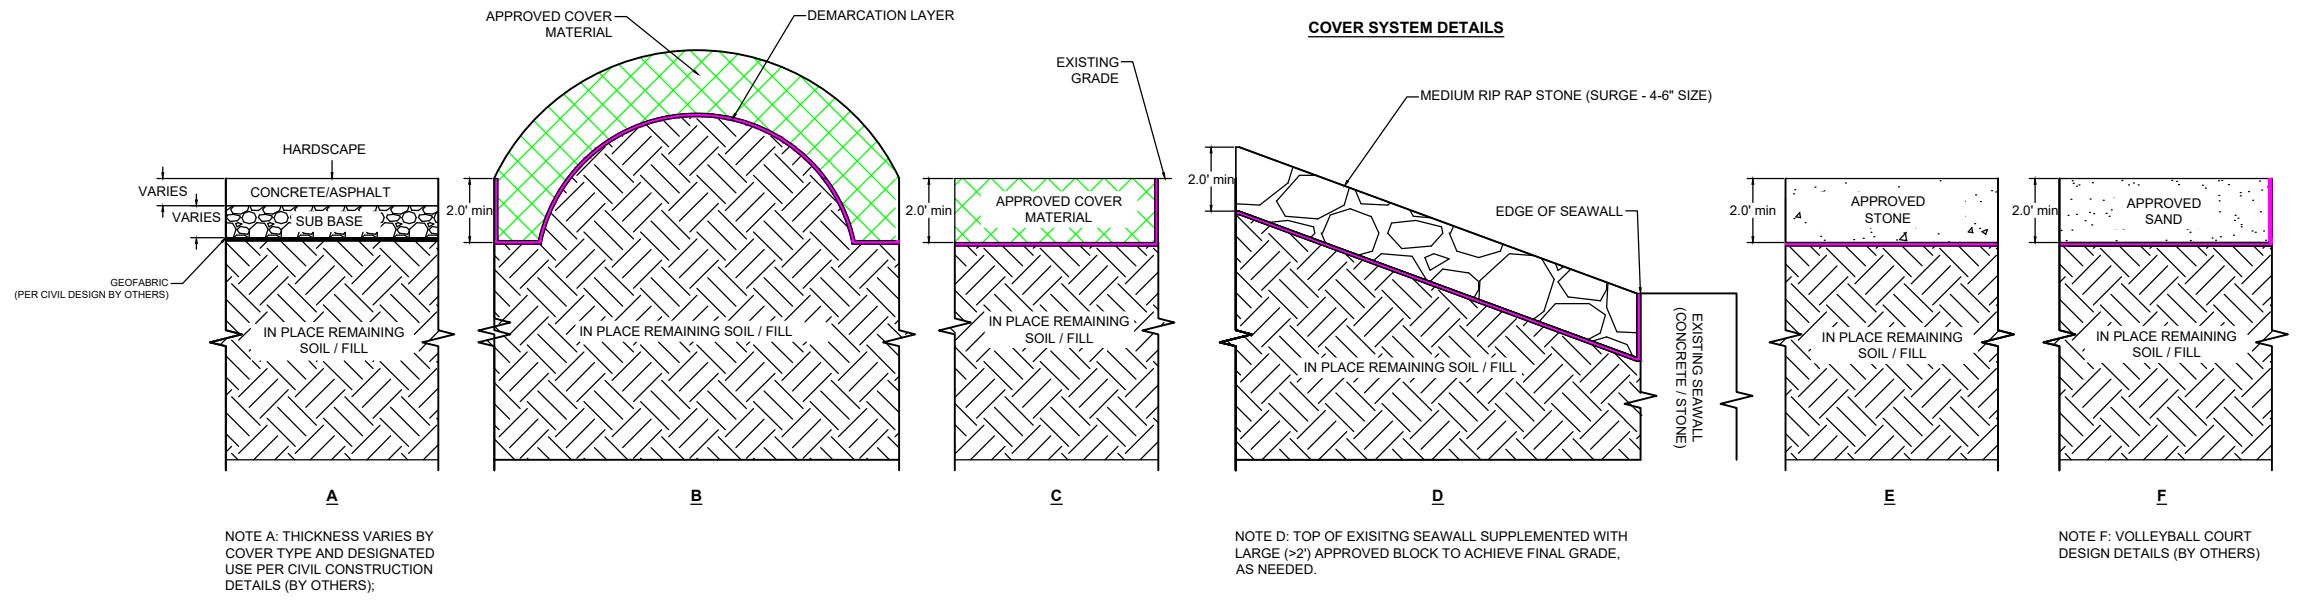
| <p>Title: COVER SYSTEM LAYOUT AND DETAILS</p> <p>Periodic Review Report</p> <p>399 OHIO STREET SITE BCP SITE NO. C915287 BUFFALO, NEW YORK</p> | | |

- Cover System – The cover system, including building foundations, concrete sidewalks, concrete or asphalt driveways and parking areas, and landscaped vegetated areas are being maintained in compliance with the SMP. Details of the cover system elements are provided on Figure 3.

NOTE: COVER SYSTEM KEYED-IN AT TRANSITIONS FROM HARDSCAPE AND/OR SITE BOUNDARY (24-INCH MINIMUM PER DER-10)

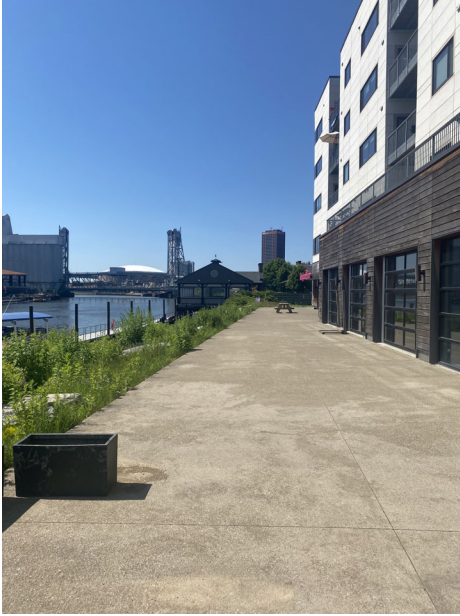
- Photo 1: Site Inspection – Mixed cover system along southern side of building (looking north).
Photo 2: Site Inspection – Mixed cover along eastern side of Building (looking north)
Photo 3: Site Inspection – Parking lot 301 Ohio area (looking south).
Photo 4: Site Inspection – Cover along eastern property boundary of the Site (looking north)

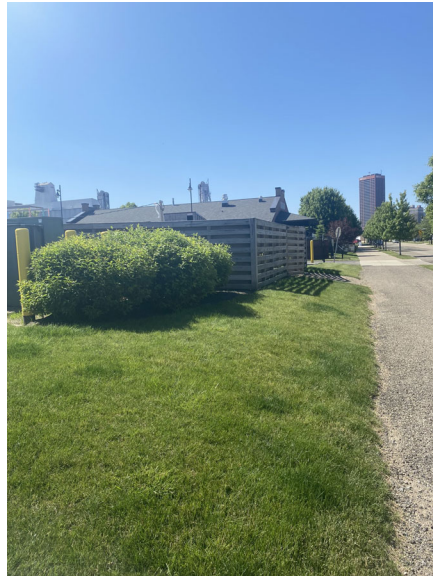
Photo 4:

Minor surface grass thinning-bare spots were noted at various locations along the eastern boundary berm. Landscape maintenance will be performed. Additional vegetation within areas of asphalt parking will be maintained.

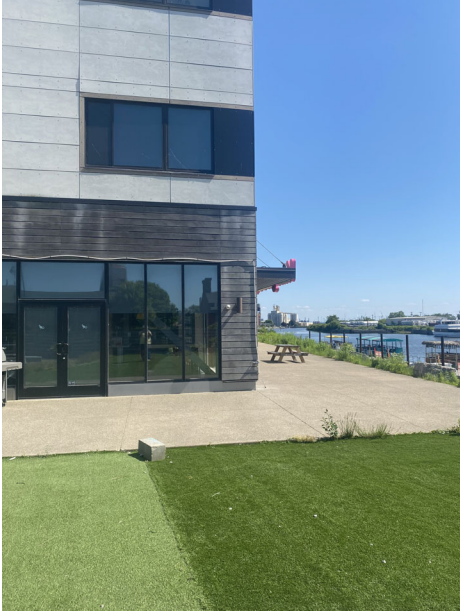
Various storage containers and surface areas are located in the 399 Ohio Street portion of the site along the river and are used seasonally for retail vending (e.g., boat tours and food vending). A portion of the sand court is covered with artificial turf (surface covering only).

- Photo 5: Site Inspection – Northern area of Site – Concrete patio and sand-synthetic turf area (looking south).
Photo 6: Site Inspection – Rip rap stone cover along the Buffalo River (looking south).
Photo 7: Site Inspection – Rip rap stone cover along Buffalo River (looking north)
Photo 8: Site Inspection – 399 Ohio portion asphalt cover (looking north).

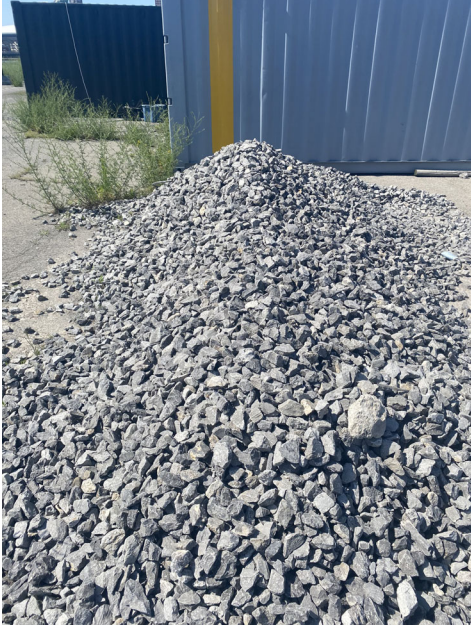
It should be noted that in May 2023, a pile of No. 3 stone was identified on-Site. It was determined that the clean stone was imported to the Site by a contractor working on the Buffalo River boat dock. The docks are outside of the BCP boundary, and the pile was surplus material that was not removed after project completion. As the pile was staged within the BCP boundary, the Department requested that an import request be prepared and submitted and subsequently approved. The pile is still present and is used as needed for maintenance of stone covered areas.

Photo 9: Site Inspection - Pile of Clean No. 3 stone (399 Parking Lot area with storage containers (looking north)

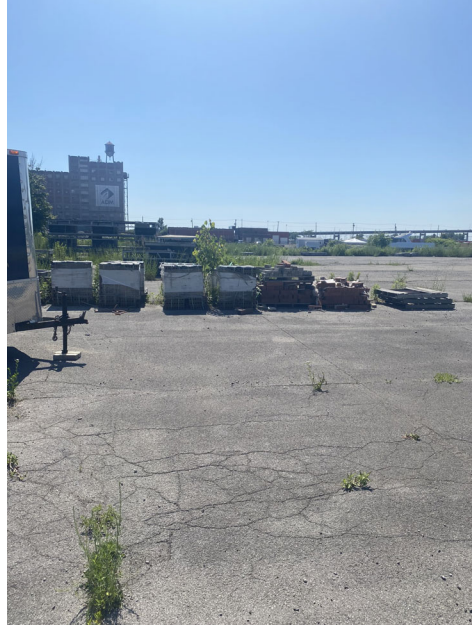
Photo 10: Site Inspection – Trailer and material pallet surface storage (399 Parking lot area) (looking west).

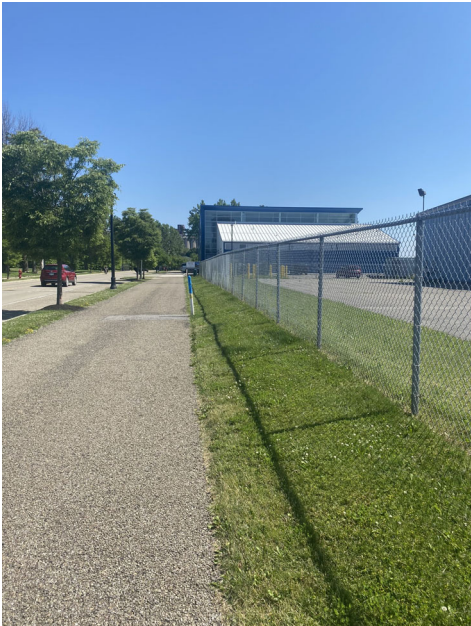
Photo 11: Site Inspection – Cover and fence along the eastern boundary (looking south).

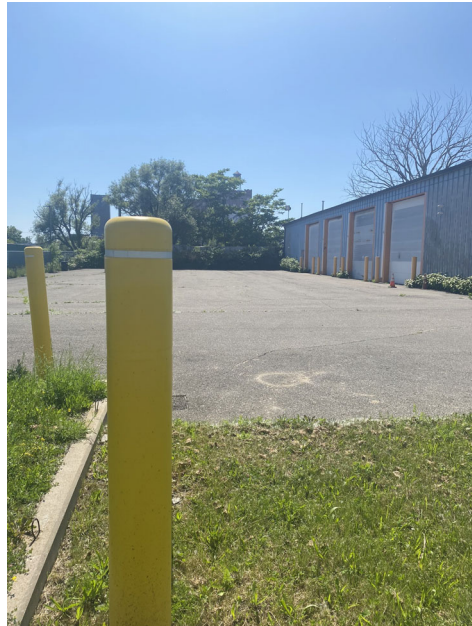
Photo 12: Site Inspection – Asphalt cover inside fence around Blue Bldg. (looking south).
