**HIGHLAND PLAZA
BROWNFIELD SITE # C915293**

**215 to 237 HIGHLAND PARKWAY
TONAWANDA, NEW YORK**

**REMEDIAL INVESTIGATION
FINAL REPORT**

May, 2017

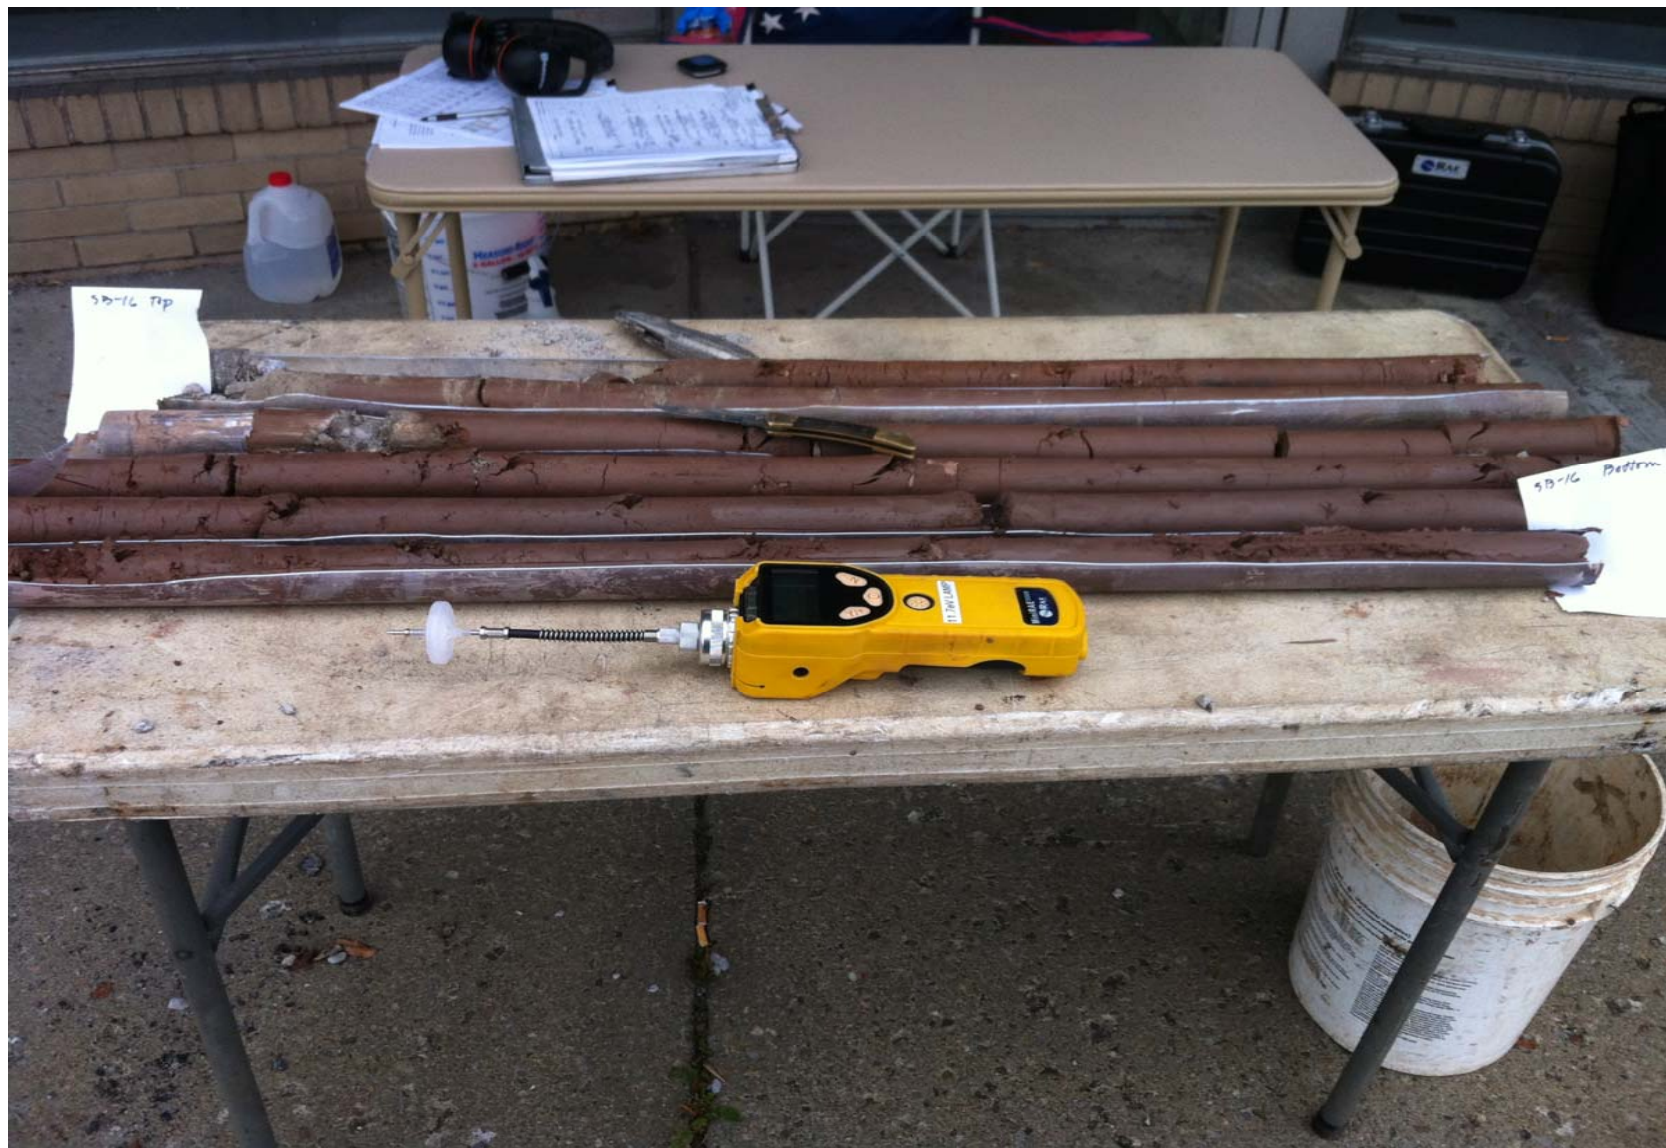
The native soils that underlie the Site consist of a very dense reddish brown silty clay that is greater than 24 feet in thickness (Photos 1, 2 and 3). There were no other soil types encountered in the soil borings that were advanced on the Site or adjacent properties. Silt and sand lenses were generally lacking in the native soil samples that were observed; however, minor amounts of sand and gravel occurred as matrix material within this silty clay unit. No groundwater was encountered during the advancement of the soil borings or installation of the groundwater monitoring wells.

Photo 1. SB-16 Soil Core showing red-brown silty clay.

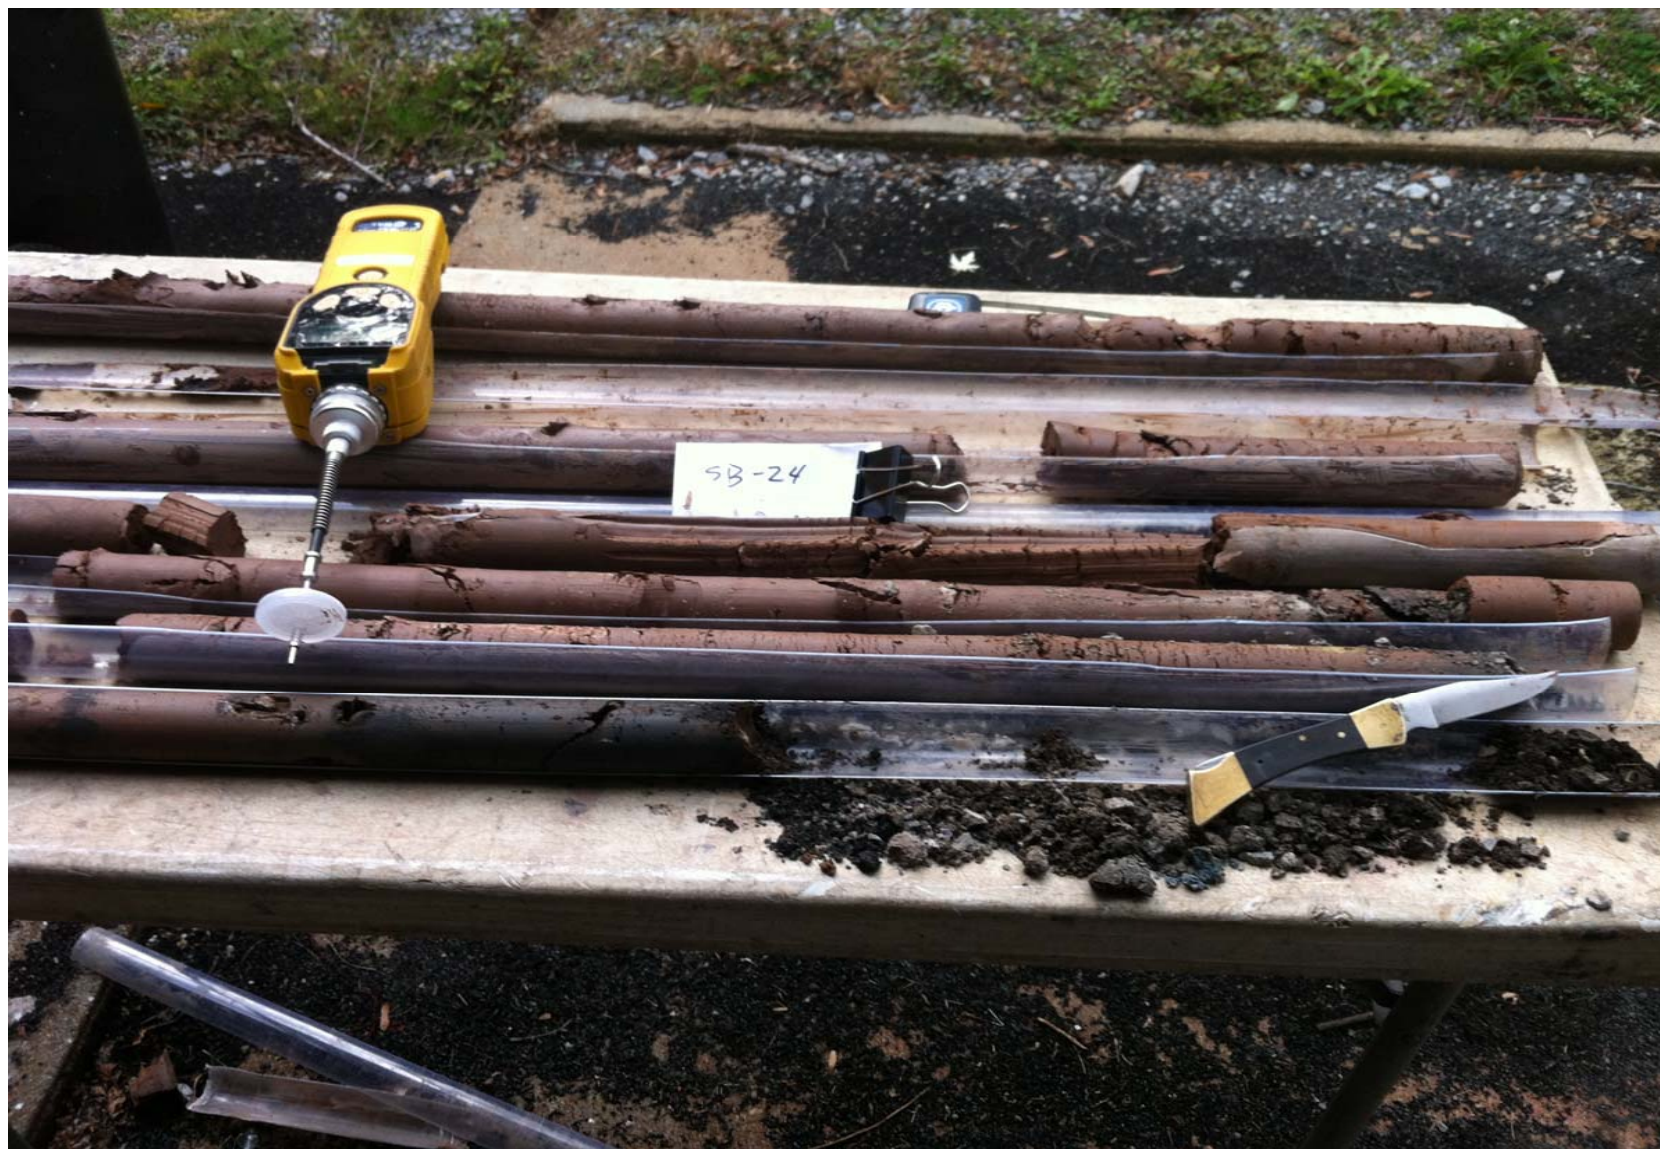
Photo 2 - Soil Core SB-24 showing millings, stained silty clay underlain by red-brown silty clay subsurface soils.

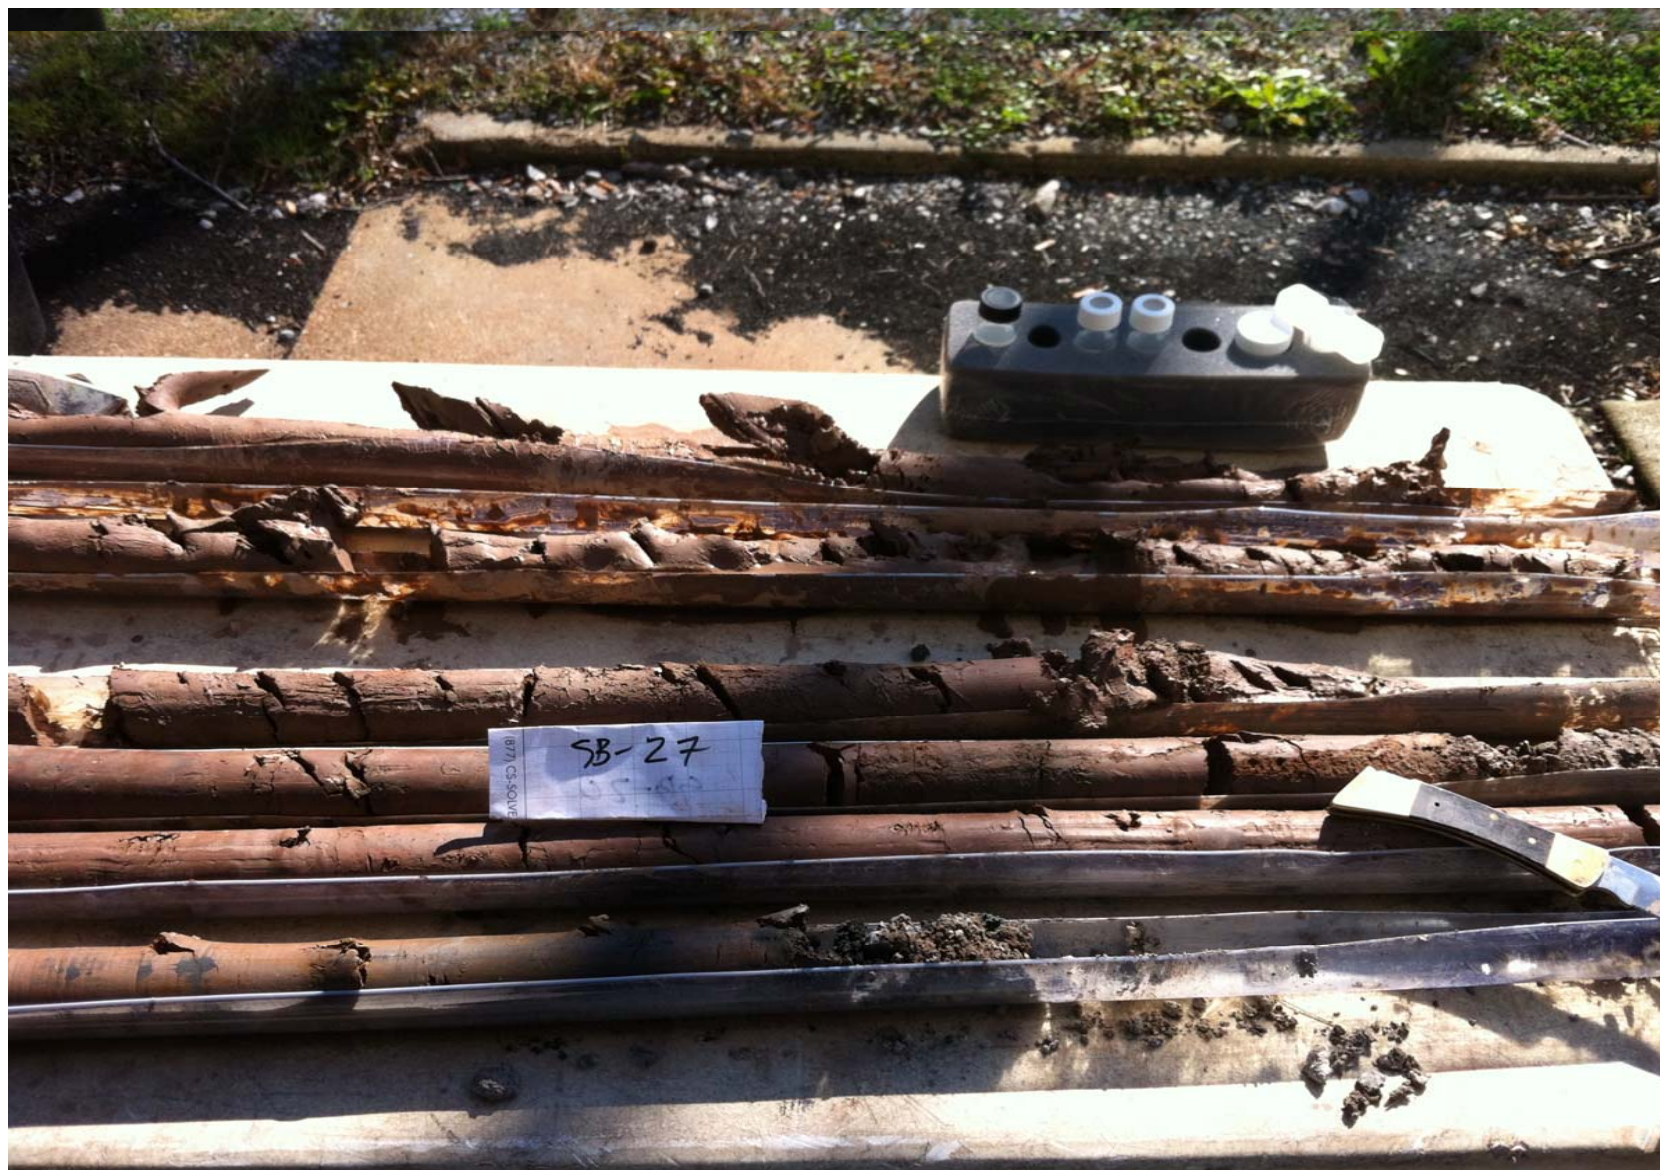
Photo 3 - Soil Core SB-27 showing millings, stained silty clay underlain by red-brown silty clay subsurface soils
