# **HIGHLAND PLAZA**

## **Periodic Review Report**

**April 29, 2019-April 29, 2020**

**NYSDEC Site Number: C 9 1 5 2 9 3**

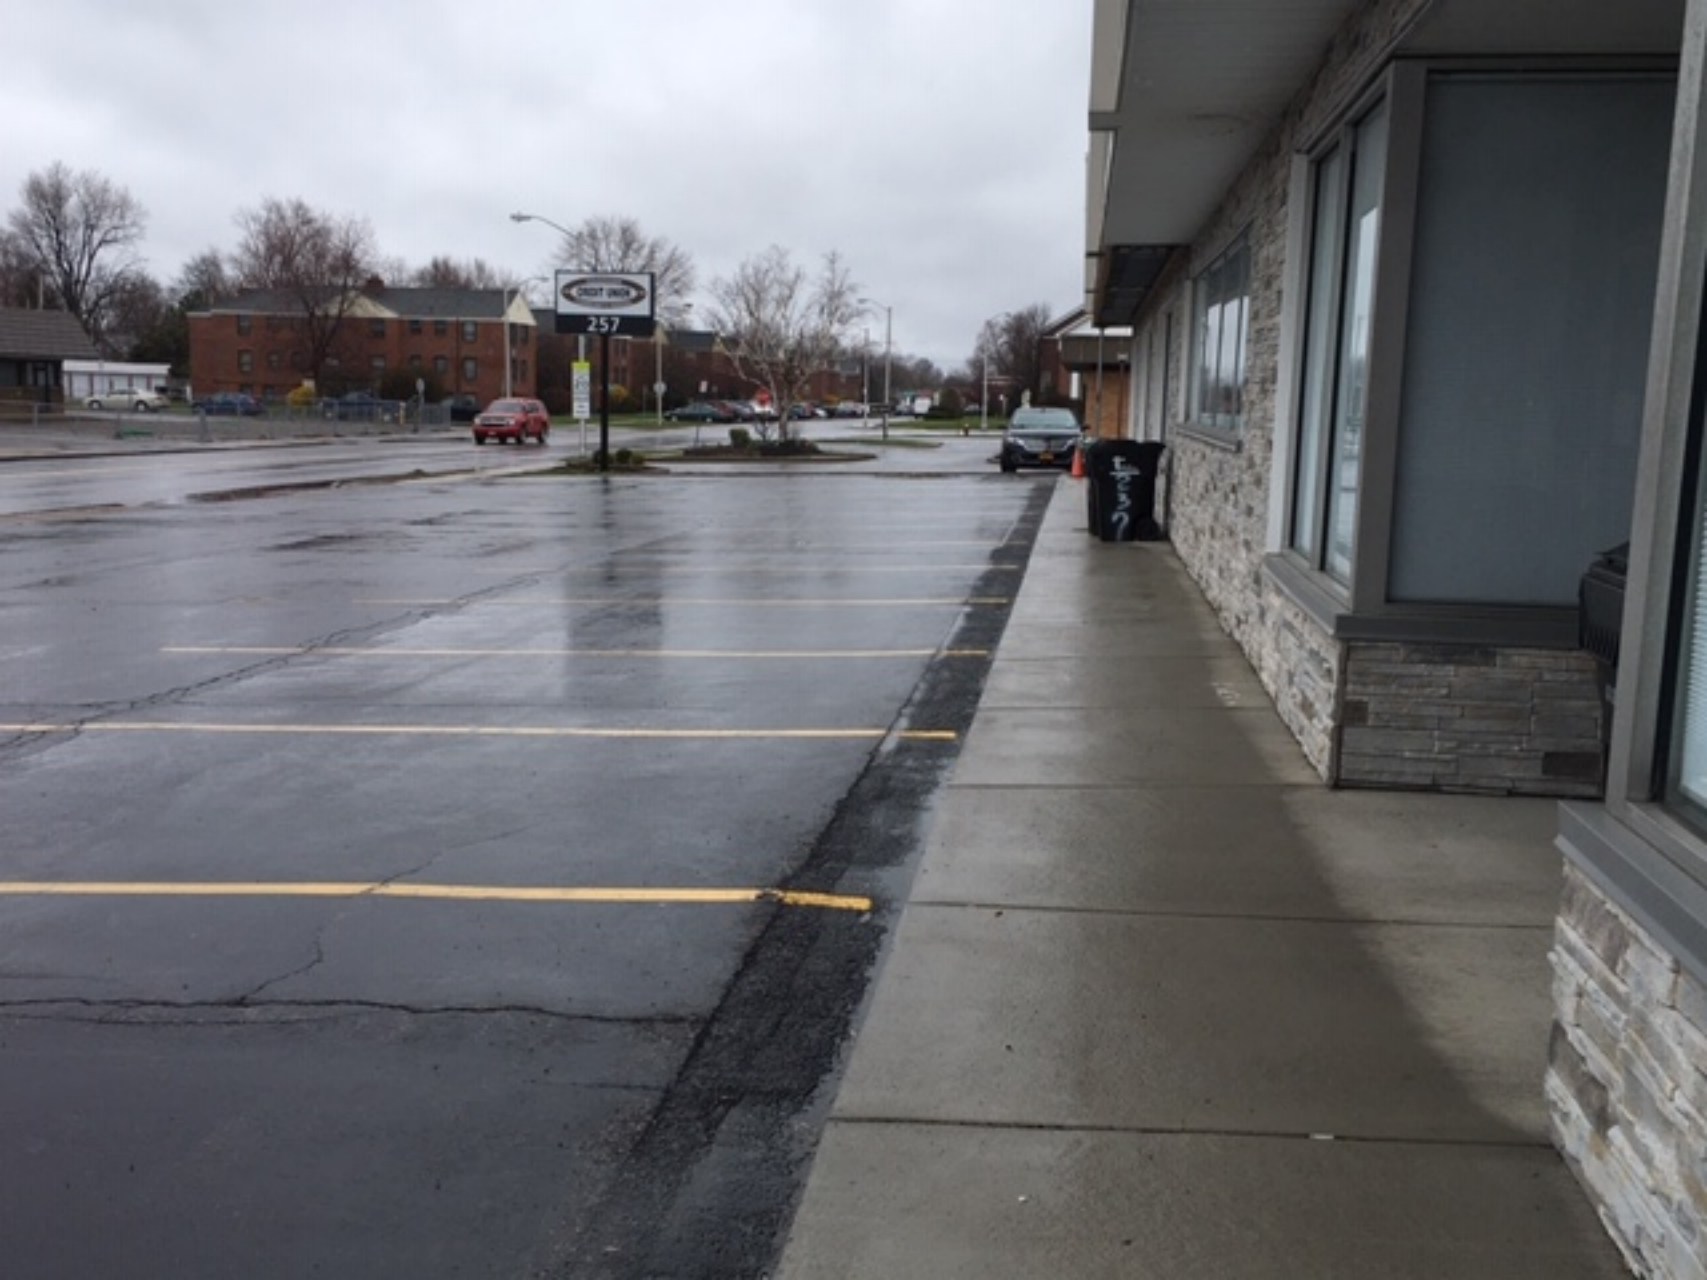
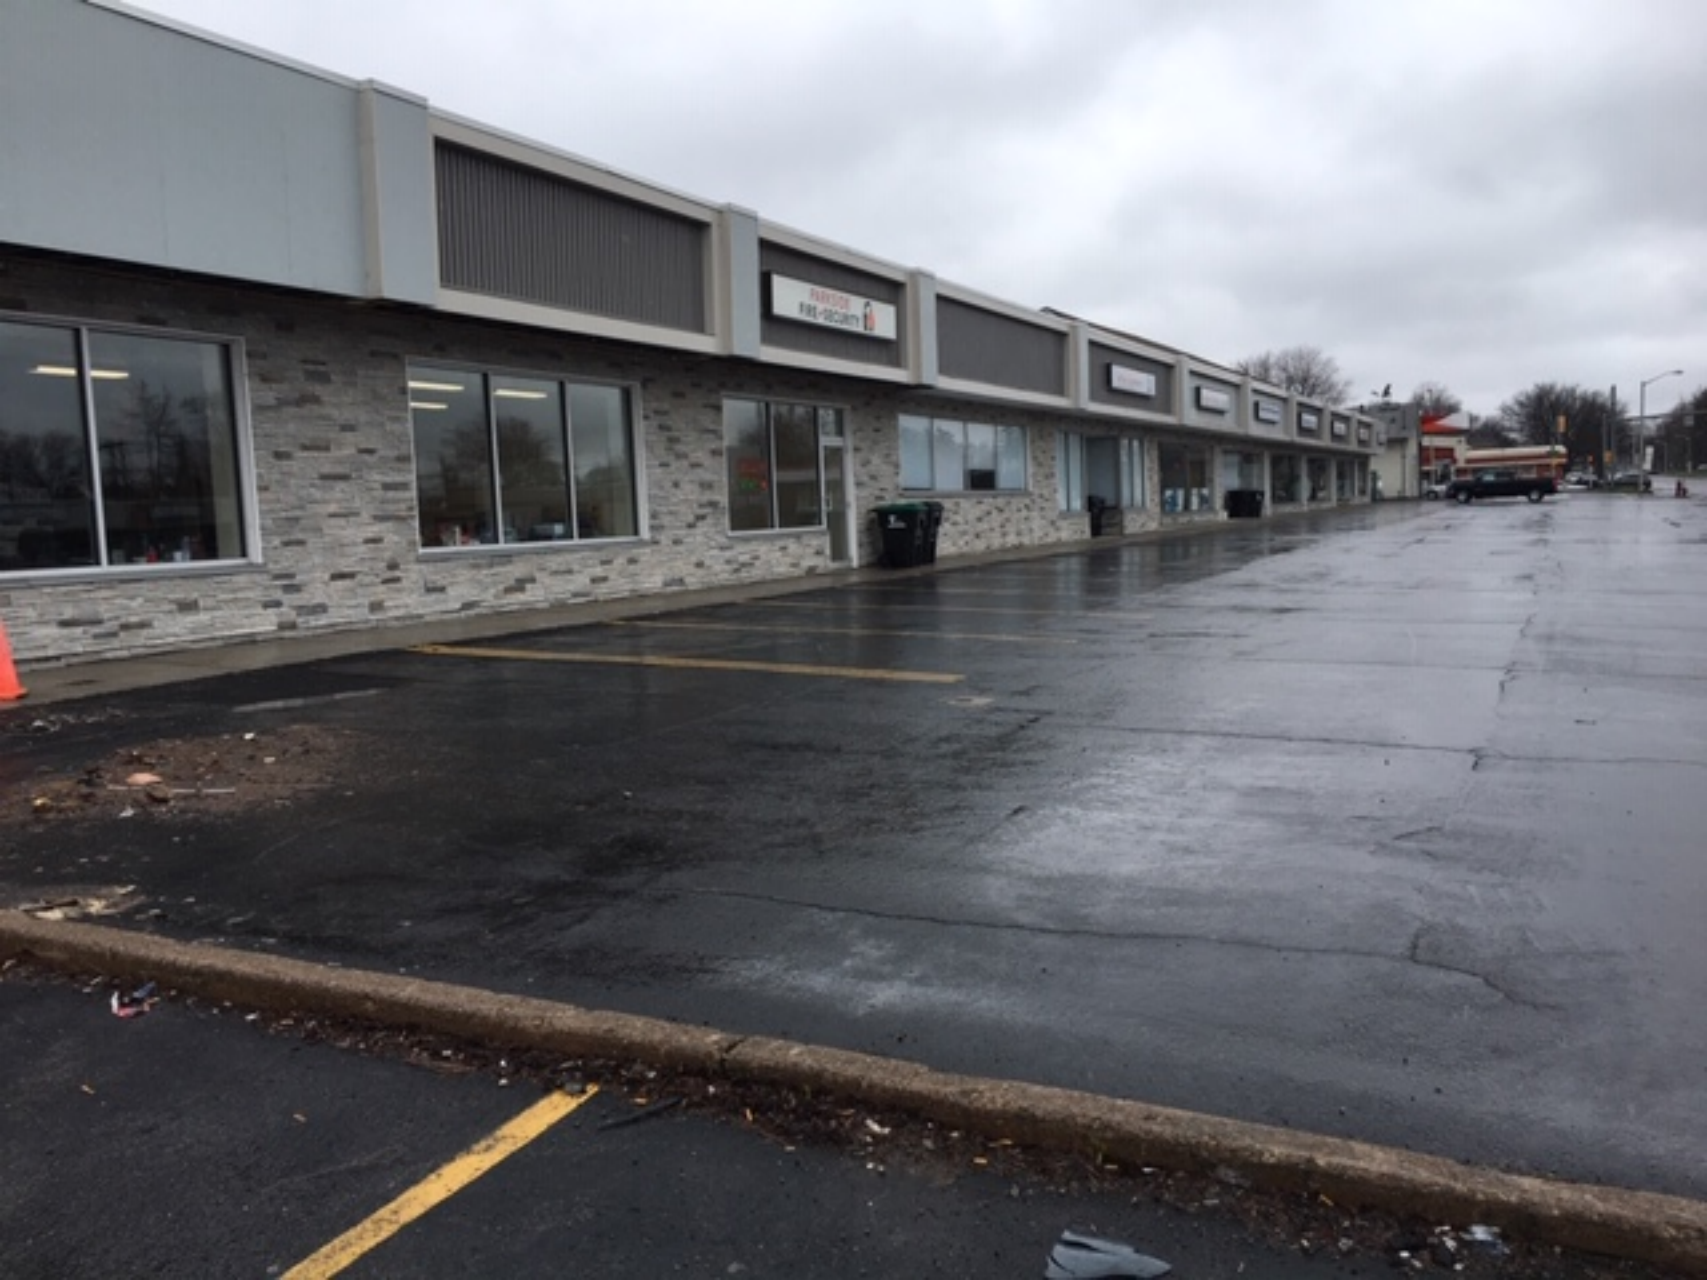
**PHOTOGRAPHS 1 & 2: FRONT PARKING LOT &  
SIDEWALK**

There were no breaches of the asphalt parking lot and concrete sidewalk directly in front of the buildings observed during the site visit on April 27, 2020.

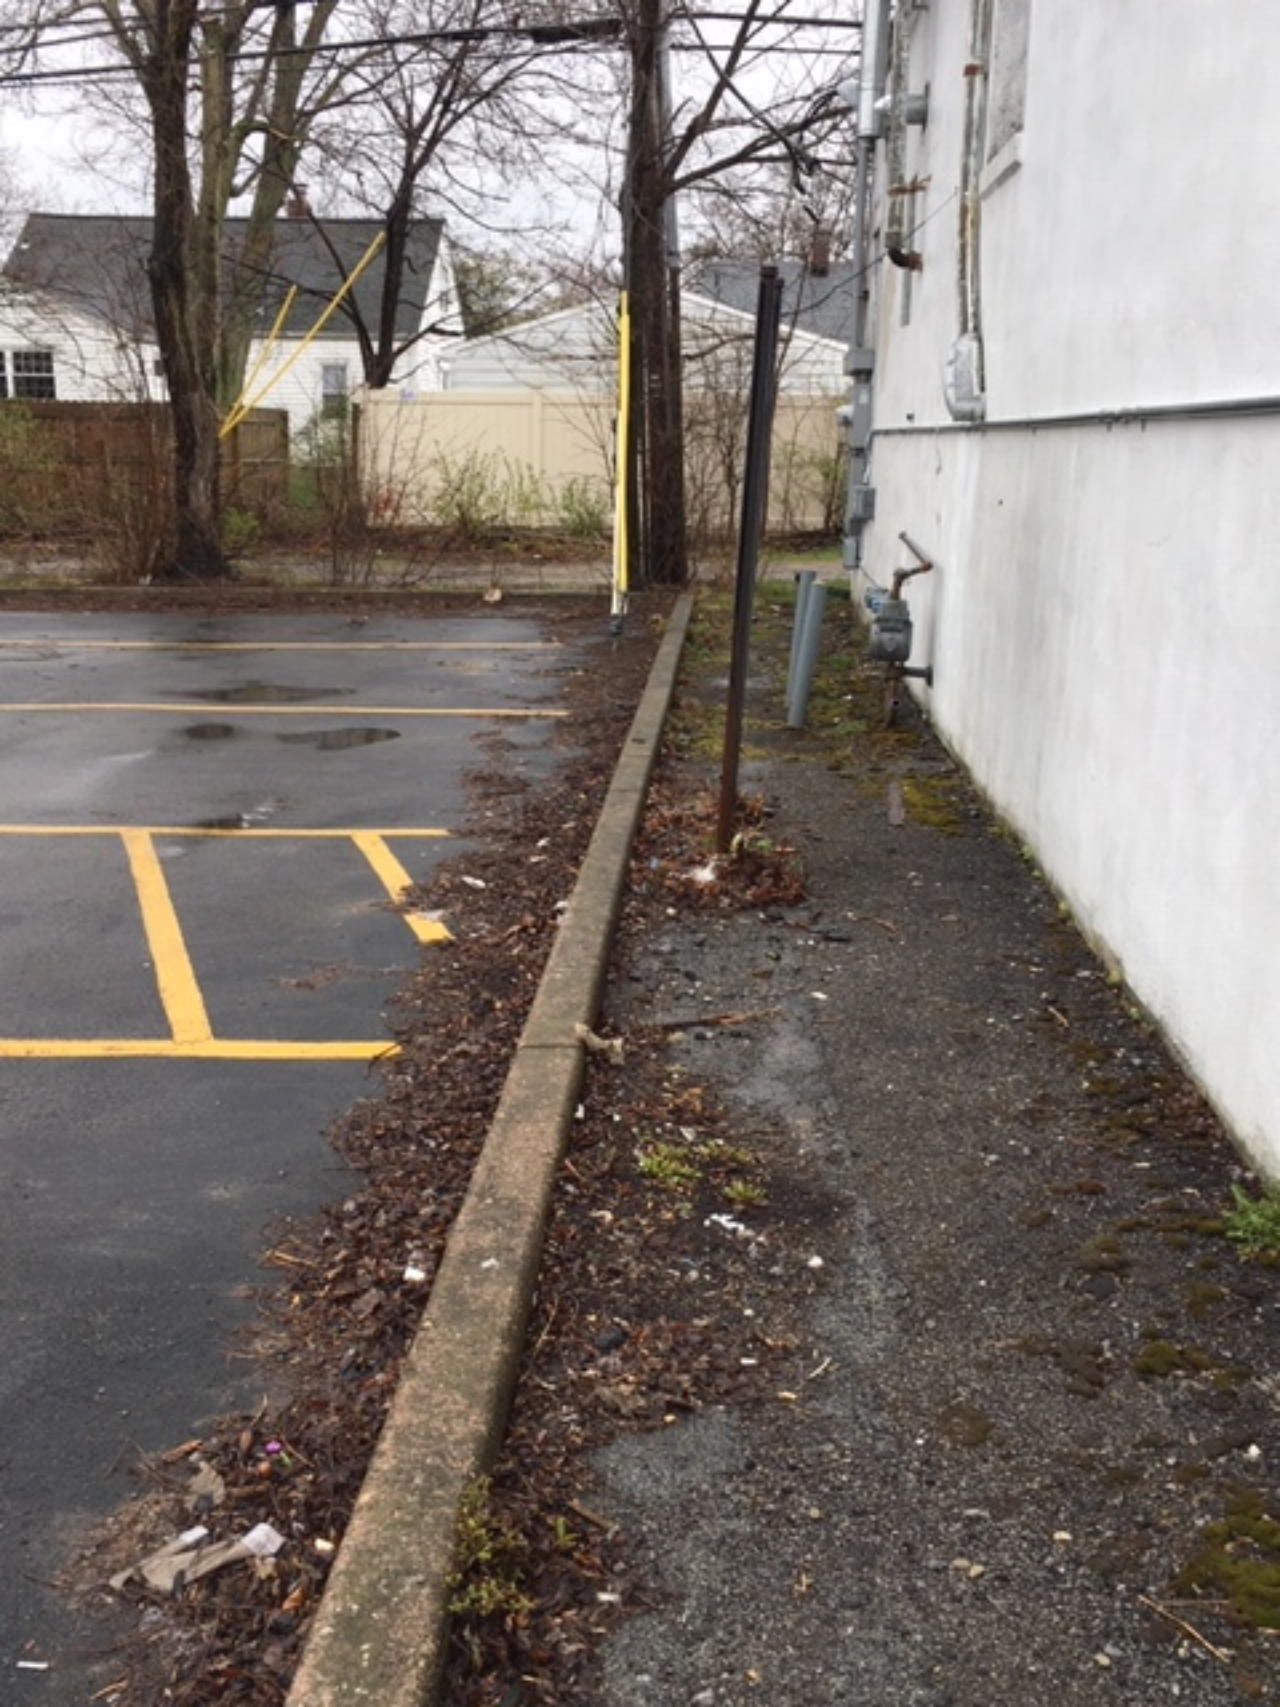
**PHOTOGRAPH OF CAP ON EAST END OF  
BUILDING #1**

There were no breaches of the soil cover along the east end of the building during the site visit on April 27, 2020.

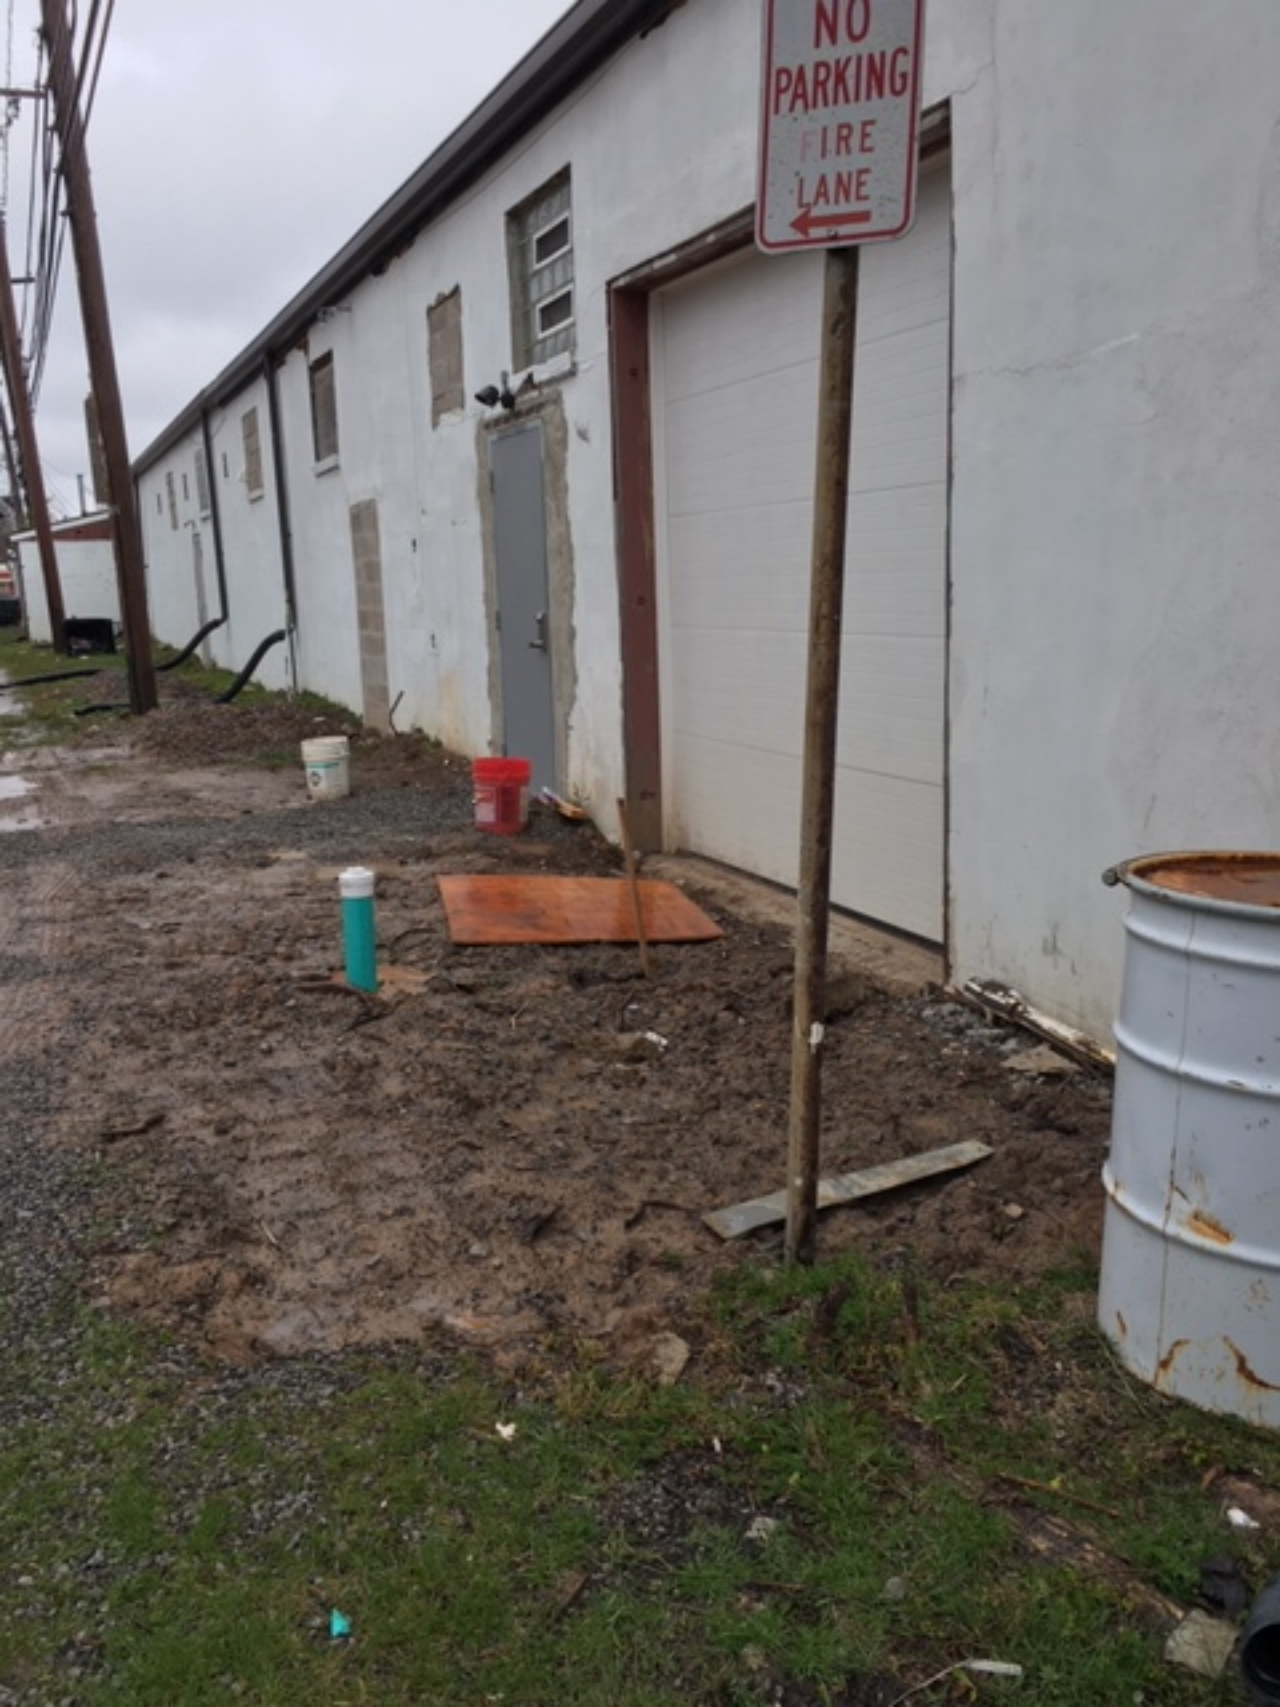
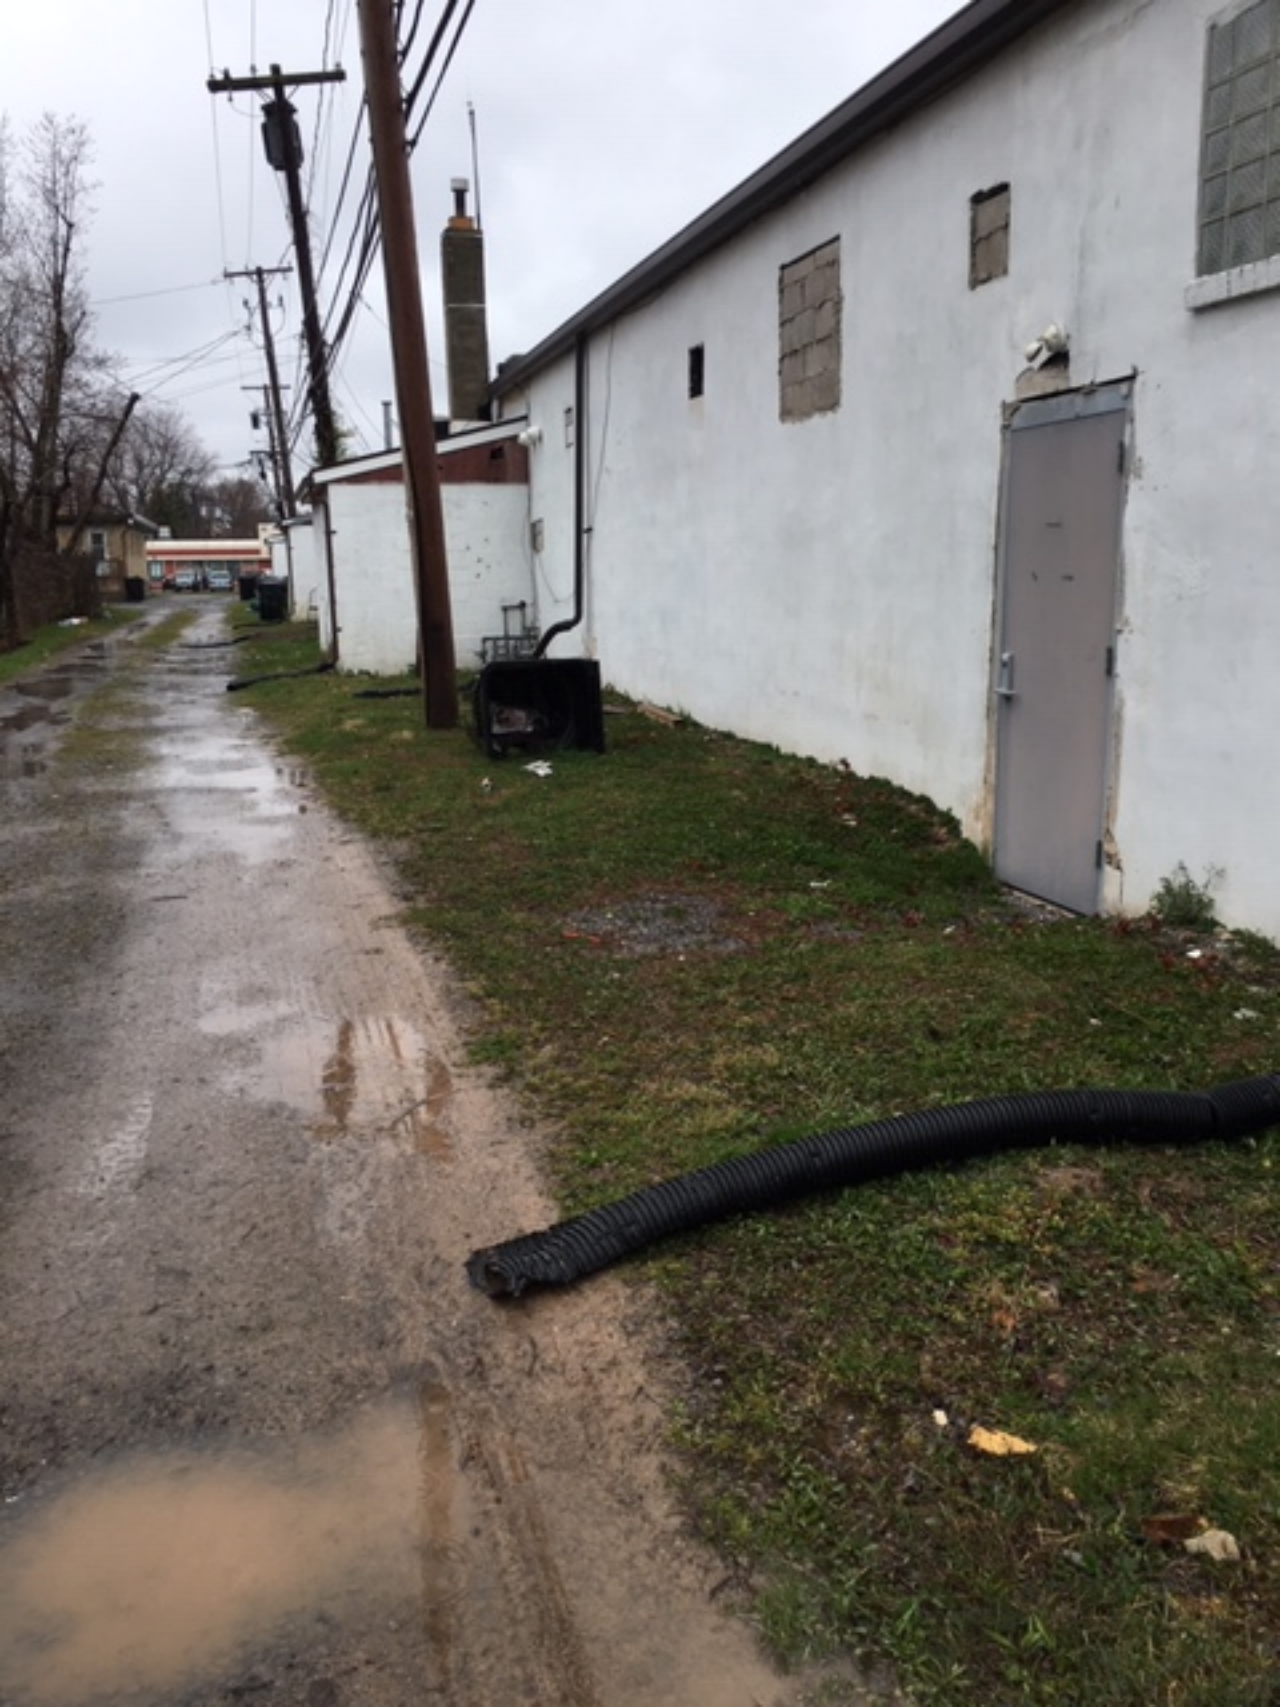
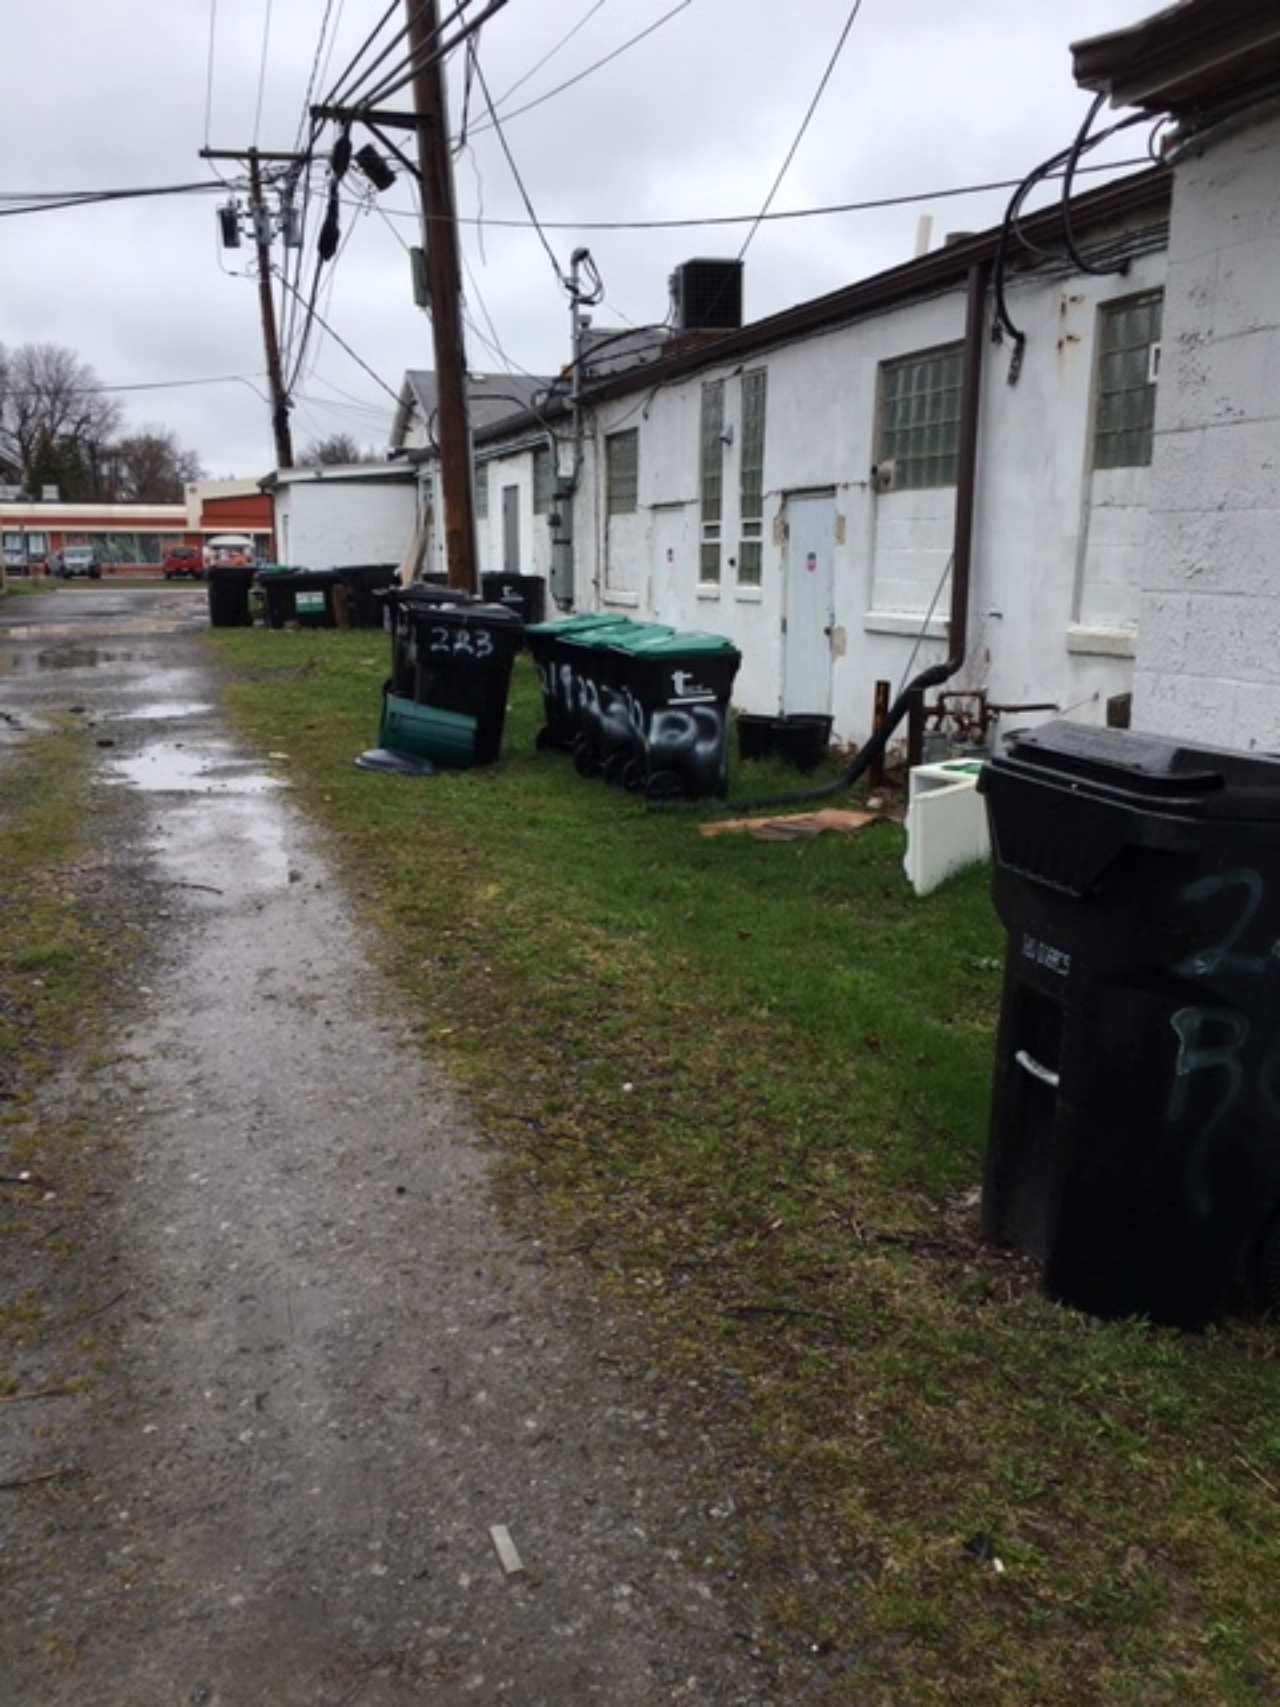
**PHOTOGRAPHS OF SOIL CAP SYSTEM BEHIND  
BUILDING**

There were two different site intrusive activities into the two foot wide clay cap behind the building during this annual reporting period:

1. The man door behind the easternmost building was blocked in, and the small concrete pad in front of the door was removed. The area was then backfilled with clean fill soil.
2. The four inch sewer line from the easternmost building unit collapsed underground, and was replaced with a six foot long run of four inch PVC pipe into the off-site sewer line located behind the building. Excavation activities were to approximately 36 inches. Crushed stone was placed around the PVC pipe and the trench was filled in with the excavated soil material. PVC clean out port is now visible behind the building (Photos 3 and 4).
